The Peace River Bridge Collapse:

***Fourteen Illustrations of the Collapse of the Bridge over
the Peace River at Taylor, British Columbia in October,
1957 with some personal recollections***

S. Thomson

Canadian Geotechnical Society, 2010

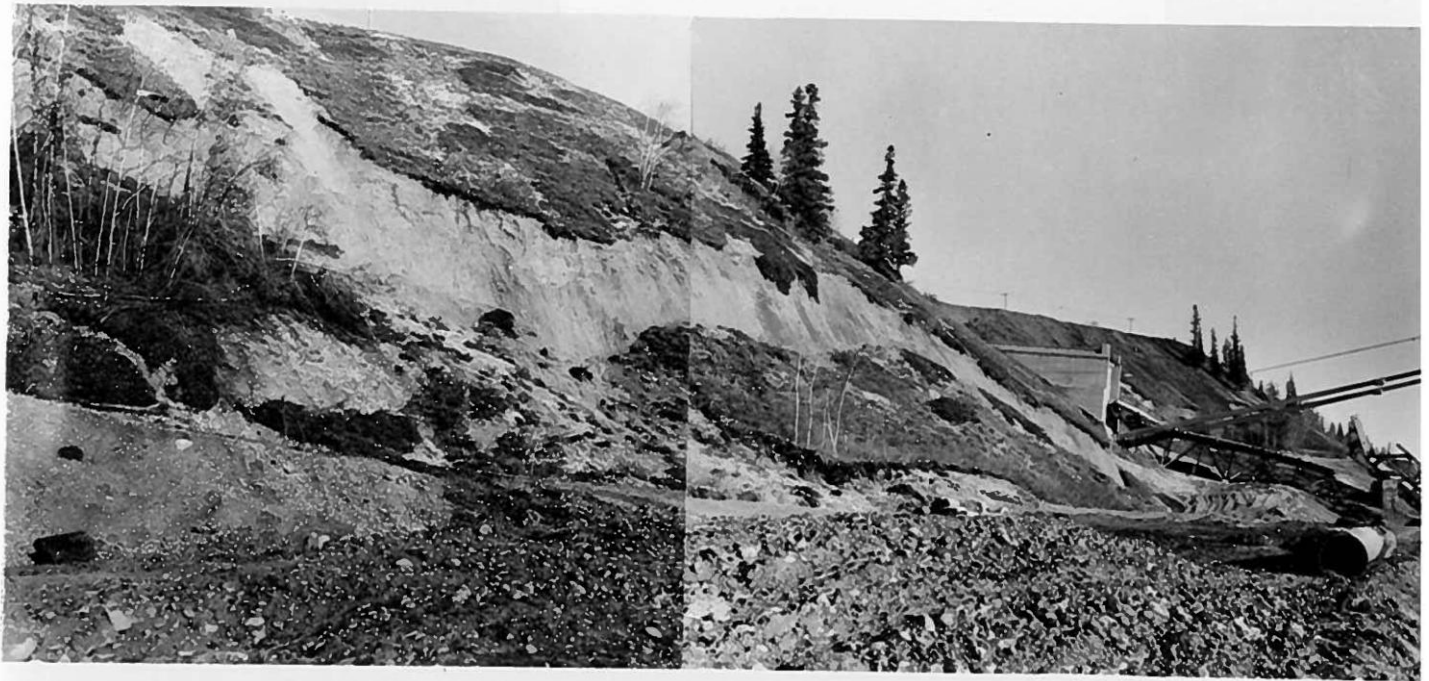
years, weathered to a highly plastic clay. The loss of strength of the clay shale since construction of the bridge was the major cause of the landslide that led to the loss of the bridge. The collapsed spans and part of the scarp are shown in Figs. 3 and 4.

Figure 3. View from west of scarp of landslide, North abutment and collapsed approach span in background

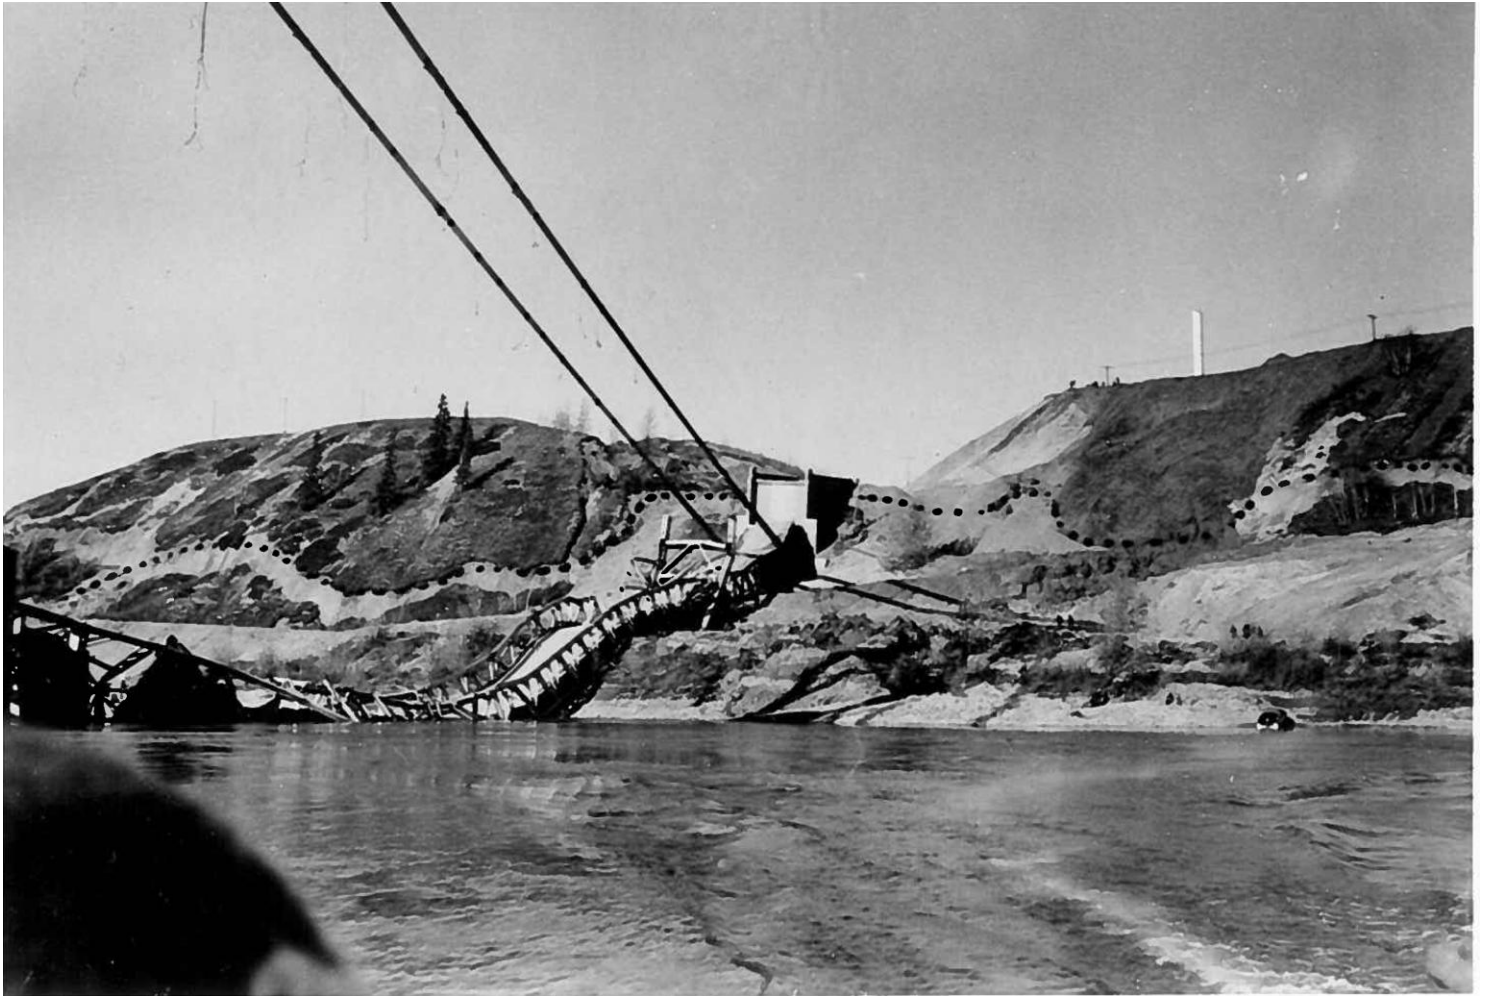
Faint shadows near the edge of the river may be evidence of the toe of the landslide. Not visible on this photo (but seen in Figure 4, taken after the event) are the pipelines delivering water to the gas cleaning plant located on the high level terrace just above the slide. Apparently, the pipelines have not broken completely but are likely leaking strongly and causing some slope erosion independent of landslide movement.

Figure 4. View from the south east of North span and approach span collapsed. Note snapped suspender cables. The dotted line traces the scarp of the slide.

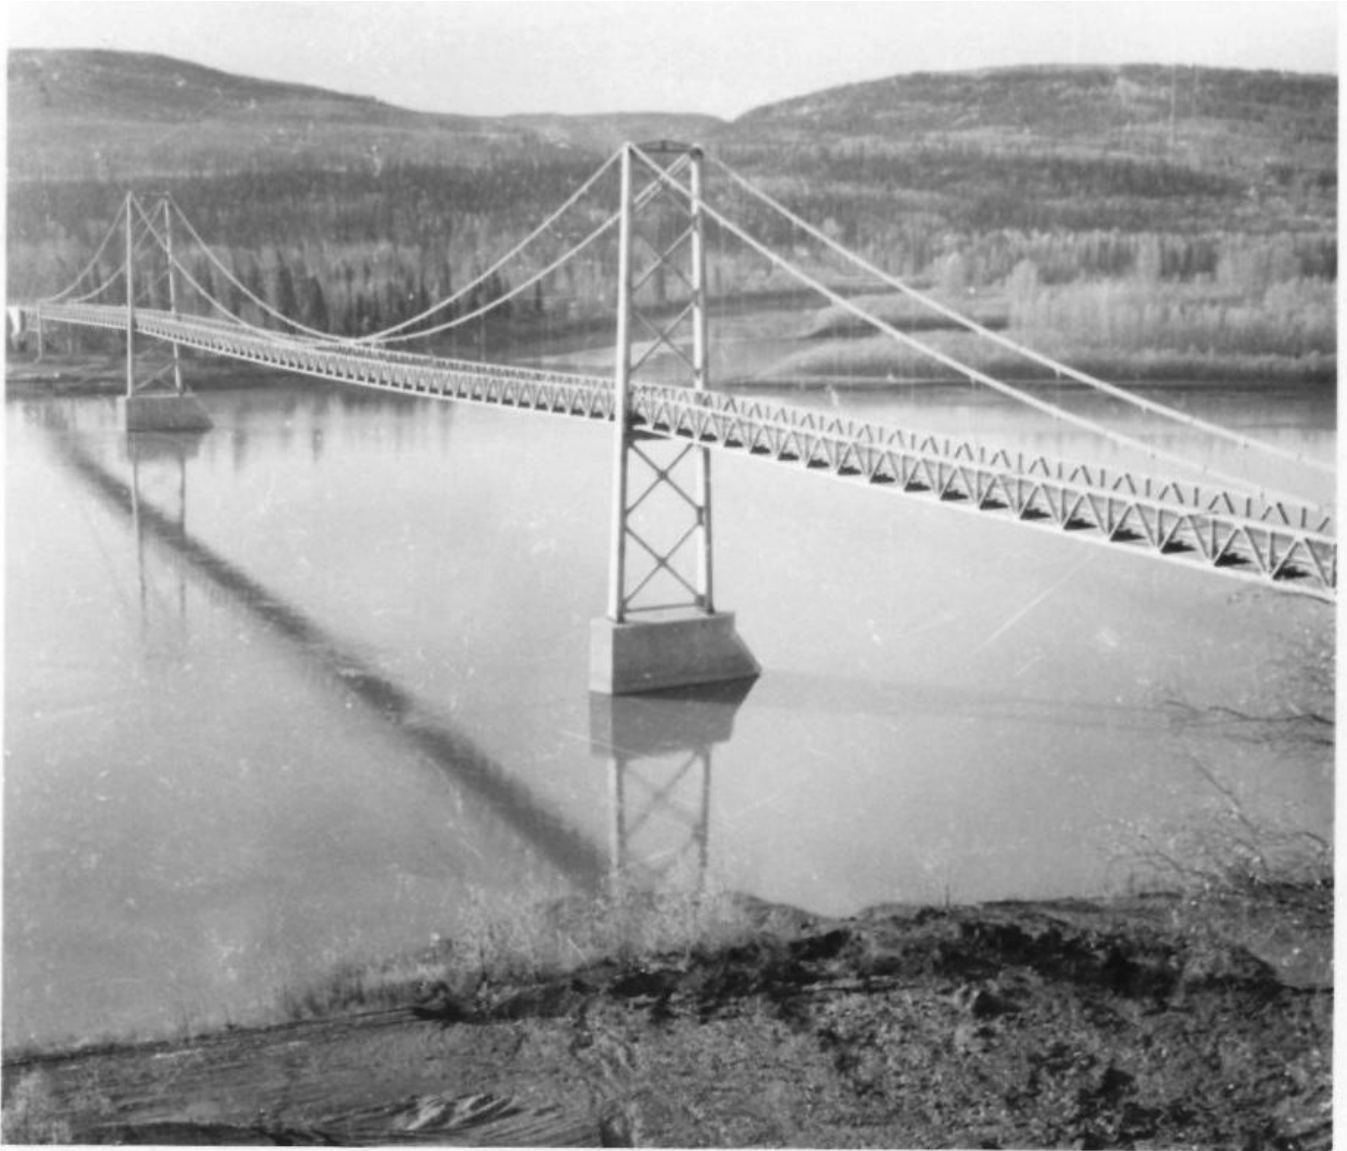
A general view from the north-east on the morning of 16 October (Fig. 5) shows the centre span, perhaps sagging. The upstream faces of the piers slope westwards and are semi-circular in plan. Debris coming down the river seemed to ride up the piers and fall off.

Figure 5. General view from northeast, 16 October.

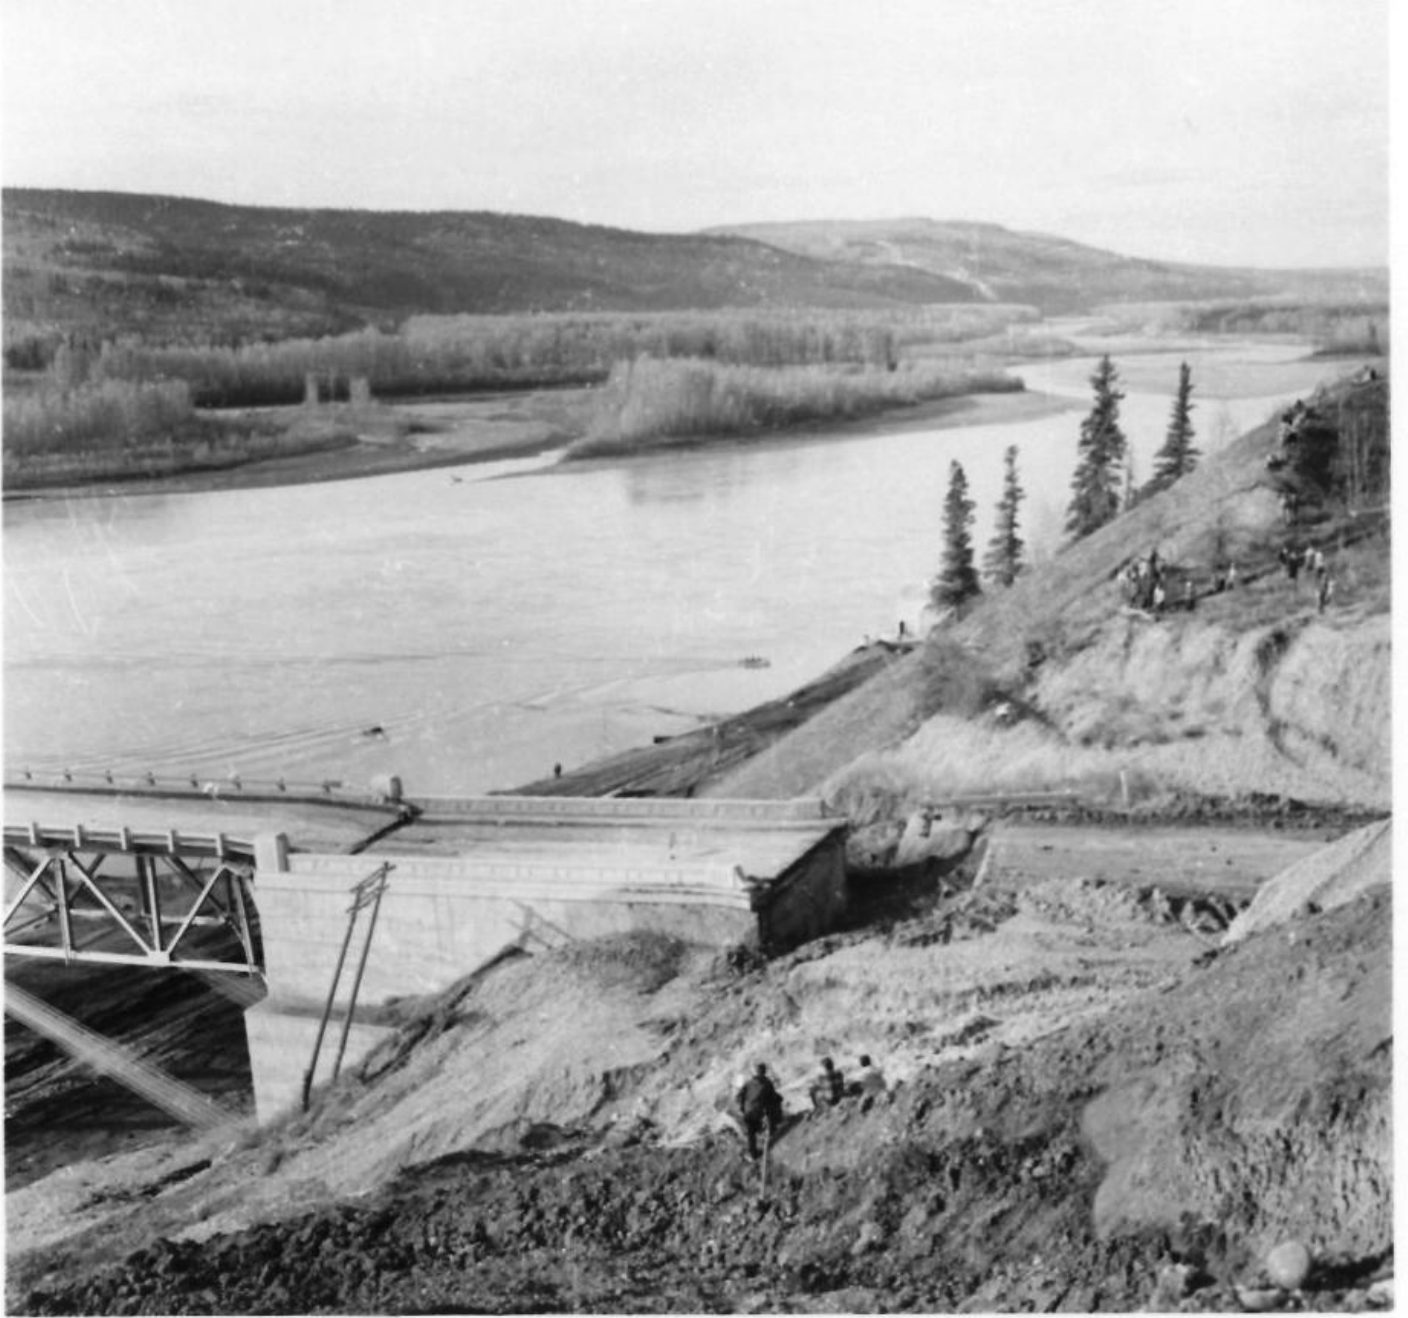
In Figure 6, the anchor block and north abutment have moved riverward and downward. The roadway on the abutment appears to have moved under the truss (Figure 7, 8) distorting the truss where it joins the abutment. The truss has been forced riverwards as the abutment has moved – note the gap behind (and north) of the abutment. The abutment was about 9 metres (30 feet) wide, about the distance the abutment moved. The truss moved the same distance without significant distortion but has distorted the cable bent.

People on both sides of the abutment are close to the crown of the slide. The scarp can be seen in Figure 6 along with ground that emerges from the river.

Figure 6. Anchor block and north abutment. Persons give scale.

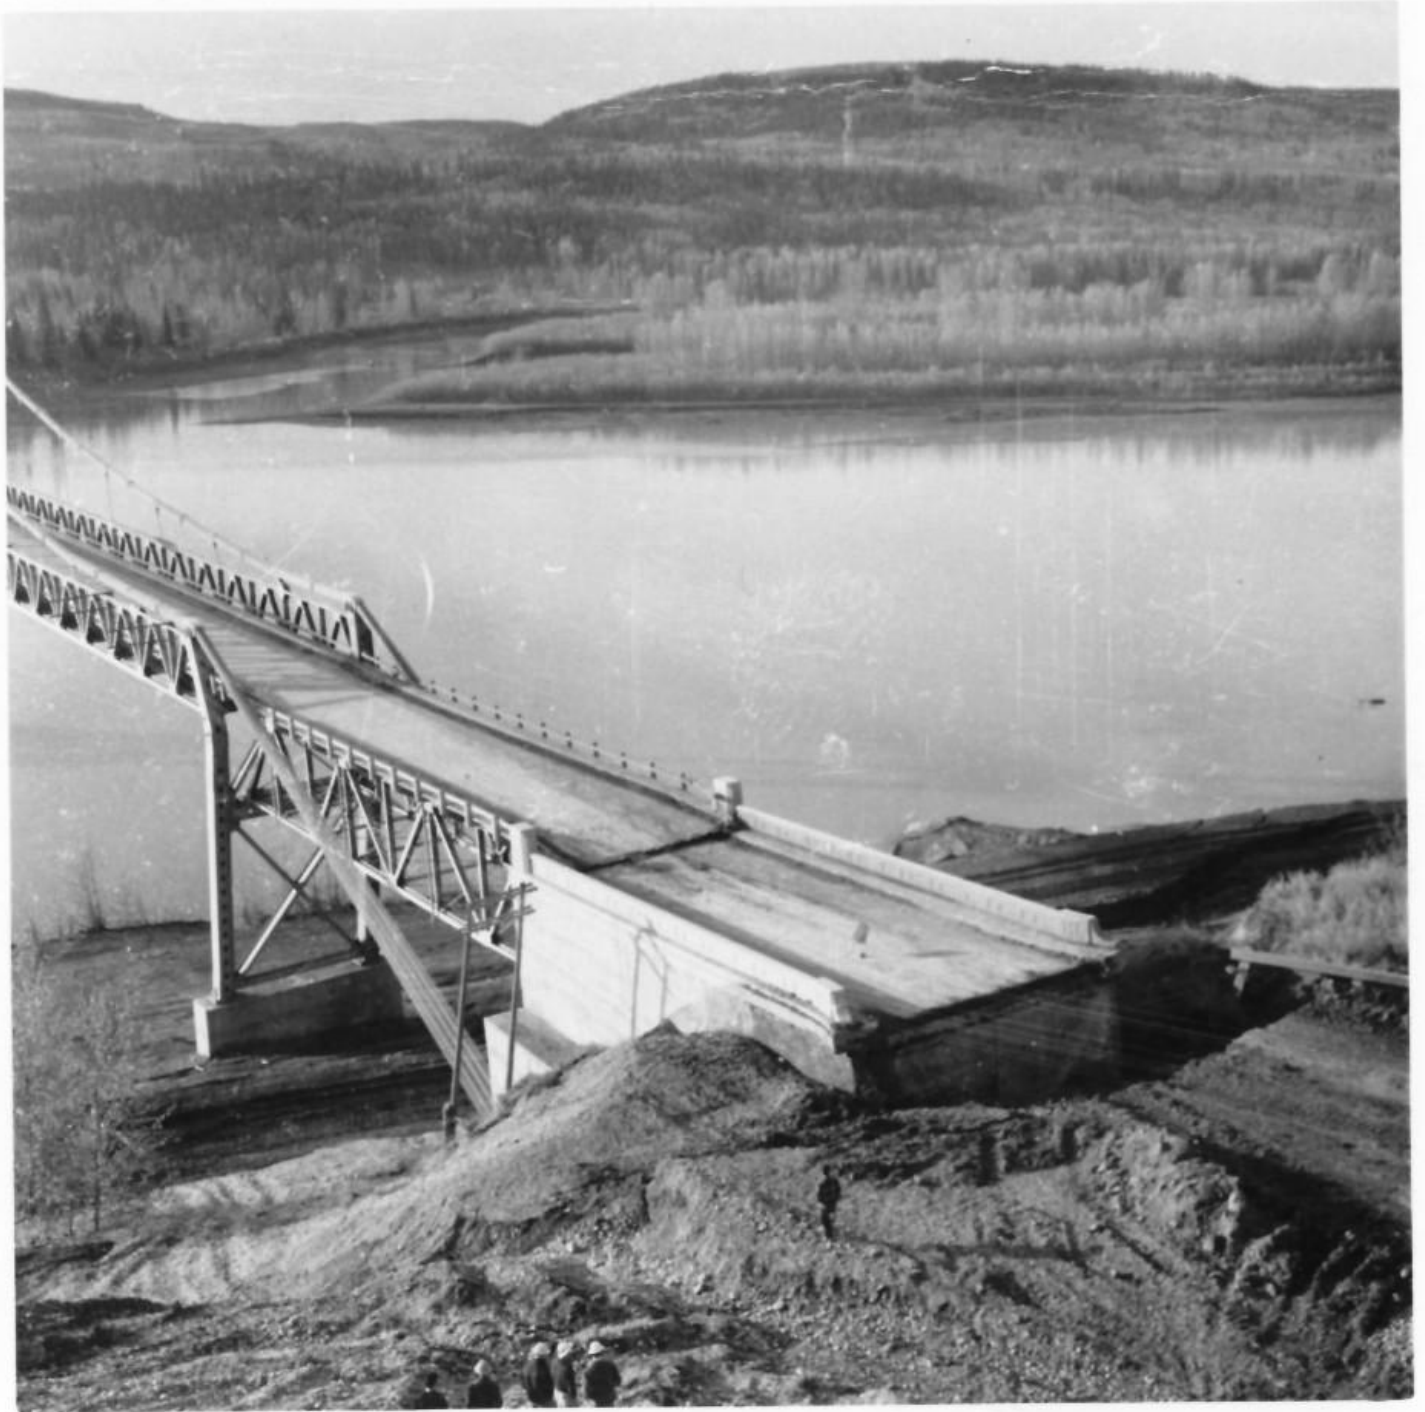
In Figure 7, the gap behind the anchor block appears to be about the same width as in Figure 6. Hence Figure 7 appears to be taken soon after Figure 6. The distortion of the cable bent at the top of the north pier is clear. The entire cable bent is leaning towards the river.

The abutment has a small tilt riverward. The truss is distressed only at its ends; it has not buckled but is forcing the cable bent out-of-position and, eventually, off its foundation.

Figure 7. Roadway on abutment has moved under the truss.

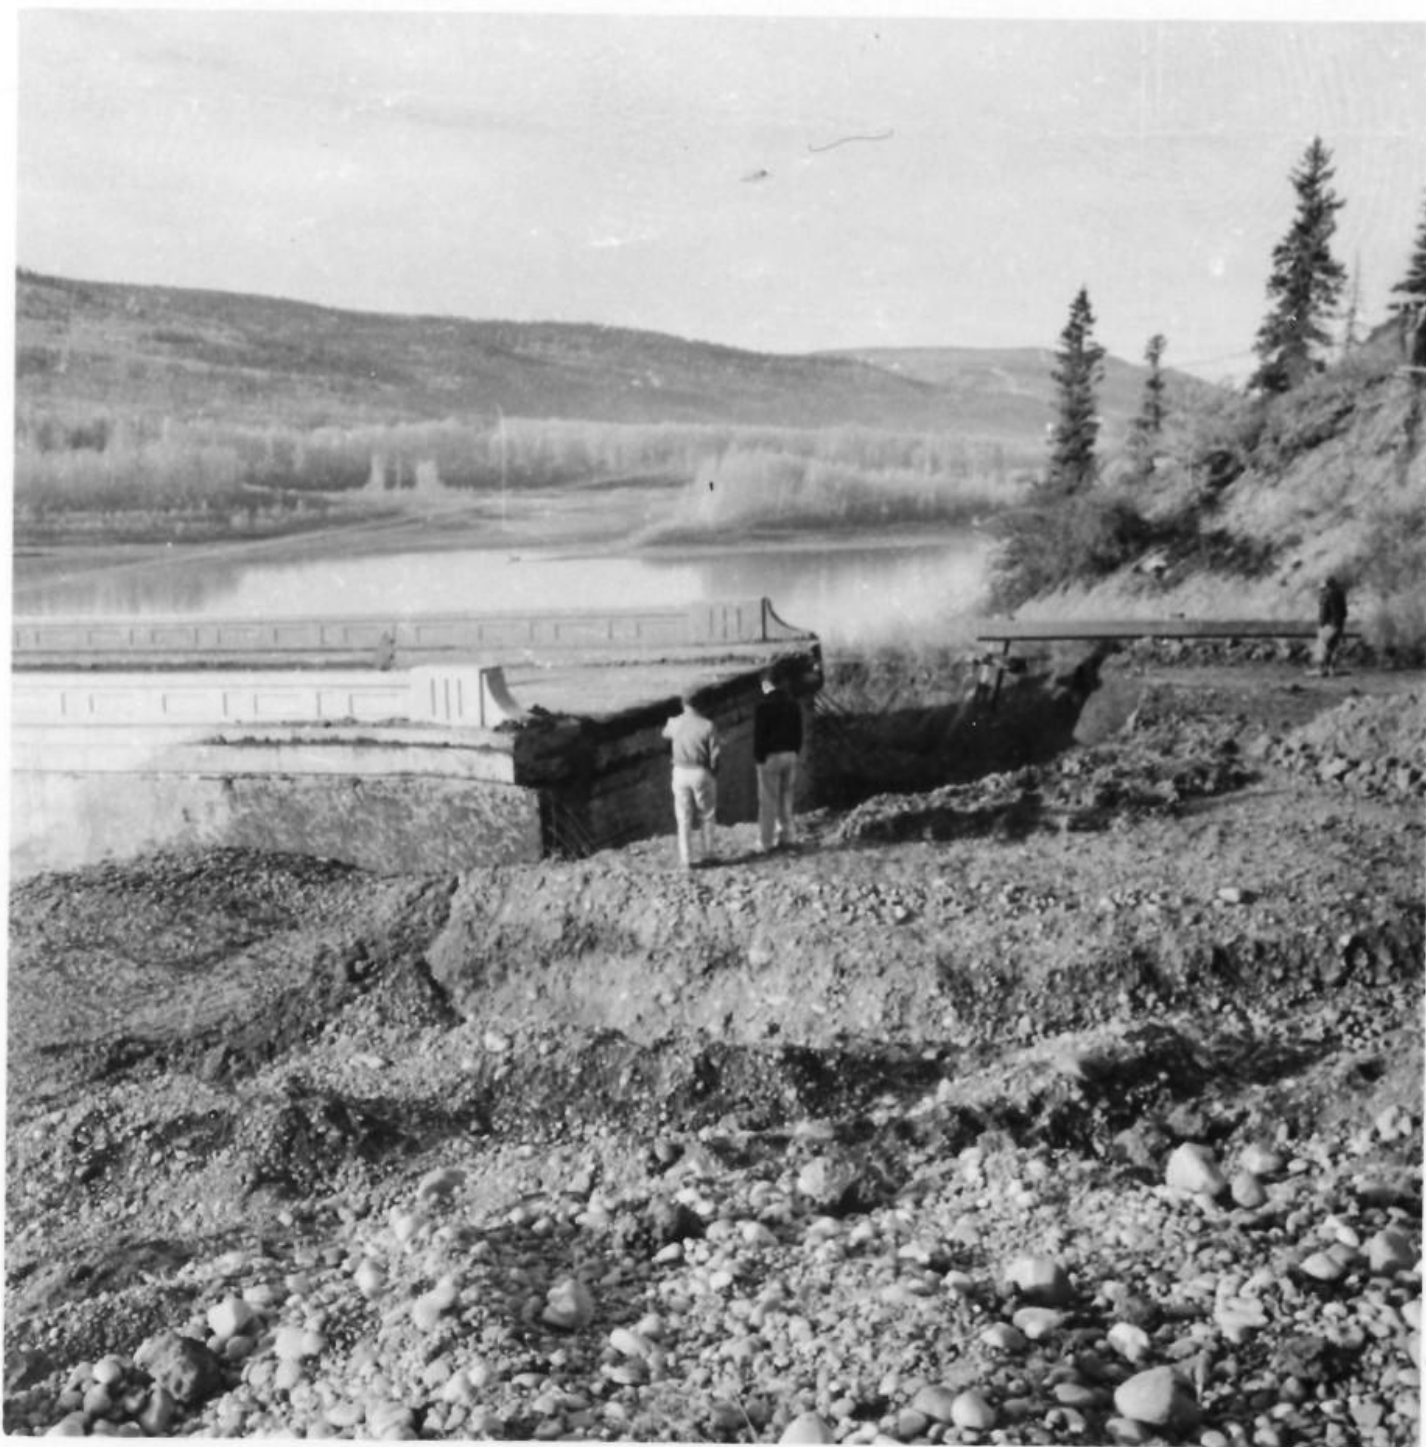
Figure 8 shows more riverward movement and greater tilt of the anchor block. The three figures are in somewhat precarious locations.

Figure 8. More riverward movement of the anchor block

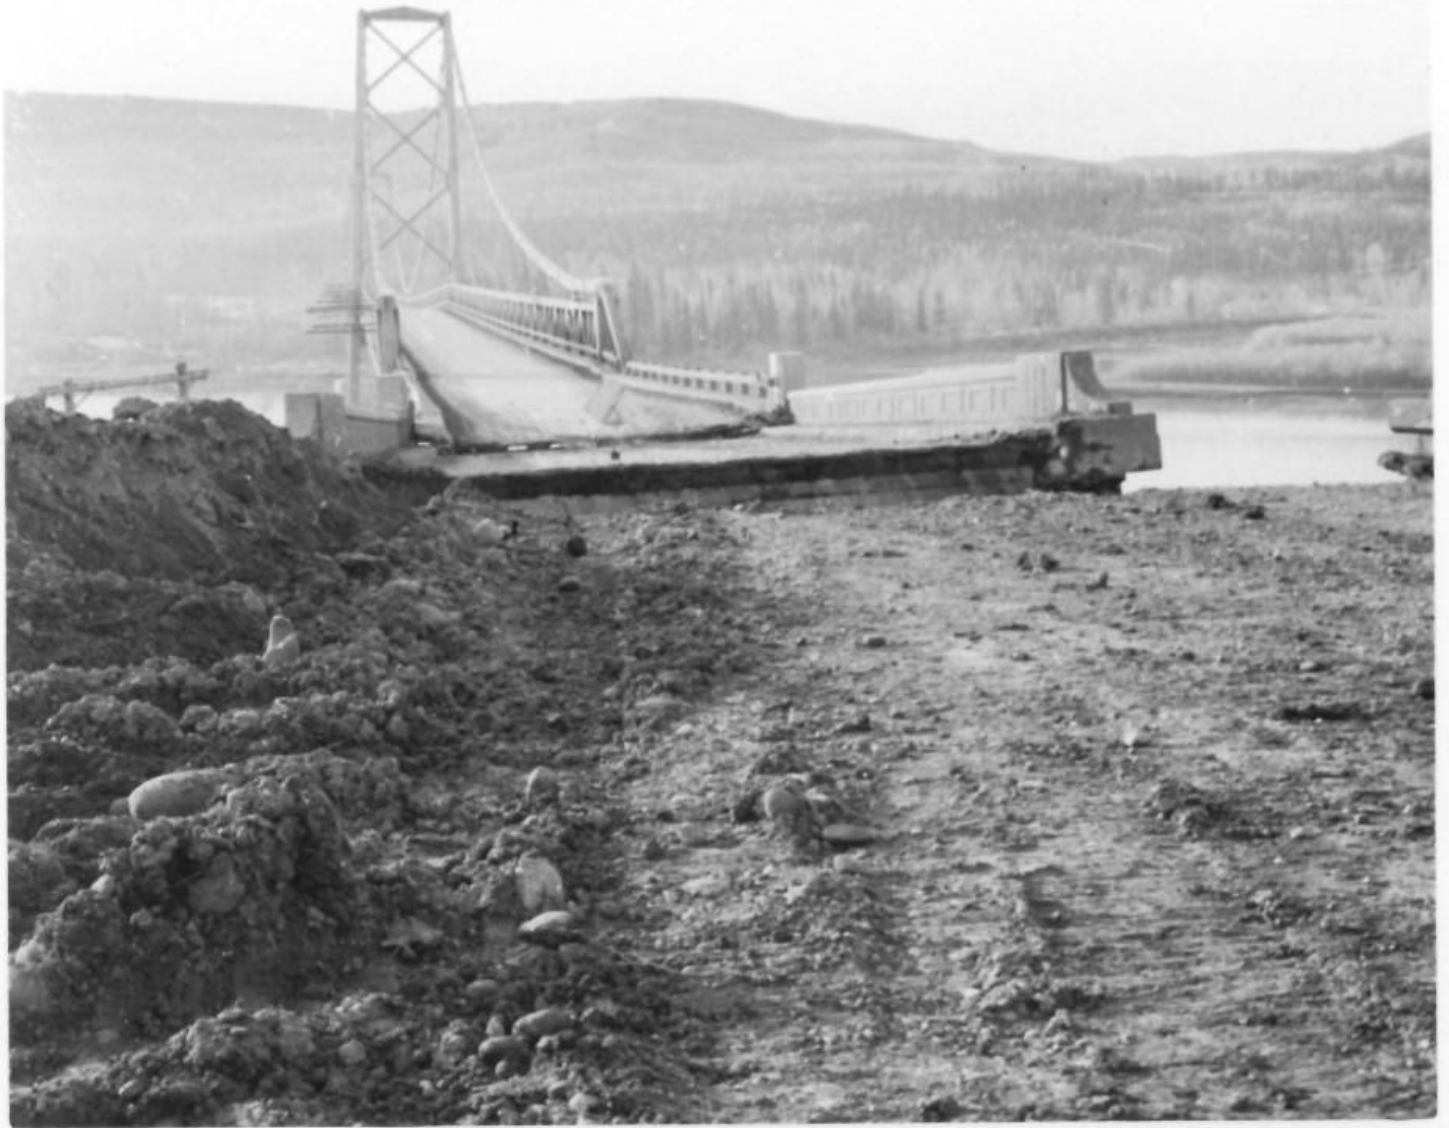
In Figure 9, the bridge deck seems to be over-riding the abutment which is tilting more and going under the road. The road bed appears kinked at the junction between the truss and the suspended side span. This probably shows more movement in the cable bent. There is a down-river tilt to the anchor block, likely the effect of pipelines breaking and water gushing out causing more slope erosion.

Figure 9. Looking south, along the Bridge

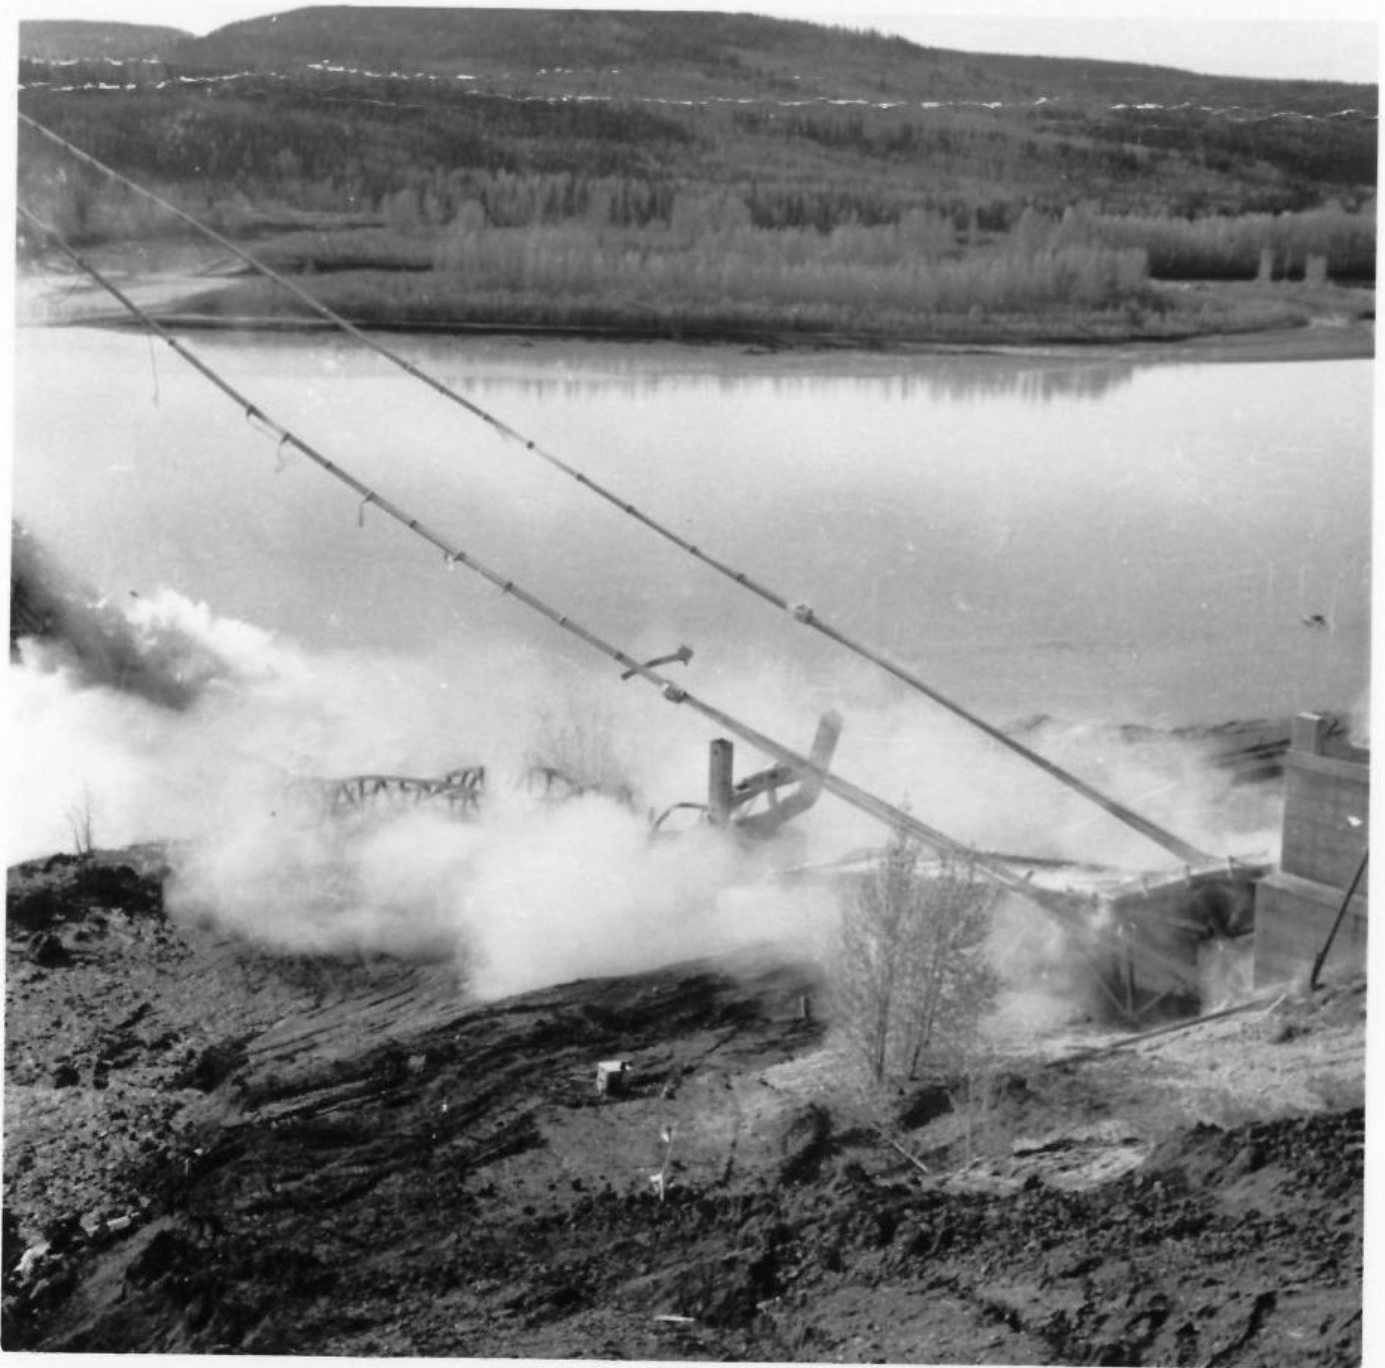
Figure 10 shows the cable bent pushed right off its foundation. The cables form straight lines from the anchor to the North tower. The lines placed a great deal of strain on the hangers, visible in Figure 5. The hangers broke and the side span collapsed. The truss had collapsed earlier when the cable bent was pushed from its foundation. Note the way the cable bent is falling. The distorted part is the top of the bent. Figure 7 suggests the bent is being pushed over at its top; it should topple towards the river and Figure 10 should show the base, not the top. If the bent were pushed off but held temporarily by the connectors where the cables went over the bent (visible on the cables in Figures 10, 11, 12) for sufficiently long to let the base of the bent move downhill – before the connecting saddles broke, the result would be as seen in Figures 10, 11, 12.

Figure 10. The fall of the north side span and truss

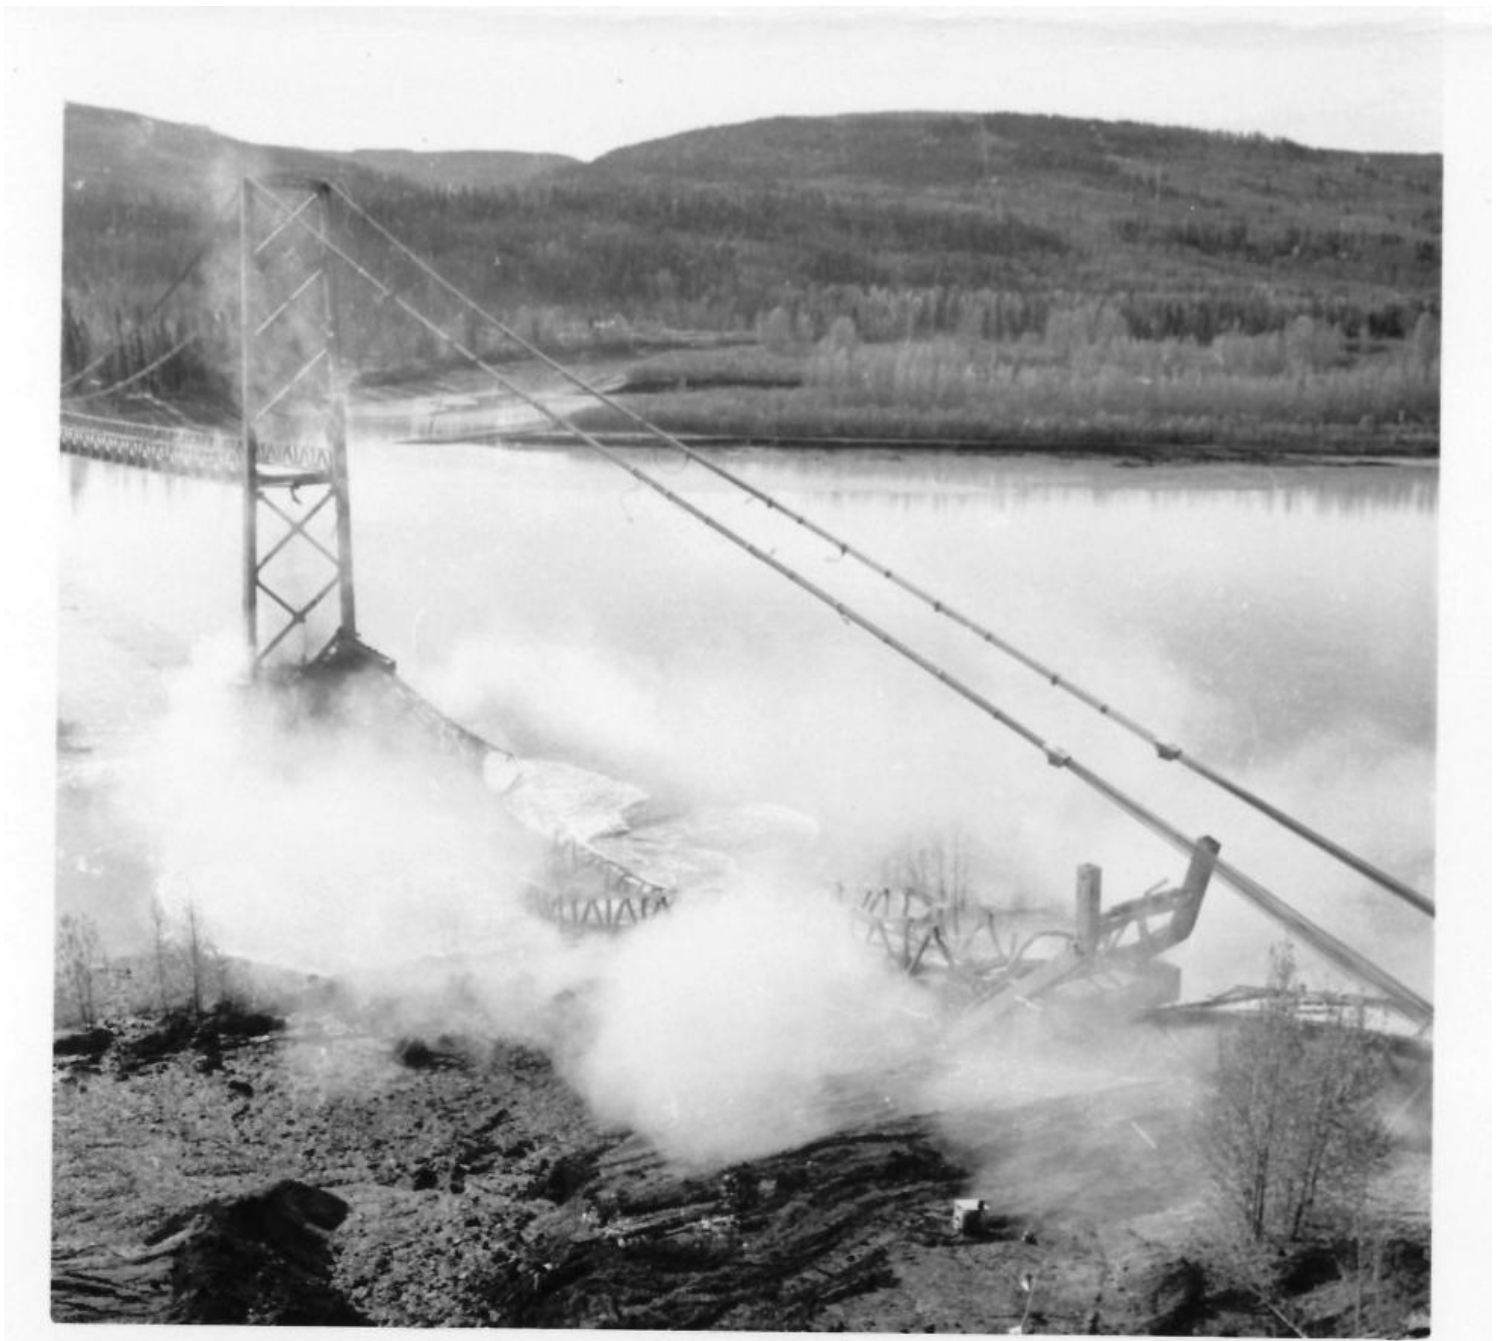
In Figure 11 and 12 the dust of the collapse covers any features of interest. Pipelines have broken and have spilled water down the slope to the northeast of the bridge, eroding much of the base of the slope. The full damage is unknown.

Figure 11. Going

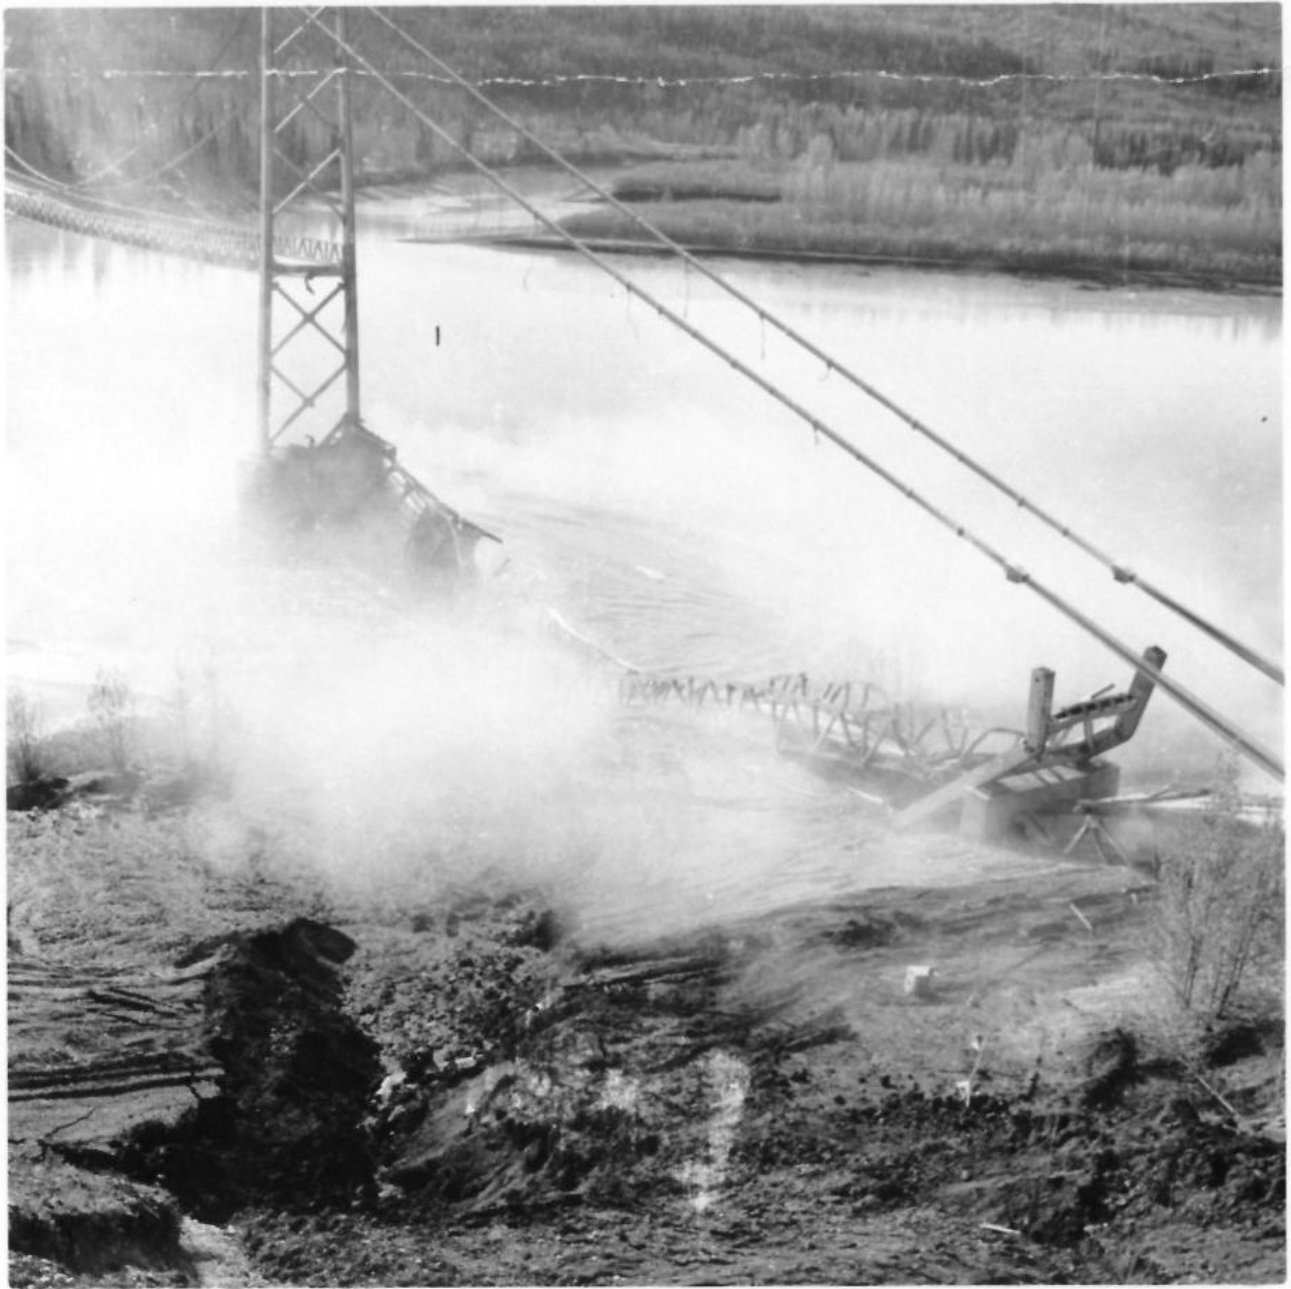
Figure 12. Gone

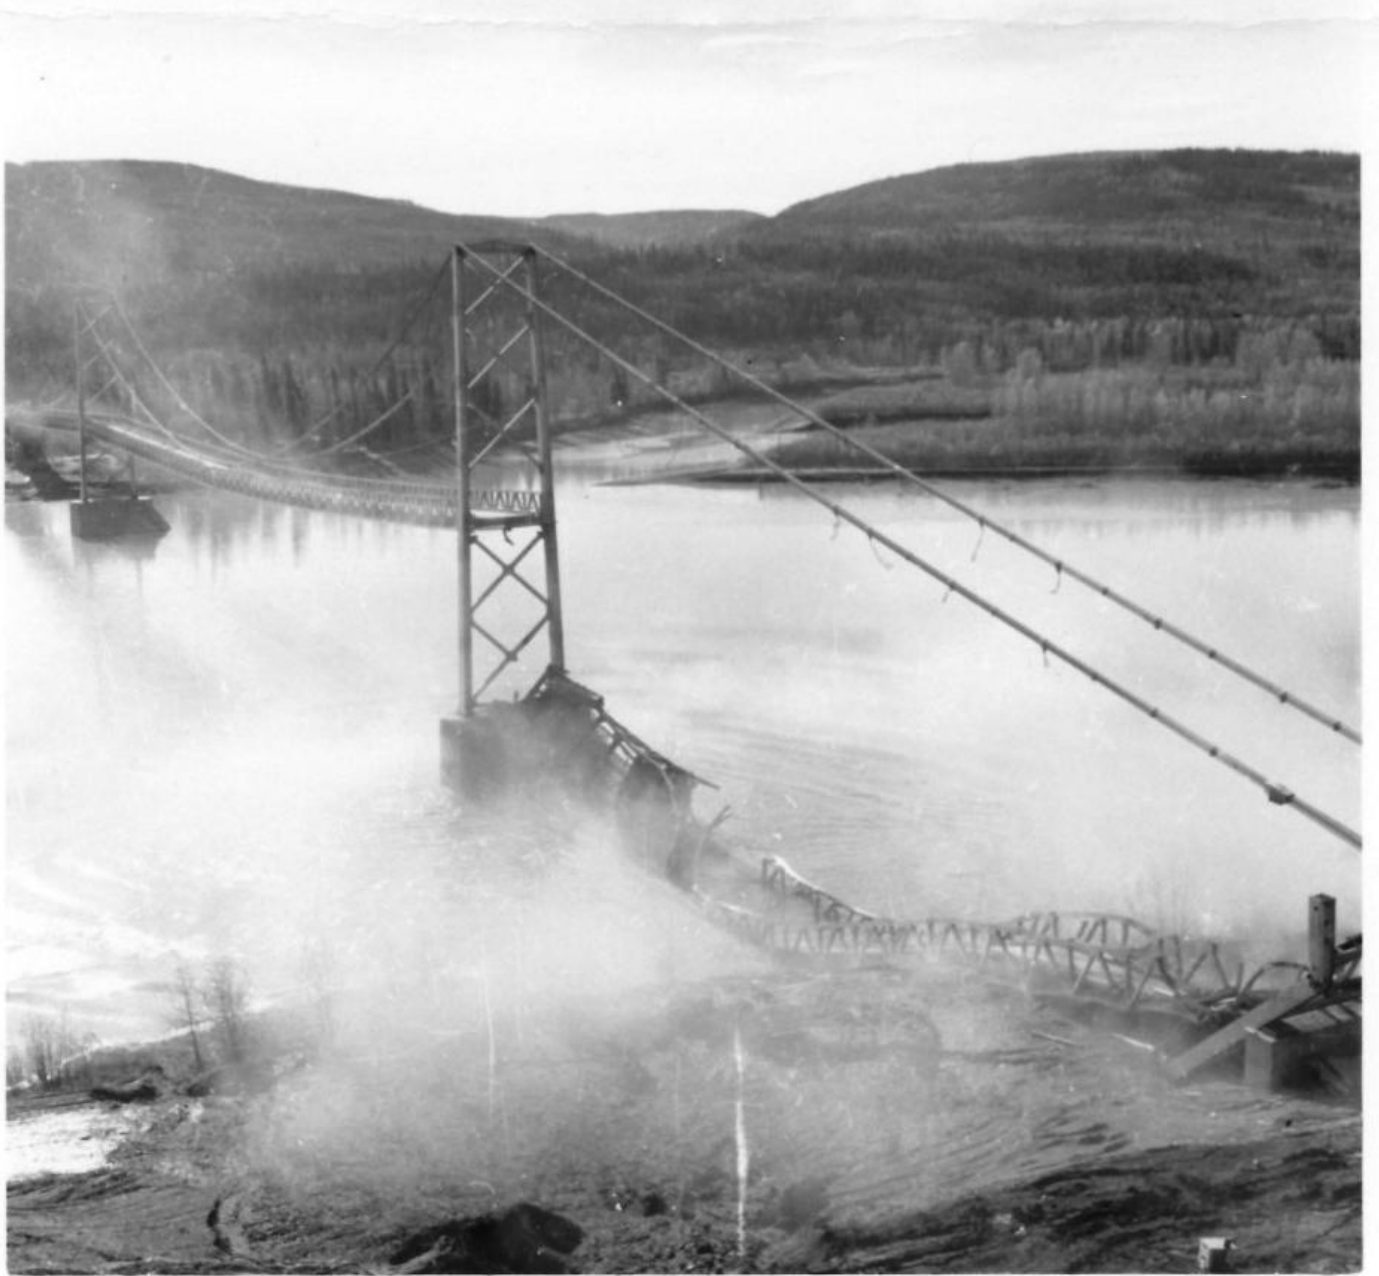
Figures 13 and 14 show the centre span sagging. The collapse caused the cables from the North Tower supporting the side span to straighten. Compare the cables the side span in Figure 5 with those in Figures 13 and 14. The positions of the cables above the north side span probably changed very rapidly as the cable bent was pushed off its foundation.

Figure 13. The damaged North Tower stands

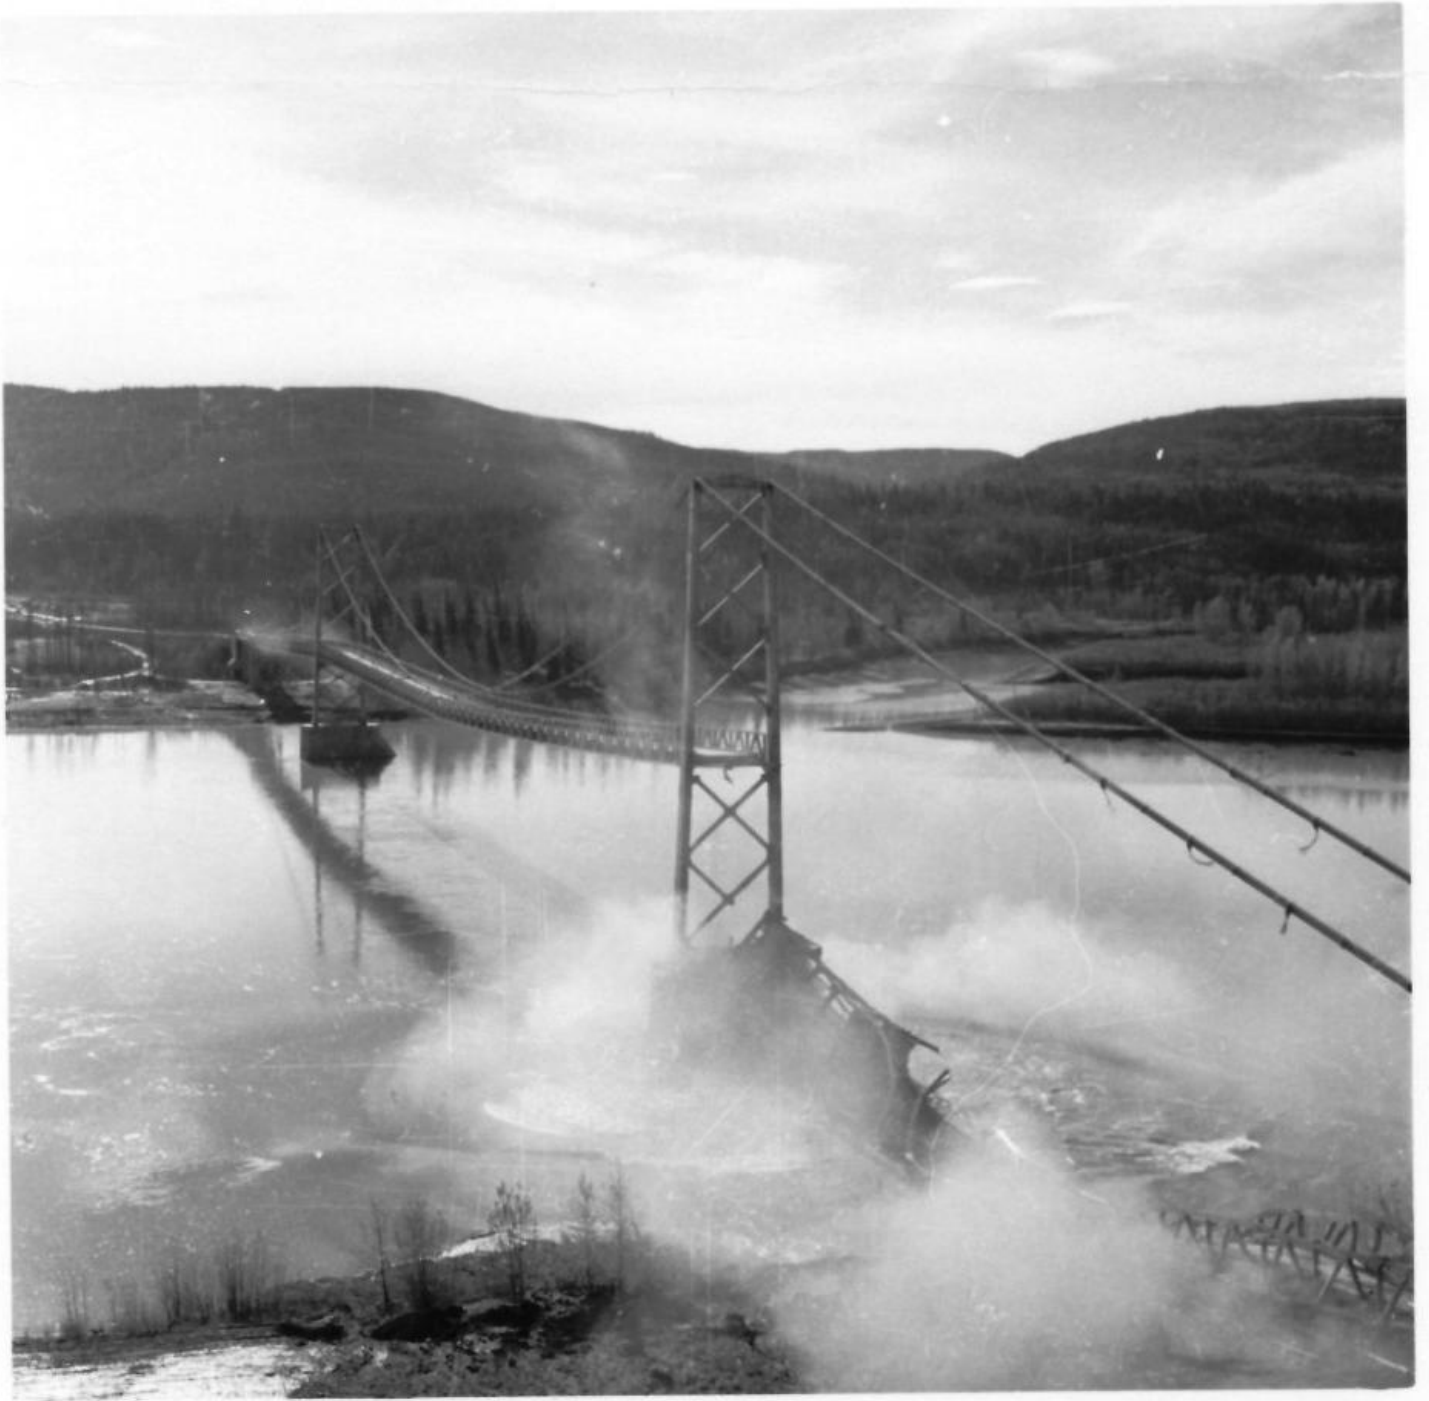
Figure 14. As the dust settles
