Ohau Point Ring Net and TECCO Mesh Drape

M. B Avery
Hiway Geostabilization Ltd, Auckland

ABSTRACT

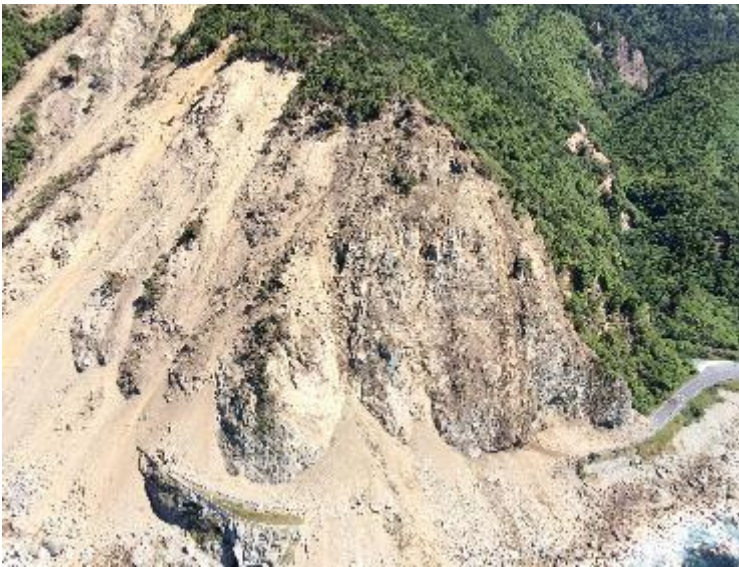
Figure 1: Ohau Point, December 2016 (photo courtesy Opus)

Ohau Point is the largest, northernmost, and most significant and challenging rockslide triggered by the Kaikoura event. Strategically this rockslide feature created a pinch point for the construction of a temporary haul route. This site quickly became the highest priority repair site and critical path to enabling the initial haul route to be established. The site is some 300 metres wide at the base and follows a triangular shape with the apex some 300 metre elevation above the roadway. As stated in the project specification (provided by NCTIR), the north face of Ohau Point “comprises closely jointed sandstone and mudstone of the Pahau Terrane deposits, consisting of bedded sandstone and mudstone. Initial helicopter sluicing and scaling of the face revealed surficial soils and boulders below the head scarp with a highly fractured and open jointed rock mass beneath”.

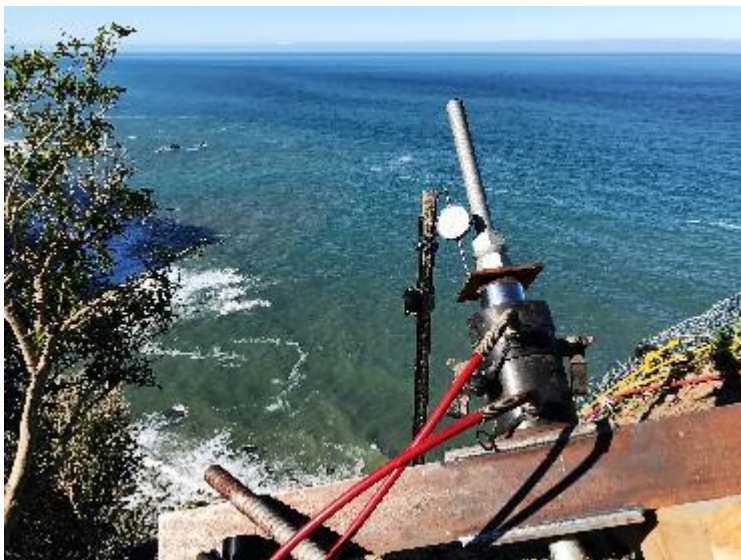
The capacity of the perimeter anchors was calculated at 430 kN based on destructive pull out tests undertaken on site.

Figure 4: Acceptance testing of the perimeter anchors.

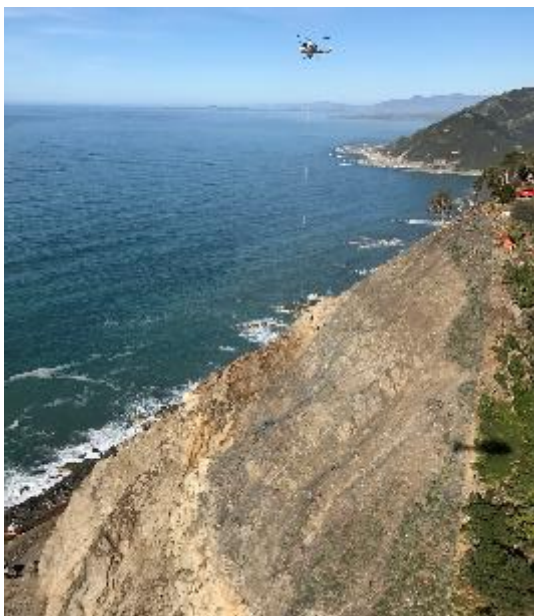
Figure 5: Helicopter installation of the ring net

The various ring net panels were 10m long by 3m, 4m and 5m wide. Panels were pre-stitched on the ground with two panels connected together length ways (to create one 20m long super panel). Originally three panels were combined into one super panel. However with the variable wind conditions on site, it was deemed more efficient (and safer) to reduce each load to two panels. The 1.5 ton connecting shackles were installed along one side and the bottom edge of the super panels to accelerate the installation process on the slope. A specially developed spreader bar was fabricated which allowed the pilot to release the panel remotely once placed on the slope to allow for safer panel installation for the rope access crew working on the slope. The panels and spreader bar were attached to the helicopter via a 30 m long line. Using highly qualified and experienced pilots, the panels were flown onto the slope at every available weather window. A total of 23 days were required to fully install the drape system.

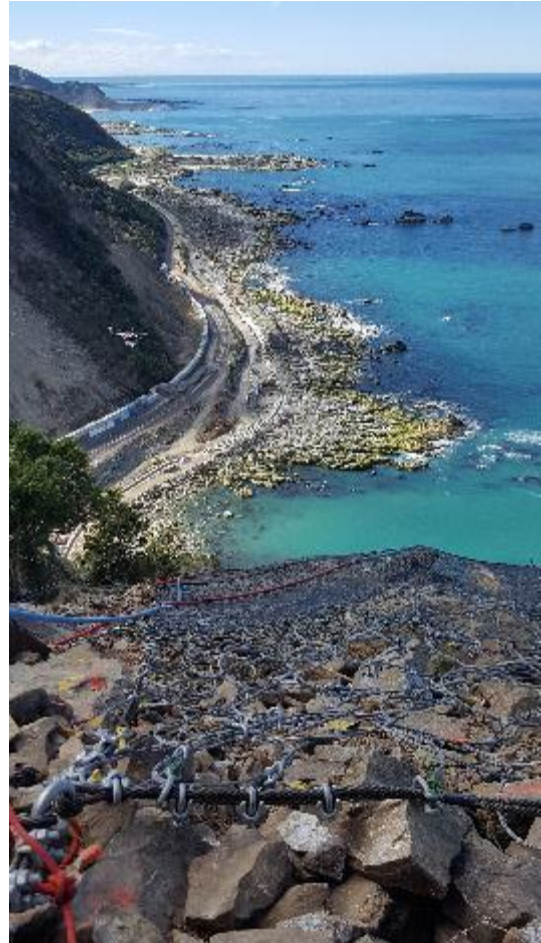
Figure 6: Completed drape showing perimeter anchor connection detail

A single 20 mm diameter steel wire perimeter rope was connected to each anchor head around the perimeter of the system. This was used to connect the ring net and mesh to the top support anchors. Once all anchors were installed and the grout sufficiently cured, the wire rope was tensioned. The maximum length between end terminations was 30 m in order to allow sufficient tension to be applied to the rope without introducing excessive friction into the system. A secondary 16 mm diameter wire rope to provide load share was installed in short lengths tying the front row of anchors to the back row.
