Slope Stabilization at km 201.4 of the Alaska Highway: Site Challenges and Lessons Learned

Jason Pellett, P.Eng., P.Geo. & Andrew Horwood, ASCT
Tetra Tech Canada Inc., Vancouver, BC, Canada

This paper presents a case history of recent slope stabilization works completed at km 201.4 of the Alaska Highway (BC No. 97) in northern British Columbia (BC).

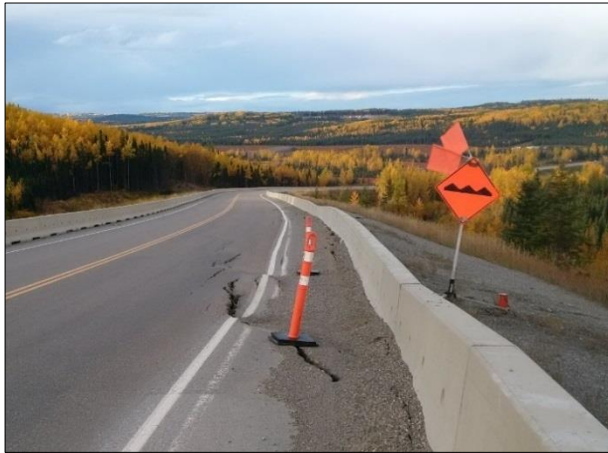
Figure 2. View of km 201.4 slide area in mid-September 2016, looking up-chainage (west) towards Pink Mountain.

- September 1: Existing tension cracks along the highway shoulder appeared dilated with possible settlement of the road surface within the slide limits.
- September 15: Cracks continuing to dilate; road surface settled by about 300 mm within the slide limits; pavement shows visible buckling and distress (Figure 2). The slope inclinometer casings and piezometers installed in 2015 were sheared off.

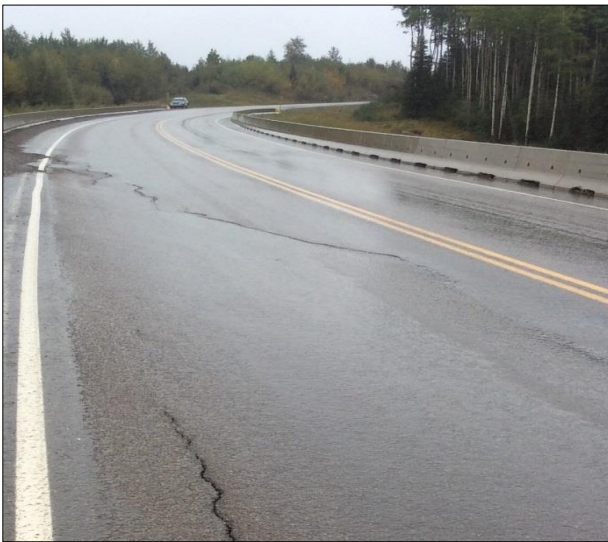
This section of highway was reconstructed in the early 1980s, which involved realigning the highway onto a 12 to 15 m high embankment fill located upslope (south) of the original 1943 alignment. Further east, at about km 201.1, the embankment fill transitions to an approximately 1 km long through-cut section in sandstone bedrock (Figure 3).

Figure 3. View of km 201.4 slide area in early September 2016, looking down-chainage (east) towards Fort St John. The parked vehicle is located at about the transition point to the bedrock through-cut section further to the east.

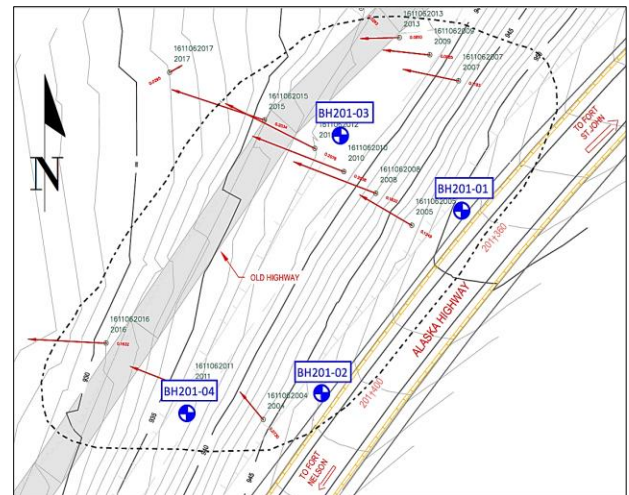
Figure 4. Survey plan of the km 201.4 area showing the testhole locations, topographic contours (1 m interval), and vector arrows of slide movement (100x magnification) established from repeated surveys of rebar pins installed on the slope. The black dashed line denotes the approximate extent of the slide area.

- November 5: The survey data revealed that the slide area extended into the treeline and was moving at a rate of up to 75 mm per day, with the largest movements located at about km 201.36 (Figure 4).

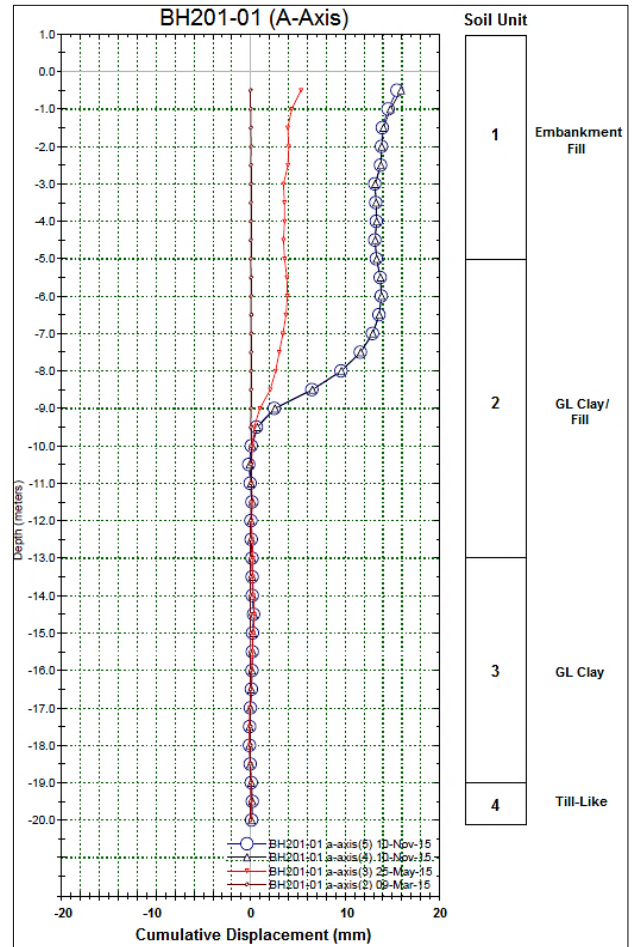
The results obtained from BH201-01 are presented on Figure 5. Slope movements were occurring along a well-defined failure plane located within Unit 2 between about 7 and 9 m below ground surface. A total of approximately 15 mm of movement was recorded between March and November 2015 (movement rate of about 2 mm/month).

Figure 5. Recorded movements (A-Axis) from the SI casing installed in BH201-01, located at the top of the slope.

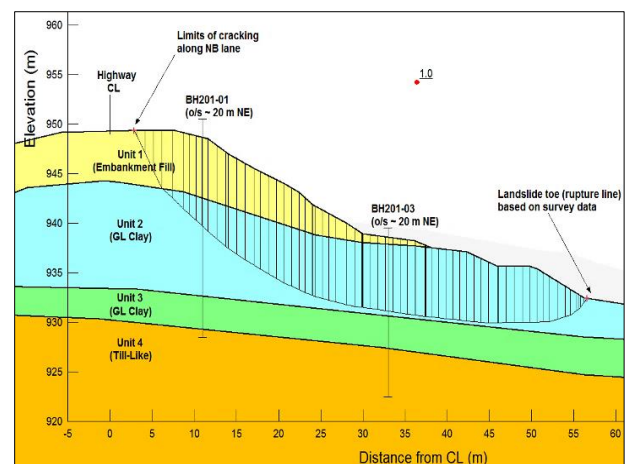
A typical slope stability back-analysis is shown in Figure 6, with various colours representing the inferred soil stratigraphy and vertical hatching of the critical failure surface.

Figure 6. Typical back-analysis of the km 201.4 slide area.

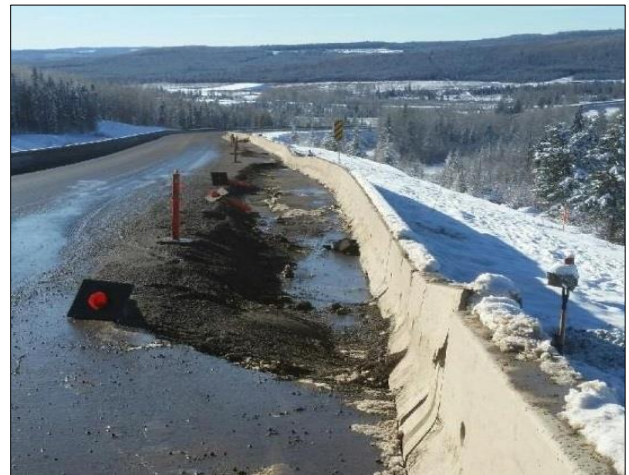
Figure 7. View of km 201.4 slide area in late October 2016, looking west towards Pink Mountain.

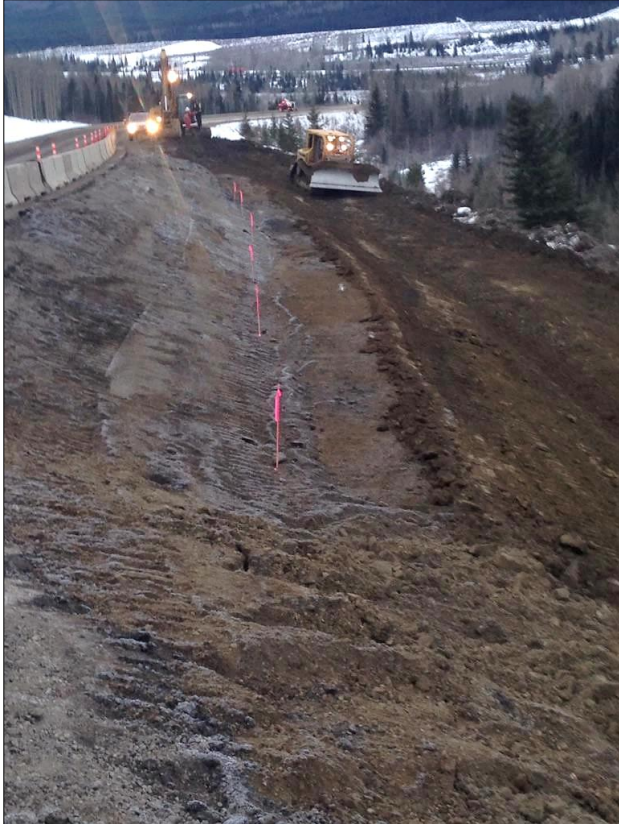
Figure 8. View of emergency unloading work (embankment removal) in early November 2016, looking west towards Pink Mountain.

Based on the observed increase in the rate of slope movement indicated by the survey data, and to facilitate safe access to the site for construction of the permanent stabilization works, the upper portion of the slide mass was unloaded (excavated) to reduce the driving forces on the slope. A total of approximately 4,500 m³ of embankment fill (equivalent to an 80 m long by 7 m wide by 8 m high cut) was removed from the slope starting on November 5; see Figure 8. The depth and extent of embankment removal was designed to achieve a minimum FoS of 1.1 as determined from limit equilibrium slope stability analysis. As can be seen from Figure 9, the unloading work proved to be very effective, with movement of the slope essentially stopped by November 6.

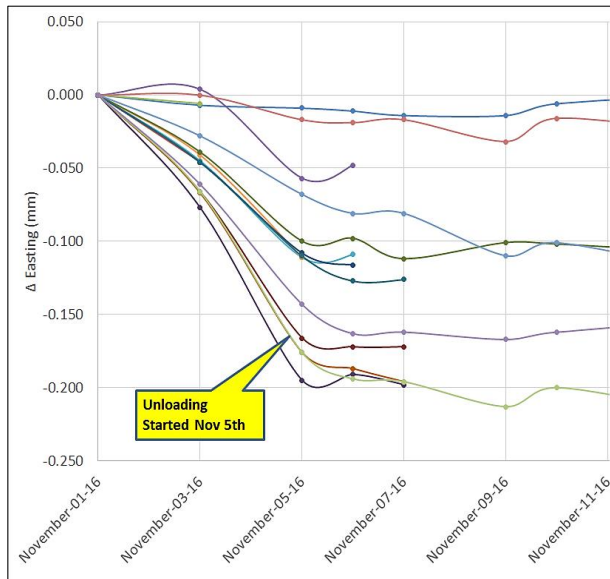
Figure 9. Slope movement survey data (Δ Easting), November 1 to 11, 2016. Y-axis scale = +50 to -250 mm.

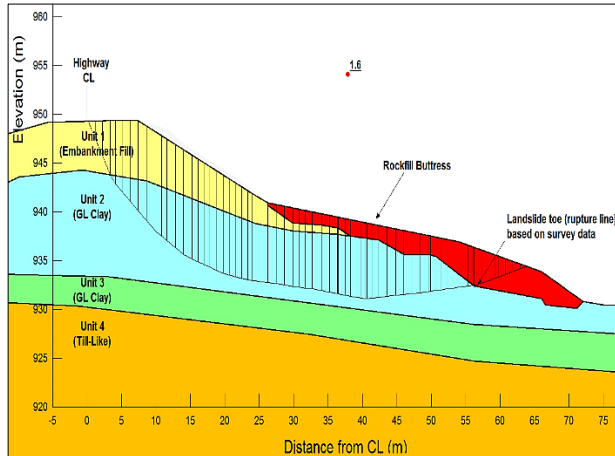
Figure 10. Typical global stability analysis of the proposed rockfill buttress at km 201.4.

The location and typical extent of the proposed buttress can be seen on the example slope stability analysis output in Figure 10. The buttress measures approximately 90 m in length, 30 to 40 m in width, and 2 to 4 m in thickness. From the analysis results, it was found that the buttress needed to be relatively wide to force the failure plane (and other potential slip-circles) to pass through the buttress rockfill, rather than daylighting upslope of the buttress or passing underneath the buttress.

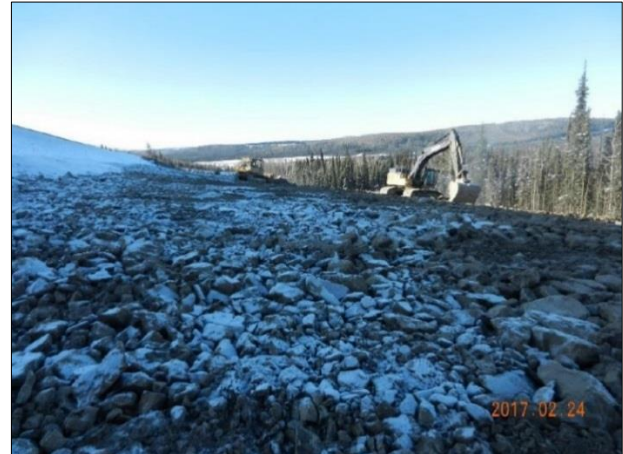
Figure 11. View of rockfill buttress construction in late February 2017, looking west towards Pink Mountain. Note tracked equipment in the middle of the photo for scale.

Construction of the permanent stabilization works was awarded to Tangle Ridge Custom Crushing Ltd. who completed the work over the month of February 2017. The constructed works included approximately 9,100 m³ of rockfill buttress, 1,400 m³ of drainage blanket and 145 m of finger drains, with construction costs totaling approximately \$740,000. The specified rockfill material was a 600 mm (24”) minus, well-graded angular aggregate with a maximum of 5% fines, which was placed in lifts and compacted by several passes of heavy tracked equipment.

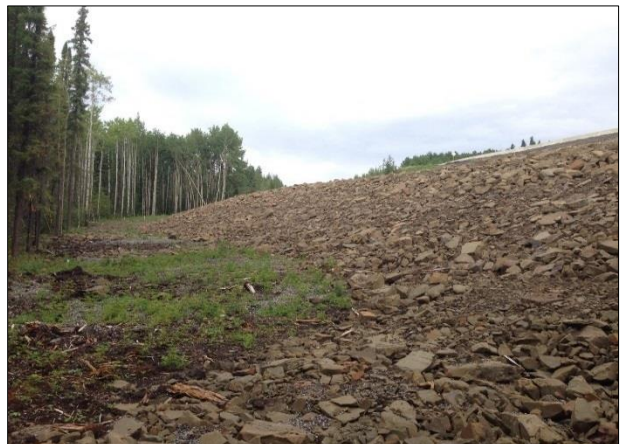
The northbound lane of the highway was re-paved through the km 201.4 area in late September 2017 following completion of the embankment repair work. The rockfill buttress appears to be performing satisfactorily to date, with no obvious movement or distress to the highway.

Figure 12. View of the completed rockfill buttress in early August 2017, looking east towards Fort St John.
