# The Johnsons Landing Landslide of 2012 – Five years of monitoring post-failure activity

The Johnsons Landing landslide of 2012 was a large debris avalanche that destroyed several homes and caused four fatalities in the Kootenay Lake area of British Columbia. The investigation that followed examined several aspects of the event including possible triggers and hazard analysis. Based on the recommendations of this investigation, monitoring of a potentially unstable area above the main landslide scarp was undertaken to determine the potential for a subsequent failure. The five years of monitoring results show ongoing minor downslope movement of an unstable mass above the main landslide scarp. These observations may reflect the settling of the unstable mass, which would be expected to diminish with time. A challenging question is how to integrate these five years of monitoring data with the initial hazard estimates and effectively communicate the results to the public.

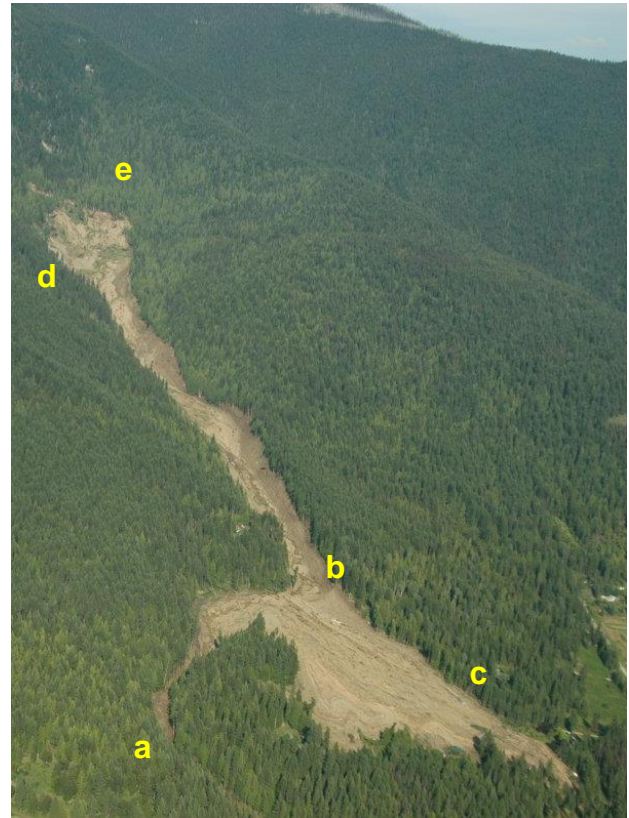
- Why and how did such a large landslide occur at a site with no history of previous landslide activity?
- What were the causes and triggering factors of the initial failure?
- Why and how did the landslide rise over the ridge (location b on Figure 2)?
- What is the likelihood of future large failures on this slope?
- If further landslides were to occur, what areas downslope might be at risk?

Figure 2. Photo of the landslide from the air, taken about 6 hours after it occurred. a – canyon with secondary debris flow; b – bend in channel and low ridge; c – bench where houses were destroyed; d – landslide headscarp; e – potentially unstable area with monitoring installations.

At location b (Figure 2), there is a sharp right bend (about 70°) and widening in the valley, below which the creek enters a narrow canyon incised into the deep glaciofluvial and morainal deposits of the Johnsons Landing bench. At this location, most of the landslide debris climbed 10 to 25 m onto a ridge, with enough speed to overtop it, and then spread out onto the bench to the southwest, where the homes were located. Debris filled the bend area to a probable thickness of 5 to 10 m. From photos taken soon after the event, and from later ground observations, a possible temporary blockage of trees formed at the head of the canyon, and this may have helped to divert most of the subsequent debris over the ridge and onto the bench. The blockage then broke, sending a debris flow which contained a large proportion of trees down the canyon to the Gar Creek fan.

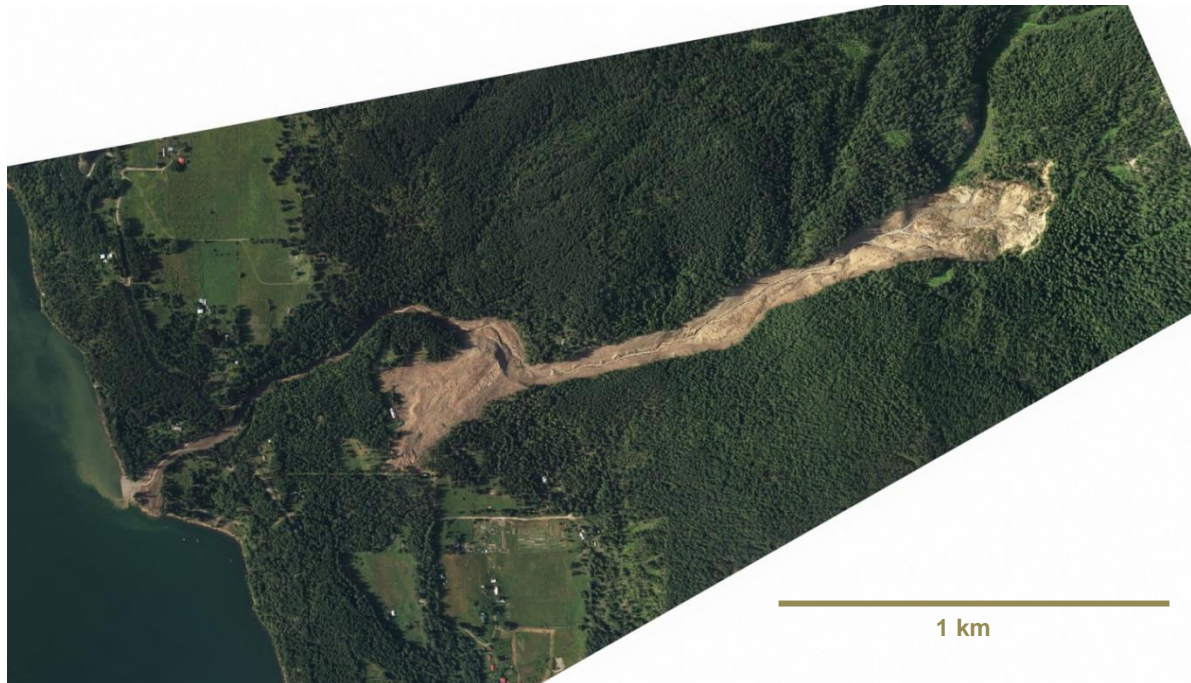
Figure 3. Orthophoto showing Johnsons Landing and the July 12, 2012, landslide. See Figure 4 for enlargement of the headscarp area. (Regional District of Central Kootenay orthophoto.)

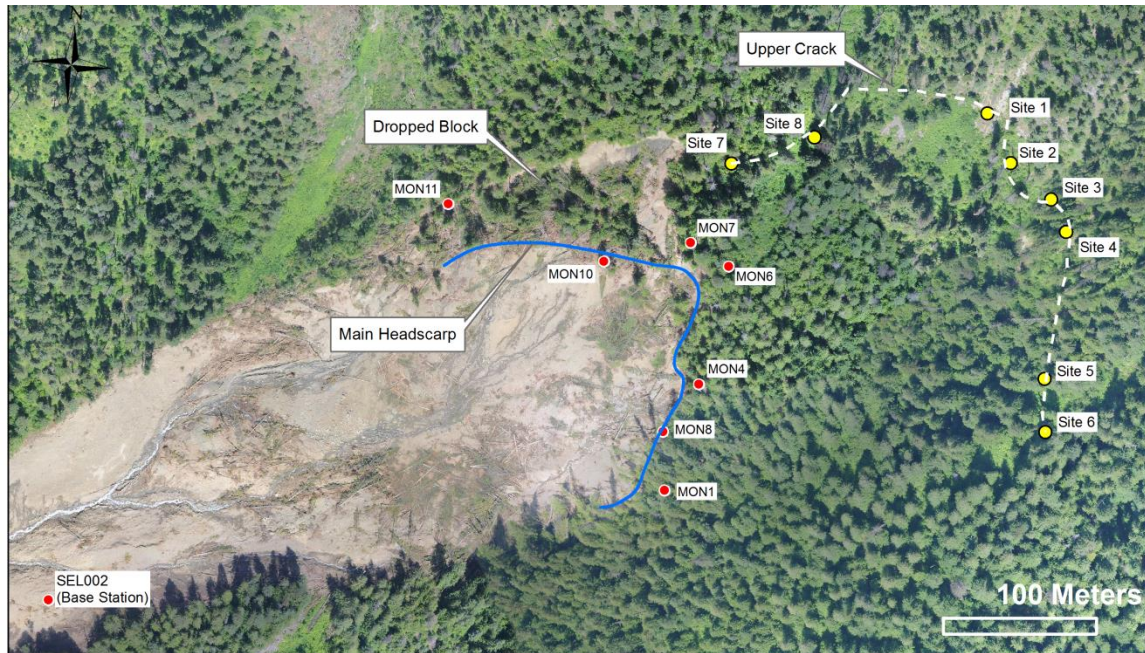
Above the main scarp, a prominent feature is a large block of more-or-less intact glacial deposits (Figure 4) which dropped down about 20 m and then stopped. It may have been arrested by a bedrock outcrop visible below the main scarp. During the search operations, there was concern that this block could fail; however, no further movement occurred. The failure plane of the landslide could not be directly observed, as it was covered by trees and loose debris which had dropped down from the scarp. Significant water was observed at the landslide scarps a week after the event; in particular, seeping from the upper scarp located above the dropped block, and from several springs within the scarp area.

Figure 4. Orthophoto of the landslide source area showing the main scarp, dropped block and upper crack. Stake measurement sites (Site 1 through Site 8) and the survey reflector sites (MON1 through MON11) are labelled. The site from which the survey reflector measurements were made is SEL002.

A continuous crack, approximately 400 m long with visible displacements of up to 4 m, was identified 200 m above the main scarp (Figure 4). The surface area bounded by the crack and the main scarp below is about 6.4 hectares.

The slope features adjacent and upslope of the 2012 landslide source area are shown on Figure 4. A potentially unstable area above the main scarp was identified during the initial investigation. The upper crack and main scarp have been the focus of the monitoring activities over the past five years.

Eight measurement sites are located along the upper crack that bounds the top edge of the potentially unstable area (Sites 1 through 8 in Figure 4). One of these sites (Site 1) is a line of 6 metal pins, with the top pin drilled into bedrock above the crack. The other sites consist of two or three wooden stakes driven into soil above and below the crack. The distance between the stakes is measured manually with a tape measure three times a year in spring, summer, and fall. One limitation to this method is that the displacement value measured between the two stakes is the total 3-dimensional movement, and is not broken down into x, y and z components. Another limitation is that the wooden stakes are susceptible to damage from freezing, snow load, and soil movement.

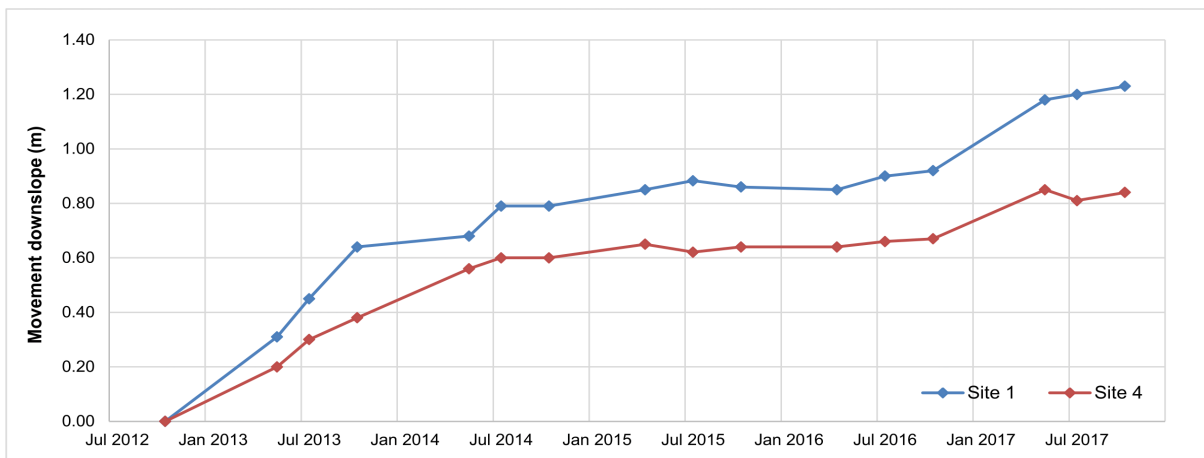
The measurement of the displacement of the upper crack over the past five years shows systematic, progressive movement at several locations at the apex of the tension crack, but limited or no movement towards the outer edges. The first year after the slide, displacement along the apex of the upper crack was 40 to 60 cm, although over the subsequent four years the annual displacement has been less. Sites 5 and 6 located near the southern end of the upper crack have shown virtually no displacement. Sites 7 and 8 on the north end of the crack have shown some minor annual displacement ranging from 0 to 20 cm depending on the year. While the stakes at Sites 2 and 3 have been destroyed by falling rocks or snowload, Sites 1 and 4 near the apex of the upper crack exhibit ongoing annual displacements in the range of 3 to 30 cm over the past four years (Figure 5).

The displacement measured at the upper crack has generally diminished each year until 2017. While 2017 was not a particularly wet spring, increased displacement was measured at both Sites 1 and 4. Over the last five years, the snowpack and spring precipitation in the West Kootenays has been much closer to normal than in 2012. Figure 6 shows a record of monthly spring (April to June)

Figure 5. Cumulative downslope movement along the upper crack at Sites 1 and 4 (see Figure 4 for site locations). Downslope movement was measured as the distance between stakes spanning the crack.

In view of the increased displacement at the upper crack in 2017 and the progressive movement at the headscarp, ongoing monitoring of the site is planned for at least the next few years. Ideally monitoring will continue until a particularly wet spring occurs with no consequent increased displacement or until movement at the headscarp and upper crack slows to zero.

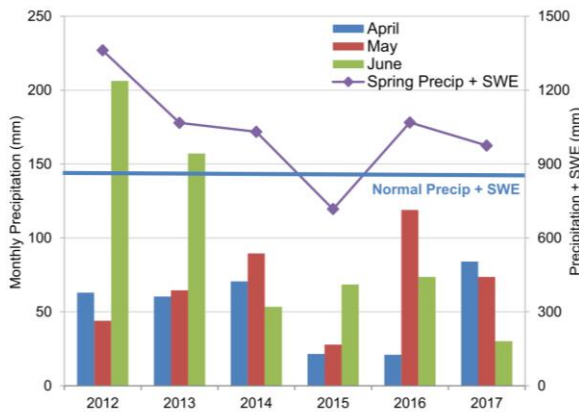
precipitation in Kaslo combined with the snow water equivalent (SWE) on April 1 at the Upper Gray Creek manual snow measurement site. Although the data only span five years, the pattern of wet and dry years does not seem to correspond to increased or decreased displacement at the upper crack. For example, 2016 was wetter than 2017, yet the crack displacement in 2017 was higher.

Figure 6. Record of monthly spring precipitation at the Kaslo Environment Canada station 20 km SSW of Johnsons Landing and the spring (April to June) precipitation from the Kaslo station plus the snow water equivalent (SWE) on April 1 at the Upper Gray Creek snow survey site 55 km south of Johnsons Landing.

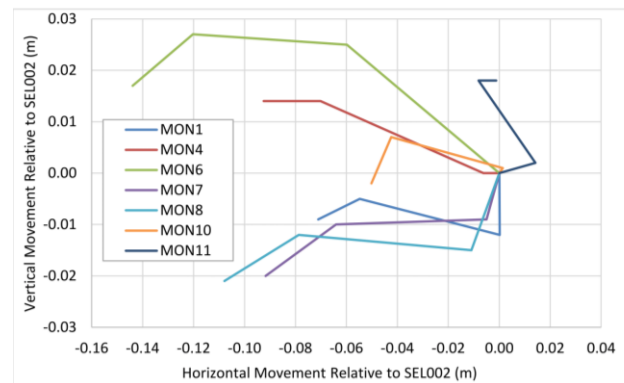
The spatial and temporal pattern of movement of the surveyed reflectors along the headscarp rim indicates that there has been some minor westerly movement of the headscarp over the past four years. The survey data show that since 2014 the reflectors along the main scarp (MON 1, 4, 6, 7, 8) have moved 7 to 14 cm in two dimensions (Figure 7). The majority of the movement has been in the negative x-direction (i.e. downslope and perpendicular to the headscarp). The movement in the z direction is negligible within the measurement error and shows no overall pattern. Figure 8 is a spatial representation of the magnitude and direction of movement at all sites. The total two-dimensional movement along the main scarp corresponds to an annual displacement of approximately 2.5 to 4.5 cm per year. Less two-dimensional movement was observed at the reflector at MON10 which is located on the dropped block, and no movement (within measurement error) was observed at MON11, which is located on stable ground outside the landslide source area.

are thought to be accurate within several centimetres, the total observed displacements of 7 to 14 cm along the headscarp are interpreted to represent real movement.

Figure 7. The horizontal and vertical movement of the survey reflectors along the headscarp. The movement is relative to the base station (SEL002). See Figure 4 for survey reflector locations. Negative horizontal values indicate movement towards the base station.

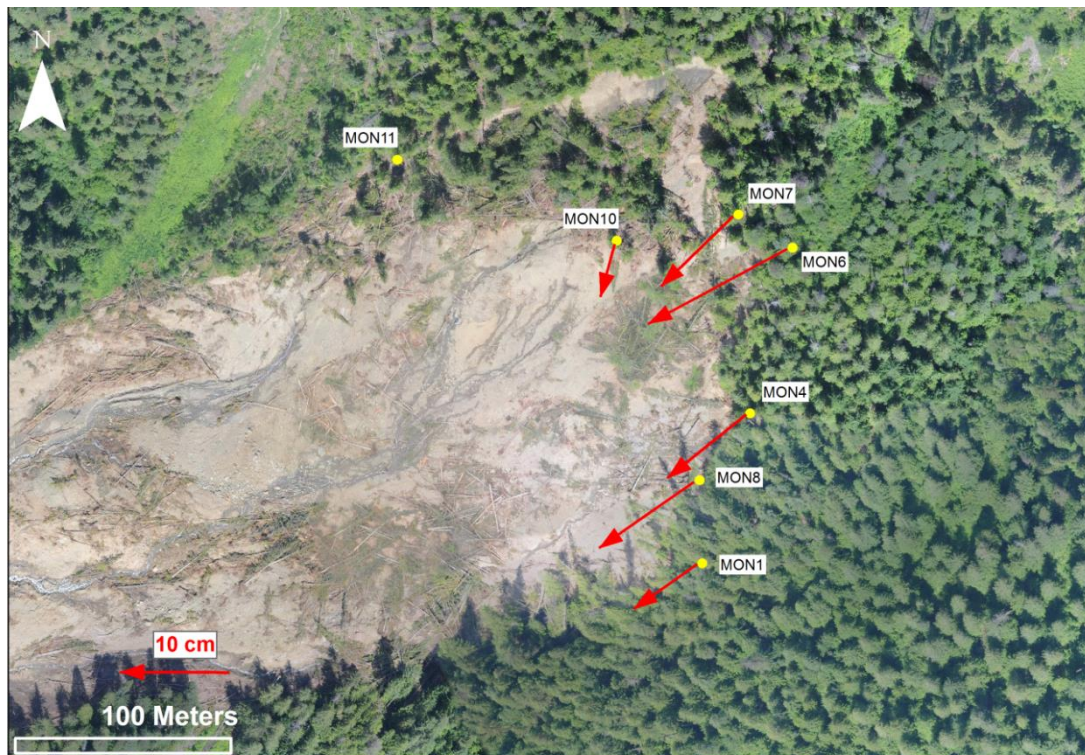
Figure 8. Horizontal movement at each of the reflector locations represented by the red arrow distance (to scale) and direction. See Figure 4 for survey reflector locations.
