# The 1976 landslide at Saint-Fabien, Québec

The Saint-Fabien landslide occurred in December 1976, 270 km east of Quebec City, Canada. The landslide took place in a glacial valley filled with glaciomarine clays covered by peat bog deposits, around Road 132, while construction was going on along the road. Unique features of this event are the almost horizontal ground surface and the failure surface that also seems to be close to the horizontal. In addition, passive and active failure zones could be observed in the debris, indicating a possible downward progressive failure mechanism, unusual in Eastern Canadian clays. The geotechnical investigations of the landslide have been done by the Québec Ministry of Transportation (MTMDET). The witnesses' accounts, that can be found in the records from the lawsuit that took place after the event, also helped to understand how the landslide took place. This paper presents the description of the events and the geotechnical investigation.

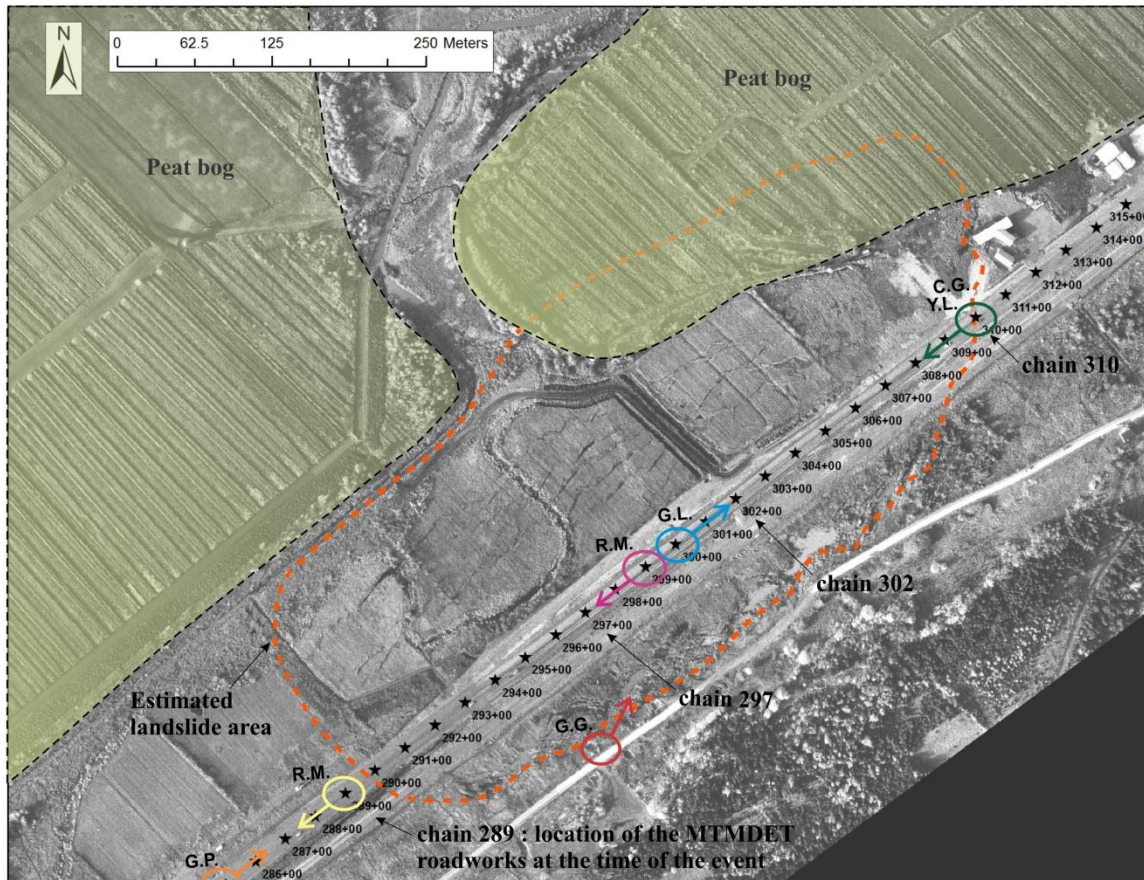
The 1976 landslide at Saint-Fabien is delineated by the orange dashed lines on Figure 1 showing a 1977 aerial photograph of the site. It is 600 m wide and 300 m long. Compression fissures can be seen in the debris, north of the road. The landslide took place in a glacial valley filled with glaciomarine clays covered by peat bogs. In the middle of the valley, just north of Road 132, there was continuous exploitation of the peat bog deposit closest to the landslide (see Figure 1). Road 132 and the Canadian National Railway (CN) cross the valley from west to east and were displaced by the landslide movement.

placing the fifth and last layer of embankment fill between those locations. On December 16<sup>th</sup>, they were progressing from the west toward the east. When the movement suddenly started around 11 am, they were working near chain 289 (Figure 1).

Figure 1 : Location of the MTMDET roadworks, the peat bog and witnesses (aerial photograph taken in 1977 after the event, road and CN railway were already reconstructed when it was taken)

In summary, almost all witnesses saw the first movement start in the north-east area, near the peat bog.

They saw the landslide propagate toward the west. At the precise time of the event, the MTMDET was working in the western area of the landslide, around road chain 289, at the opposite of the location of the first movement (see Figure 1).

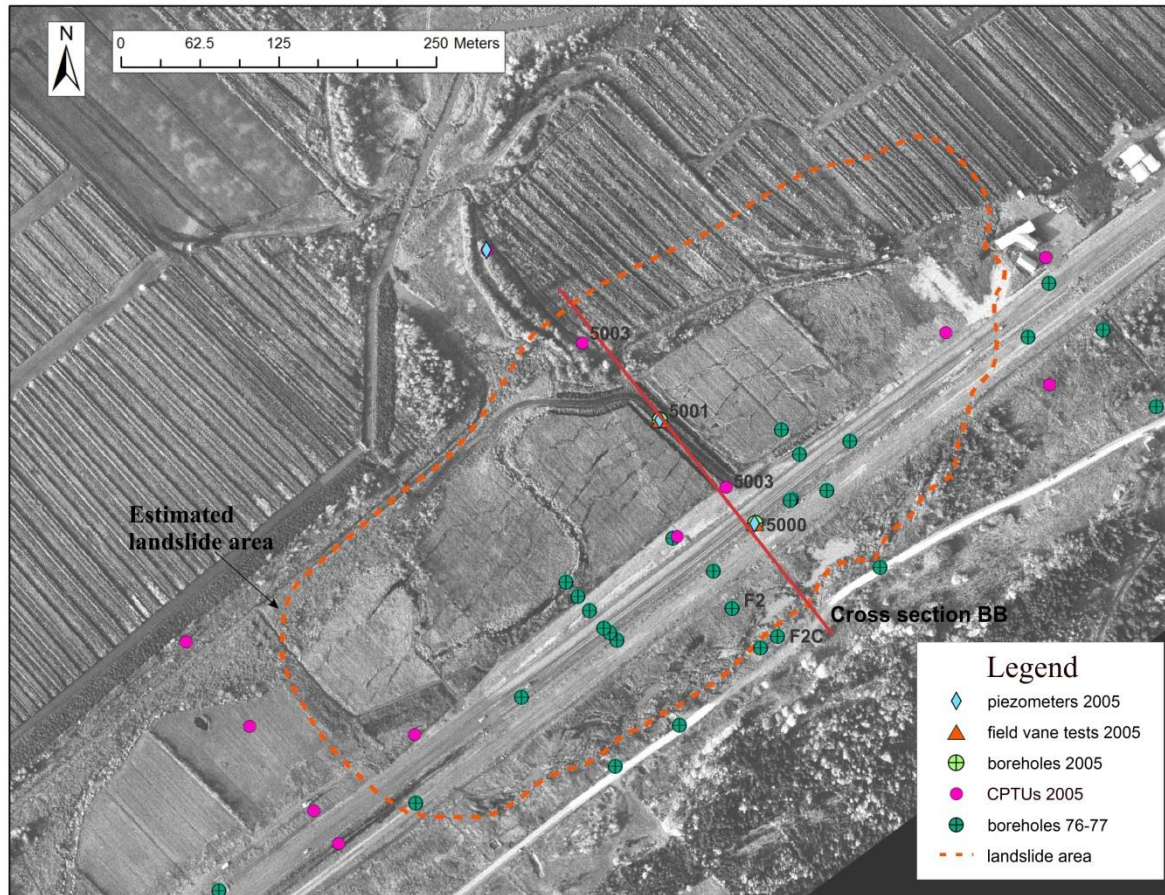
Figure 2: Location of selected boreholes done in 1976 and 1977 and the investigation work done in 2005. Cross section BB is shown in red

The geotechnical investigation at the site was performed in two phases. The first phase started in December 1976 and finished in March 1977. The second phase took place between August and October 2005 as part of a research project involving Université Laval. In both cases, the MTMDET was in charge of the investigation. The first phase included 29 boreholes, 26 field vane test profiles and 18 piezometer installations. In the second phase, 2 new boreholes and 2 new field vane test profiles were performed and 3 new piezometers were installed. There were also 14 piezocone penetration tests with pore pressure measurements (CPTUs) that were performed. Selected boreholes done in 1976 and 1977 are located and represented by the dark green dots on Figure 2. Those advanced in 2005 are represented by the light green dots.

The field vane tests, CPTUs and piezometers from the 2005 investigation are represented respectively by orange triangles, pink dots and blue diamonds on Figure 2. Laboratory tests were also carried out on samples from locations 5001 and 5000 including grain-size distribution, water content ( $w$ ), consistency limits (plastic limit,  $w_p$ , and liquid limit,  $w_l$ ) and sensitivity ( $S_t$ ) calculated from the intact ( $S_u$ ) and remolded ( $S_{ur}$ ) shear strengths from the Swedish fall cone.

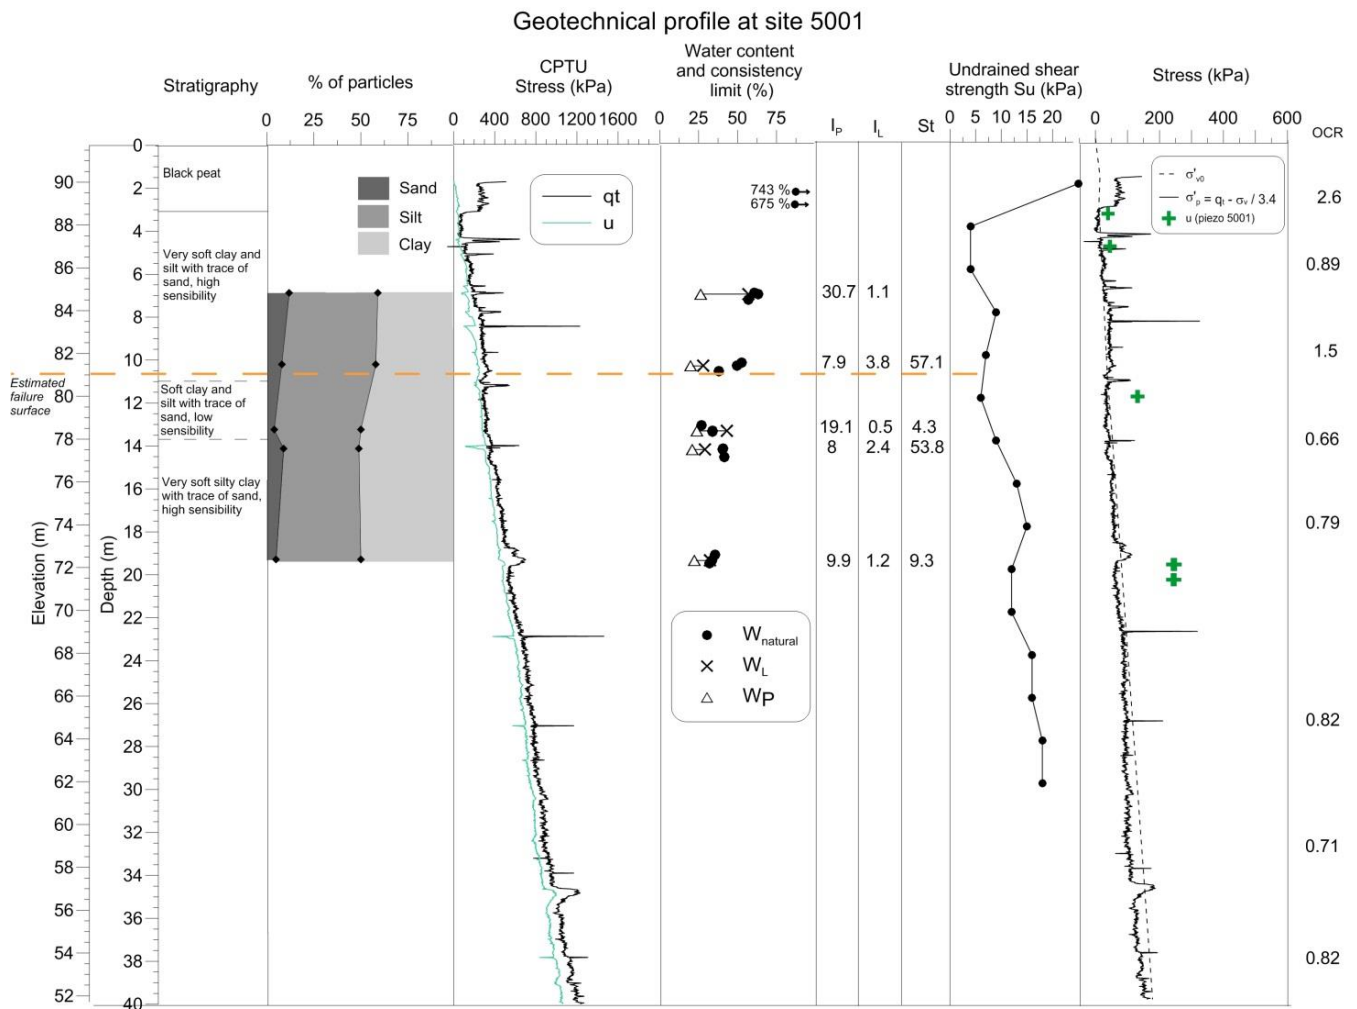
The complete geotechnical profile from location 5001 is presented on figure 3. The upper 3 m consists of peat. This first layer can be easily identified with the CPTU's corrected tip resistance ( $q_t$ ) of about 300 kPa. The water content in this layer is as high as 743%, which can be typical of peat. The undrained shear strength from vane tests ( $S_u$ ) is about 25 kPa.

The second layer is a soft, sensitive and normally consolidated grey silty clay, with occasional thin layers of sand, presenting variable properties. This layer starts at a depth of 3 m down to a depth of 40 m. The CPTU's corrected tip resistance increases with depth from 100 to 1500 kPa. The water content decreases with depth from approximately 60 % at a depth of 7 m down to 33 % at a depth of 19 m. The liquid limit decreases throughout the

layer from 57 % at a depth of 7 m, down to 32 % at a depth of 19 m. The plastic limit is almost constant, varying between 20 and 26 %. The liquidity index therefore varies between values of 1.2 to 3.8 throughout the layer with a surprisingly low value of 0.5 at a depth of 13 m. The soil has a high sensitivity of 57 and 54 at depths of 10 m and 14 m, with lower values of 4 and 9 at depths of 13 m and 19 m, respectively. The plasticity index varies between values of 8 and 31 throughout the layer. The undrained shear strength obtained from the field vane tests ( $S_u$ ) indicates the presence of very soft to soft clay with values from 4 kPa at a depth of 3 m to 18 kPa at a depth of 30 m.

At some locations, the contact between the debris and the intact soil was estimated using CPTUs and field vane tests performed within the landslide limits. This allowed estimating the failure surface at a depth of 10.5 m.

Figure 3: Geotechnical profile at site 5001

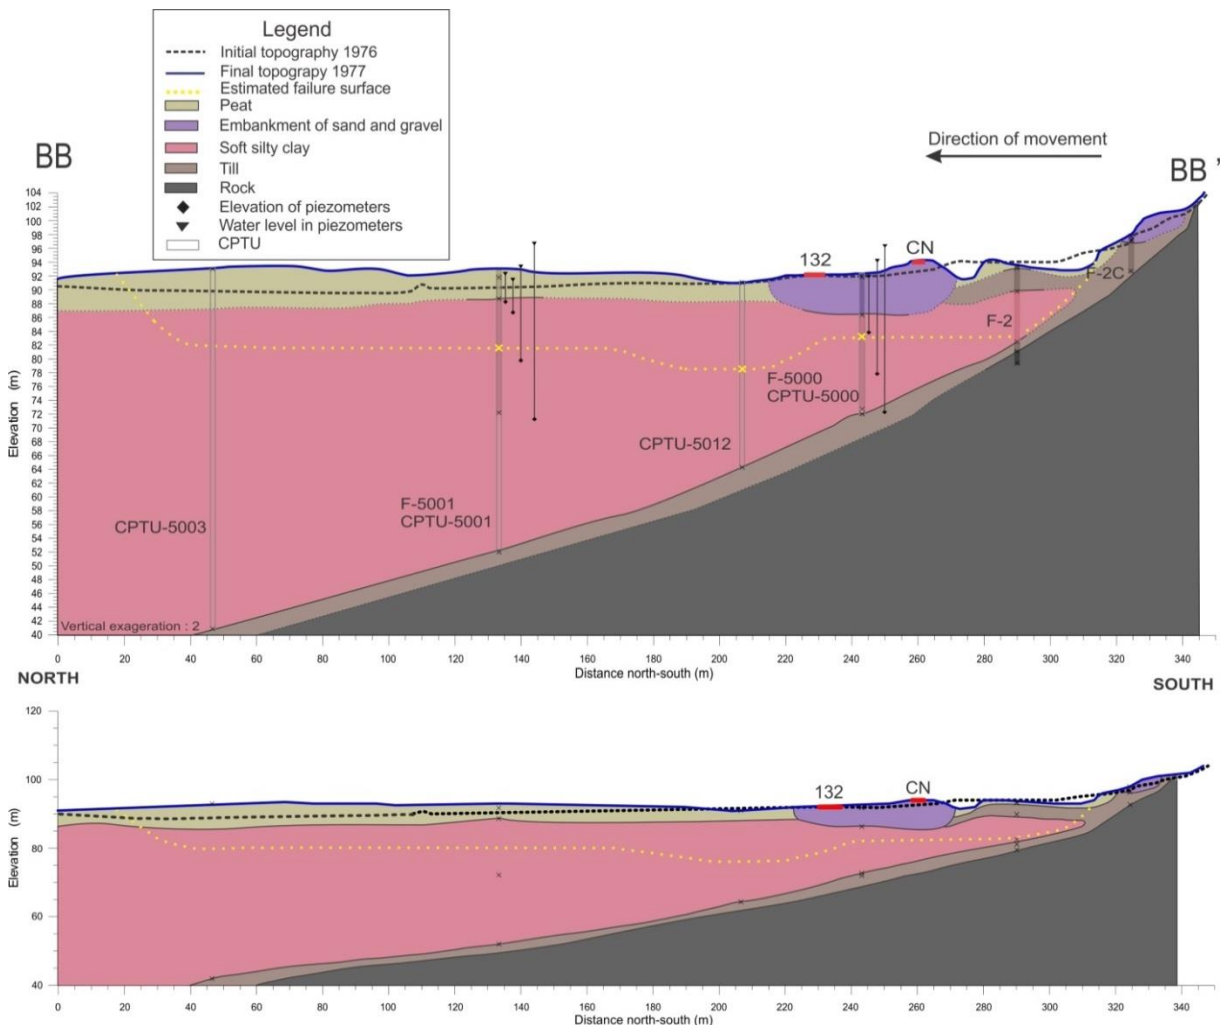
1977. An active zone of subsidence approximately 2 m deep is visible south of the road, at a distance of 310 m on the horizontal axis of Figure 4. A passive heave zone is located north of the road, with up to 4 m of uprising compared to the initial ground level. This heave zone

corresponds to the area where compression ridges can be observed (see Figures 1 and 2). The landslide caused about 20 m of translational movement toward the north. This translation is not visible on Figures 1 and 2 and the cross section (Figure 4), because no aerial photograph was taken before the reconstruction of the road and the CN railway in 1977.

in thickness and/or a road/rail embankment comprised of sand and gravel of 5 to 7 m in thickness, underlain by a thick layer of soft silty clay, as described in the previous section. The clay deposit is underlain by a till layer of roughly 3 m in thickness resting on bedrock. On Figure 4, it can be noticed that the bedrock surface below the landslide area slopes down in a northerly direction at a relatively constant rate.

The yellow dotted line on Figure 4 shows the elevation of the failure surface as estimated from the CPTUs. The interpreted failure surface elevation is marked with a yellow "x" at locations 5001, 5012 and 5000 at elevations of 81.8, 78.5 and 83 m, respectively. Those are approximately at a depth of 10.5 m below the initial ground surface.

Figure 4: Cross section BB of the landslide showing topography before and after the event, stratigraphy and water level in the piezometers. The upper cross section is depicted with a 2X vertical exaggeration and the lower cross section is depicted with no vertical exaggeration.

The cross section also includes the water levels in piezometers at locations 5000 and 5001. An upward gradient of about 0.30 is noted in the clay deposit at location 5001, and of about 0.39 in the till at location 5000. Those gradients are probably caused by water pressure coming from the outcropping till on the limits of the valley.

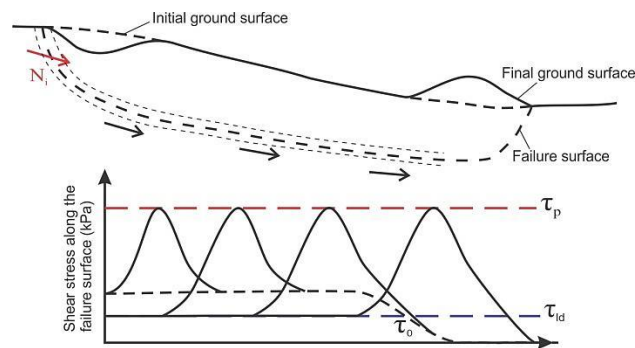
When a soil deposit presents a strain-softening behaviour during shear, a local disturbance ( $N_i$ ) applied at the top of the slope can bring the stresses to exceed the peak shear strength ( $\tau_p$ ) locally and decrease toward the large deformation shear strength ( $\tau_{ld}$ ). This may cause a loss of strength at this point that will put additional stress on the clay further downslope. Therefore, this may bring the clay to reach the peak shear strength at this other point, and so on. The main failure then progresses downslope and the large-deformation shear strength ( $\tau_{ld}$ ) and additional pressure will be mobilized along the failure surface (see Figure 5). During this process, if the downslope pressure caused by the progressive failure becomes larger than the passive thrust in the slope, a global passive failure will occur (Bernander 2000, 2008 and 2011, Locat et al. 2011 and Leroueil et al. 2012).

Figure 5: Initiation and propagation of downward progressive failure
