VELA DRAGA – ROCKFALL PROTECTION OF THE A8 MOTORWAY– A DIFFICULT CONSTRUCTION SITE ON A MAIN TOURISTIC TRAFFIC LINE IN ISTRIA

Gernot Stelzer
Trumer Schutzbauten GmbH, Kuchl, Austria
Metka Ivnik
Feniks+ d.o.o., Tržič, Slovenia
Darjo Durjava & Žiga Jeriha
EHO Projekt d.o.o., Ljubljana, Slovenia
Ivan Jurčić
Bina Istra d.d., Zagreb, Croatia
Ahren Bichler
Trumer Schutzbauten Canada, Vancouver BC, Canada

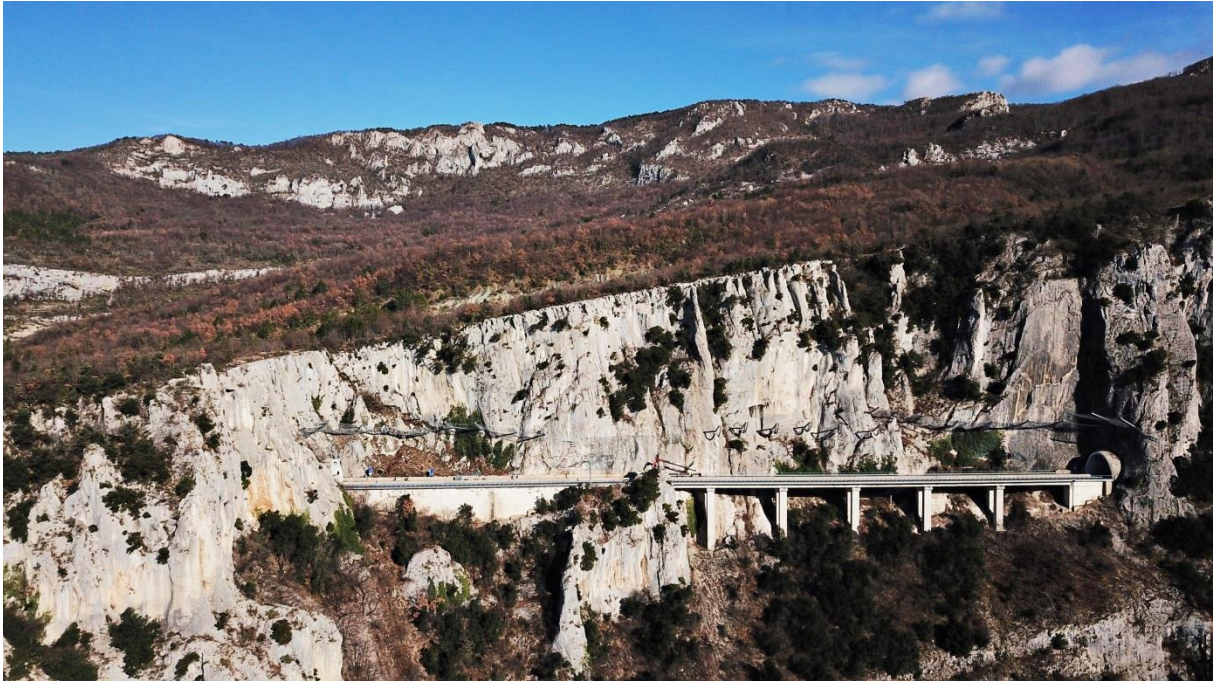
The section of motorway of concern is approximately 225 m long (Figure 3). Of this, 105 m is constructed on backfill material with a 8-15 m high retaining wall supporting the outer shoulder. The remaining 120 m of road is a viaduct constructed within a few meters of the slope. The road corridor is a maximum of 10 m wide, including a 1.25 m paved shoulder on either side. Each lane of traffic is 3.75 m wide. At either end of the road segment, there is a U-shaped portal that stands just over 9 m high and is approximately 7 m wide. Running along the inside shoulder there is a main electrical power line and international optical cable line that connects services between the Istria and Kvarner regions.

Figure 3. Oblique aerial view of project site showing partially installed mitigation measures.

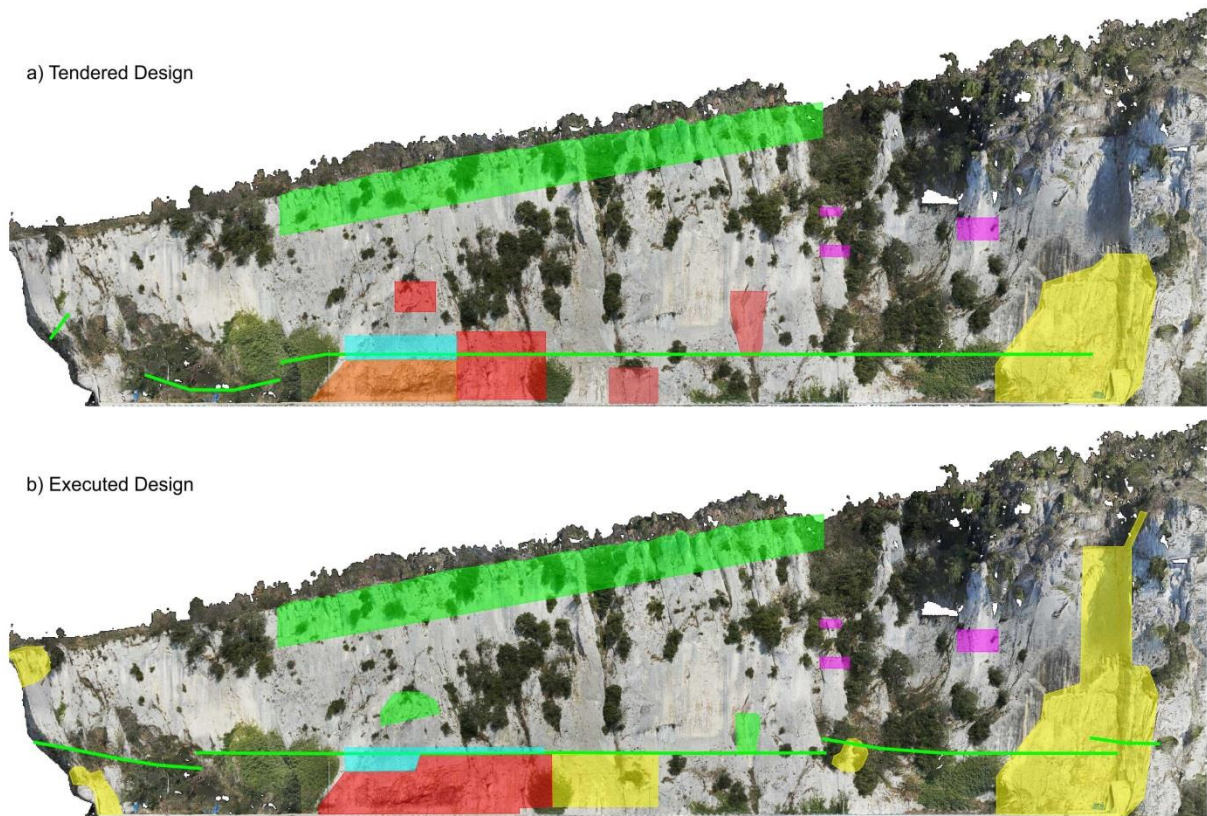
Figure 4. Mitigation layout for the tendered design and the executed design overlaying an orthophoto draped over a 3D model.

The preliminary design used for the tender procedure consisted of the following mitigations, with their location shown in Figure 4a:

Figure 4b shows the detail design with the above mentioned adapted mitigations

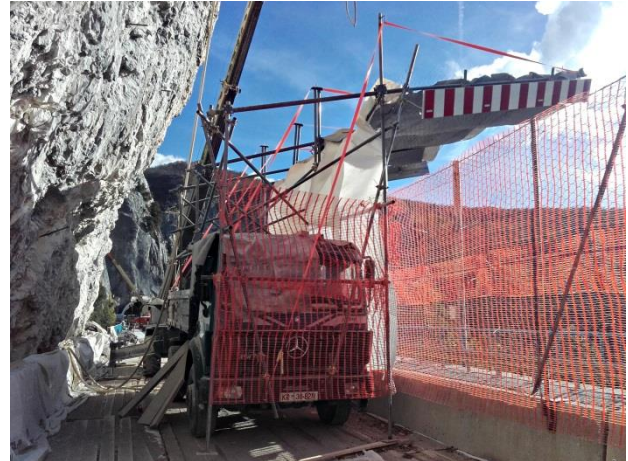
Figure 5. Cantilevered screen to protect traffic from drilling operations. Wooden planks used to protect the road surface can also be seen.

For example, a special cantilevered protection barrier was attached to a haul truck to help protect passing vehicles from falling debris during drilling operations (Figure 5). Dust was also a major concern so drill rigs were fitted with heavy rubber mats that helped control the dispersion of dust and small particles. Some limited closures were allowed for the most sensitive areas, i.e. the slope overhang and above the portals, but for only short intervals at pre-determined times (e.g. post installation on Sunday between 07:30-08:00 or anchor testing between 00:00-03:00) when traffic was at its lowest intensity.

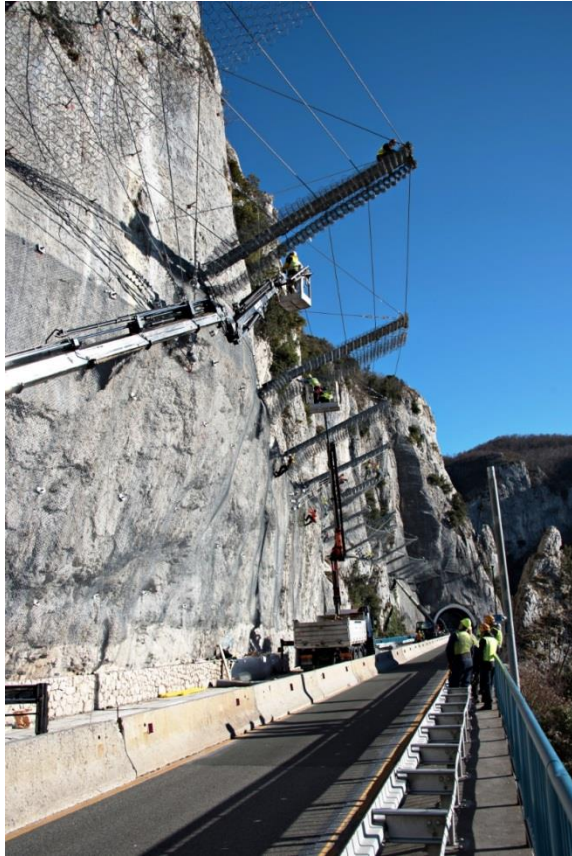
Figure 6. Installation of the 3000 kJ rockfall fence.

285 m of rockfall catchment fences were installed in 4 separate lines. A 43 m long TSC-2000-ZD 2000kJ barrier with a height of 6 m was installed above the western portal. The remaining fences consisted of 242 m of TSC-3000-ZD 3000 kJ barriers with 7 m heights (Figure 6). A 43m, 148m and 78 m long fences were installed along the main face of the slope while a 16 m long fence was constructed above the eastern portal and which overlaps one of the other fences in order to seal off the inside corner. Furthermore, gully nets consisting of the same nets used in the barriers were installed below the fences to close off major gaps in topography.

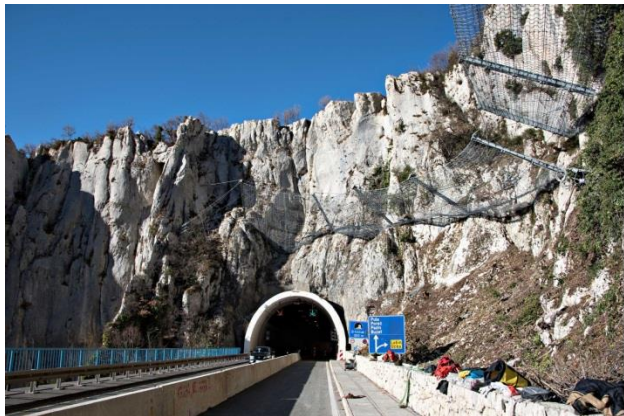
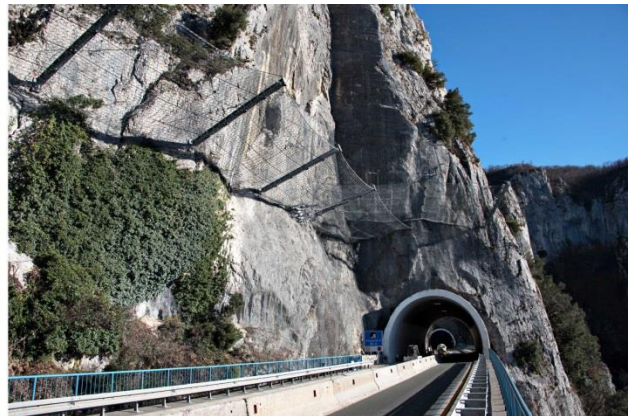
Figure 7. Complete portal protection (left: western portal, right: eastern portal)

The result of the project is the complete protection of 250 m long (including slopes above the portals, Figure 7) up to 60 m high vertical limestone cliff which endangered the only traffic route between two important regions in Croatia.
