CATASTROPHIC FAILURE OF A BEAVER DAM AT CHUDNUSLIDA LAKE, EAST CENTRAL BRITISH COLUMBIA

Brent Case, BC Ministry of Forests, Prince George, British Columbia
Peter Egyir, BC Ministry of Forests, Prince George, British Columbia
Marten Geertsema, BC Ministry of Forests, Prince George, British Columbia

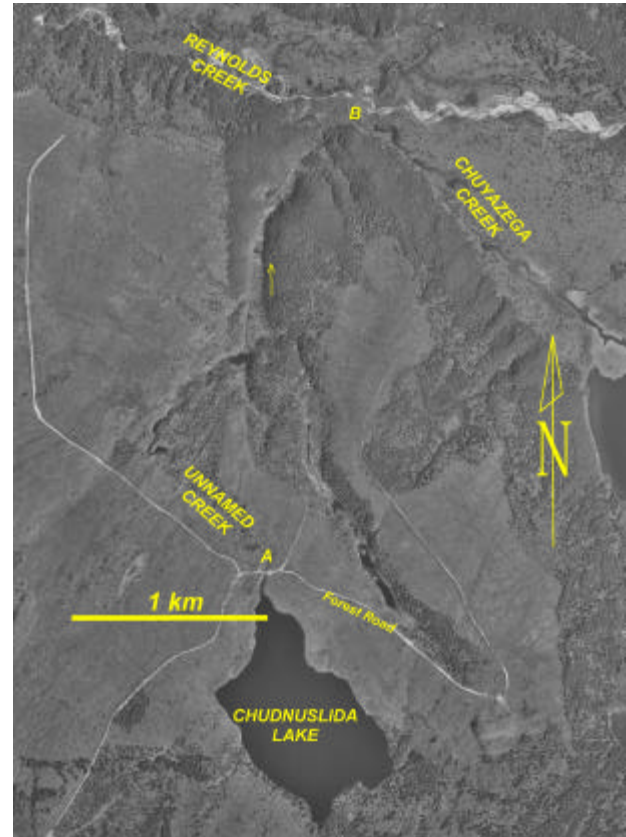
Some time in July or August 2000, a beaver dam on an unnamed outlet stream of Chudnuslida Lake (Figures 1 and 2) failed, resulting in lowering of the lake. The resultant flood scoured and aggraded the unnamed outlet stream (hereafter referred to as "the creek") over a distance of 4 km, and formed a gravelly fan where it entered Chuyazega Creek (Figure 2).

Figure 2. Orthophoto showing Chudnuslida Lake and area. Letters A and B denote the locations of the beaver dam and the fan, respectively.

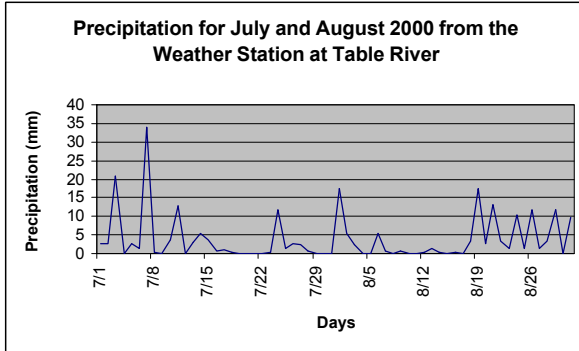
Catastrophic beaver dam failures are generally preceded by unusually high rainfall, or high spring runoff (Hillman 1998). Figure 3 shows the precipitation recorded at a MOF weather station near Table River, approximately 30 km from the study area during July and August 2000. The graph indicates a fairly heavy rainfall of 34.1 mm on July 7, 2000, suggesting the dam failure may have occurred subsequent to July 7, 2000.

Figure 3. Daily record of precipitation for July and August 2000 MOF weather station near Table River

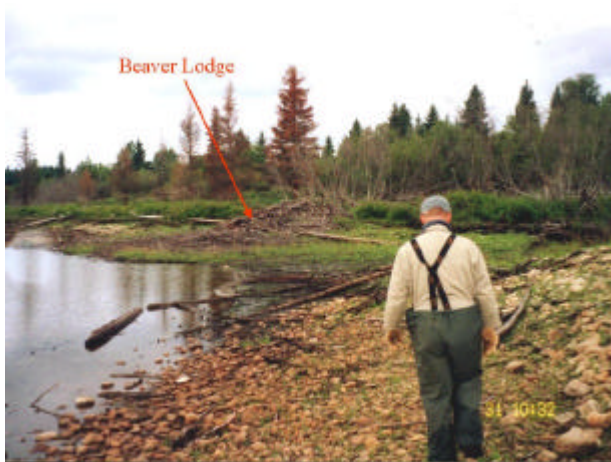
Failure of a beaver dam triggered a catastrophic flood down the outlet creek of Chudnuslida Lake. A beaver dam was evident on 1988 and 1997 aerial photographs (BCB97009: 59 – 60; and BCB88036: 243 -244) between a forest road crossing, the creek, and the lake (Figure 2). An abandoned beaver lodge was also located near the outlet of the lake (Figure 4).

Figure 4. Photo showing an abandoned beaver lodge at the head of the outlet stream.

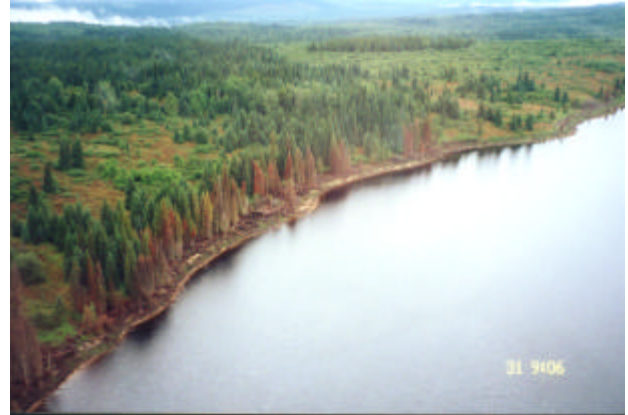
Dead vegetation (Figure 5) and abundant coarse woody debris on the lakeshore (Figure 6), especially in the vicinity of the creek, mark the high water level of the lake. Evidence of the high water marks suggests the beaver dam raised the lake level 1.5 m to 2.5 m. Given that Chudnuslida Lake has an approximate surface area of 1 km² the dam increased the volume of the lake between approximately 1.5 and 2.5 million m³. It follows that this was the volume of water that flowed down the unnamed creek.

Figure 5. Photo showing dead vegetation around the edge of the lake indicating drowning upon submergence.

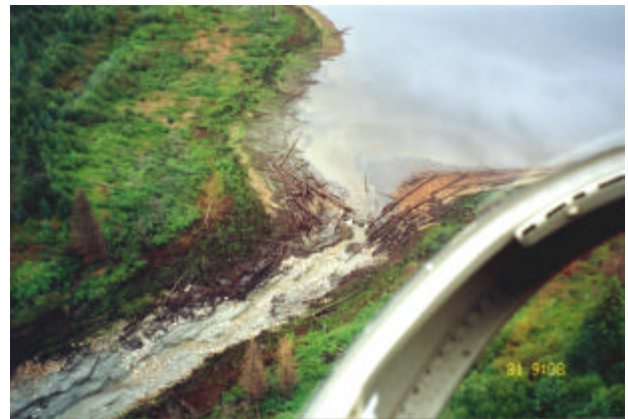
Figure 6. Photo showing stranded log debris and a scoured channel at the outlet of Chudnuslida Lake.

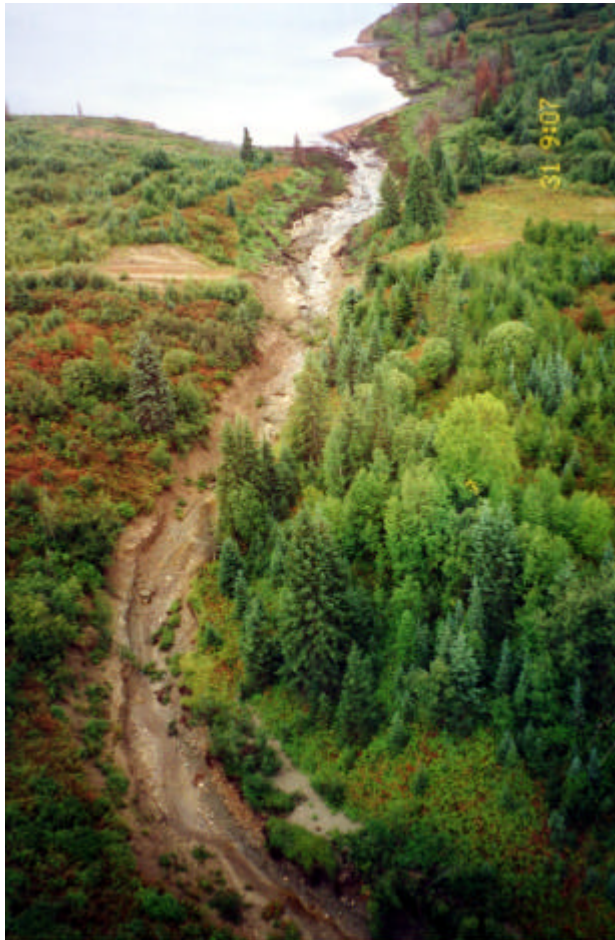
The catastrophic release of the impounded water scoured out the creek channel (Figure 7) and the valley slopes in

The creek bed was scoured between 1 and 4 m deep. The scouring was more pronounced at the confined, upper reach of the creek. Based on the thickness of the gravel and organic debris deposited along the creek channel, it is evident that the depth of the flood ranged up to 5 or 6 m.

Figure 7. Photo showing the scoured creek channel near the outlet of Chudnuslida Lake.

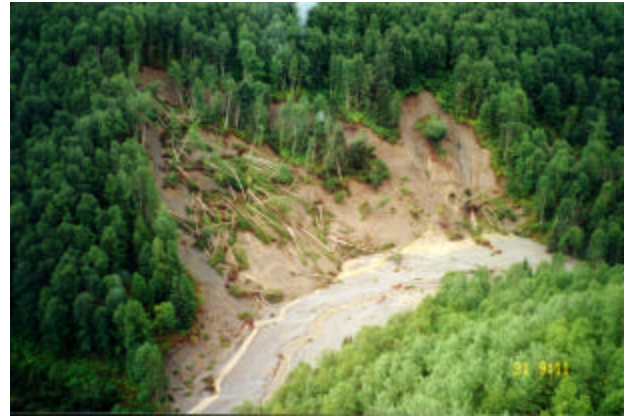
the outside bends (Figure 8) from Chudnuslida Lake down to where most of the debris was deposited in a fan at Chuyazega Creek (Figure 9). The event left numerous unstable slopes along the valley sides over much of the creek below the road crossing (Figure 10). It was evident that some old landslides along the valley side slopes were reactivated by bank erosion during the flood.

Figure 8. Photo showing the unstable gully wall of the creek, and flood triggered instability.

We did not recommend any mechanical slope stabilisation along the creek gully due to access limitation. In addition, we judged that any attempt to mechanically stabilise the gully walls could cause more environmental damage to the unnamed creek and surrounding terrain.

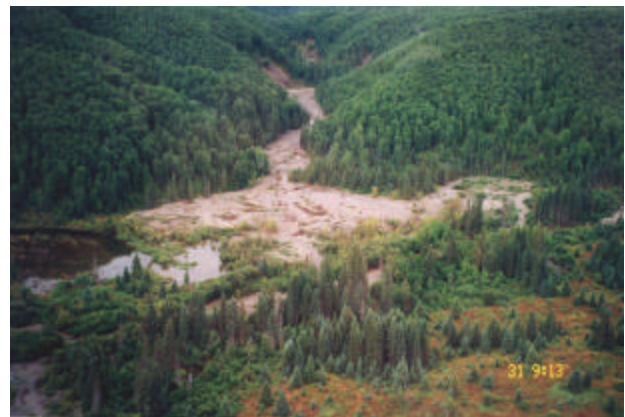
With the scour along the creek and the landslides along the valley slope, we estimate that 30,000 to 80,000 m³ of sediment was deposited in bars in the lower, wider portion of the channel, and as a fan into Chuyazega Creek and on its floodplain.

Figure 9. Photo showing the debris fan at Chuyazega Creek.

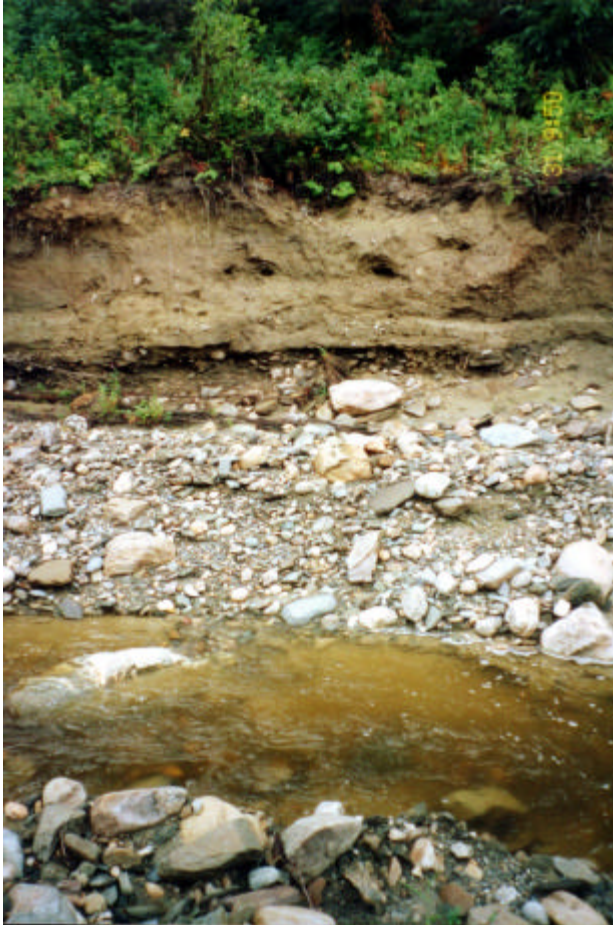
Soils exposed along the gully walls and the scoured creek bed consisted mainly of till overlying glaciofluvial deposits (Figure 10). Sand and gravel containing variable amounts of silt, clay, and cobbles were the dominant soils.

Figure 10. Photo showing diamicton overlying sorted sand and gravel in an area where the creek bed was down cut.

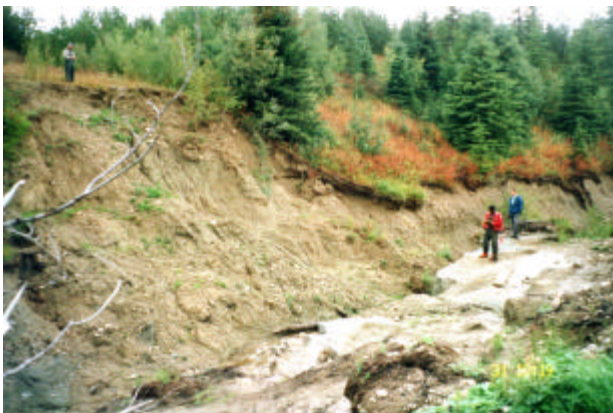
The flood left a 15 m deep washout at the location where the existing forest road crossed the creek (Figure 11). At the road crossing the creek originally flowed through a

900 mm culvert, which was displaced during the flood. Sections of the culvert were found at three different places, downstream of the original culvert location.

Figure 11. Photo showing the depth of the washout at the original road crossing. Note persons for scale.

The relatively high walls created from the road embankment washout presented a significant safety concern to traffic. We prescribed that the side of the remaining road embankment that was accessible be pulled back to no steeper than 2 horizontal: 1 vertical. The material derived from the re-sloping was to be used in constructing a berm across the width of the adjacent road. The berm was intended to prevent vehicle or equipment access past the washout area. We also recommended that the rest of the road downchainage of the creek crossing be deactivated provided the road is not required for any industrial or recreational use.
