GROUNDWATER BLOW-OFF AND PIPING DEBRIS FLOW FAILURES

Drummond S. Cavers, AMEC Earth & Environmental, Burnaby, BC 604 473-5307

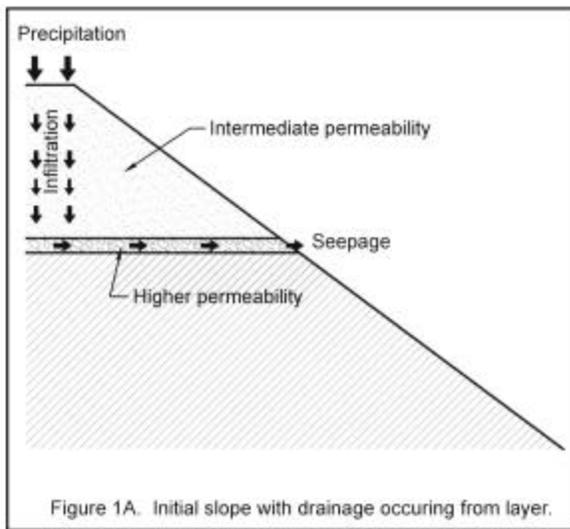
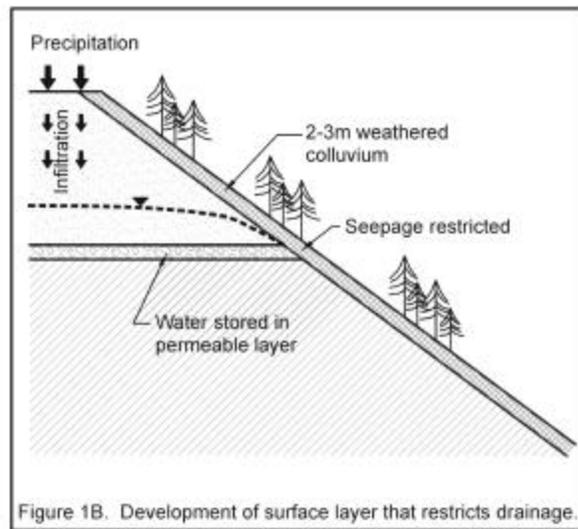
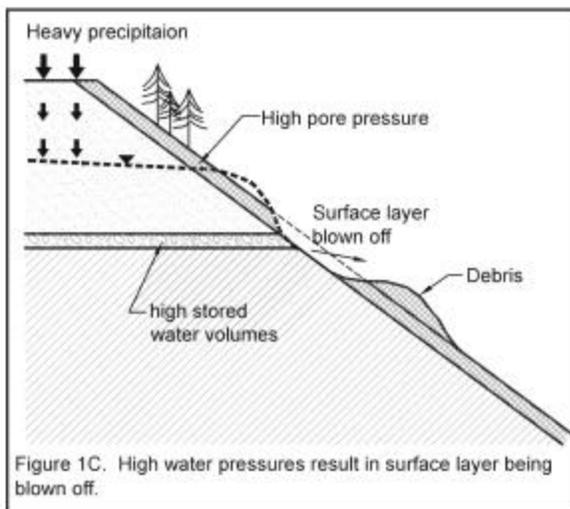
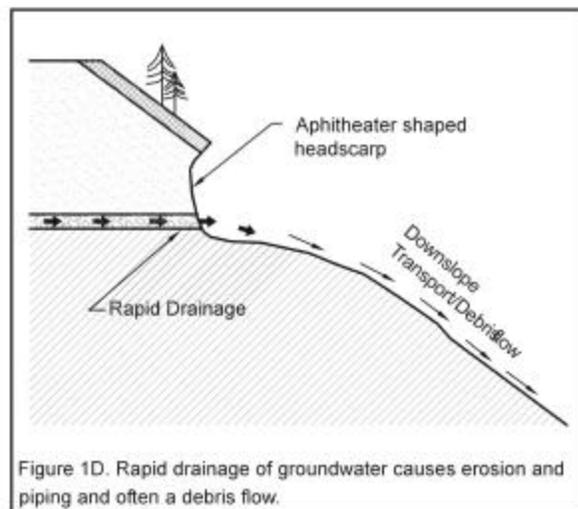
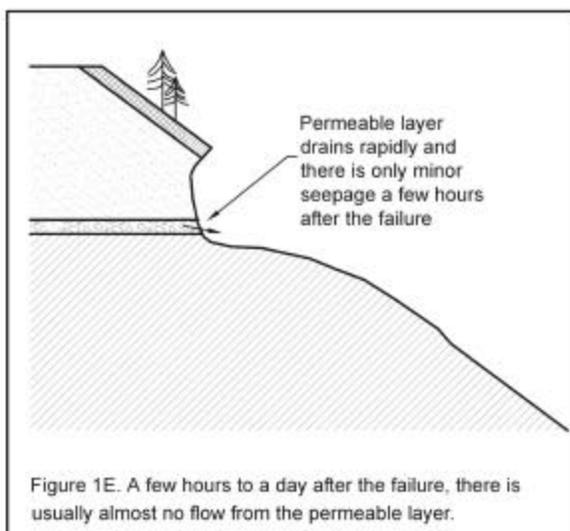
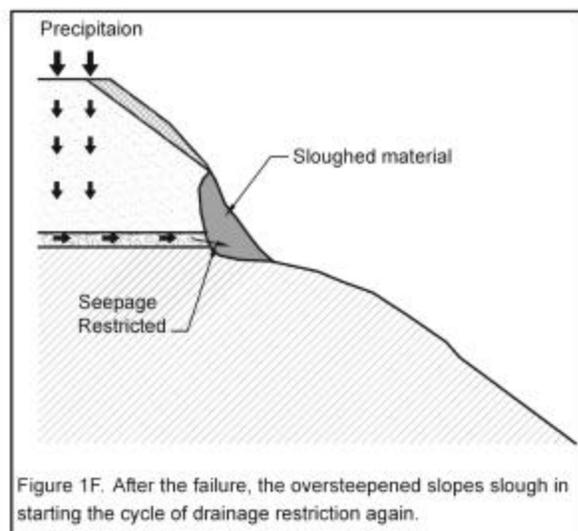
The cycle of failure often starts with the development of vegetation on a slope underlain by bedded sediments (Figure 1A). Colluvial processes and vegetation growth result in mixing and weathering of a near surface layer of soil that may be 1 to 3 m deep. This near surface layer, which gradually becomes less permeable and

As the seepage drainage from the permeable layers is increasingly blocked, groundwater storage in the permeable layers tends to increase, as does the groundwater pressure applied to the base of the lower permeability layer developed along the slope (Figure 1B).

Eventually, the groundwater pressures along the bottom of the low permeability layer may reach the point where the effective stresses along the bottom of the layer are close to zero (Figures 1B and 1C). In some cases, upward bulging of the surface layer indicates that the layer has been pushed up by the high groundwater pressures. In other cases, small translational sliding movements may occur prior to complete failure (and may sometimes facilitate drainage so that complete failure does not occur). High groundwater pressure conditions resulting in failure often occur during periods of high precipitation and runoff that cause increased infiltration on upland and adjacent areas.

Figure 1. Schematic drawing showing cyclic development of a groundwater blow-off failure.

As a result of the high groundwater pressures, the surface layer may be blown off over a local area (Figure 1C) allowing rapid drainage of the stored groundwater to occur.

High drainage rates of large volumes of stored groundwater often result in retrogressive piping erosion of the bedded sediments (Figure 1D) forming an amphitheater-shaped depression with steep or overhung sideslopes. The elevation of the bottom of the basin is controlled by the seepage point(s). Large volumes of material may be eroded, creating a debris flow. A gully is often eroded down the slope below the failure by the high velocity debris flow. In other cases, the piping erosion erodes back into the slope and uphill, creating a deep ravine. Translational sliding of the oversteepened slopes around the amphitheater contributes further sediment that is transported downslope by the high drainage flows. The actual failure usually only lasts a few minutes to a few hours. It is important to note that in virtually all the failures observed, there was no appreciable surface flow into the head of the failure area.

After drainage of the stored groundwater is complete, there is usually very little seepage from the failure area and this seepage may be obscured in some cases by material that has sloughed from the sides of the amphitheater (Figure 1E). As erosion of the sides of the amphitheater occurs and vegetation grows on the area, the cycle of failure often repeats over a period of years (Figure 1F). The reoccurrence interval varies depending on precipitation patterns and growth rates, but in coastal BC may be on the order of 20 to 60 years, based on apparent tree ages, and in the interior may be somewhat longer in some areas.

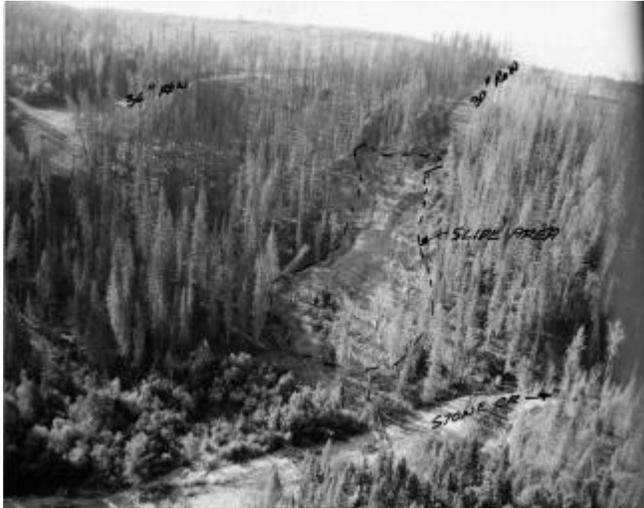
area and while the pipeline right-of-way was covered with the failed debris, the pipeline itself was not a cause or trigger of the failure. The failure initiated near the mid-point of slopes that were approximately 90 m high at angles of 25 to 30°. Debris from the failure was washed out onto lower angle slopes (a colluvial apron from previous failures) near Stone Creek. There was a clearcut on the flatter slopes above the failure, but this was probably not a major factor in the occurrence of the failure since there were numerous old gullies across the slopes produced by previous blow-off failures. Prior to the blow-off failure, there were evidently some translational movements of the surficial layers since there was some vegetation growth on the upper part of the failure scarp.

Figure 2A. Aerial view of a blow-off failure at Stone Creek that was located in ridged ground resulting from previous failures. The initiation of the failure was at the mid-point of the slope. There was no surface flow into the failure. The debris ran out onto the lower part of the slope.

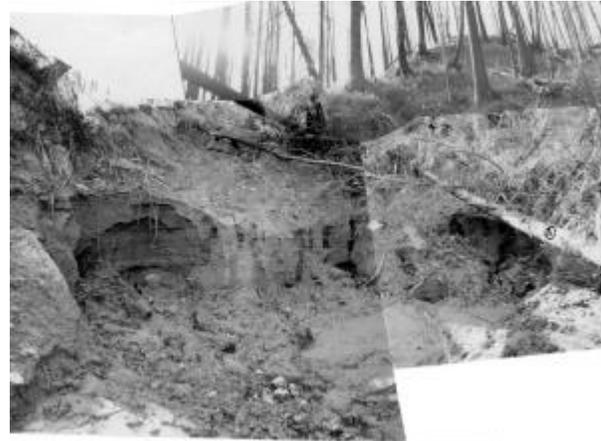
The exposures in the area included bedded glaciofluvial deposits including silt, sand and gravel with some till. As shown on Figure 2B, the upper end of the failure was amphitheater-shaped and was located at the top of an old gully formed by a previous failure. There were several layers from which seepage occurred during the failure and there were piping holes visible at several points around the head scarp area. The debris from the failure ran down the slope and gully as a debris flow and accumulated on a colluvial apron near the creek. The timing of the slide may have been related to an increase in surface infiltration as a result of a forest fire on the upland area above the slide two years prior.

Figure 2B Detail showing the crest of the Stone Creek failure. The main seepage exit was below the colluvium and slough in the lower part of the photo. Some of the cavities left by soil piping above the main seepage area are visible just above the sloughed material. There was evidently a small amount of translational movement prior to the failure since there were a few small plants growing on the upper part of the failure scarp. Drainage was installed by digging down through the sloughed material.

The failure could have exposed the pipeline, but did not. Also, the generation of sediment from the area, while natural, was a concern to local regulatory personnel. As indicated, the failure was a natural event with no connection to the pipeline. Ongoing groundwater drainage was provided by hand digging a hole and installing a treated timber crib surrounded by non-woven filter cloth and drained by a culvert to provide ongoing drainage from the seepage layers. Additional drainage has recently been installed in nearby areas.

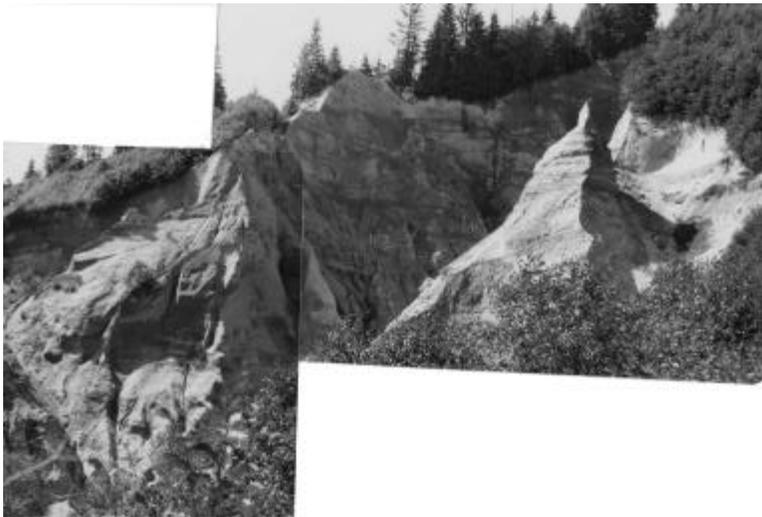
Several of the blow-off failures on and near the steep mined slopes retrogressed back into the slope to form large ravines (Figures 3A to 3D). The failures in the gravel pits have ranged up to several hundred thousand cubic meters in single failures. Large ravines were eroded during single events. Unlike many of the other failures discussed in this paper, the low permeability surface zone on the mined slopes was formed by colluvium and in many cases there was no substantial vegetation development. In some cases, the failures resulted from extremely high infiltration rates and the drainage reduction due to surficial sloughing. Freezing of the surface may have been a factor in a few cases.

Figure 3A (left) Oblique view of gully formed in sandy glacial drift overlying bedded sands and gravels with occasional silt layers in a gravel pit along Pipeline Road, Coquitlam (photo taken around 1984). The amphitheater shaped bowl with steep sideslopes at the head of the gully is visible behind the pinnacle at the right side of the photo. This gully eroded back into the ridge over a few hours.

Figure 3B (right) Crest area of a blow-off failure that eroded a steep gully downslope of the failure. This failure occurred on an oversteepened face formed by excavation. The restraining layer may have been formed by natural permeability variations and sloughing rather than vegetation growth. The groundwater induced piping started high up on the face and undermined a root mat remaining after the bench had been logged. Subsequent sloughing of the oversteepened slopes in the crest area (shadowed area) covered the seepage point.

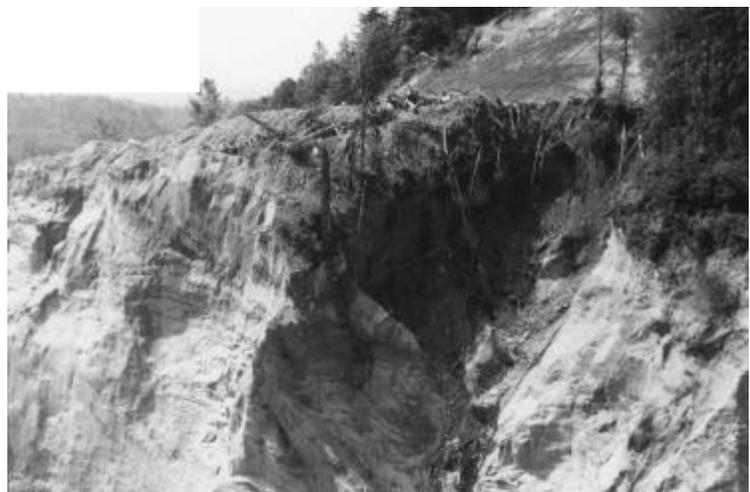
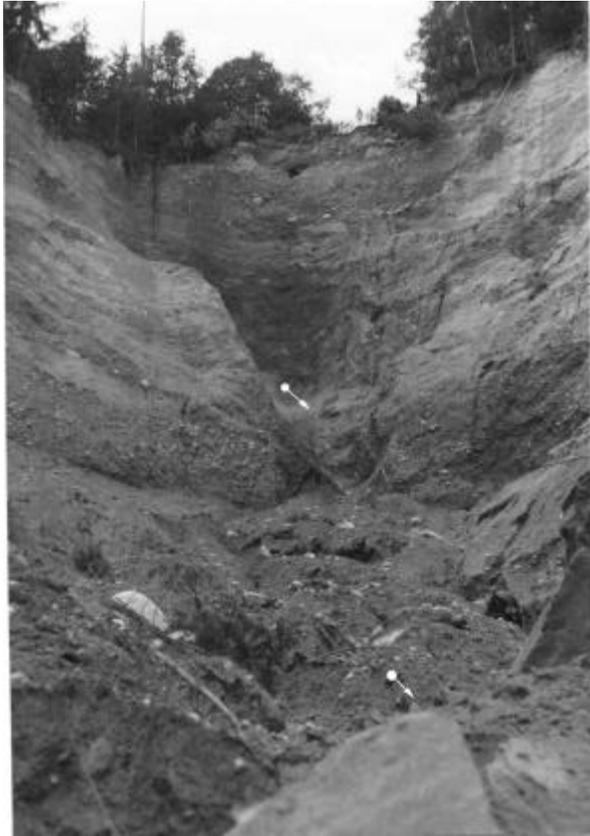
Figure 3C (above). Looking upslope along the eroded canyon at the headscarp area of a blow-off failure along Pipeline Road (photo taken around 1984). The amphitheater shaped head area with oversteepened slopes is visible. There appeared to have been two main seepage points (shown on photo), resulting in a stepped profile. Similar to most of the groundwater blow-off failures observed, there was no significant surface water flow into the gully and much of the volume of the gully was eroded over a single short period. Some of Pipeline Road failures later retrogressed in subsequent cycles of failure as a result of seepage egress being blocked by sloughed material.

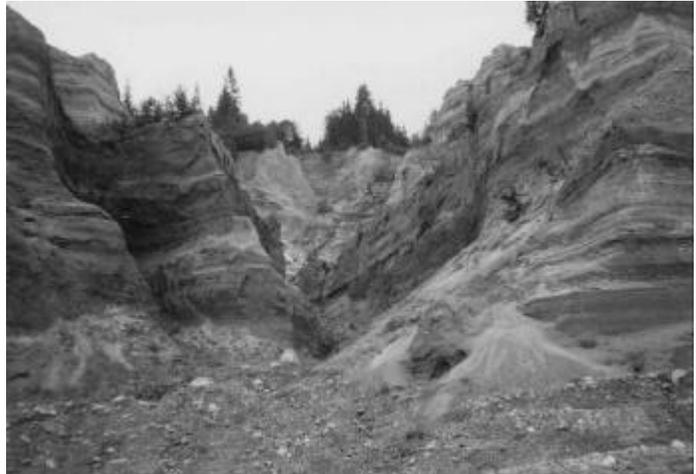
Figure 3D (above). Looking upslope along a very large gully initially formed within a 24 hour period by retrogressive erosion during a blow-off failure. The head of the gully is in the background of the photo, visible through the V-shaped gully in the foreground. In the 1960's to early 1980's, some very large gullies were formed over very short time periods by groundwater blow-off mechanisms followed by soil piping and erosion.

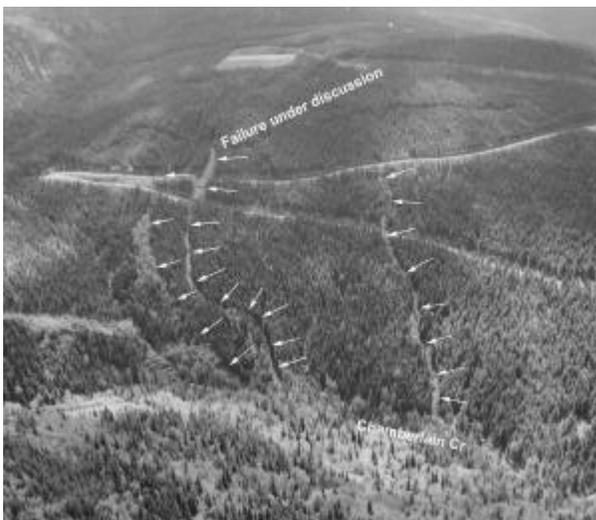
There were several old failures on the slope (Figure 4A) that predated construction of an access road switchbacked across the slope. The failure under discussion initiated above the road switchbacks and traveled across two road segments on the slope. As shown on Figure 4B, there was no surface water flow into the head of the slide.

Figure 4A (left). Debris flow failures above Chamberlain Creek are indicated by arrows. The center failure is discussed in the text. The other two failures are old ones that predate the construction of the access road. The failure occurred on slopes of 25 to 30° and ran a lineal distance of over 800 m down to the creek.

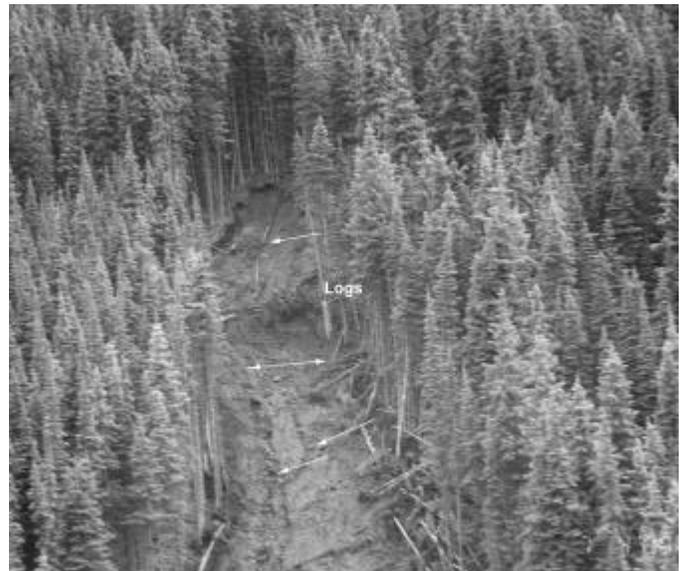
Figure 4B (above). Headscarp of failure showing several seepage areas (arrows) from shallow bedrock. There was no surface flow into the slide area. The logs were at a step where there was an additional smaller failure immediately upslope.

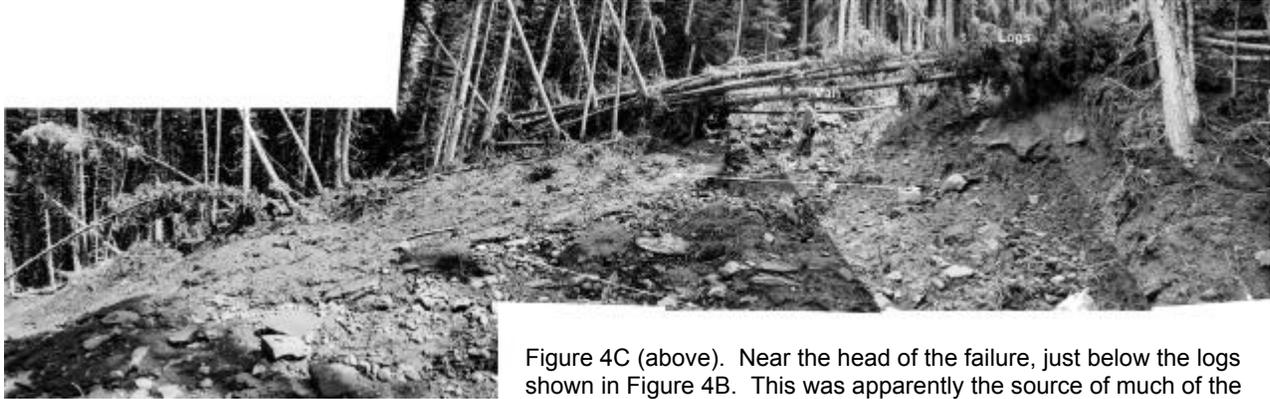
The main area of initiation had a rounded headscarp (Figure 4C). Two days after the failure occurred, there was still locally appreciable amounts of seepage issuing from the rock. Development of a full amphitheater shaped depression did not occur since the shallow rock restricted downcutting erosion. There were several seepage areas in the headscarp area and there was a narrower retrogression upslope from the area shown in Figure 4C (above the logs shown in the figure) where there was another area of seepage. Several bulged areas were found on nearby slopes by probing with a hand auger. These areas had voids above the bedrock surface where the pore pressures under the till and root mat had evidently been high enough to push the soil upward, but not quite high enough to blow it off.

Figure 4C (above). Near the head of the failure, just below the logs shown in Figure 4B. This was apparently the source of much of the seepage outflow, although the failure retrogressed higher up the slope beyond the logs. The double headed arrows across the slope show some of the main seepage horizons. A man standing under the logs shows the scale. Photo 4D below was taken 175 m downslope from the location of this photo

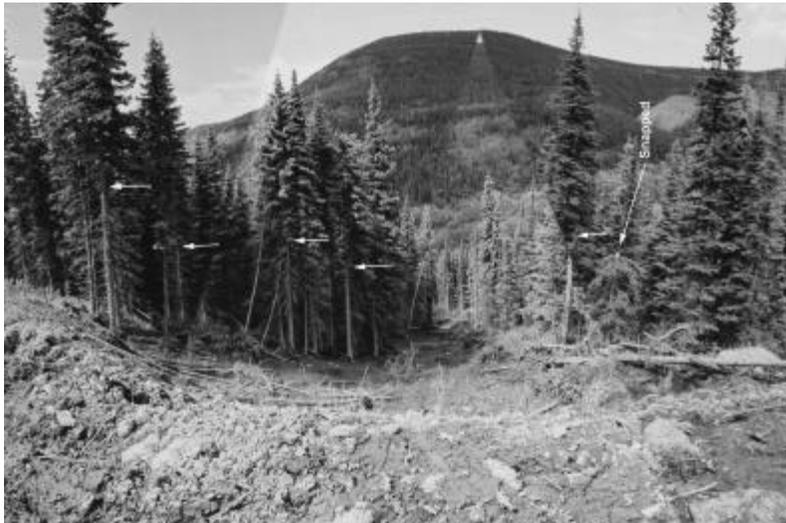
The flow traveled at high velocity, especially in the upper part of the failure. Where it crossed the first logging road switchback, the slide evidently jumped off the road fill and trimmed branches off trees and snapped a tree to elevations 10 m above the local ground surface (Figure 4D). Where the slide crossed the two road switchbacks, large amounts of wood debris and water were deposited on and diverted down the roads. Farther downslope, at a bend on slightly flatter terrain, the slide velocity was estimated at 20 m/s. This velocity was probably lower than higher up the slope.

Figure 4D (left). Looking downslope where the slide crossed a logging road switchback. The high velocity of the debris flow at this point is shown by the trim lines on the trees (arrows) which were almost 10 m above the ground. The debris flow evidently jumped off the road at this point (like a ski jump), accounting for the trim lines. Note also the tree that was snapped off near the same elevation at the right of the photo. The main slide path downslope of the road was 10 to 12 m wide at an overall slope of 23°. A large amount of woody debris was deposited behind the photographer on the road.

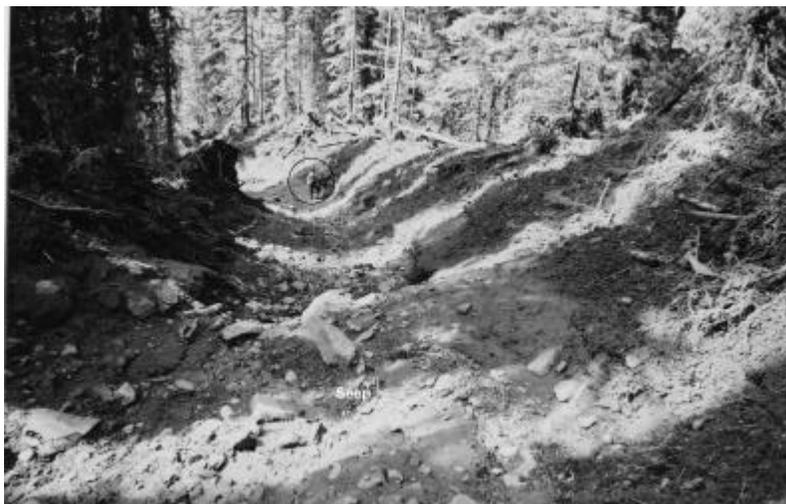
Along most of the slide path, the slide debris ran down a gully that was typically 10 to 15 m wide with steep sideslopes (Figure 4E). It is not clear whether the slide followed an existing gully formed by past events and cleaned it out, or whether the slide eroded a new gully. However, in view of the other old failures on the slope, it is likely that at least part of the gully had been formed by similar previous events.

Figure 4E (left). Looking downslope at the first major bend. Note the man circled in the background for scale. There was a seepage area in the foreground that contributed additional water. As the slide eroded the surficial materials along its path, additional seepage occurred from the bedrock and probably increased the volume of the flow.

The bend was 57°, with an estimated radius of curvature of 60 m and the super-elevation was estimated to be 2 m, indicating a velocity of 20 m/s. The velocity here may have been lower than at the logging road in Figure 4D since a large amount of water and debris was diverted where the slide crossed the road.
