# RAILWAY GROUND HAZARD RISK SCENARIO: RIVER EROSION: EARTH-SLIDE

Tim Keegan, Canadian National Railways, Edmonton, Alberta  
Brian Abbott, Canadian National Railways, Edmonton, Alberta  
Dave Cruden, University of Alberta, Edmonton, Alberta  
Iain Bruce, BGC Engineering Ltd, Vancouver, B.C.  
Mark Pritchard, BGC Engineering Ltd, Vancouver, B.C.

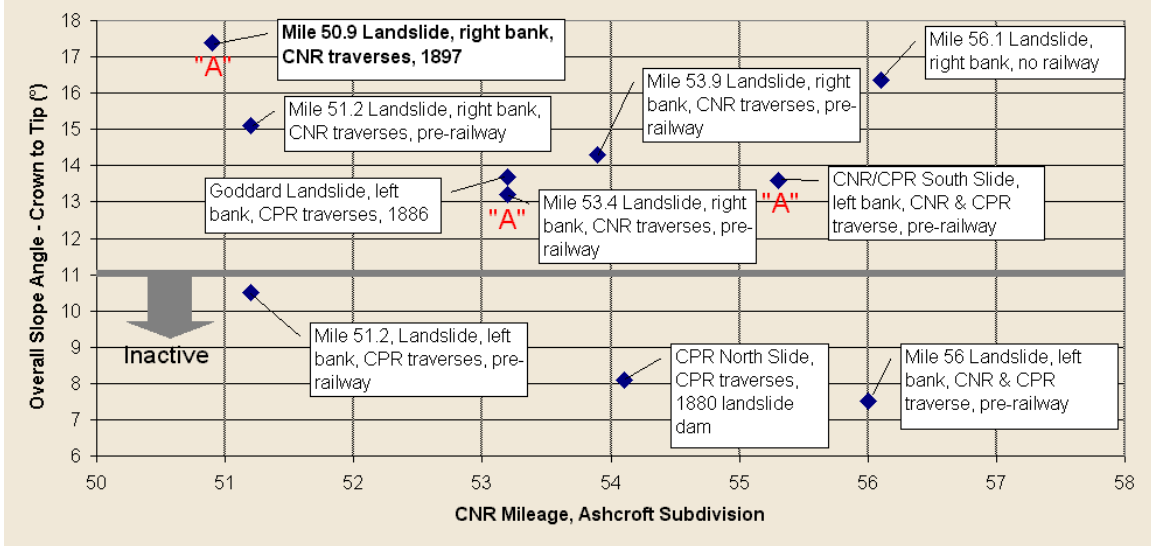
Figure 4: Overall Slope Angle of Landslides Downstream of Ashcroft on the Thompson River

Consequently slope angles for the major landslides along reach of the Thompson River have been measured and presented on Fig. 4. Landslides that are known to be active since the 1997 flood event are noted with an “A” in Fig. 4. The first observation is that the landslides that have a slope angle below  $11^\circ$  namely at CNR mileages 51.2 (left bank), 54.1(left bank) and 56 (left bank), correspond to those landslides that have been observed to have undergone secondary compound movements and are now reactivated, retrogressive, compound earth-slides. These landslides all have low slope angles, have no recent activity, have pushed the river over and formed a meander away from them and show air-photo evidence of uphill-facing scarps. Of note also is that each of these landslides has corresponding landslides on the opposite bank of the river with slopes significantly above  $11^\circ$ .

Landslides with slopes greater than 11°, including Mile 50.9, have sharper scarps inferring they are younger in their evolution and active. At CNR mileage 53.4 the two opposing landslides appear to have balanced themselves off at a slope angle of around 13.5°, still 2.5° above 11°. In the context of this paper, the most significant observation is that the Mile 50.9 Landslide has the highest slope angle at 17.5°. It is concluded from this that the secondary compound earth-slide movement has yet to occur at this location. This is not to say that the secondary movement is likely in this case as there are a number of unknown conditions that may preclude it but nonetheless the possibility warrants significant attention.

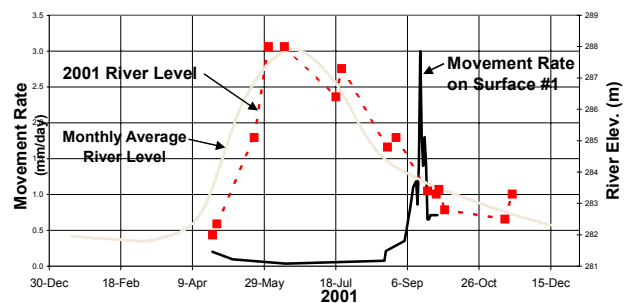
Figure 5: Mile 50.9 Landslide: Toe block movement rates versus river level during 2001.

The triggering event for the reactivated, multiple rotational earth-slide, using Wicczorek's (1996) definition, is inferred to be draw-down conditions brought on by very low river levels in the Fall or Winter months following flood and scour events. The correlation between river level and slide movements is highlighted in Fig. 5. Movement rates measured on the rupture surface in the toe area of the Mile 50.9 Landslide are plotted with river levels from April to October of 2001.

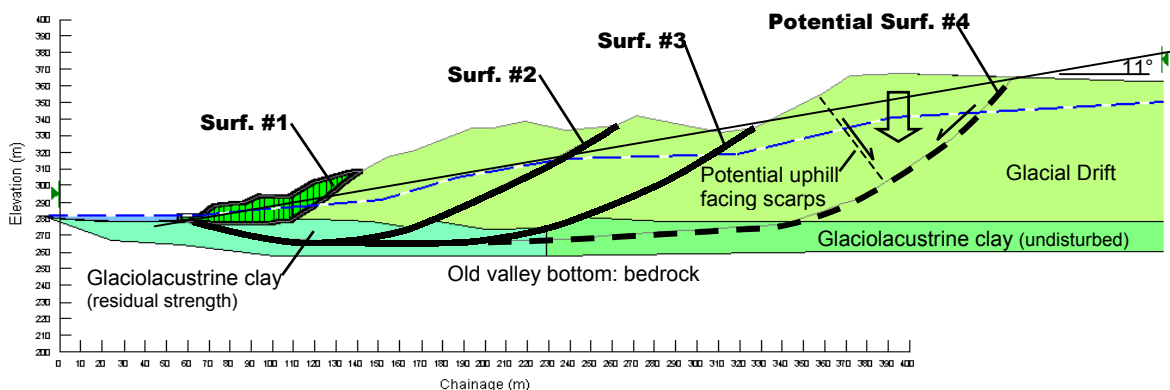
Figure 6: Mile 50.9 Landslide general surface stability back-analysis section.

A cross section of the slide is shown in Fig. 6. Failure surfaces are interpreted from slope indicator readings

and known scarps. Surface #4 is inferred from truncated slip-circle search,  $45^\circ + \phi/2$  scarp dip and an arc shaped depression observed behind the existing crown. Piezometric levels are taken from instrumentation near the toe of the slope and extrapolated back to mimic

ground surface. Analysis indicates that surfaces #1 and #2 are essentially meta-stable. The stability of surfaces #3 and potential surface #4 are relatively higher provided the glaciolacustrine clay remains undisturbed. When the shear strength in the glaciolacustrine clays is dropped from  $\phi_p' = 19^\circ$  and  $c' = 20$  kPa to the residual strength of

$\phi_R=11^\circ$  and  $c'=0$  along surface #4 in the analysis there is a 19% drop in sliding resistance. This condition could be triggered were there excessive movements and stress release on surfaces #1, 2 or 3 (strain weakening). Another possible trigger for movement on surface #4 is an incremental increase in pore pressure in the glaciolacustrine deposits resulting from events such as high antecedent precipitation or up slope irrigation.

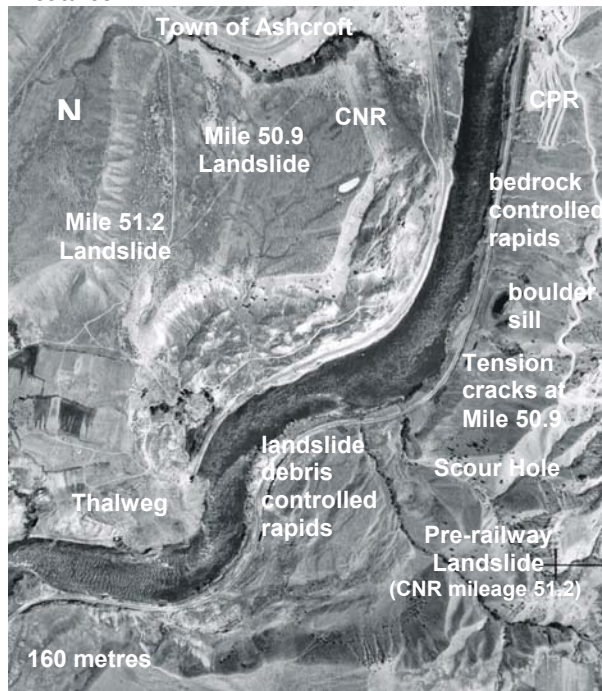
Figure 7: Location of landslide and river hydrology features.

Fig. 7 illustrates the general arrangement of the landslide and river features in the vicinity of the Mile 50.9 Landslide. To understand the river erosion processes in proximity to the Mile 50.9 landslide it is necessary to examine the river morphology.

The river is relatively straight in its approach to the Mile 50.9 Landslide, followed by a moderate rightward bend. The toe of the landslide is on the inside of this bend. In these circumstances, it would normally be expected to find the thalweg located adjacent the left bank whereas,

as shown in Fig. 8, the thalweg is located close to the right bank. The reason for this is apparent from Fig. 7. Upstream, the rapids are controlled by shallow bedrock on the left bank of the river and, opposite the landslide; the left half of the channel contains a series of boulder bars. This continuous zone of roughened bed on the left side of the channel likely forces flow and the thalweg to the right half of the channel.

Apparent from the rapids that wrap around the slide debris of the prehistoric landslide (noted on Fig. 7) and the 6 metre scour hole upstream of the rapids, the channel is actively degrading into slide debris which came from both sides of the river and is attempting to reestablish its pre-slide level. This process of channel degradation (Savigny et al, 2002) is expected to continue and thus will result in the erosion of material at the toe of the Mile 51.2 and 50.9 landslides. History supports this assessment as movements were observed and remediation required at the location of these landslides in the years following significant flood events most notably the 1921, 1948, 1972, 1997 and 1999 floods. Channel degradation, a ground hazard event, is thus the key preparatory factor to the earth-slide hazard in this case.

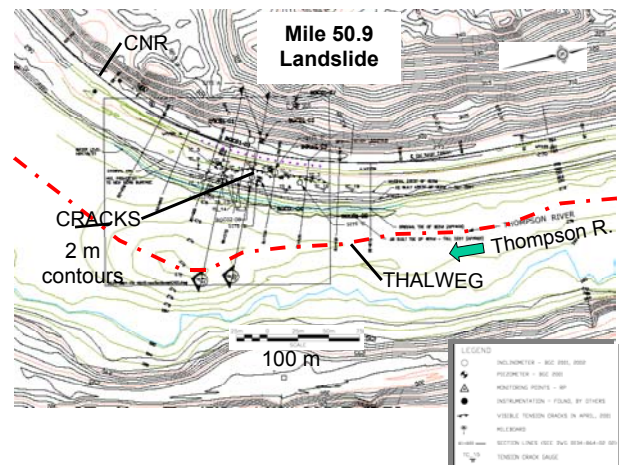
Figure 8: Bathometric survey of river channel at Mile 50.9 Landslide

Immediately downstream of the tension cracks the river appears to have scoured out a 6 metre deep hole towards the middle of the channel (see Fig. 8). Further downstream, a pre-railway landslide originating from the left bank has evidently pushed the channel significantly to the right and caused the landslide debris controlled rapids noted on Fig. 6. It is likely this secondary compound earth-slide event resulted in a pre-railway landslide dam that flooded a large area upstream. Once breached, the river down cut into the right bank over-steepening the slope. This probably triggered the activation or reactivation and possible retrogression of the Mile 51.2 and 50.9 multiple rotational earth-slides, the first movement type. The 6-metre deep hole in the thalweg immediately downstream of the Mile 50.9 Landslide may be a remnant of the channel that existed before the pre-railway landslide.

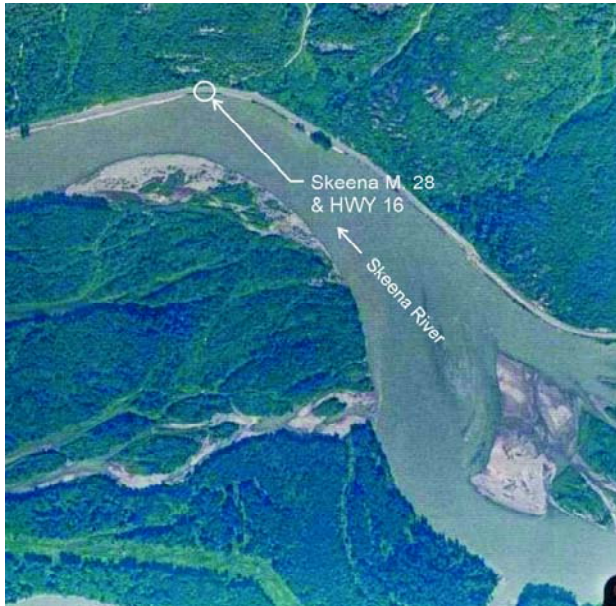
Figure 10: Skeena Mile 28 location photograph

On February 20<sup>th</sup>, 2002, a small earth-slide occurred over a period of a few hours on the riverbank between Miles 28.04 and 28.06 of the Skeena Subdivision. As seen in Fig. 10, the landslide occurred on the north or right bank of the Skeena River above an outward bend in the main channel. The main scarp was located within 1.5m of the track centreline. Although the track showed little noticeable deflection an 80 m arc shaped tension crack had formed in the highway pavement reaching the centre line of the highway at the midpoint. In less than 24 hours, the slide scar was backfilled with angular riprap and the track re-opened.

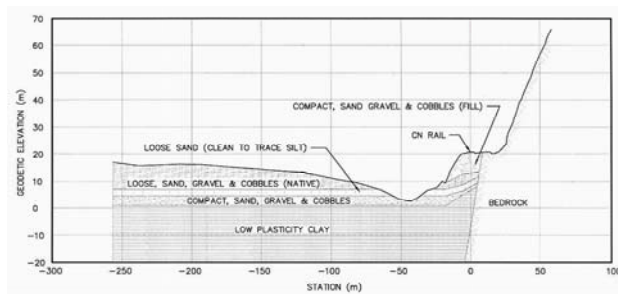
Figure 11: Interpreted stratigraphic cross-section looking downstream. (Note: 2:1 vertical exaggeration)

- Scour events during past floods are recognized as the key preparatory factor to the earth-slide hazard. The February failure classed as a rapid rotational earth-slide was likely triggered by a rise in soil pore pressures from snowmelt or draw down conditions brought on by a period of low river level following formation of a scour hole.
- Fig. 11 presents one interpretation of the stratigraphy at the site. The basal rupture surface was likely bounded in a loose sand horizon.
- Analysis indicated that a deeper potential rupture surface was marginally stable in a low sensitivity, soft, low plasticity, glacio-marine clay and silt that underlay the granular and loose sand horizons. The Liquid Limit of the silts ranged between 22.8% and 24.9% while the Liquid Limit of the clays ranged between 33.3 and 35.0%.

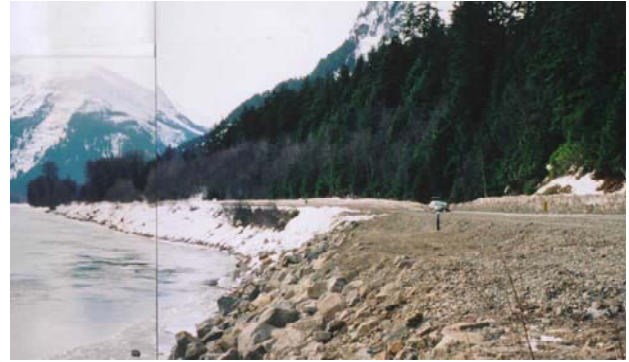
Figure 12: View looking downstream after site investigations and February bank repair. (The slope inclinometer casing in the photograph is near the upstream edge of the backscarp).

Fig. 12 shows the riverbank immediately following the site investigations and the February bank repair.

Prior to spring runoff, CNR undertook additional riprap work upstream and downstream of the February slide site. Despite the additional riprap protection, a second failure occurred at or near the same location during spring snowmelt runoff on July 18<sup>th</sup>, 2002. This time the earth-

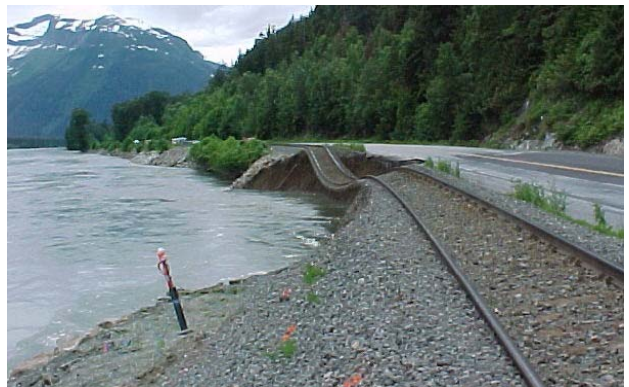
Figure 13: Skeena Mile 28: View looking downstream at July 18 landslide site

slide had retrogressed to involve the track grade and the left lane of the highway but had stopped at the ledge in the bedrock surface encountered near the centreline of Highway 16. As shown in Fig.14, both earth-slide events occurred in the eastern half of the scour hole coincident with the bedrock knoll on the north side of Highway 16.

The failure removed support for the rail grade and produced tension cracks in the adjacent Highway 16. Fig. 13 illustrates the site following the earth-slide event. The location of the failure can be related to Fig. 12 using the slope inclinometer casing visible in both photographs. Immediate repair was made by filling the slide scar with riprap and temporarily re-aligning the rail grade to occupy one lane of the highway.

It is inferred that the second failure was triggered by additional river scour during high flow. The July 18<sup>th</sup> landslide is classed as a rapid reactivated retrogressive rotational earth-slide.

A more extensive riprap program was undertaken to further reinforce the earlier riprap construction. It was recognized that continued erosion and undermining of riprap would likely occur. Since it was impractical to place riprap to the bottom of the thalweg using equipment on

the bank, the scour hazard was mitigated by construction of a riprap launching apron of sufficient size to retard future undermining from scour at the toe. In total, approximately 20,000 m<sup>3</sup> of riprap was placed. In addition, a real-time warning system of mercury switches on tip-over posts linked to the railway signal controls were installed on the riverbank through the affected area.

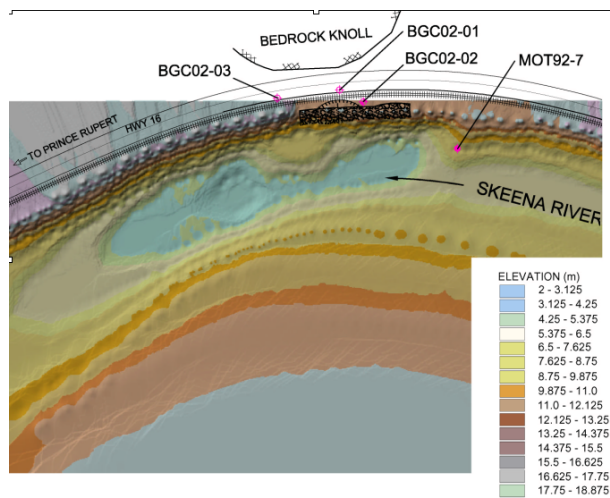
Figure 14: Skeena Mile 28 -Slope shade image of July 2002 bathymetry.

A second bathymetric survey after the July failure indicated that the scour holes downstream of the February failure had deepened since the March, 2002 survey. Figure 14 shows shaded bathymetric contours from this second survey that illustrate the scoured area and the partial infilling of the scoured area by material from the July failure.

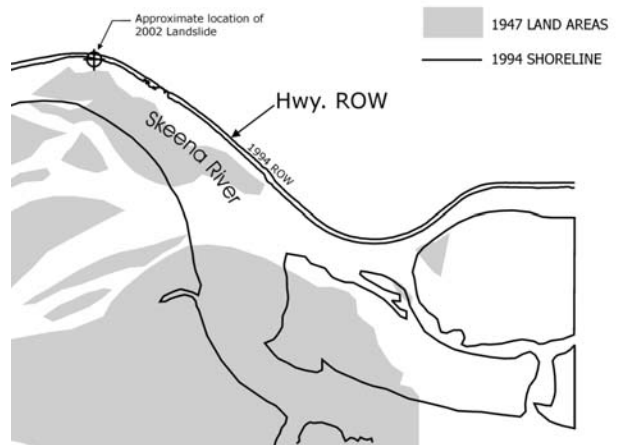
Figure 15: Skeena Mile 28 - Overlay of 1947 and 1994 river locations.

was located on the south side of the valley and did not impact on the track. By 1963, the main channel had migrated north until it was against the north bank, although the river curvature was less than is presently the case. Between 1963 and present, the outer edge of the meander migrated downstream and the angle between the main direction of flow and the north bank appears to have steepened such that the flow is now directed more toward the riverbank as opposed to along it. Figure 15 shows an overlay of the 1947 channel location on the 1994 location, illustrating the major shift of the main river channel.

Traces of the river channels from the 1947 and 1994 photographs were overlaid to quantify the bank erosion. This work illustrated that the north bank near Mile 28 has been eroding since 1963 at a rate between approximately 0.3 m/yr in the upstream half of the river bend, to 0.75 m/yr at the downstream limit of the bend.
