# DEBRIS FLOW HAZARD AT FIVE MILE CREEK, BANFF, ALBERTA

Simon Cullum-Kenyon, Thurber Engineering Ltd., Calgary, Alberta, Canada  
Heinrich K. Heinz, Thurber Engineering Ltd., Calgary, Alberta, Canada  
John C. Sobkowicz, Thurber Engineering Ltd., Calgary, Alberta, Canada  
Doug VanDine, VanDine Geological Engineering Ltd., Victoria, BC, Canada  
Doug Kerr, Parks Canada – Highways Service Centre, Banff, Alberta, Canada

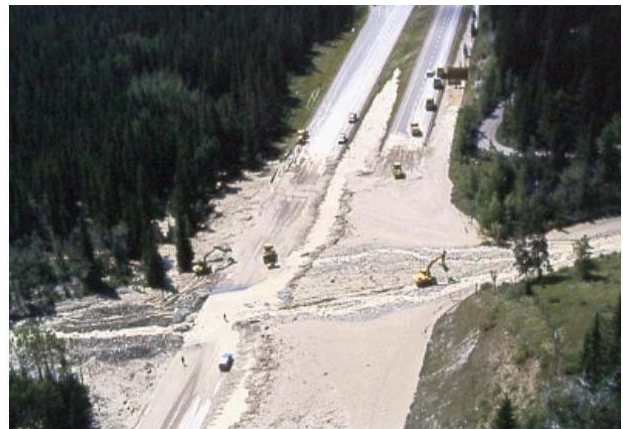
Figure 1 – Immediately after the August 1999 debris flow, clearing the Trans Canada Highway (photo courtesy of Parks Canada)

The 1999 debris flow event occurred on August 4, at approximately 6:45pm, and covered approximately 200 m of the Trans-Canada Highway in debris that was several metres thick in places, resulting in total closure of the Highway. Debris, including mud, trees and boulders several metres in diameter, plugged the highway culvert and flowed over the road, causing erosion of the shoulder above the culvert outlet. No injuries resulted from the flow, but there was substantial damage, including loss of the fibre-optic communications lines on the outside shoulder of the eastbound lanes, and loss of the pedestrian access to the Cory and Edith Pass trailheads from the Fireside day use area. Bouldery debris stopped short of the Canadian Pacific Railway mainline, though mud plugged the ditch and culvert, requiring some maintenance work.

It took approximately 20 hours to clear the two eastbound lanes so that the highway could be partially re-opened. It took approximately three weeks for the highway to be restored to normal operating conditions, requiring removal of approximately 40,000 m<sup>3</sup> of debris from the highway and another 15,000 m<sup>3</sup> from the downstream channel.

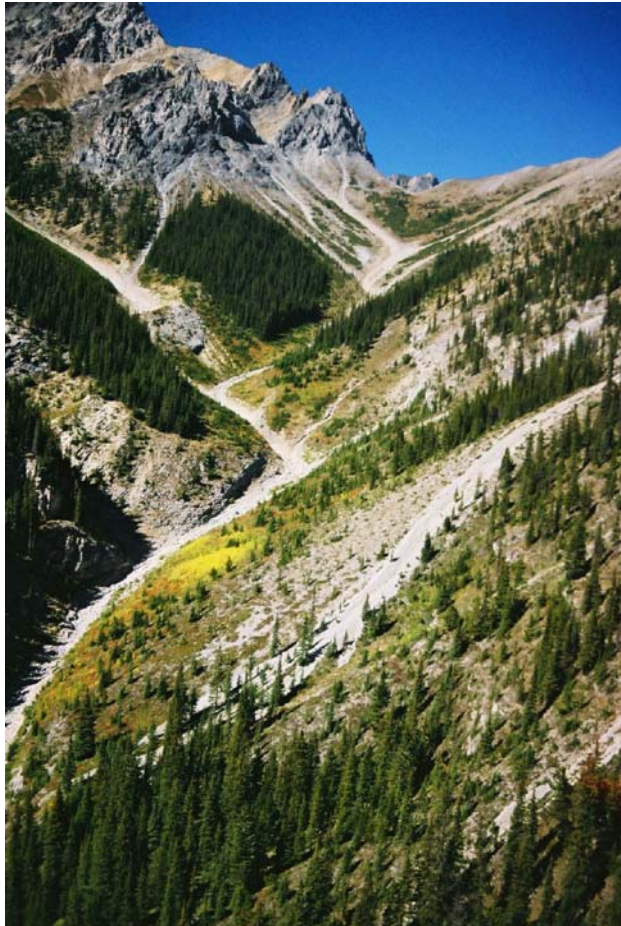
The upper reaches of the watershed are characterised by sediment inputs from avalanche tracks and tributary creeks. Creek gradient ranges from 10° to 17° within the mapped reaches (Figure 2).

There is no clear evidence for an initiation point for the 1999 debris flow. Levées occur throughout the upper reaches of the watershed, though some are likely the result of avalanche activity. A rock-controlled constriction near the upper mapped portion of the creek retains a significant quantity of sediment, representing a potential initiation point. However, there is evidence for debris flow activity immediately upstream of this area. It is thought likely that high creek flows and debris floods from tributary creeks combined to gradually form a debris flow in the upper reaches as additional sediment was added to the flow.

Figure 2 – Upper reaches of the watershed.

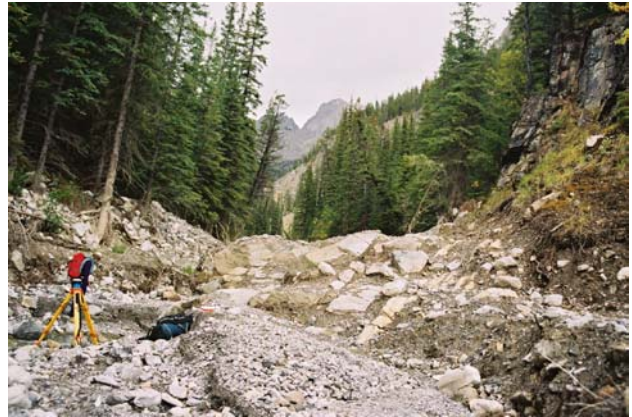
The middle reaches of the creek are characterised by scour of the creek bed and incorporation of additional debris from the channel sides. Creek gradient is between 6° and 12°.

Prominent bouldery levées occur locally along the channel. Particularly on outside creek bends, there has been erosion and undercutting of the creek banks, resulting in landslides in many cases (Figure 3). Several major landslide scarps occur through this section, though most appear to be older slides that have contributed minor sediment during the recent debris flow event.

Figure 3 – Middle reaches of the watershed. Note how the rock promontory has been stripped clean. Bouldery levée and damage to tree to the left of the picture.

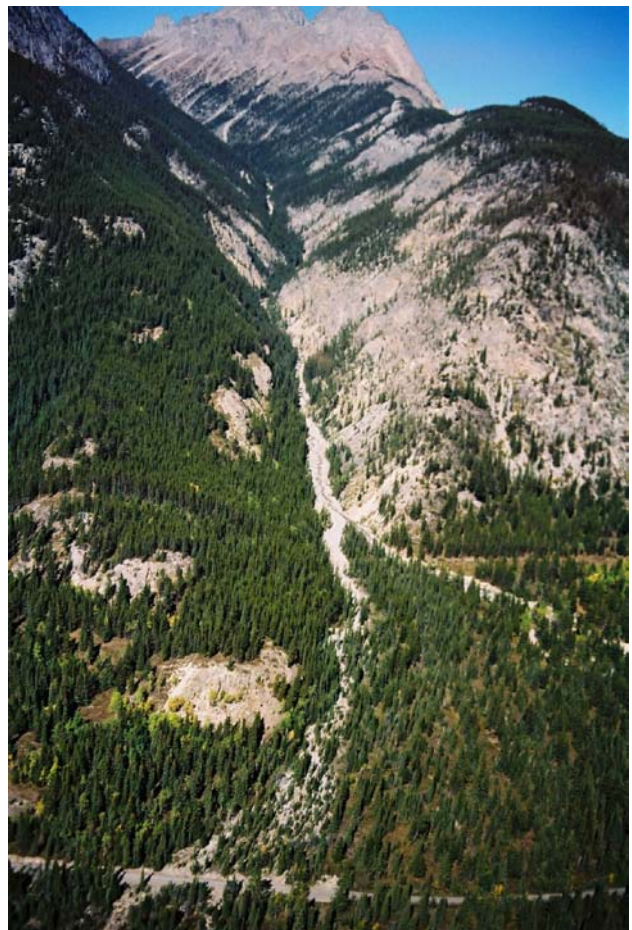
Figure 4 – Overview of middle and lower portions of the watershed and the west channel on the fan. Note how the west channel becomes diffuse as it crosses the Fireside day use area access road (bottom of picture).

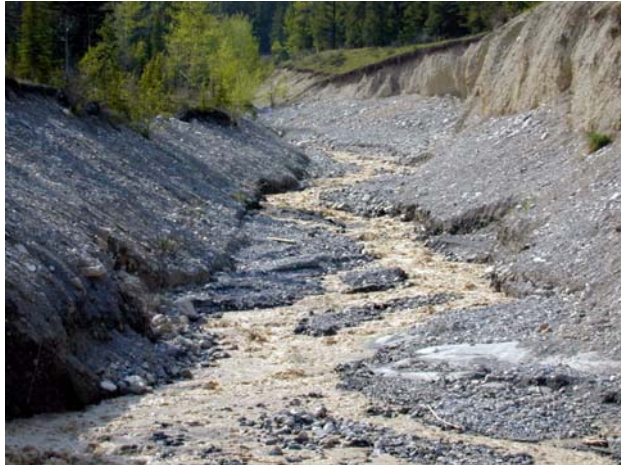
Downstream of the pedestrian bridge, the channel gradient becomes locally steeper towards the highway culvert, with local channel scour (Figure 5). There has also been significant local bank erosion. The channel is highly incised through this reach.

Figure 5 – East channel during the freshet in June 2002, immediately above the Trans Canada Highway culvert (photo courtesy of Highwood Environmental Management).

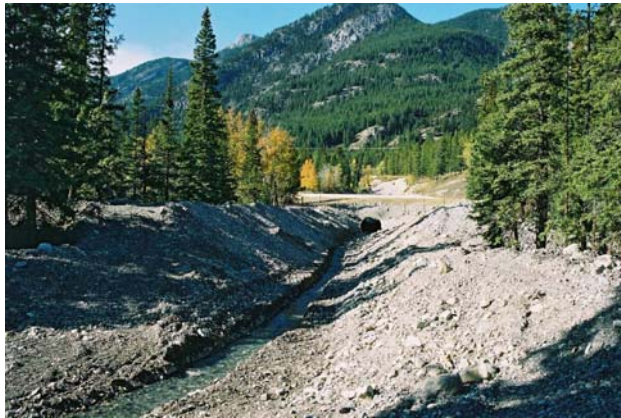
Figure 6 – East channel below the highway culvert in September 2001.

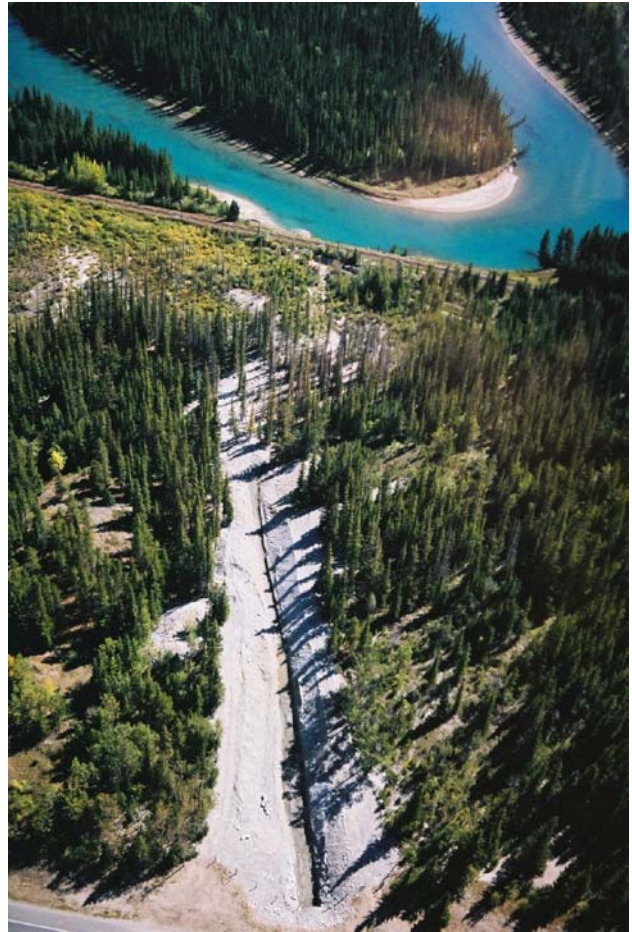
Downstream of the culvert, the creek runs through a roughly 1 m wide artificial channel with a 1° - 2° gradient. Gravel from previous channel clearing operations has been piled-up along the channel sides (Figure 6). Beyond this reach the channel opens out across the lower portion of the fan. There is significant deposition of gravel, cobbles and boulders through the trees at this point, and as a result, a large number of trees are showing distress. The limit of the main lobes of debris is approximately 70 m upstream of the Canadian Pacific Railway culvert (Figure 7).

Figure 7 – Lower portion of the east channel towards the Bow River. The channel has been cleaned several times.

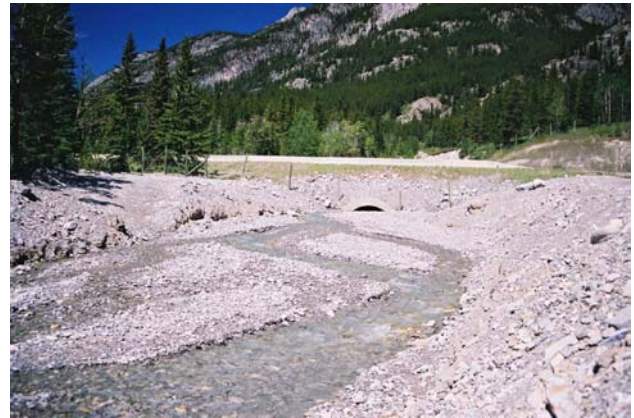
In addition to the debris flow hazard to infrastructure on the fan, the other main objective was to reduce or eliminate the need for channel maintenance on the lower fan resulting from gravel transport and deposition (Figure 9).

Figure 9 – East channel downstream of the highway culvert in September 2002. Note the large quantity of gravel in the channel compared with Figure 6.

Parks Canada has decided to proceed with the terminal berm concept. This option entails construction of a diversion berm at the fan apex, which would allow normal creek flows to continue along the east channel, while diverting floods and debris flows into the west channel.
