# SEVERE WEATHER WARNING LEVELS FOR GEOTECHNICAL RAILWAY HAZARDS

Chris M. Bunce and Clive H. MacKay, Canadian Pacific Railway, Calgary, Alberta  
C. Derek Martin, University of Alberta, Edmonton, Alberta

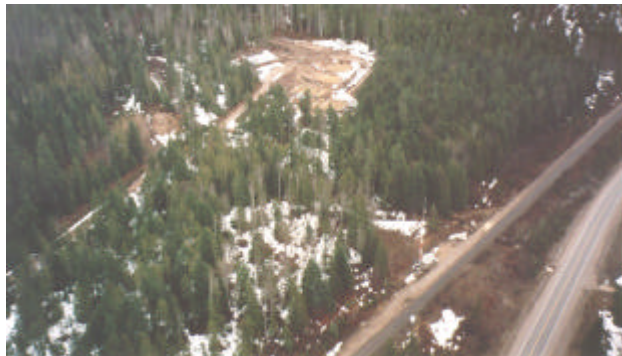
#### Case 1 - Shuswap Sub, Mile 22.6, June 13, 1990

At 17:20 on June 13, 1990 a debris flow of 5000 m<sup>3</sup> inundated the tracks at Mile 22.5 of the Shuswap Subdivision, 29 km west of Revelstoke, BC. The debris flow apparently hit a passing train derailing the 4<sup>th</sup> to 17<sup>th</sup> cars. The debris flow originated as a landslide of 200 to 600 m<sup>3</sup> of colluvium over

bedrock. It entered the streambed about 2.2 km upstream of the track. The gradient of the creek is on the order of 16 degrees. The slide appears to have been triggered by a combination of erosion at the toe slope and saturation of the soil.

The landslide and subsequent debris flow was triggered by severe rainfall as recorded at Malakwa 13 km west of the site and Revelstoke 29 km east. The 70 years of records for Malakwa indicate that this area received normal rainfall for several days prior to June 13, 1990. However, over 230 mm of rain fell on the area in the prior 30-days. This 30 day antecedent rainfall has a return period estimated at 34 years. Furthermore, the preceding 120-day rain and snowmelt of 630 mm of precipitation is expected to occur less than once every 80 years. Despite the rarity of the climatic conditions leading up to June 13, 1990, a debris flow damaged a neighbouring property in the spring of 1999 (Figure 4). The spring 1999 event had little impact on the railway but it filled the fish hatchery ponds with debris and sediment. The antecedent and precipitation conditions prior to the 1999 event have not been investigated at this time.

Figure 4. Oblique aerial photo of Shuswap Sub, Mile 22.6 on April 4, 1999 following a debris slide into the Fish Hatchery during the spring of 1999. This event did not affect the railway or highway. The June 13, 1990 debris flow inundated the track immediately east (right) of the radio tower.

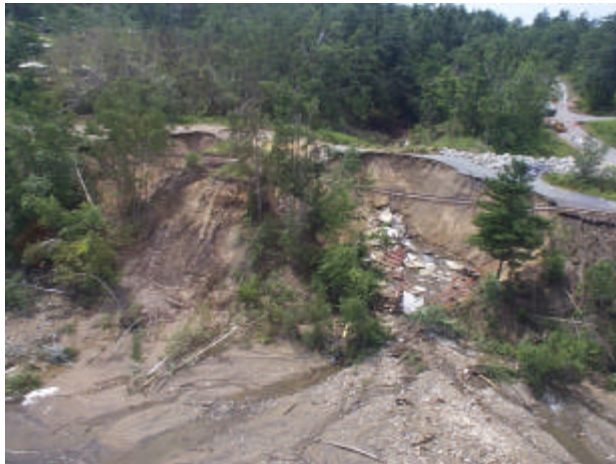
#### Case 3 - Canadian Mainline, Mile 143.85 to Mile 155.30, June 26, 1998

Over the course of several days in June 1999, a section of the Canadian Mainline south of Plattsburg, New York endured a severe weather condition resulting in numerous landslides and areas of erosion. This eight-mile section of track was located between Port Douglas and Port Kent on the west side of Lake Champlain. Damage at 34 sites between Mile 143.85 and 155.3 consisted of hydraulic gully and slope erosion, seepage erosion, debris flows, and massive-shear subgrade landslides (Figure 5). Landslide and erosion volumes ranged from ten to several thousand cubic metres. At the largest event, the destruction of a culvert, at Mile 150.17 near Port Douglas, caused the derailment of a train. Fortunately, the operators escaped with minor injuries, however, the railway

Figure 5. Oblique aerial photo of one of the many massive-shear subgrade landslides and seepage erosion sites near Port Kent (north of Port Douglas, NY).

Along this section of west shore of Lake Champlain the track is located 20 to 45 m above the lake shore. It traverses bedrock outcrops; colluvial and dense till side slopes; alluvial sand and silt terraces; and the lacustrine silt and clay deposits. The track damage was primarily in the areas of erodible silt and sand fills and natural silt and sand deposits; and in the areas of interbedded lacustrine silts and clays. At the failure sites, natural slopes are at the or slightly above the angle of repose due to gully, slope, and lake-shore wave-erosion.

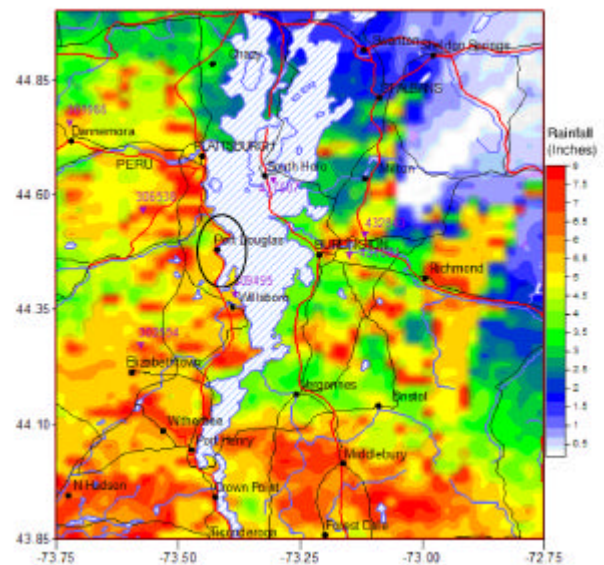
To investigate why the 11.5 miles of track between Mile 155.3 and 143.8 was so heavily damaged the available weather radar data was analyzed. The results of this analysis are illustrated in Figure 6 and shows that the precipitation in the area of interest ranged from 0 inches in the northeast to 8 inches in

localized areas. The plot is consistent with the lower rainfalls in Willsboro and Burlington and the higher amounts in Peru, but it also shows the dramatic spatial variability across the region and along the CPR track. Notably, the area of damage did not directly receive as much rainfall as other areas of the track. However, the drainage basin to the west of the damage area did receive intense rainfall and likely contributed to the concentration of damage in this region.

Figure 6: Lake Champlain, NY weather radar precipitation for the month of June 1998 with the track in red along the west shore and an ellipse around the area of damage.
