# Discontinuity characterization and numerical modelling of the Paekakariki Landslide, Kāpiti Coast, New Zealand

Matthew Lawrence

## ABSTRACT

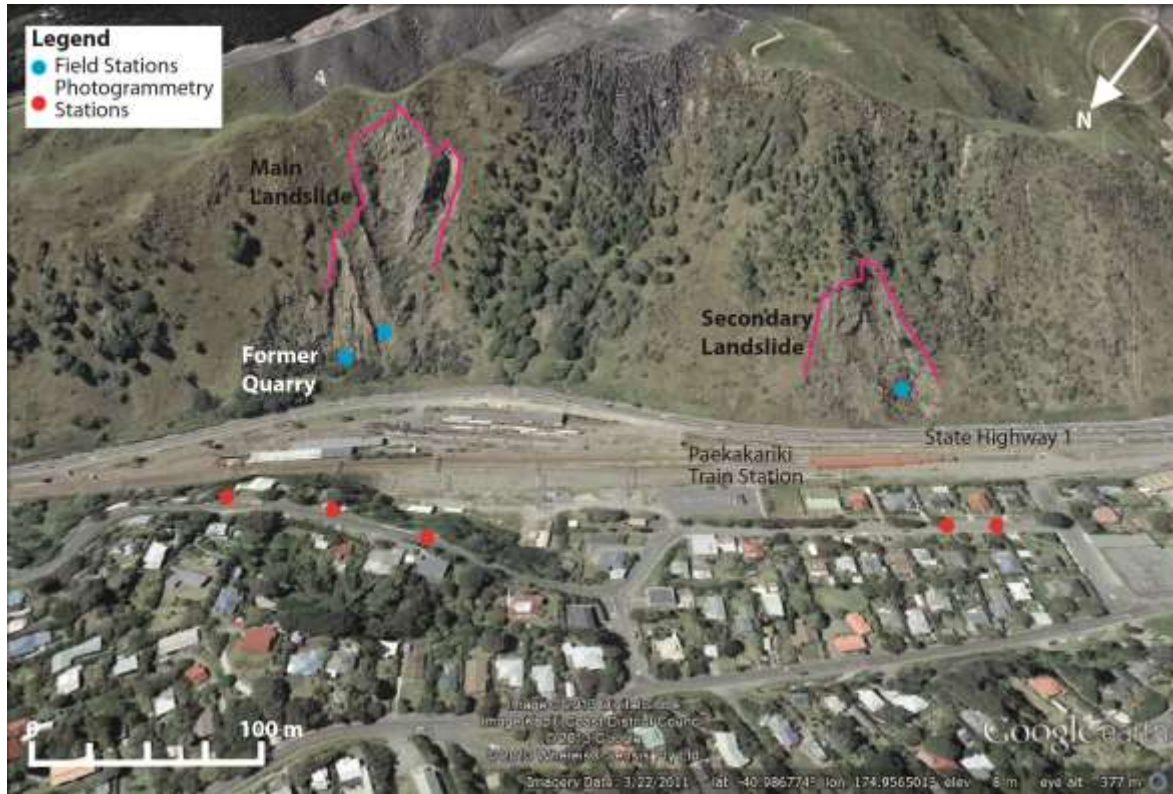
Figure 2: Overview of field and photogrammetry stations. March 2011 imagery from Google Earth.

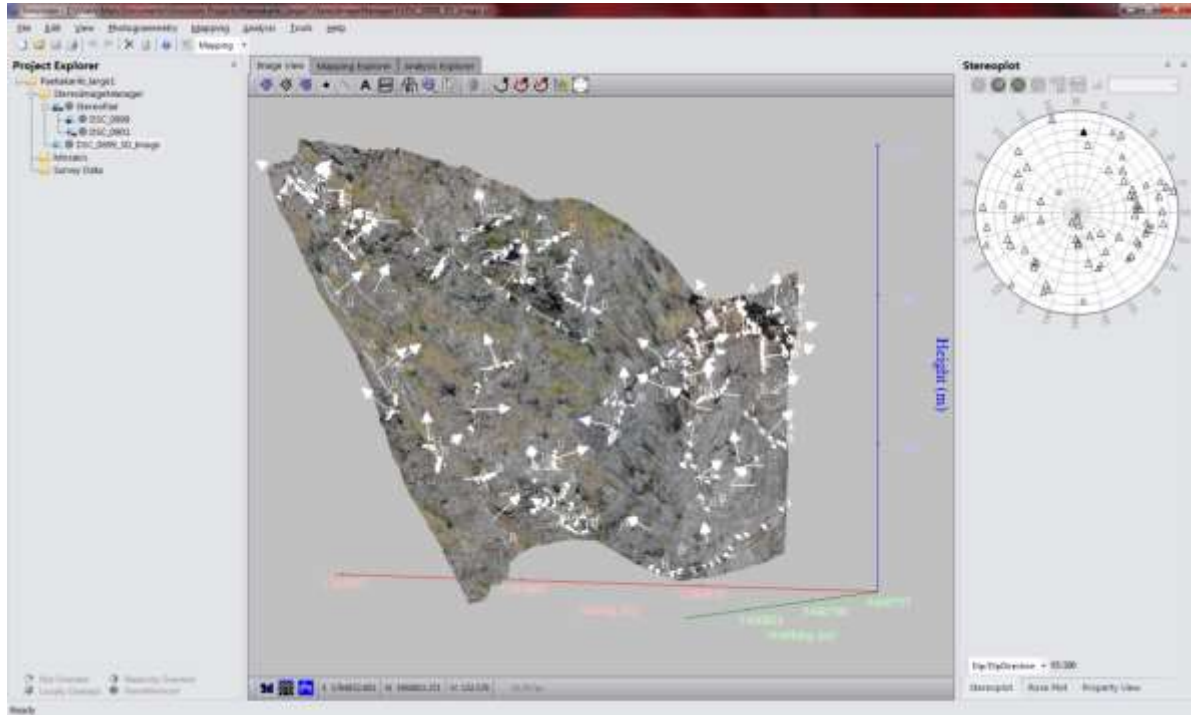
Figure 4: Example of discontinuities identified in the 3D terrestrial photogrammetry model

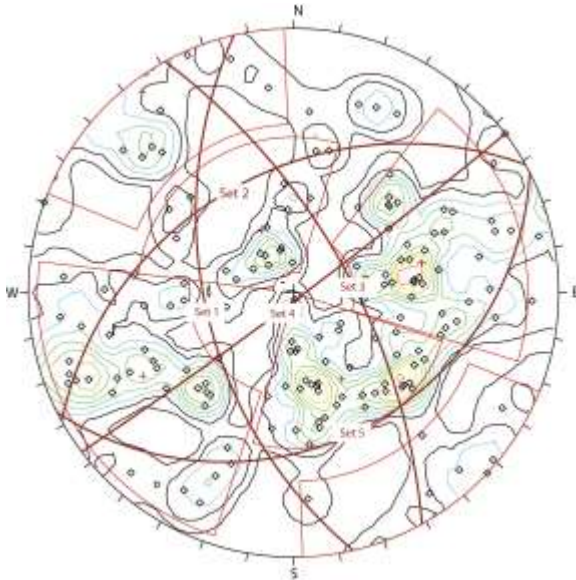
A summary of the discontinuity set orientation obtained by each site investigation technique is provided in Table 1. Figure 5 presents the stereonet of the combined datasets where five discontinuity sets were identified. The combination of the two data sets is

Figure 5: Stereonet of the discontinuity sets identified when combining the field and photogrammetry data sets

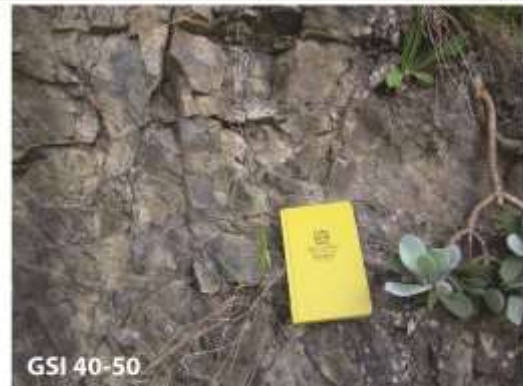
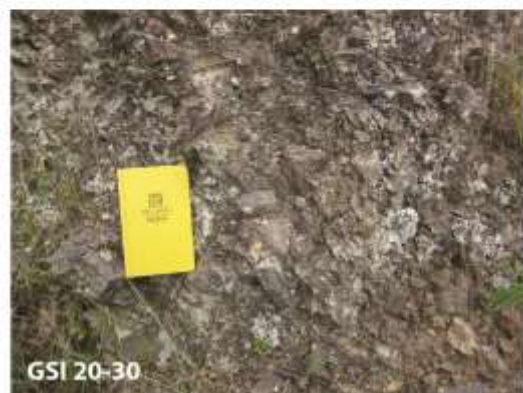
considered to be complementary as they can compensate for the scale (field measurements) and orientation (photogrammetry) biases of each technique and they sample different parts of the study area. The average rock mass quality using the GSI was found to be between 40-60 (Figure 6) but it decreased to 20-30 near tectonic structures (shear zones). Field estimates of the unconfined compressive strength (UCS) for the greywacke units present at the site suggested that it was strong (50-100 MPa, as defined in NZGS, 2005).

Figure 6: Geological Strength Index (GSI) estimates (modified from Marinou et al., 2005). Photographs are of outcrops at the main landslide field station. See Figure 2 for location.

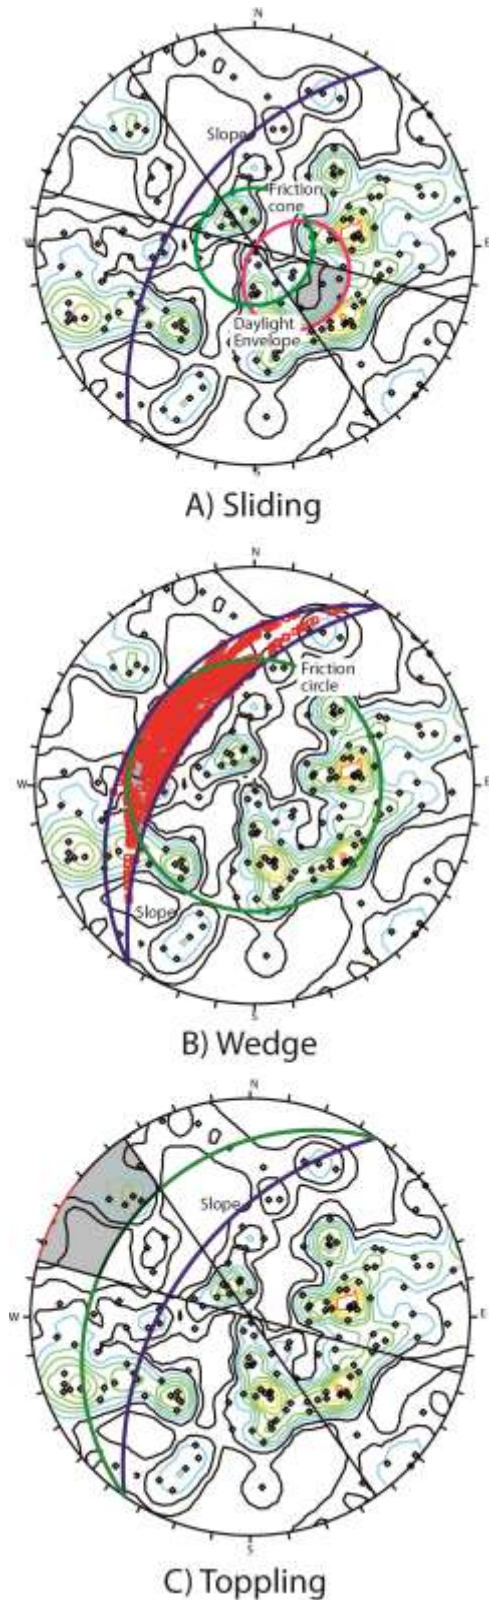
Dips (Rocscience, 2012) allows the user to analyse and visualize structural data using stereographic projections. The combined structural data from the field measurements and terrestrial photogrammetry was used to conduct a kinematic analysis to identify feasible failure mechanisms. This analysis tests for three simple structurally-controlled failure mechanisms: toppling, planar sliding and wedge failure (Wyllie & Mah, 2004). The pre-failure hillslope orientation was estimated using ArcGIS (Esri, 2010) to be approximately  $50^{\circ}/305^{\circ}$  (dip/dip direction). The friction angle along the discontinuity surfaces was assumed to be  $35^{\circ}$  as most discontinuity were found to be planar and rough (Goodman, 1980). The kinematic analysis (Figure 7) suggests that wedge sliding is the most likely failure mechanism with planar sliding and toppling being only marginally feasible. This is consistent with the wedge shape morphology of the failure scar (Figure 2).

Figure 7: Kinematic analysis using the combined discontinuity dataset. The analysis assumed a slope orientation  $50^{\circ}/305^{\circ}$  (dip/dip direction) and a friction angle of  $35^{\circ}$ .

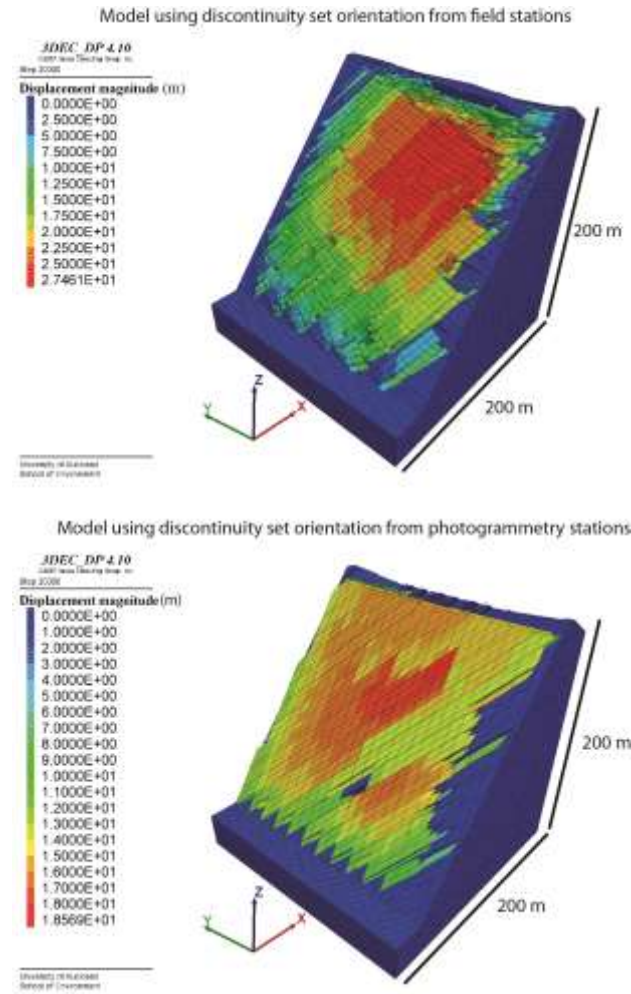
3DEC is a three-dimensional distinct element software by Itasca (2008). The rock mass is represented by a collection of blocks bounded by discontinuities. As the intact rock strength of the greywacke was strong ( $\sim 70\text{MPa}$ ), the blocks were assumed to be rigid (i.e. they do not deform and all displacement is controlled by the discontinuity orientations and strengths). Two models were investigated to assess the influence of the discontinuity set orientations. The first model used the sets identified in the field investigation while the second model used the data from the terrestrial photogrammetry (Figure 8). It is observed that both models lead to a similar deformation pattern. The model applying the discontinuity sets based on field measurements has an asymmetric (slope parallel rotation) component similar to that observed by others in the field (Yan, 2008) and numerical models (Brideau and Stead, 2012).

Figure 8: Total calculated displacement obtained in the three-dimensional distinct element models using discontinuity set orientations from the field measurements and photogrammetry analysis

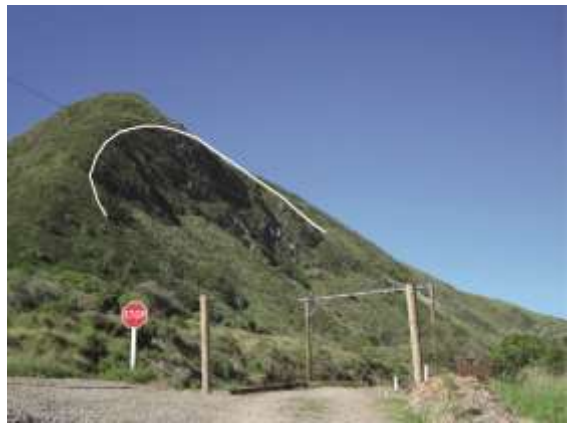
Figure 9: Unstable slope 2.5 km south of the main study area
