# Mitigation of the Belly River Landslide Using a Multidisciplinary Approach

Bryan Bale

Roger Skirrow

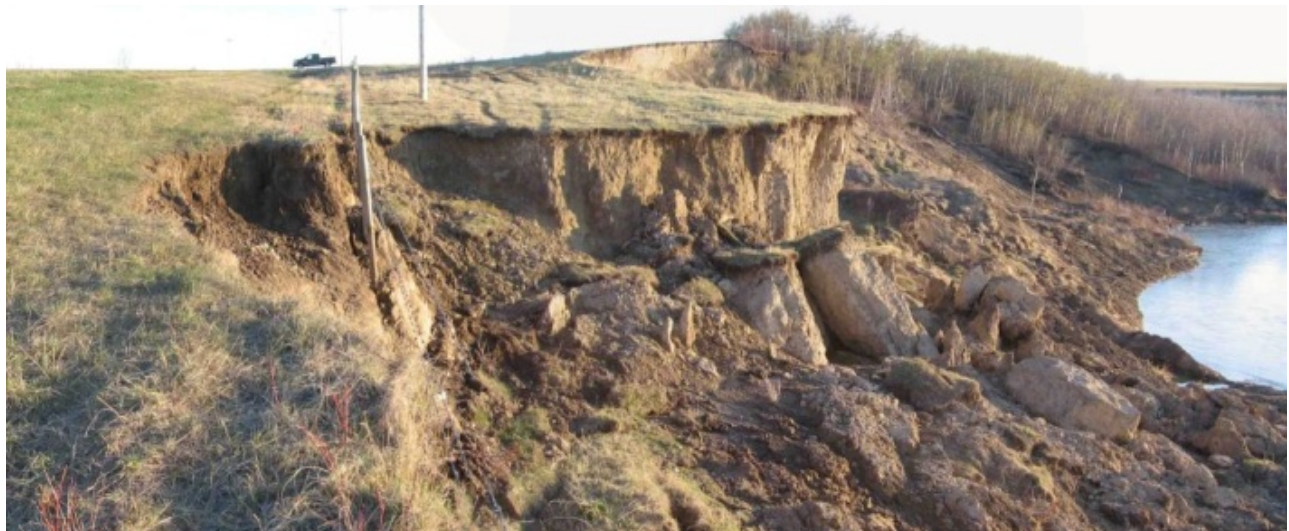
The site was inspected again in May 2010. The headscarp had retrogressed significantly since June 2009 and was 5 to 6 m from the road surface along a 40 to 50 m length along the highway. The headscarp had intercepted the ditch invert, channelled surface water into the slide area and worsened the slope instability. Because the site was a hazard to vehicle safety, AT decided to proceed with mitigation to protect the highway. Refer to Figure 2 for an illustration of the site in 2010, and Figure 3 for an aerial image of the site in 2009.

Figure 2. Facing south at the area of main slide encroachment in May 2010. The highway embankment is visible at the left edge of the photo. Block topples and rotational or flow landslides are caused by river erosion and groundwater seepage.

Work to slow the landslide retrogression was initiated in May 2010. The near-vertical headscarp area was graded to a 1H:1V slope and launched soil nails were installed on a 1 m grid along the slope crest nearest the highway. Approximately 50 soil nails were installed to reduce block topples from the scarp. The ditch was also dammed upstream of the slide crest and a drainage pipe was installed to carry water beyond the slide area.

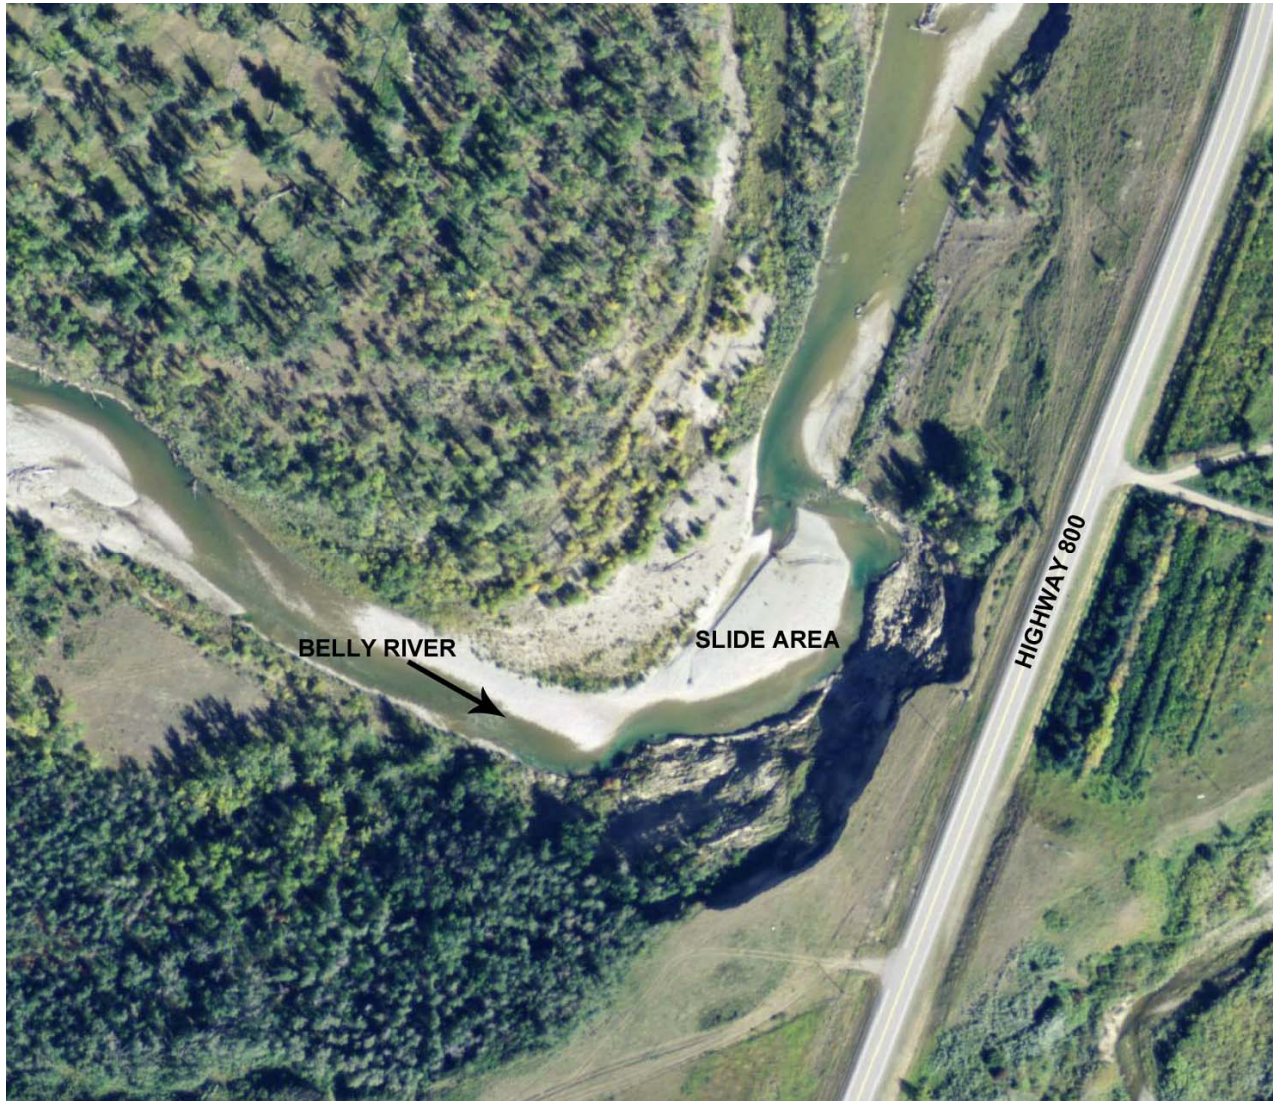
Figure 3. Aerial image of the site area in 2009.

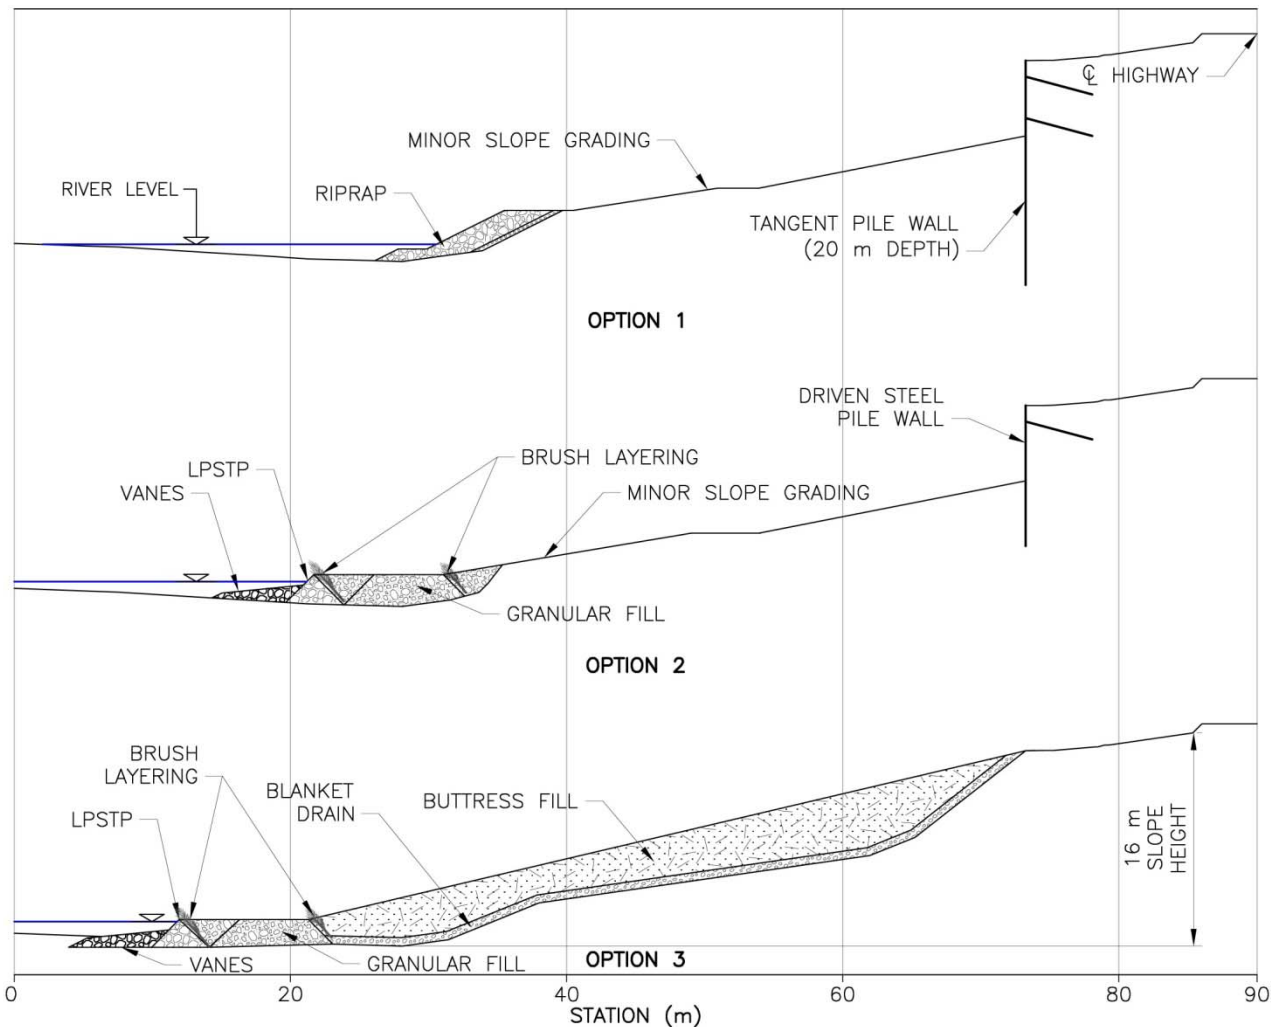
Figure 4. Cross-section of the preliminary mitigation options.

Option 1 included a relatively large, tangent, cast-in-place pile wall to 20 m depth along the highway right-of-way to support the highway as the slide mass continued to deform. The colluvium was to be graded to improve drainage and vegetation established to provide minor stability improvement of the slide mass. Rip-rap bank protection was to be installed along the existing channel alignment to protect against continued erosion. The design was considered a primarily geotechnical repair, with minimal input from the other disciplines. The design provided a high level of certainty that the highway would be protected but at a cost of roughly \$5.2 Million, which was higher than the other options. The design involved minimal interaction with the river; therefore, it could be constructed if regulatory approval was not obtained for work in the river. Poor aesthetics due to the exposed pile wall and high cost were the main disadvantages.

Option 2A included a 10 m deep, driven, steel pile wall to support the headscarp near the highway. The shallow pile wall required support from the slide mass below, which was to be achieved by drainage improvement of the slide mass with trench drains and bio-engineering techniques to consume water, and an interceptor trench upslope of the headscarp. In addition, the channel was to be shifted 20 m into the river and armoured by LPSTP and redirective vanes. The design was multidisciplinary with contributions from each component required for the success of the entire design. The cost was estimated to be \$2.9 Million.

A variation of this design, Option 2B, was also considered and included a buttress fill at a 4H:1V slope to replace the pile wall. This option had approximately the same cost as Option 2A and was easier to construct but had higher uncertainty of slope stability until evaluation of the borrow source for the buttress fill could be completed. For preliminary purposes, it was assumed that fill would be imported if required. Both options had relatively low

Option 3 included a 30 m encroachment into the river channel to restore the 1995 channel alignment and bank armour with LPSTP and vanes. A buttress fill was to be constructed at 5H:1V to support the landslide headscarp. The estimated cost was \$2.8 Million. Although the cost and constructability were advantageous, the encroachment into the river was perceived to be a significant disadvantage due to the major channel realignment.

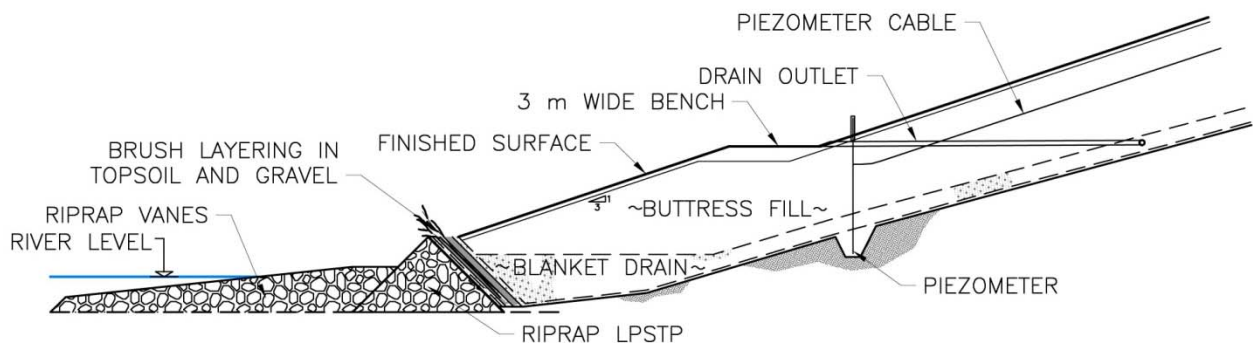
Figure 5. Cross-section of the mitigation design at the toe of the slope showing the main hydrotechnical and geotechnical design components.

The primary component of the geotechnical design was a 4H:1V buttress fill intended to stabilize the landslide area and support the highway. Ease of construction was important. All aspects of the geotechnical design were intended to be easily achieved to allow rapid construction.

A granular blanket drain was constructed on the graded slide mass along the entire slide area from the slope crest to the riverbank armour. The intent was to convey the seasonally high groundwater seepage and

LPSTP is a free-standing rip-rap structure that reduces encroachment compared to traditional rip-rap because it can be constructed steeper and does not require a key-in at the toe. It also allows the incorporation of live willow plantings behind the rip-rap, which were part of the bio-engineering strategy. The LPSTP was built to the elevation of the 1:2 year return period peak discharge.

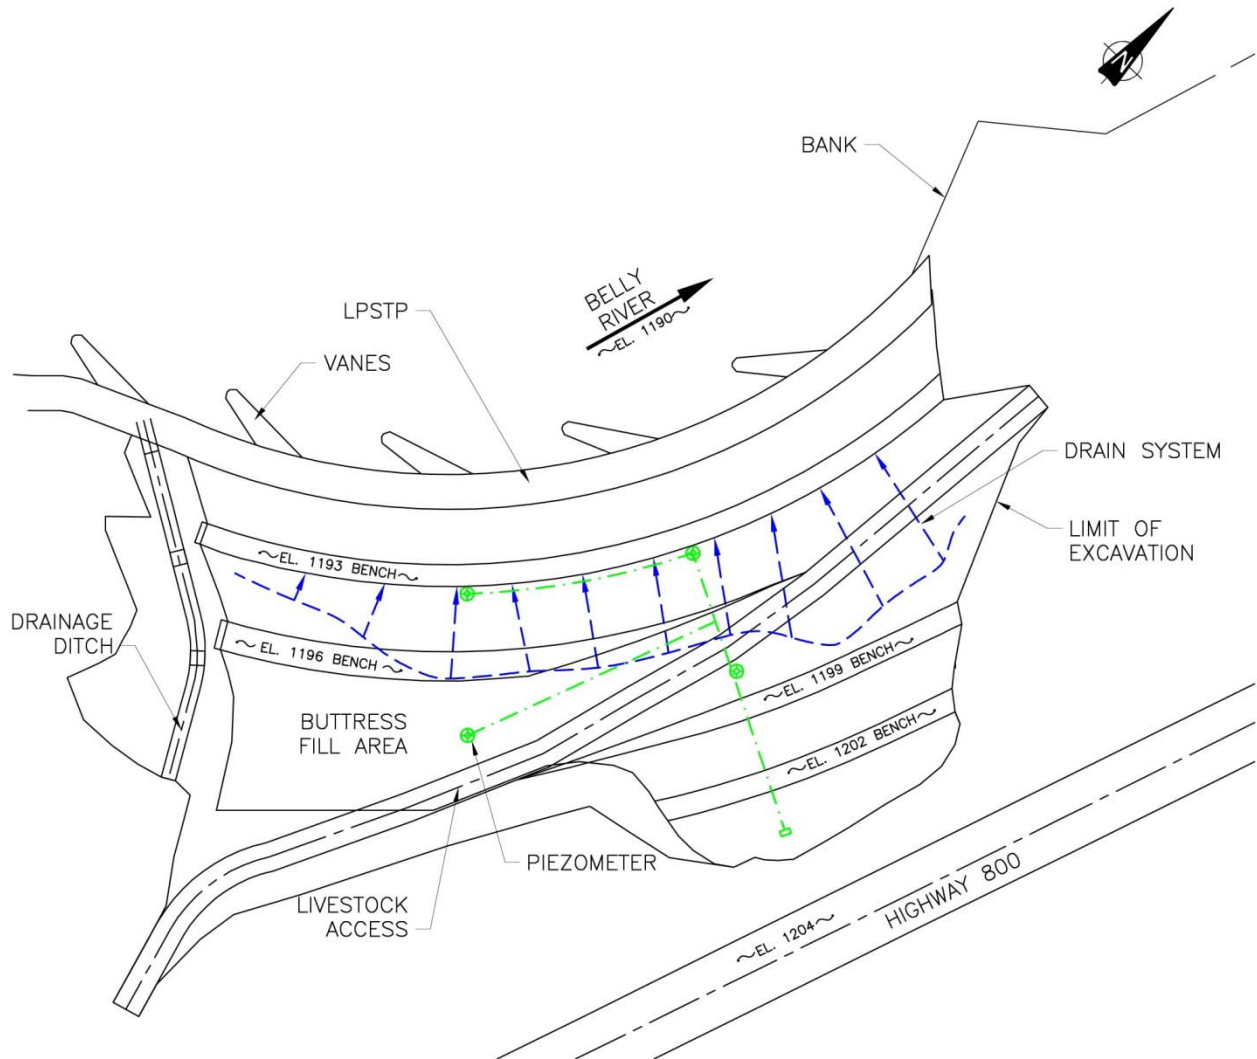
Figure 6. Site plan of the mitigation design showing the main design components.

The buttress fill was constructed along an approximately 100 m wide portion of the slide at the area of main encroachment. To improve ease of construction, relatively low compaction was specified by tracked construction equipment. A specification for the compaction method with periodic density checks was recommended. The buttress fill was designed as a benched slope, with the bench platforms nearly flat with 500 mm thick topsoil to hold moisture for vegetation. An erosion resistant drainage channel was included to intercept surficial flow and overflow from the bench platforms. One of the benches was aligned diagonally along the slope from the crest to river level, with fencing on both sides to provide livestock access through the site.

The hydrotechnical works included riverbank erosion protection along the entire 210 m length of the landslide area with LPSTP and redirectional vanes. The bank armour was installed along an intermediate channel alignment that encroached into the river by approximately 20 m. Granular fill was placed in the river to restore the channel alignment and provide construction access.

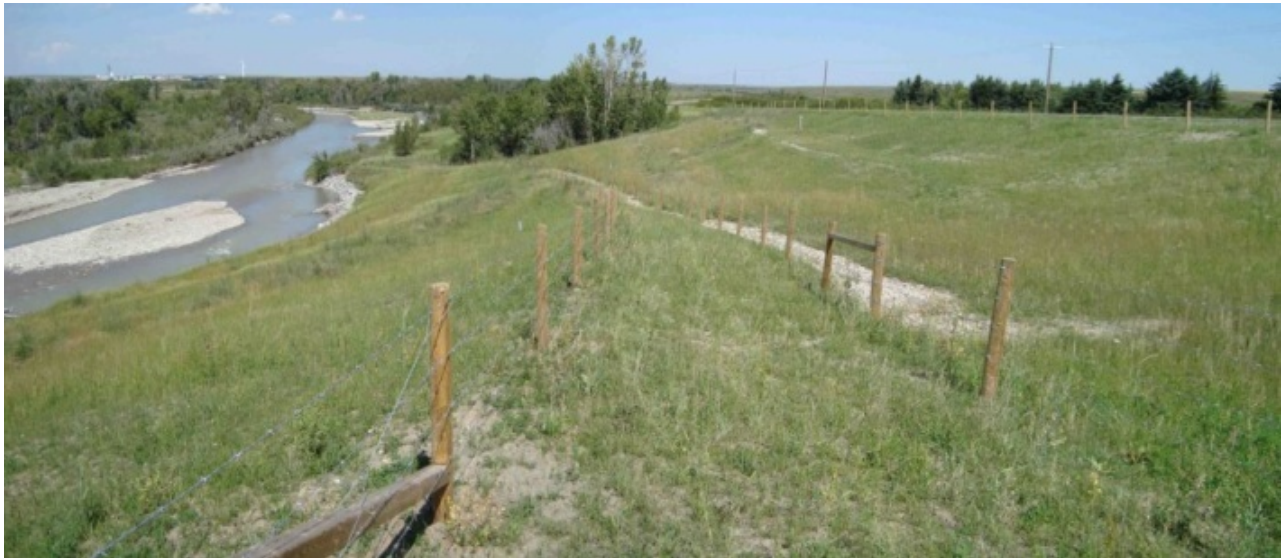
The mitigation work functioned well through 2013 with no deformation of the slide mass, highway or riverbank, and no significant erosion. The vegetation growth was quite aggressive. All deficiencies noted from the Willow Creek mitigation were successfully addressed.

Figure 7. Facing north at the main buttress fill area in August 2013, showing the benched fill slope and livestock access path with vegetation becoming well-established.
