A Century of Landslide Activity in Glaciolacustrine Deposits in Jeffersonville, Vermont, USA

Springston, G.E. MSc., Sevi, Adam F. P.E. Ph.D. & Kanat, Leslie. Ph.D.

ABSTRACT

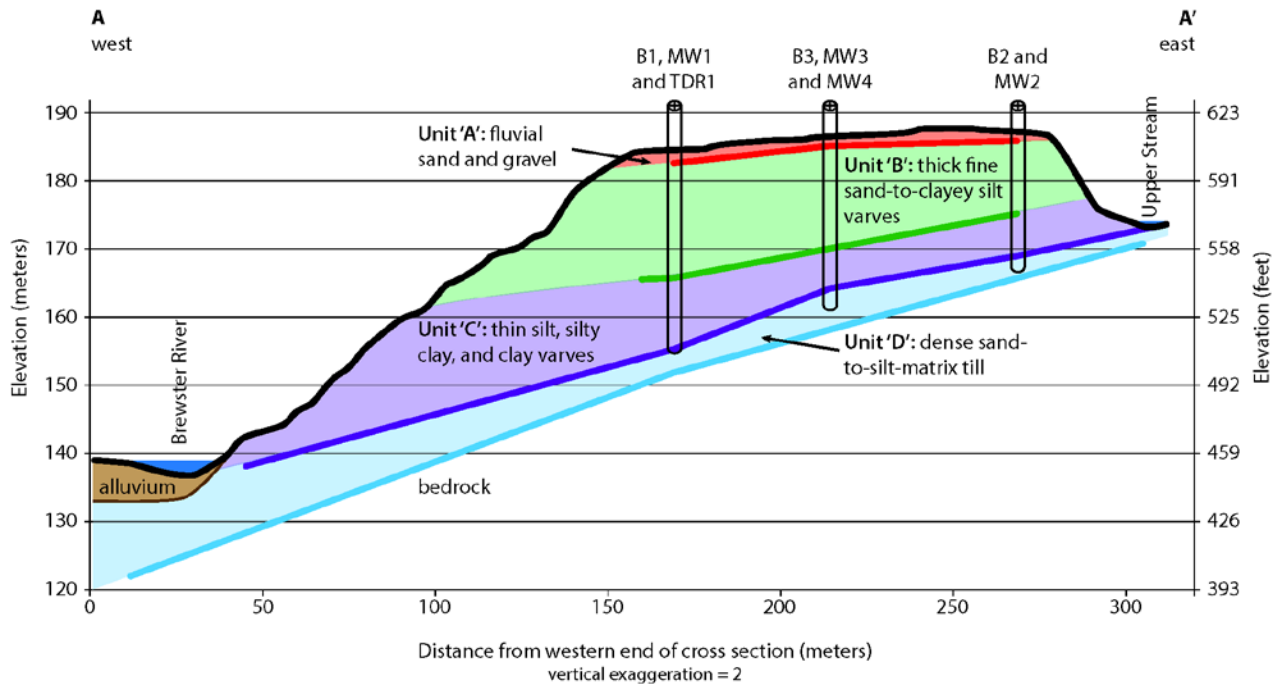
The uppermost surficial materials are early Holocene stream terrace deposits (Unit A in Figure 3). These consist of loose to dense, silty fine sand to coarse sand, pebbly coarse sand, and pebble-cobble gravel on top of the main terrace (Figure 4). Bedding is approximately horizontal and fining-upward sequences range from 0.22 to 1.13 m thick. These fluvial materials were deposited on top of the lacustrine sediments by the Brewster River

The next unit consists of sandy Pleistocene lake bottom deposits (Unit B in Figure 3). It includes medium-dense fine sand, very fine sand, and silty very fine sand with thin silt and silty clay laminae (Figure 5). The material consists of couplets of coarser-grained sediment deposited during the melt season and finer-grained sediment deposited from suspension during the winter. These annual layers are known as varves. The thickness of these couplets ranges from 0.46 to 1.0 m, with thickness increasing toward the top of the unit. The overall thickness of the unit ranges from 10.7 m at B2 on the east side of the terrace up to 16.8 m at B1 on the west side. This unit of thick varves is about 16 m thick at the 1999 slide and is interpreted to have formed as bottom-set beds formed by the prograding delta of the Brewster River into the Fort Ann stage of glacial Lake Vermont (Wright 2003).

Below the sandy varved deposits is a thick unit of varved, silt-clay Pleistocene lake bottom deposits (Unit C in Figure 3). The material consists of stiff silt, silty clay, and clay in horizontal couplets of silt overlain by a thin silty clay or clay layer (Figure 6). Individual couplets range in thickness from about 7 to 60 cm. The thickness of the

Figure 3. Geologic cross section A – A'. The location is shown in Figure 2. The surficial geologic units are shown in Table 1 and described in the text. Till is observed at the base of the slope on the east side of the Brewster River, in each of the borings, and on the east side of the Upper Stream. Depth to bedrock is based on exposures in the Upper Stream and north-south seismic refraction lines at boring B1 and near the western end of the cross section on the west side of the Brewster River.

Pleistocene till comprises the base of the stratigraphic section (Unit D in Figure 3). It consists of dense fine sand to fine-sandy silt-matrix till. Thickness ranges from at least 0.9 m at B1 to at least 2.9 m at B3. The unit is exposed on the hillslope east of the upper stream and in an isolated exposure at the base of the western slope of the terrace on the east side of the Brewster River.

A second area of concern is in the vicinity of Cross Section A-A', to the east of the school. This is currently the site of an active landslide-gully complex that is gradually eroding back into the field on top of the terrace. Although preliminary analysis suggests that the likelihood of a major slope failure is less than in the area to the north of the 1999 slide, monitoring will be continued.

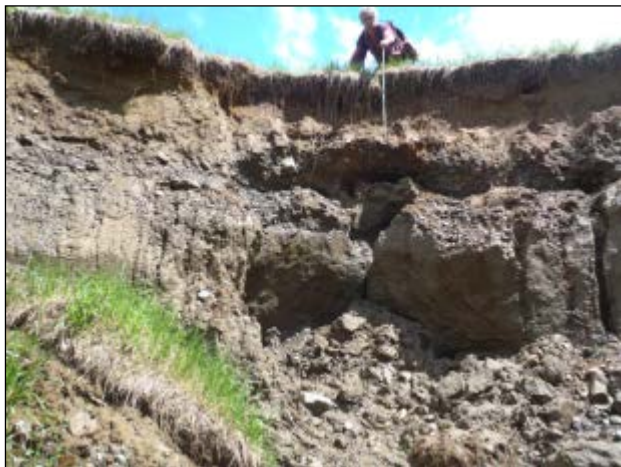
Figure 4. Upper fluvial sand and gravel (Unit A) exposed at head of landslide-gully complex at Cross Section A-A'.

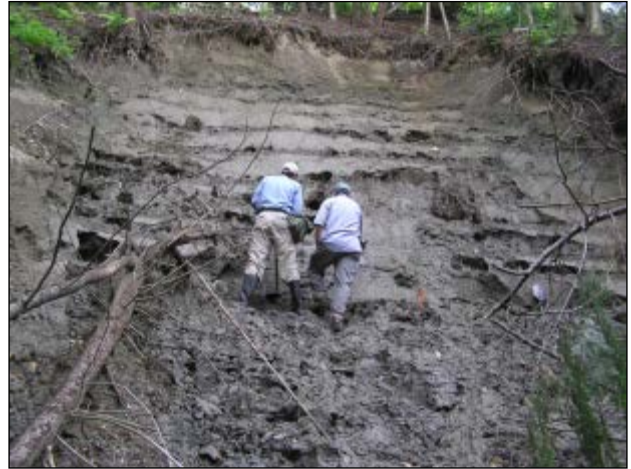
Figure 5. Looking up at top of 2006 slide. Material consists of thick varves composed of 0.46 – 0.76 m layers of fine sand separated by thin silty clay layers (Unit B). Photo courtesy of Jonathan Kim, Vermont Geological Survey.

Besides the large landslides described above, there are several active landslide-gully complexes on the slopes to the north and south of the 1999 landslide. On 2 July 2006 the owners of a house located immediately north of the 1999 slide returned home after an absence of several days to find a lot more sunlight reaching their home – a slide had occurred sometime in the preceding week and removed part of the tree canopy on the slope to the west of their house. Examination showed this to be a landslide-gully complex which ends in a small alluvial fan at the base. The landslide at the head was a translational earth slide and is shown in Figure 11. As the material moved downslope it appears to have broken up into an earth flow. Toe erosion was not a cause of this slope

failure. Instead, the cause appeared to be high pore-pressure due to heavy rains in the preceding weeks. Another landslide-gully complex is located directly opposite the Cambridge Elementary School (Figure 2) and has been actively eroding over at least the last 20 years. In April of 2009, accelerated slumping occurred at the head of this complex, apparently due to seepage forces due to snow-melt (Figure 7). Sediment from the slump flowed down and into the Brewster River. The stability of this section of the slope will be discussed in Section 5.1 below.

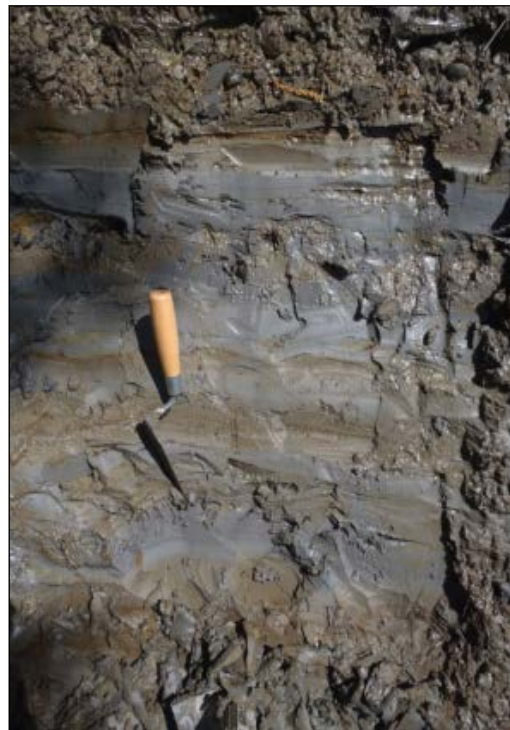
Figure 6. Stiff, varved lacustrine deposit at the site of the 2011 landslide (Unit C). Very fine sand and clayey silt are brown and silty clay is grey. Trowel for scale.

In May of 2011, at the end of a heavy snowmelt season and after very heavy rains, a renewed slope failure occurred in the northern portion of the 1999 landslide scar. Although only about 17 m wide at the base and approximately 17.3 m high, the shallow translational earth slide did carry material out into and halfway across the Brewster River.

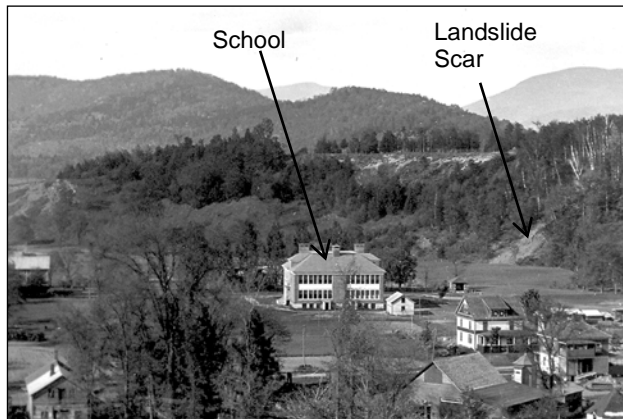
A photo taken by Harold Thomas in the fall of 1911 shows an extensive, partly healed slide scar on the upper part of the slope downstream of the school building, on or near the site of the 2006 slide (Figure 7). This is downstream of the scar visible in the 1942 photo cited below. The 1911 photo shows an area of bare soil behind and to the west of the school that appears to be a landslide scar. This may represent fresh toe erosion by the Brewster River. Thus, slope failure at the site appears to be ongoing from at least 1911.

Figure 7. View of Jeffersonville looking northeast in 1911. The prominent building in the center is the present-day Cambridge Elementary School. The Brewster River is behind it at the base of the slope. Note a landslide scar behind and to the right of the school and the break in the treeline at the top of the slope. Photo by Harold Thomas, from the collection of Wendell “Stub” Wells, Jeffersonville.

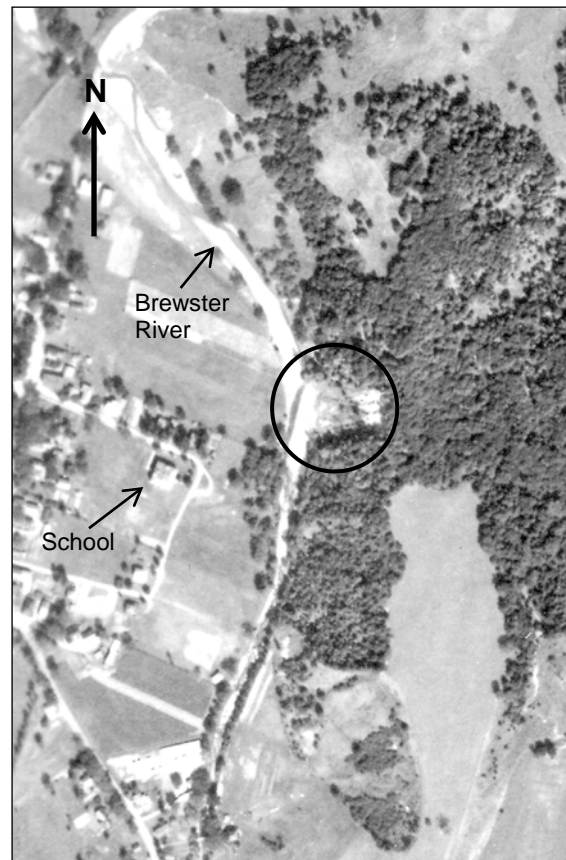
Aerial photos taken in 1942 show a well-defined landslide scar just downstream of the school building (Figure 8, circled). As there appears to be low vegetation on the lower parts of the slide scar, the movement must have taken place at least a few years previously. The

location of the scar at an outside bend of the Brewster River suggests that toe erosion was an important factor in the slope failure. This site appears to be at the south end of the 1999 slide.

Figure 8. Aerial photo taken on 1 August 1942. The Brewster River flows northward through the center and a landslide scar is visible on the right bank in the center of the photo (circled). Detail from photo DCC-6-15 from Vermont Department of Forests, Parks and Recreation.

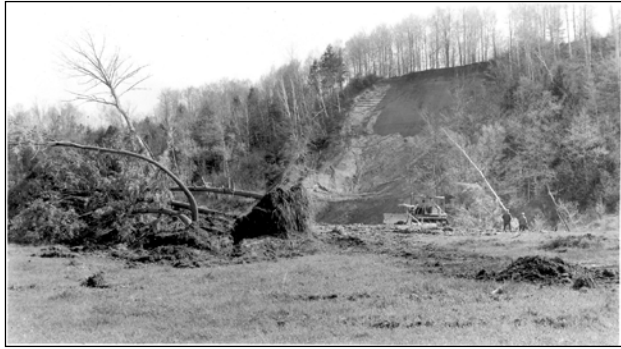
Landslides occurred at the site on 10 and 11 May 1954 (Anonymous 1954). Figure 9, which was taken soon after, shows slide debris and whole trees on the west side of the river with the landslide scarp in the background. Although an eyewitness reports that most of the material was immediately trucked away (Stub Wells, personal communication, 2004), aerial photos taken in 1962 show that a remnant of the toe deposit is still visible on the west shore of the Brewster River (Figure 10). This landslide is within the area of the 1999 slide described below.

Figure 9. Landslide at site in May of 1954. Bulldozer for scale. The landslide occurred on the slope east of the river and is visible in the back, right. The trees in the foreground at left are part of the toe deposit and are on the west side of the river. Photo by Harold Thomas, from the collection of Wendell "Stub" Wells, Jeffersonville.

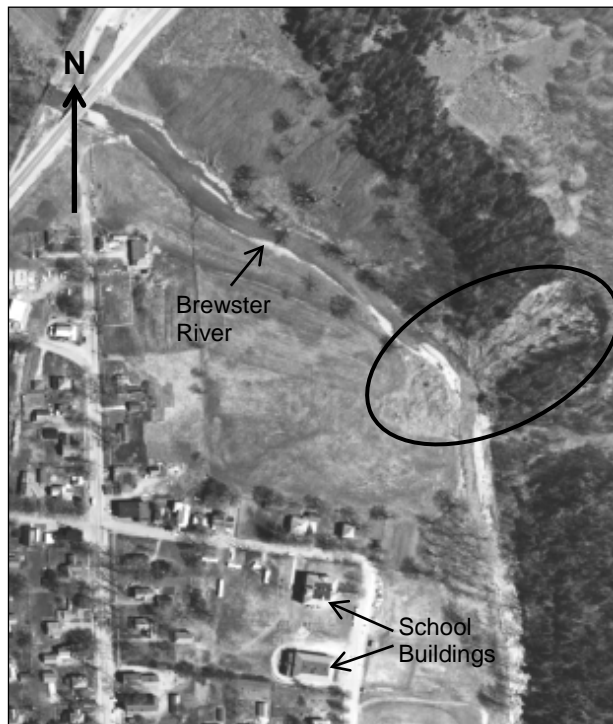
Figure 10. Portion of aerial photo taken in the spring of 1962. The Brewster River flows northward from bottom right to upper left. The 1954 landslide and a remnant of the toe deposit are outlined by the ellipse. Photo VT-62-L 11-188, from the collection of the VGS.

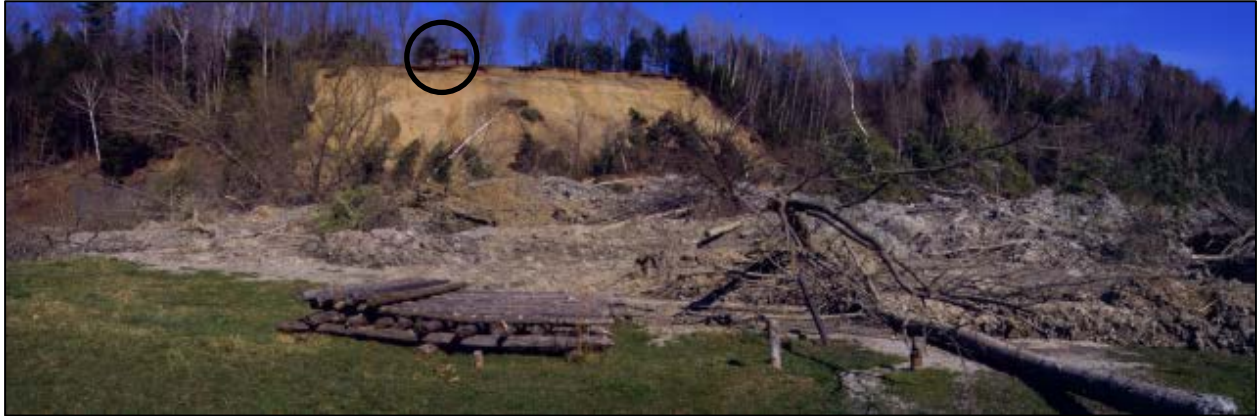
shows the landslide as it appeared after the second of the three 1999 events. The toe deposits extended more than 150 m westward from the west bank of the Brewster River and mud from the runout splashed onto two houses. One residence was directly affected by the landslides: A house at the top of the slope was evacuated after the April landslides and was later bought out by the local

The first of the 1999 landslides (11 April) removed material from the outer part of the slope. This may have been a predominantly translational earth slide-flow. The second landslide (18 April) was the largest and appears to have had a major rotational component. The failure surface appears to have rooted on the top of the intraformational slump deposit within the lower part of the glaciolacustrine deposits (Unit C of Figure 3). The third landslide (4 July) seems to have been the smallest of the three.

The causes of the 1999 slides appear to be at least two-fold. An analysis of monthly rainfall data from the National Weather Service station in Burlington by Bierman *et al.* (1999) indicated that precipitation in the several months preceding the 1999 landslides had been well below normal. Bierman *et al.* (1999) did suggest, however, that heavy rains during the preceding summer played a role in the slope failures via two mechanisms: by flood waters undercutting the toe of the slope and by precipitation causing an increase in pore pressure in the low permeability silt-clay deposits. In this scenario, the low permeability of the material allowed pore pressure to remain high throughout the winter and into the following summer.

Figure 11. View of landslide on 20 April 1999 from field on west side of river looking east, two days after the second 1999 slide. Toe deposits are in the foreground and the landslide scarp on the east side of the Brewster River is in the background. Note house (circled) at top of scarp. House was removed later in year. Panorama of three photos courtesy of Jon Kim, Vermont Geological Survey.

the north of the 1999 slide. The toe of this slope needs to be protected from erosion by the Brewster River as substantial toe erosion at this location would make slope failure much more likely.

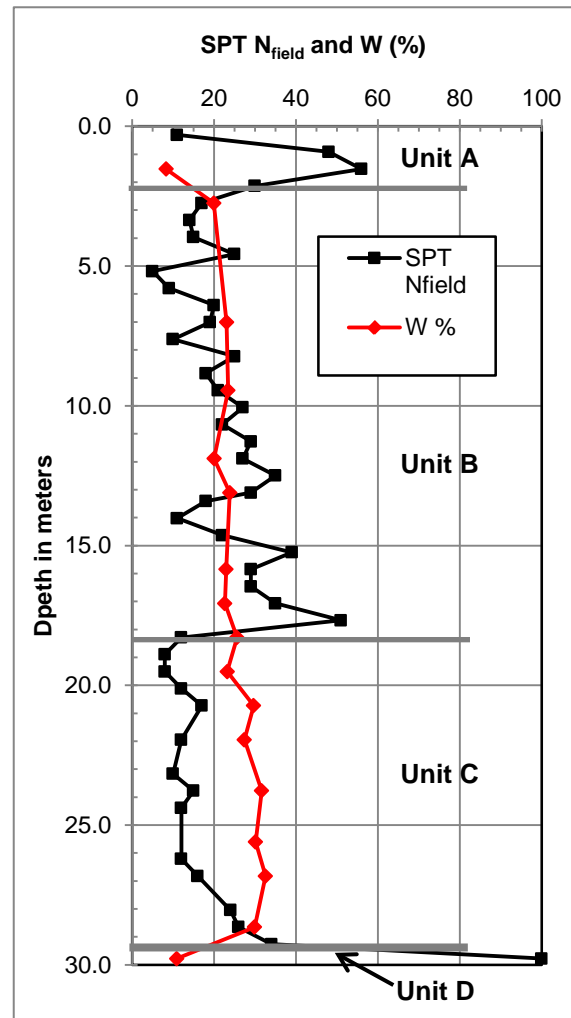
Assessment of the engineering characteristics of materials was performed using field data, laboratory testing, and correlation techniques. Figure 12 shows Standard Penetration Test and moisture content data for boring B1. Both split spoon and Shelby tube samples were available from the 2009 borings.

Figure 12. Geotechnical properties at Boring B1 on Cross Section A-A'. SPT N_{field} is Standard Penetration Test . W is water content in percent. Other properties shown in Table 2.

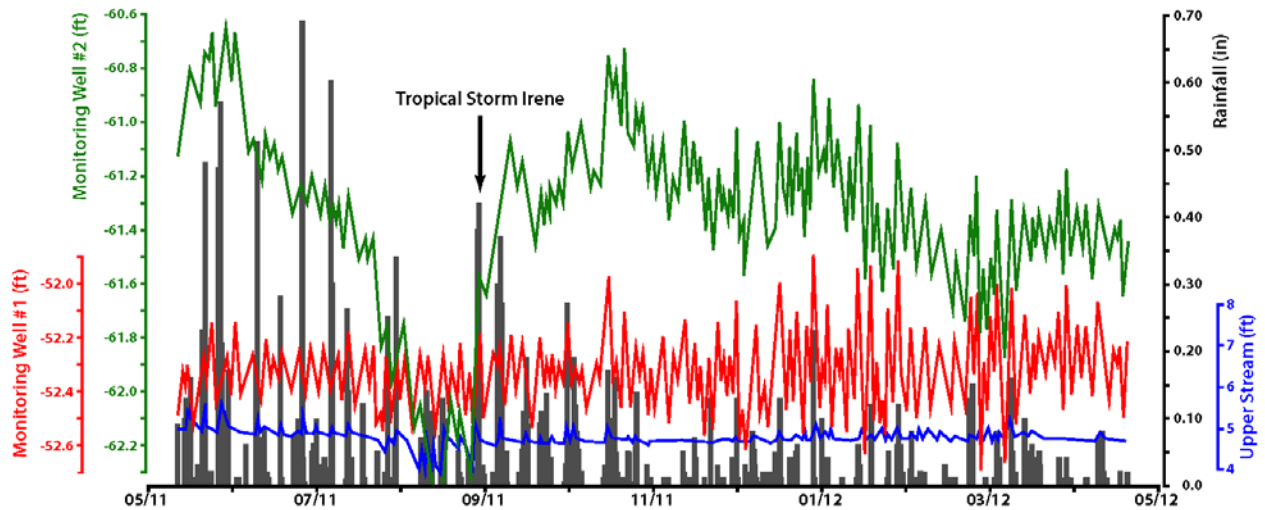
Groundwater level monitoring for one year suggests that the height of the water table at Monitoring Well MW1 varies minimally throughout the year ($\pm .033$ m or 0.11 feet; see the red line in Figure 13). Monitoring Well MW2 exhibits larger fluctuations (± 0.10 m or 0.33 feet) and tends to reflect changing water levels in the Upper Stream that are coupled to large precipitation events (for example, Tropical Storm Irene on 26 Aug 2011; see the green line in Figure 13). This suggests that the Upper Stream (blue line in Figure 13) supports the water level in the nearby well (MW2) but has no influence on more distal wells.

The slow decline in water table heights, as recorded in MW2, suggest that groundwater levels persist for months after significant precipitation events thus, maintaining high pore pressure in the Unit C and reducing slope stability.

Figure 13. Precipitation and water table levels at Deer Run Heights. The series run from May of 2011 to May of 2012. Monitoring well and gauge locations are shown in Figure 2. MW1 red; MW2 green; upper stream gauge dark blue; hourly precipitation grey (Weiss 2012).
