Risk management framework and mitigation for rock fall hazard at the Clowhom River Hydroelectric Project, near Squamish, BC

Charles Hunt, Shelley Higman & Bob Patrick
Tetra Tech EBA, Vancouver, BC, Canada

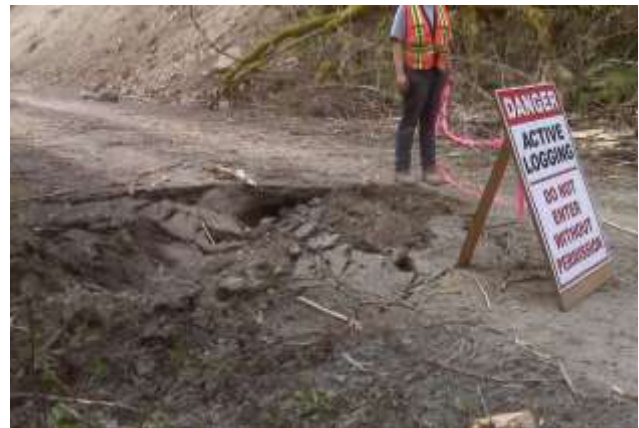
Figure 4: Impact Location of Rock Fall

Before the measures outlined in the previous section could be constructed, a rock fall event occurred on May 5, 2008, initiating just to the south (downstream) of the proposed location for the lower intake weir. The rock fall event deposited several small boulders on the FSR, and one boulder impacted the outer edge of the FSR with sufficient force to create a small crater (Figure 4). Figure 5 shows a general overview of the rock bluff source area.

The source of the recent rock fall appears to be from a wedge style failure. It is apparent from the character of the visible open joints within the rock on the southern side of the wedge, that further significant rock fall could occur from this location.

In terms of potential causes, the climatic conditions at the site indicate that any of: heavy rainfall, freeze-thaw, wind, snowmelt, or channelled run-off could induce rock fall, in connection with the observed adverse joint pattern and high degree of weathering, as suggested by studies carried out by McCauley et al. (1985).

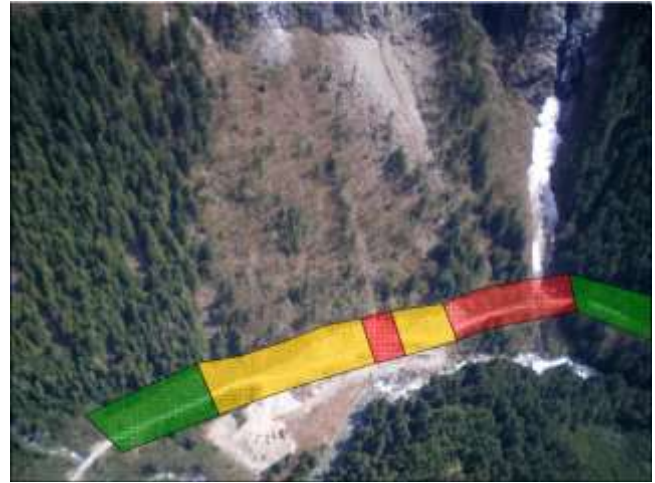
Figure 6: Subjective Probability of Rock Fall Over the 2 Year Construction Period. Low=Green, Medium=Yellow, High=Red

Based on the results of the detailed rock fall hazard assessment and the 2008 rock fall event, the likelihood of a rock fall event impacting areas of the FSR and the adjacent proposed penstock alignment, has been categorised into Low, Medium and High. The probability has been assessed for the time period during the 2 years of construction. In the long term almost all of the area below the rock slope could be impacted by rock fall. The probability is presented as green (Low), yellow (Medium) and red (High), respectively on Figure 6.

The probability of a rock fall event is highest below the main talus slope and within the gully to the south (debris flow and snow avalanche hazards are present, as well as rock fall). Another high risk location occurs where the smaller talus slope at the base of the main rock bluff has created a chute for larger boulders to travel down to the FSR. Other locations have generally been shown as medium and low probability.

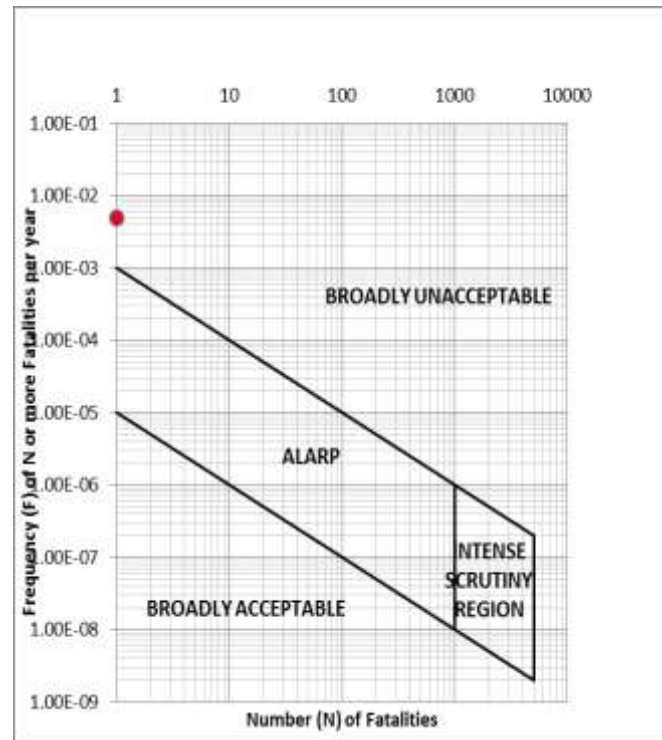
Figure 7: F/N plot considering road users along the FSR (criteria modified from Hong Kong Government Planning Department (1998)).

Societal risk estimates are typically presented on graphs showing the expected frequency of occurrence and cumulative number of fatalities, referred to as F/N plot (Figure 7). The accepted societal risk for one life lost is 10^{-3} / annum (see Figure 7). The graph is subdivided into four areas: unacceptable risk; tolerable risk that should be reduced further if practicable according to the as low as reasonably practicable (ALARP) principle; broadly acceptable risk; and a region of very low probability but with the potential for >1000 fatalities that require intense scrutiny. Porter and Morgenstern (2013) indicate that from the perspective of potential loss of life from a landslide (or in this case, rock fall), development is typically approved if it can be demonstrated that the rock fall risk falls in the ALARP or broadly acceptable regions on an F/N plot.

The estimated probability of one or more lives lost is 5×10^{-3} /annum ($144 \times 365 \times 9.3 \times 10^{-8}$), which plots in the Broadly Unacceptable region of the F/N plot (Figure 7) due to rock fall within the study area.

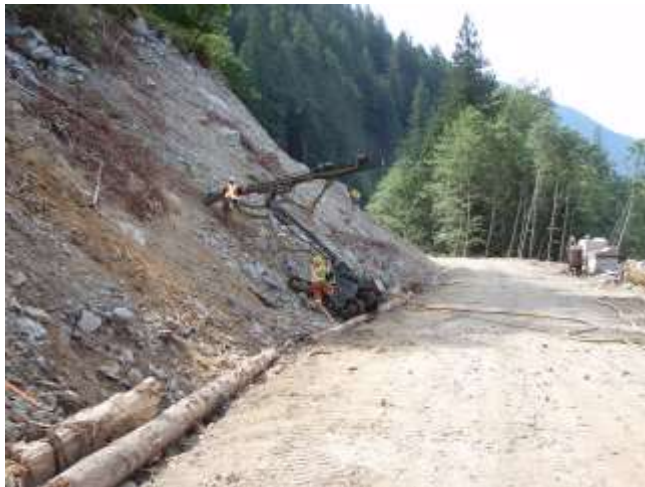
Figure 9: Drilling and Grouting for Fence Anchors

Design issues encountered were associated with the installation of the fence anchors as they needed to be drilled, installed and grouted into loose talus. Two issues arise when drilling into a slope of this material: first, loose

material in the talus slope collapses into the anchor drill hole, thus making it difficult to pull the drill bit and stem out of the hole prior to anchor installation; secondly the loose talus material exhibits poor rock to grout bond strength. Significant volumes of cement grout could be lost into the voids of the talus material; thus, it is very difficult to determine the degree to which the anchors have been properly encapsulated by grout.

Both of these problems were resolved with the use of self-grouting, Dywidag hollow stem anchors with a sacrificial drill bit. Pre drilling of anchor holes is no longer necessary with a sacrificial drill bit and grout can be pumped continuously through the hollow anchor and bit. These anchors are suitable for use in coarse talus soils and provide for a more reliable, efficient means of anchor installation and grout encapsulation in difficult ground conditions

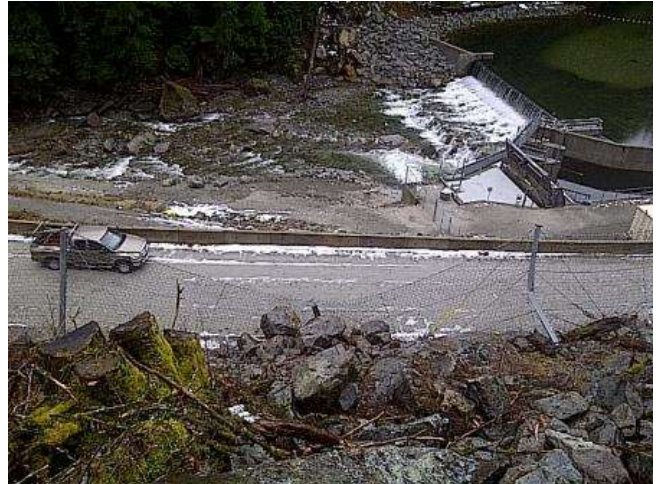
Figure 11: Rock Fence Damage as Viewed from Above

A rock fall event occurred in December 2011 that tested the Trumer Catch Fence. Although it was not possible to determine the velocity of the boulders, the photographs in Figures 11 and 12 suggest that the event may have been beyond what the fence was rated for; however, it seems to have performed extremely well given there were no impacts to the FSR or the headworks. The largest boulder in the fence was about 2 m in diameter and the rock fall reportedly initiated at least 300 m upslope of the fence.
