Hydro-geomorphic response to the June 19-21, 2013 storm in Canmore and the Municipal District of Bighorn, Alberta

Matthias Jakob, Hamish Weatherly, Ashley Perkins, Stephanie Bale and Jamie Sorenson
BGC Engineering Inc, Vancouver, B.C., Canada
Rosie Howard, Roland Stull
Earth and Ocean Science Department, University of British Columbia, B.C., Canada
Andy Esarte
Town of Canmore, Alberta, Canada

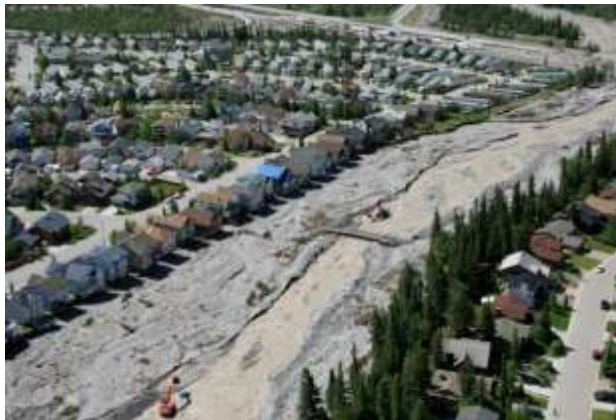
The June 2013 storm event led to extensive aggradation along Cougar Creek both upstream of the fan apex and on the fan reaches, which was accompanied by lateral instability on the fan as the channel lost confinement. Comparison of 2009 and 2013 LiDAR surveys indicates that local aggradation and erosion of up to 8 m and 5 m occurred. The channel aggradation allowed the streamflow to overtop the confines of the previously confined channel which led to flood waters eroding banks past property lines, undermining buildings foundations and destroying the support of decks and supported balconies (Figure 6). The peak flow of the debris flood appeared to have exceeded at least three to four times the estimated 100-year return period flood of 16 m³/s (AMEC, 2003). The flood event was unusual in that high flows were sustained for a period of several days.

Figure 6. Aerial view of Cougar Creek fan following the June 2013 flood.

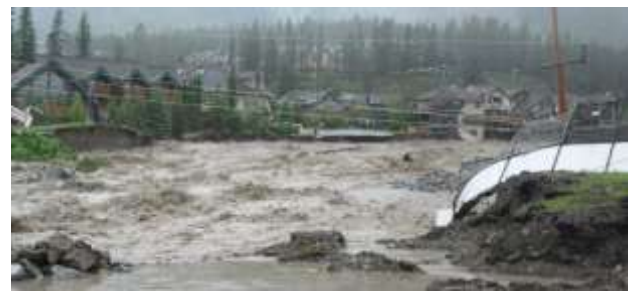
Above Elk Run Boulevard, aggradation and channel widening resulted in the creek eroding a section of road and the backyards of a number of homes. An outdoor hockey rink on the left bank of the creek at Elk Run Boulevard was also completely destroyed (Figure 7). A major concern during the flood was Elk Run Boulevard becoming outflanked, resulting in the creek overtopping the road and potentially heading into the subdivision. Emergency crews were present throughout the storm at the road crossing to keep the culvert inlet as free of debris and sediment as possible and to minimize the amount of outflanking that did occur (major erosion occurred behind both concrete wingwalls). Existing riprap on either bank was completely destroyed during the flood, presumably due to initial undermining followed by channel aggradation.

Figure 7. Upstream view of Cougar Creek from Elk Run Boulevard during the June 2013 flood.

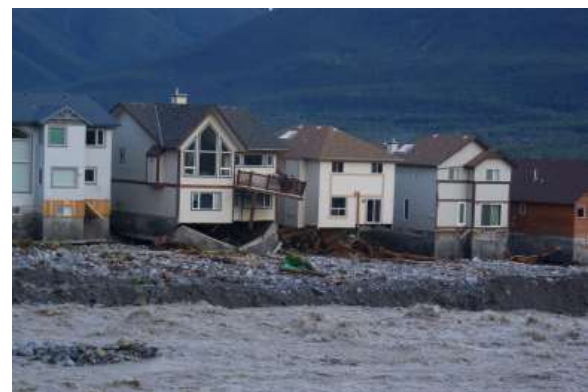
Between Elk Run Boulevard and Highway 1, the creek also significantly widened. Damages to homes were severe in this reach (Figure 8). Walking paths on either side of the creek were completely eroded and a pedestrian bridge was outflanked on either bank, although it was not washed away. Riprap placed on the banks and in the channel during 2012 was completely destroyed, initial undermining followed by channel aggradation.

Figure 8. Damage to homes along left (east) bank of Cougar Creek between Elk Run Boulevard and Highway 1.

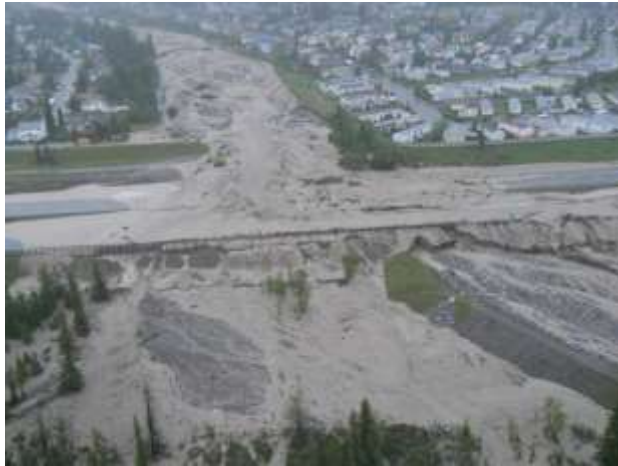
Additional major damage was recorded at Highway 1, where the blocked culverts resulted in flows avulsing over the highway and down the median to the east (Figure 9). These overflows resulted in portions of the highway being undermined and collapsing. Further downstream, the box culverts at Highway 1A and CP Rail were also blocked by sediment and debris, the latter of which was out of commission for approximately three days until it was repaired.

Figure 9. Lower Cougar Creek fan during July 19, 2013 flood. Photo: Alpine Helicopters.

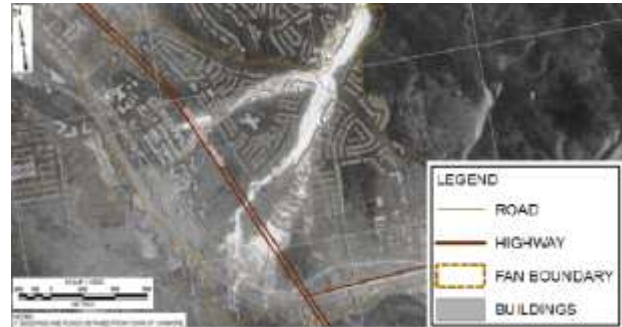
Although the June 2013 debris flood was unusual, a 1947 air photograph of the fan illustrates that the Cougar Creek fan has historically been a very active landform (Figure 10).

Figure 10. Cougar Creek current buildings and lot lines superimposed on a 1947 air photograph.

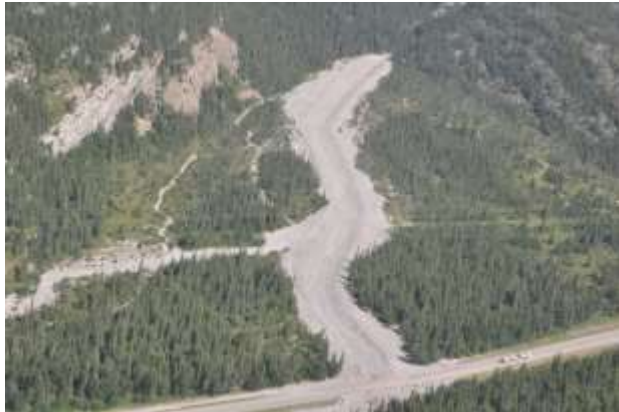
From the fan apex at elevation 1345 m, the creek flows for about 1 km down to Highway 1A (Figure 13). Prior to the June 2013 flood, streamflows used to be

conveyed under the highway through a 2.2 m diameter culvert. This culvert was destroyed by the June 2013 debris flood. The CP Railway is located a further 230 m downstream, below which Jura Creek discharges into a side channel of Bow River.

Figure 13. Jura Creek fan with a re-excavated channel through the centre of the fan and the avulsion path to the left (west). Highway 1A in the foreground. July 2013.

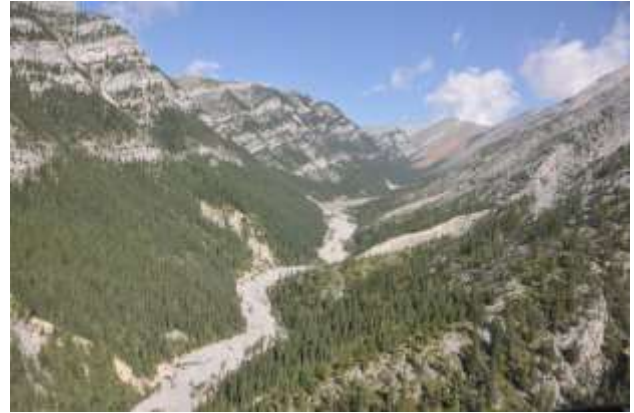
Both creeks are incised into a thick unit of presumably late Pleistocene sediments (Figure 14 and 15). These sediments are very unstable and provide a quasi-unlimited supply of sediment during flood events. The implication is that a repeat hydroclimatic event of similar magnitude to 2013 storm (or larger) will result in similar or larger sediment movements with similar or more severe flood consequences, and potential risks to personal safety.

Figure 14. Upper watershed of Jura Creek showing a very active floodplain approximately one month after the June 2013 debris flood.

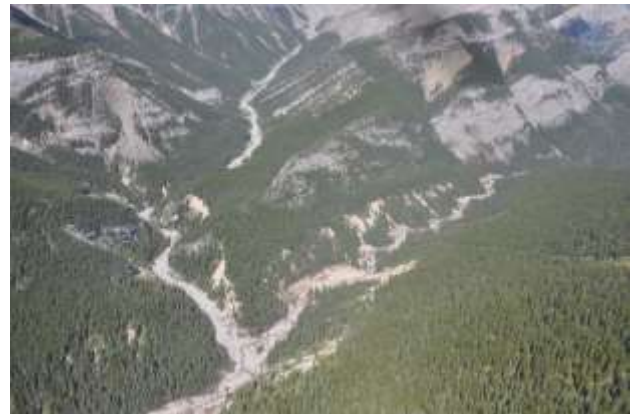
Figure 15. Upstream view of Exshaw Creek in mid reaches. The channel is incised into a thick sequence of unstable late Pleistocene sediments. July 2013.

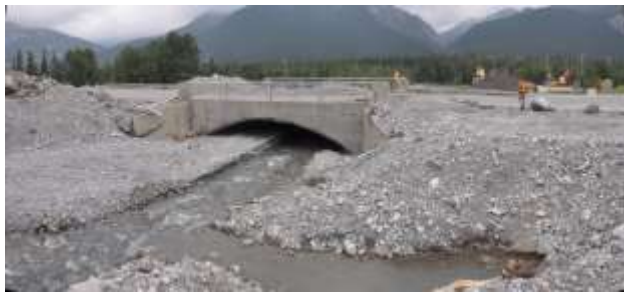
About this time the bridge at Highway 1A had become blocked with debris and a second flow avulsion developed on the left (east) bank of Exshaw Creek (Figure 16). These overflows were conveyed along the upslope ditch of Highway 1A toward the already inundated low-lying area, further aggravating flooding there.

Figure 16. Downstream view of the Highway 1A bridge spanning Exshaw Creek. July 2013.

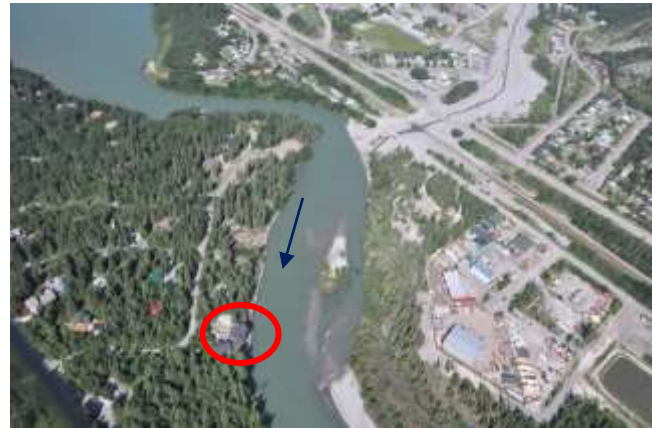
The high sediment volumes mobilized in Exshaw Creek also resulted in a secondary fan forming at the confluence with Bow River. Reeve Dene Cooper noted that the fan temporarily extended about two-thirds of the way across the river at the peak of the flood event, resulting in Bow River flows being diverted along the right (south) bank which led to significant bank erosion of the Heart Creek fan (Figure 17). One home in Lac des Arcs was severely undermined by the bank erosion. Review aerial imagery indicates that approximately 15 m of bank erosion occurred at this location during the flood event.

Figure 17. Aerial view of the confluence of Exshaw Creek with the Bow River. Deposition at the mouth of Exshaw Creek concentrated flows along the right bank of the Bow River, resulting in bank erosion and undermining of one home (circled in red). All homes of Lac des Arcs are located on Heart Creek fan.
