The Johnsons Landing landslide of 2012, Kootenay Lake area, British Columbia

Peter Jordan

BC Ministry of Forests, Lands and Natural Resource Operations, Nelson, BC, Canada

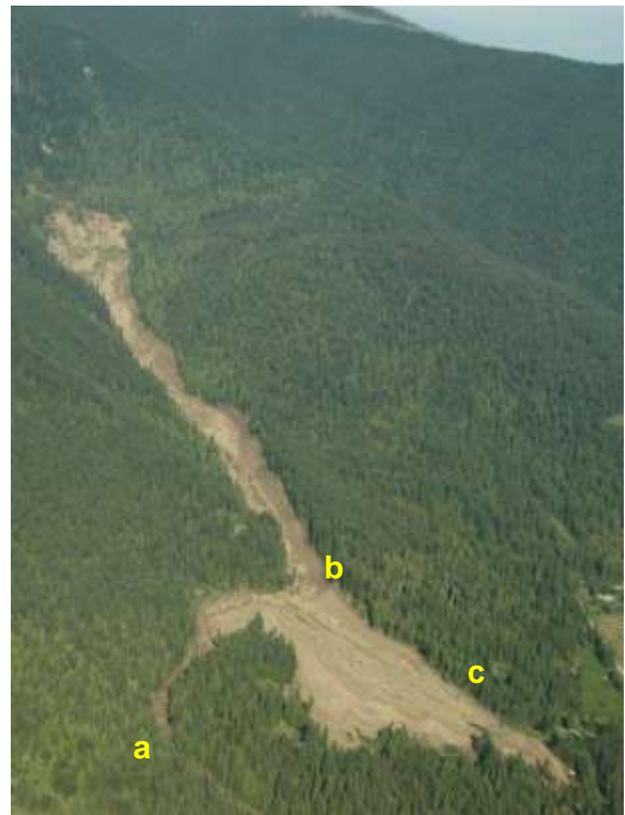
landslide suddenly occurred, destroying four homes, damaging two others, and covering an area of about 20 ha with debris (Figure 2). Four residents were killed in their homes. As well as the loss of life and destruction of property, water supply, electricity, telephone, and road access to parts of the community were cut off for a year.

Figure 2. View of the landslide from the air, about 6 hours after it occurred. a – canyon with secondary debris flow; b – bend in channel and low ridge; c – bench where houses were destroyed.

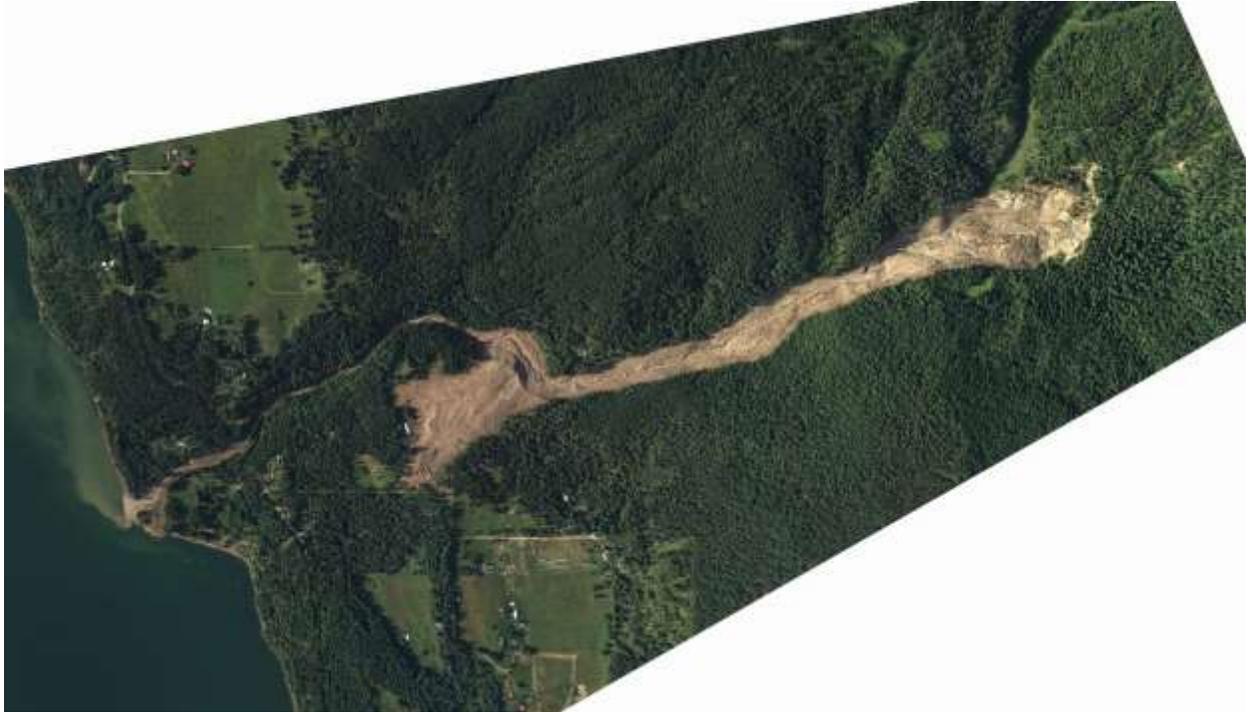
Figure 3. Orthophoto showing Johnsons Landing and the July 12, 2012, landslide. See Figure 4 for interpretation of features. (Regional District of Central Kootenay orthophoto.)

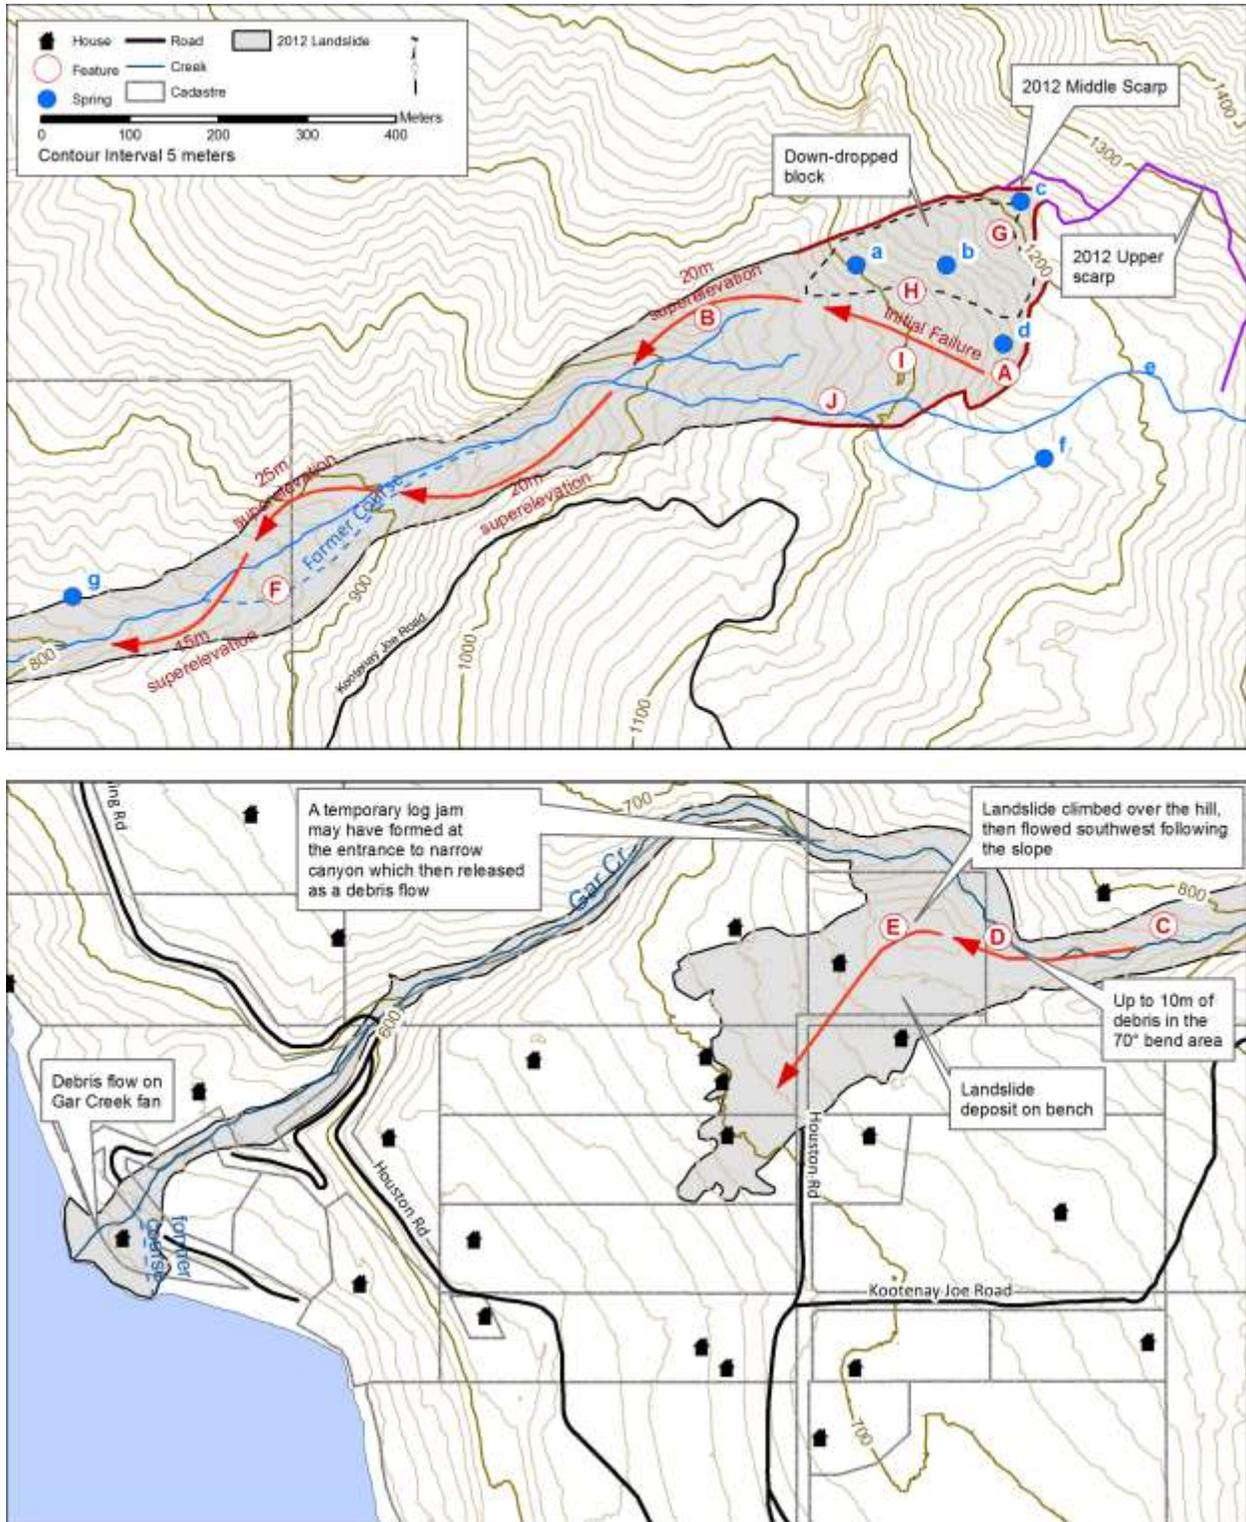
Figures 3 and 4 show the main features of the landslide. It consisted entirely of unconsolidated sediment (soil) of morainal, glaciofluvial, and colluvial origin. These deep glacial deposits form an irregular, gently-sloping (20-40%) terrace between 1100 and 1300 m elevation, in the middle part of the Gar Creek valley. The landslide appears to have originated in the southern part of the source area (location A on Figure 4), where the main scarp is about 10 to 15 m high. The landslide gained speed rapidly, and climbed about 30 m up the opposite valley wall (B). It then continued at high speed down the valley, climbing up the alternate valley walls three more times, with superelevations of 15 to 25 m. In the lower part of the valley, it straightened out (C), although still travelling at high speed with a depth of about 13 m.

At location D, there is a sharp right bend (about 70°) and widening in the valley, below which the creek enters a narrow canyon incised into the deep glaciofluvial and morainal deposits of the Johnsons Landing bench. At this location, most of the landslide debris climbed 10 to 25 m onto a ridge (E), with enough speed to overtop it, and then spread out onto the bench to the southwest, where the homes were located. Debris filled the bend area to a probable thickness of 5 to 10 m. From photos taken soon after the event, and from later ground observations, a possible temporary blockage of trees formed at the head of the canyon, and this may have helped to divert most of the subsequent debris over the ridge and onto the bench. The blockage then broke, sending a debris flow which

From eyewitness descriptions and from superelevation, the landslide velocity down the channel is estimated at 90 to 120 km/h (25 to 33 m/s) with a reduced speed as it flowed onto the Johnsons Landing bench. Although the landslide was described by eyewitnesses as a single event which lasted less than a minute, there is some evidence from the deposits that it may have been a more complex event with several surges of debris, maybe only seconds apart. A substantial amount of debris was deposited in a wide part of the upper channel (F). Above the main scarp, a prominent feature is a large block of more-or-less intact glacial deposits (G) which dropped down about 20 m and then stopped. It may have been arrested by a bedrock outcrop (H) visible below the main scarp. During the search operations, there was concern that this block could fail; however, no further movement occurred. Within the source area, below the main scarp (I) a large area is covered with mostly intact trees with their root wads attached. This appears to be a result of a large block of debris which fell off the main scarp, and

Figure 4. Map showing the features of the Johnsons Landing landslide. The top and bottom figures are the right (east) and left (west) parts of the map, respectively. Figure from the report (Nicol et al. 2013).

disintegrated on the slope below. This debris covers most of the area where the failure plane of the landslide might otherwise be observed. Significant water was observed at the landslide scarps a week after the event; in particular, seeping from the upper scarp located above the dropped block, and from several springs within the scarp area (H, I, J).

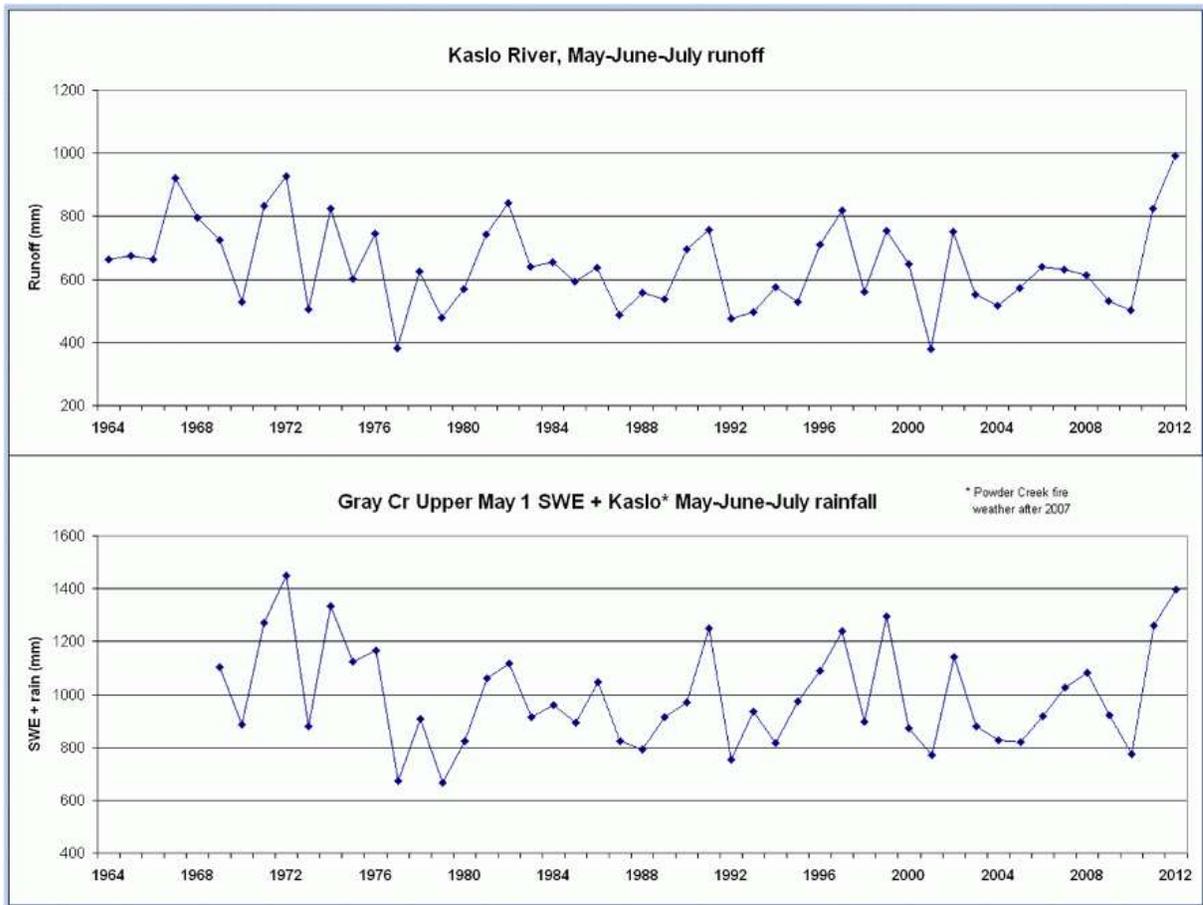
Figure 5 shows two hydrologic measures which may provide an index of available water in the spring – early summer period. These are total May-July runoff for the most representative nearby streamflow gauge, Kaslo River, and the sum of May 1 snow water equivalent and May-July rainfall at nearby stations. Although arbitrary, these measures may provide a qualitative indication of valley-bottom groundwater levels in the area. The figure shows that using these indices, 2012 was amongst the wettest spring seasons since records began.

Figure 5. Graphs illustrating runoff and precipitation for the May-July spring freshet period, 1964-2012. The lower graph is an index consisting of snow water equivalent (SWE) plus rainfall for the period, for representative stations.

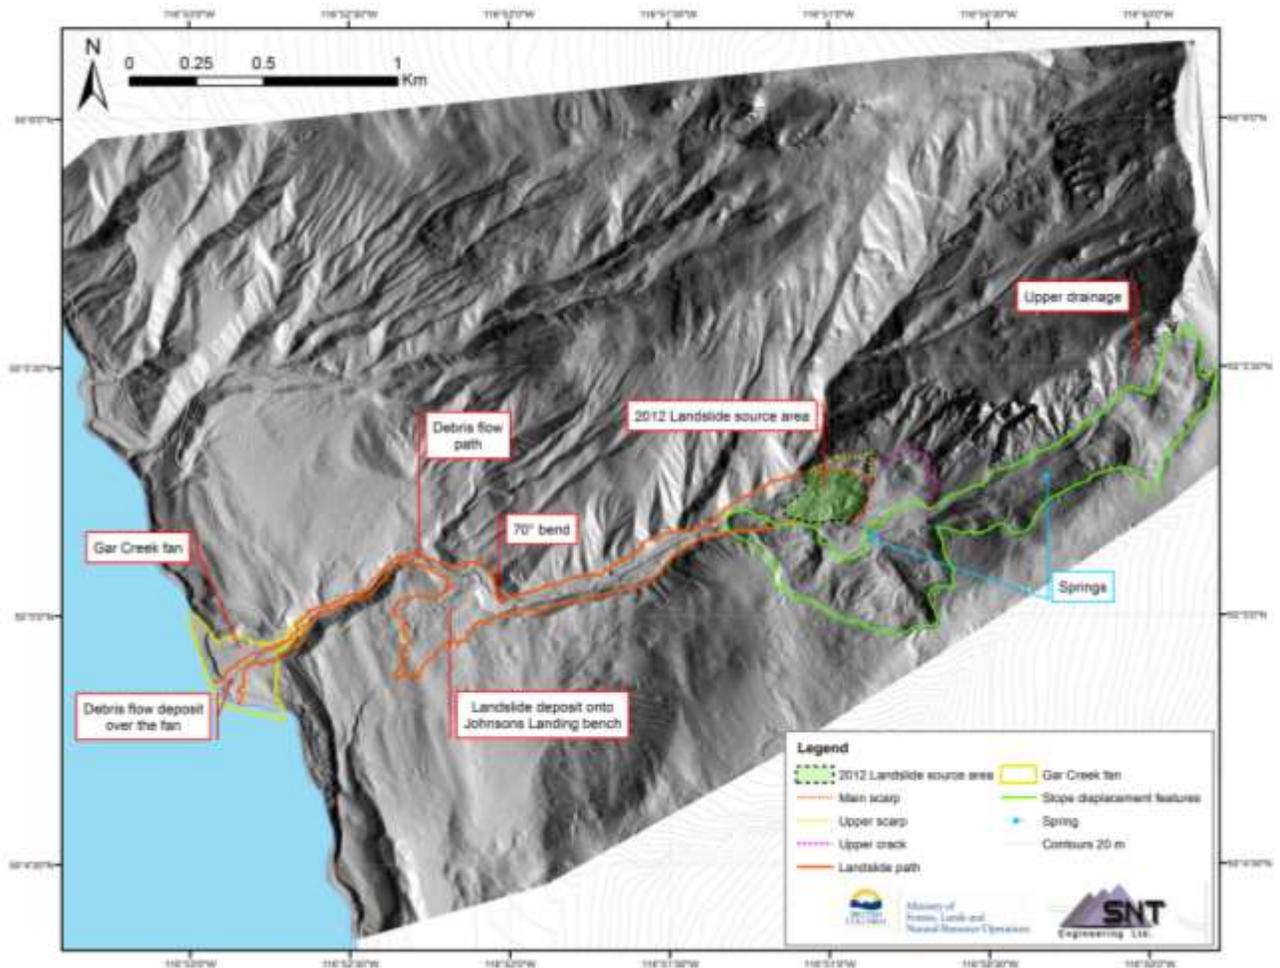
Figure 6. LIDAR image of the Johnsons Landing landslide and adjacent area. The dashed purple line shows the upper crack bounding the potential future landslide, and the green line outlines the area of displaced bedrock in the upper Gar Creek valley. Figure from the report (Nicol et al. 2013).

LIDAR imagery and field traverses in the failure area identified a continuous crack, approximately 400 m long and 200 m above the main scarp, with visible displacements of up to 4 m. The surface area bounded by the crack and the main scarp below is about 6.4 hectares. The depth to bedrock is unknown and the average depth of a potential failure surface is uncertain. However, lower and upper bounds of the potential volume can be estimated by assuming it varies from 1 to 5 m at the crack, to 8 to 12 m at the main scarp.

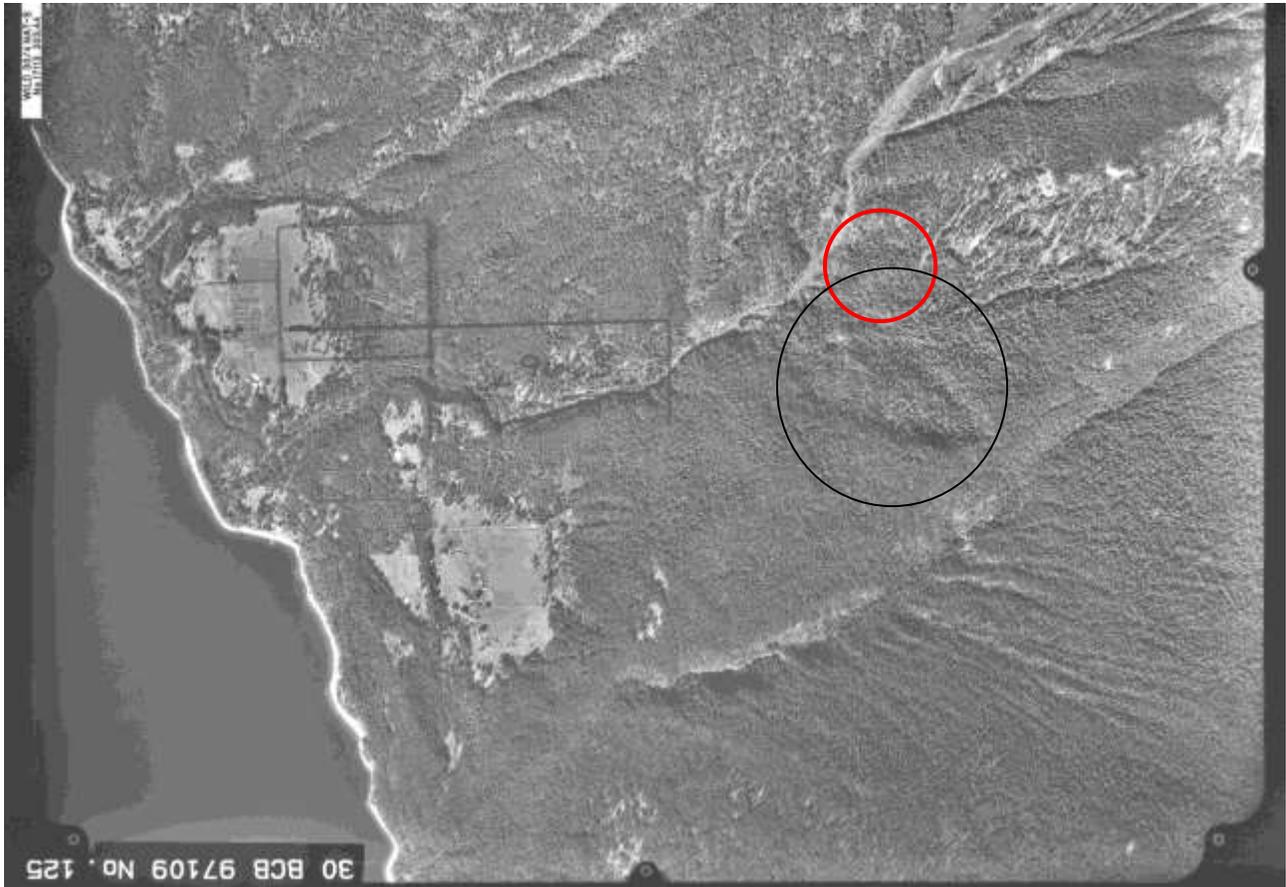
Figure 7. Pre-landslide air photo of the Johnsons Landing area. Red circle shows the location of the 2012 landslide source area. Black circle locates the ancient bedrock landslide feature, part of the area of displaced bedrock in the Gar Creek valley. Compare with Figure 3, which shows the area on the bench inundated by the landslide.

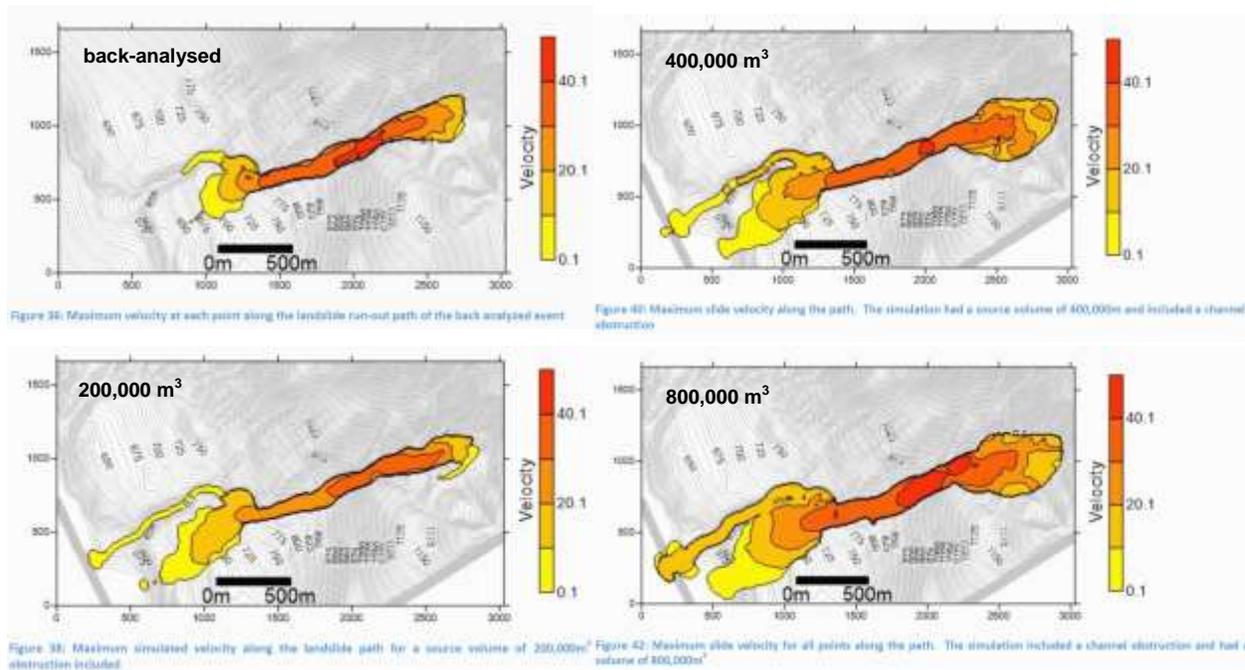
The runout analyses show that a future landslide of similar magnitude to the 2012 landslide will travel further due to the lack of trees in the channel and on the bench, and therefore a lower basal friction. An uncertainty in the modeled runout is the assumption that a channel obstruction formed at the entrance to the canyon. Without an obstruction, the model predicts that most of the debris should run down the canyon to the fan. The likelihood of another channel obstruction is less than during the 2012 event due to fact that there will be fewer and/or smaller trees incorporated into a future landslide (at least for the next several hundred years).

Figure 8. Examples of output from the DAN-3D runout analysis. The upper left map shows the back-analysed extent and velocity; the other three maps show the forward analysis for three potential future landslide magnitudes.

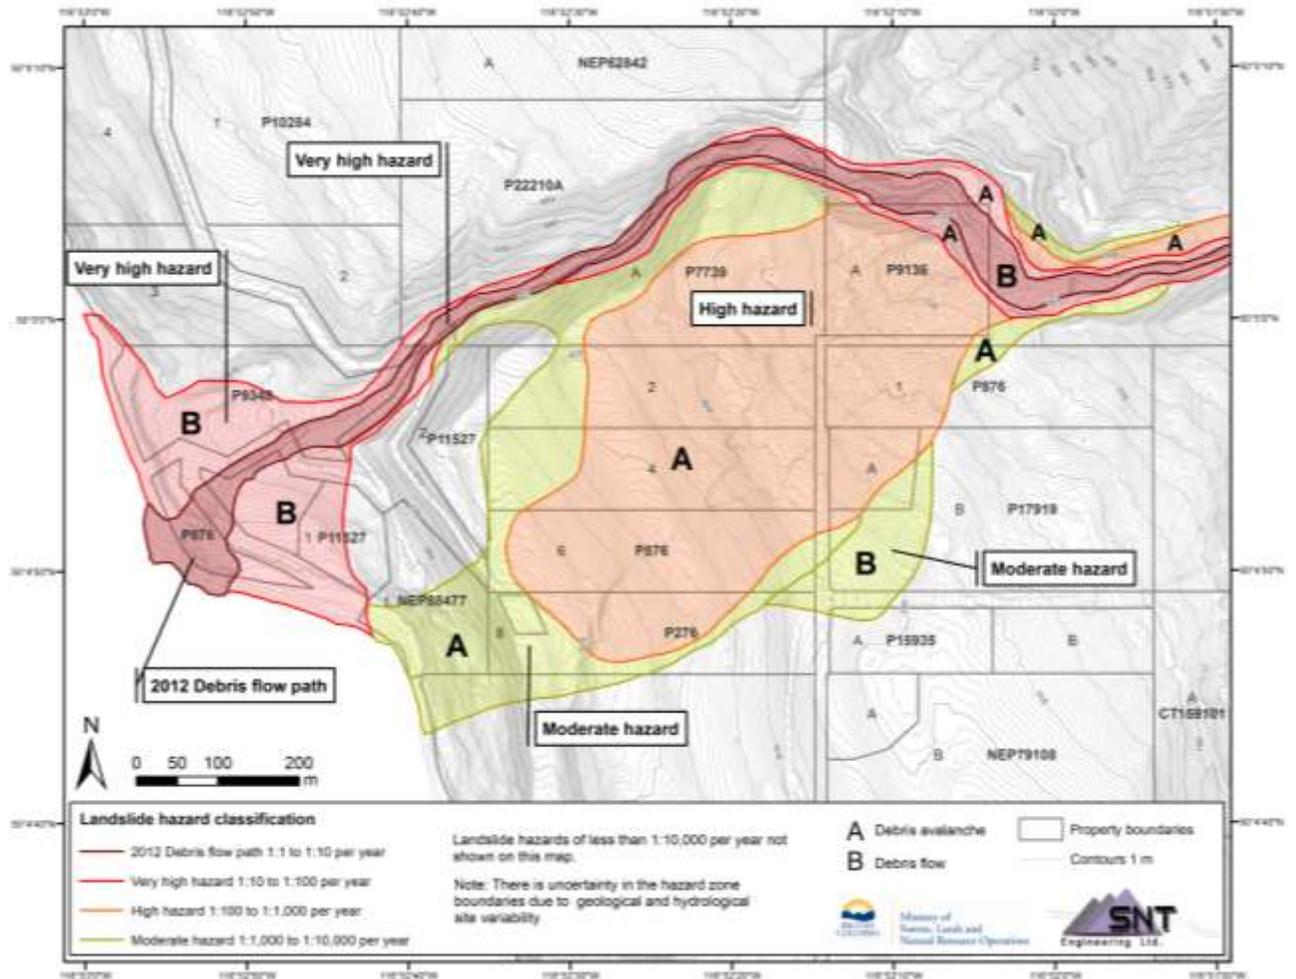
Figure 9. Map showing hazard zones derived from the runout analysis. Figure from the report (Nicol et al. 2013).

- Notify local residents of the estimated hazard and risk.
- Restrict further land development or building in the areas identified as having a moderate, high, or very high hazard unless subsequent geotechnical investigations are conducted that supports the development, recommends protective works, and/or reduces the assessed hazard.
- Establish communication plans and protocols to update residents and visitors of local conditions during periods of potential increased landslide hazard.
- Establish a watershed plan for resource management and development on crown land within the Gar Creek watershed.
