### THE FAILURE AND RIGHTING OF THE TRANSCONA GRAIN ELEVATOR

The foundation failure and righting of the Transcona Grain Elevator in 1913 is a truly remarkable case history made famous by its collapse during filling after foundation pressures exceeded the bearing capacity of the underlying clay foundation soil. The following photographs and documentation provides a record of the bearing capacity failure, how the original designers struggled to understand the cause and most remarkably, how ingenuity and determination led to the successful righting of the 20,000 ton structure. It provides an account of the landmark work carried out in the 1950's ending with a modern perspective made possible by finite element modelling techniques.

### THE FAILURE AND RIGHTING OF A MILLION-BUSHEL GRAIN ELEVATOR\*

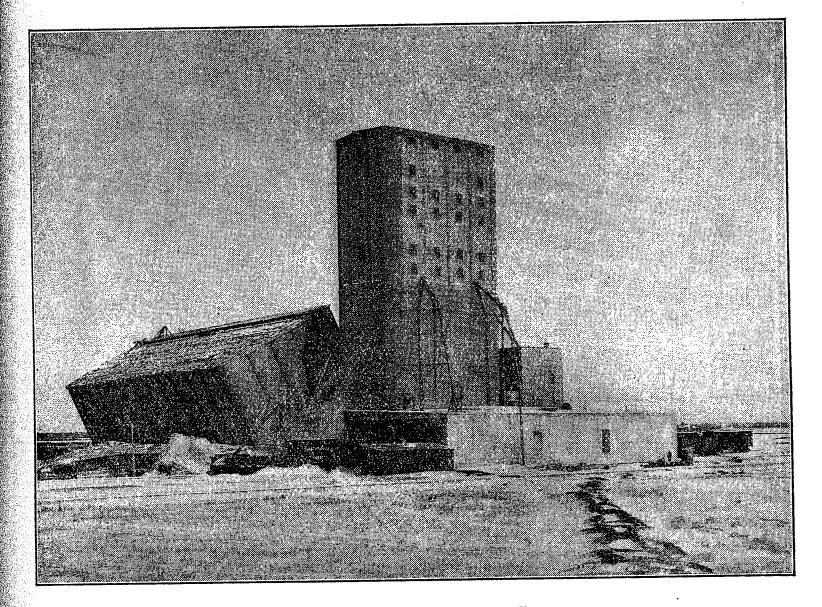
An examination showed the east side to be 5 ft. above, and the west side 29 ft. below, the original position; the building was also approximately 4 ft. lower at the north than at the south end. An upheaval of 5 or 6 ft. of the ground surrounding the bins occurred during the settlement. At an angle of  $26^{\circ}$  53' the center of gravity of the loaded structure had moved over almost to the low edge. The upheaval and the compacting of the soil along the west side saved it from completely falling over. Above this, on the west side, 52 ft.

FIG. 3.---VIEW OF ELEVATOR AFTER SETTLEMENT.

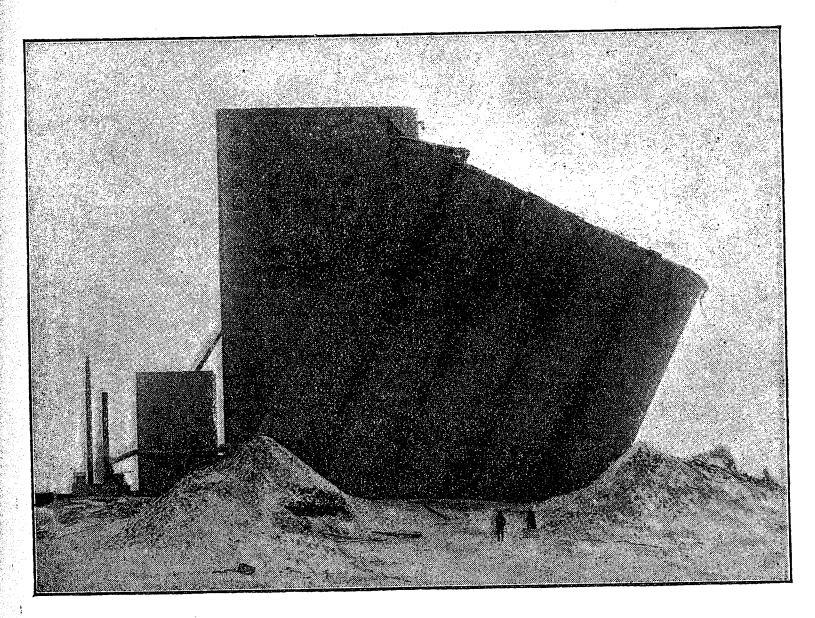
FIG. 4 .--- VIEW OF ELEVATOR AFTER SETTLEMENT.

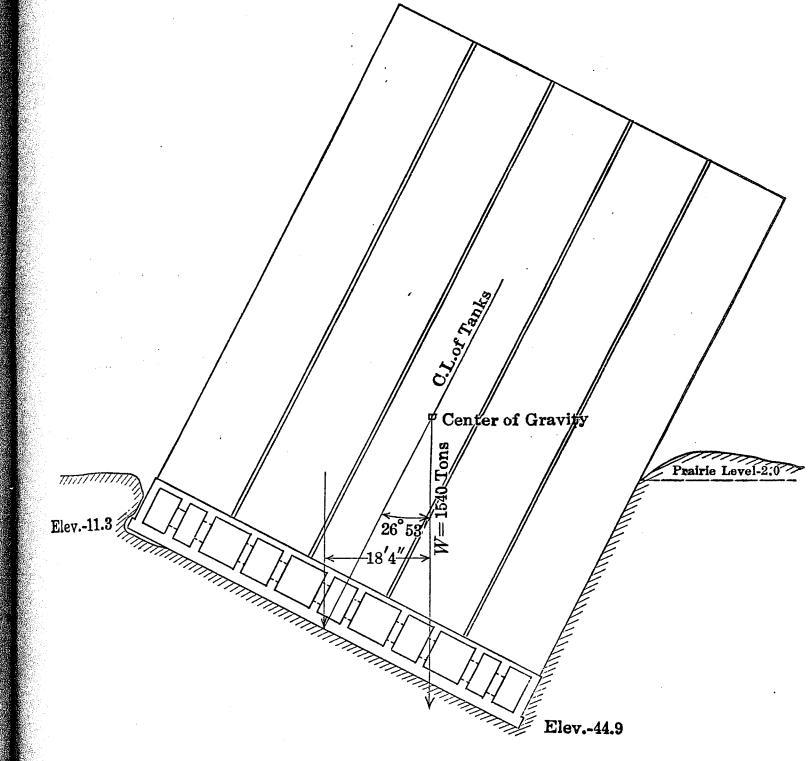
the filling of the different tanks so as to distribute the load uniformly. Settlement began on October 18th. The bins at this time contained about 875 000 bushels of wheat. A vertical sinking of 1 ft. occurred within an hour after the settlement was first noted. This was followed by an inclination toward the west, which increased until, at the end of 24 hours, the binhouse rested at an angle of  $26^{\circ}$  53' from the vertical.

SECTION THROUGH BINS AFTER SETTLEMENT Fig. 5.

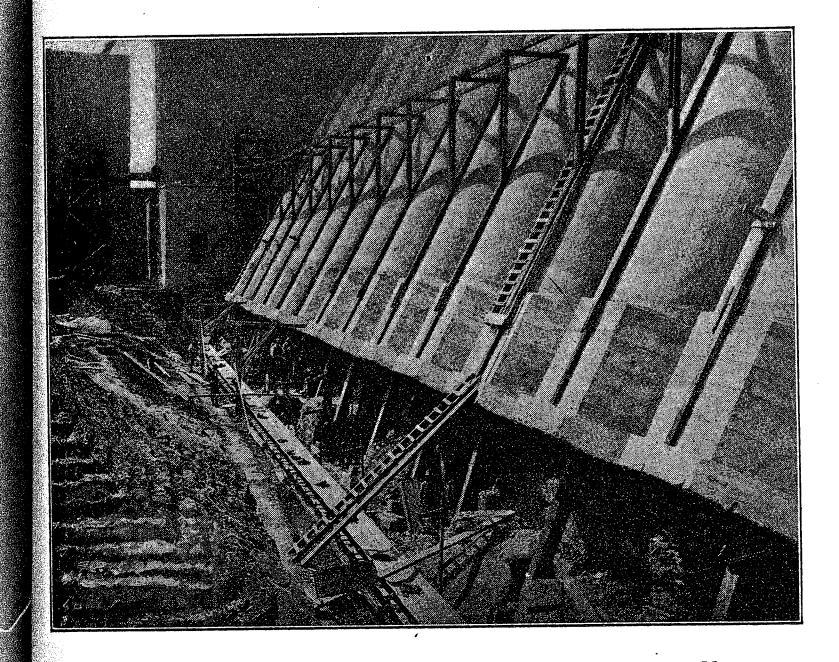
FIG. 10.--EXCAVATION TOWARD WEST FROM UNDER EAST EDGE OF MAT.

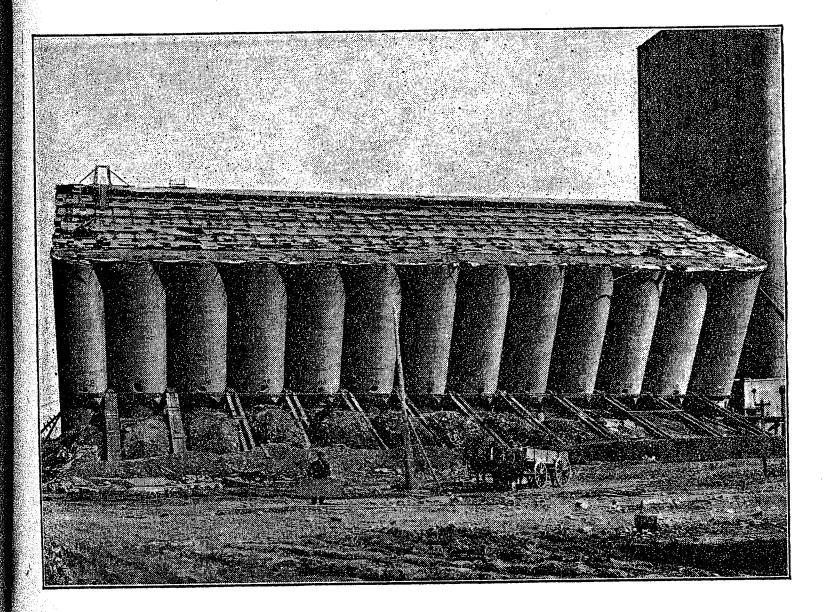
FIG. 11.—LINE OF PUSHERS AGAINST WEST SIDE OF BIN STRUCTURE, SHOWING HOLES THROUGH WHICH GRAIN WAS TAKEN OUT.

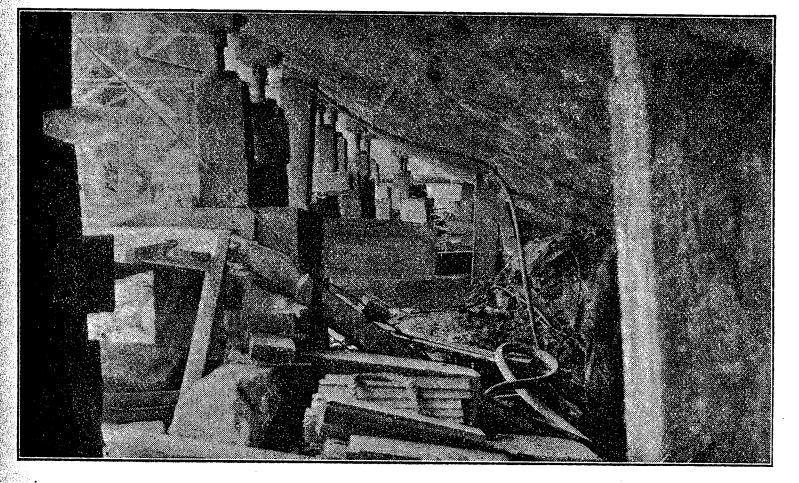
FIG. 12.—SHORING SCREWS, ON "G" ROW OF PIERS, CARRYING EDGE OF MAT.

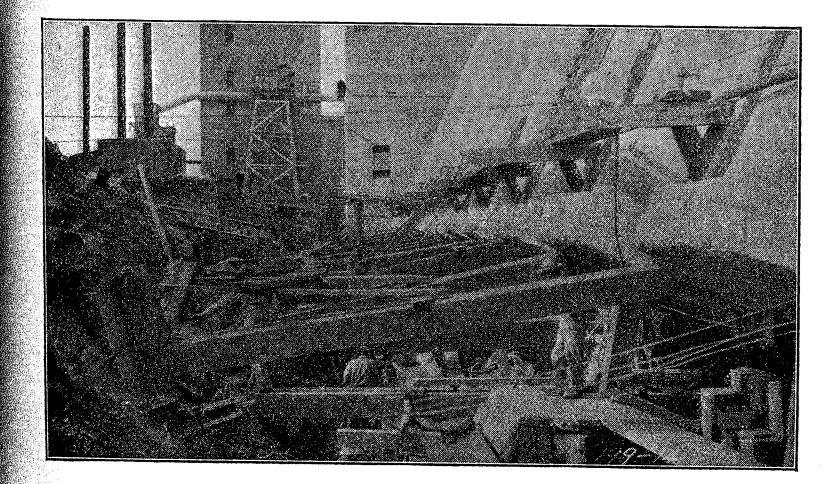
FIG. 13 .- KICKING BRACES AGAINST EASTERN EDGE OF MAT AT BINHOUSE.

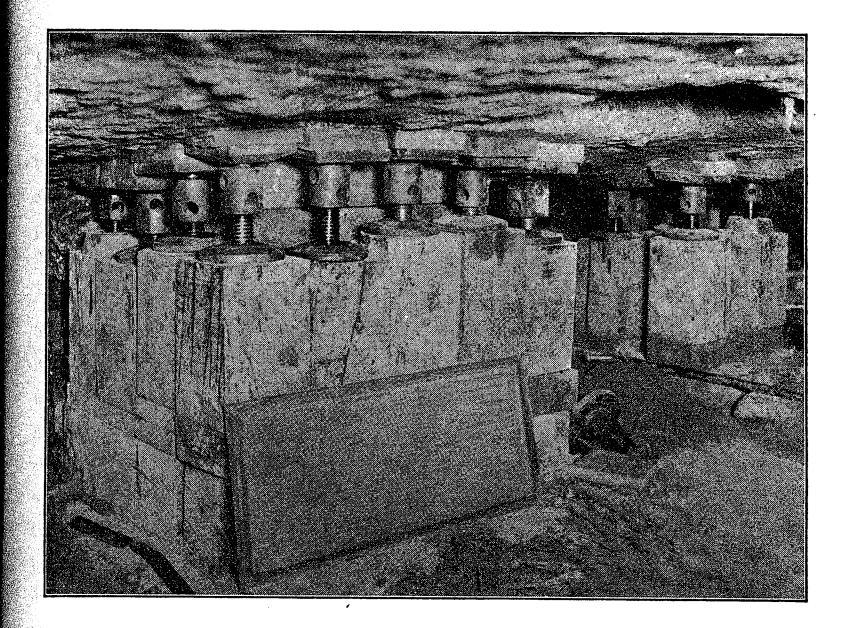
FIG. 17.-TYPICAL JACKING UNITS ON AND BETWEEN "K" PIERS.

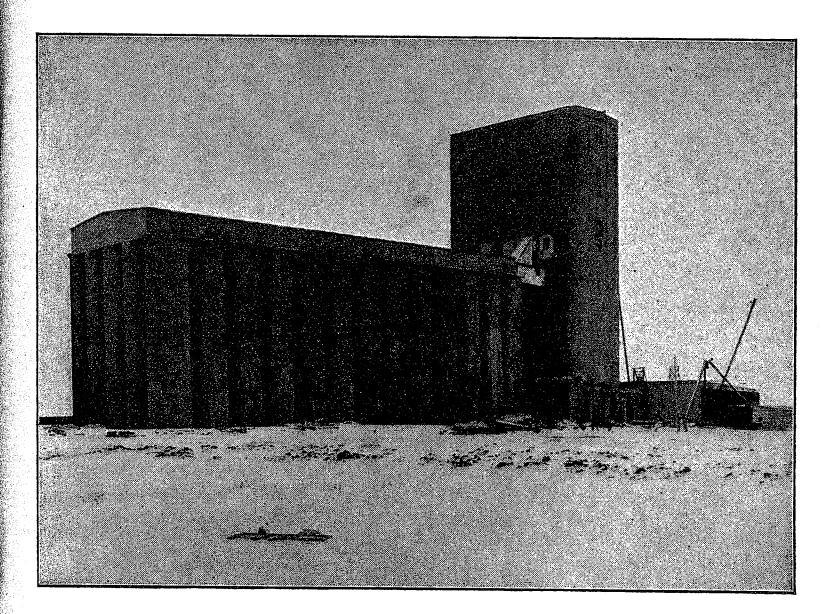
FIG. 18.-STORAGE BINS IN RIGHTED POSITION.

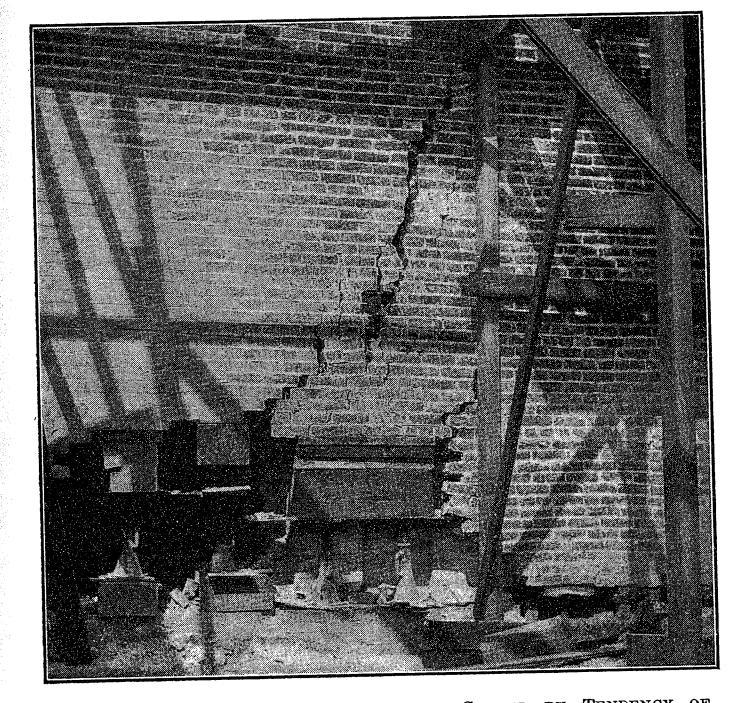
FIG. 25.—CRACK IN WALL OF BUILDING CAUSED BY TENDENCY OF BLOCKING TO ROLL.

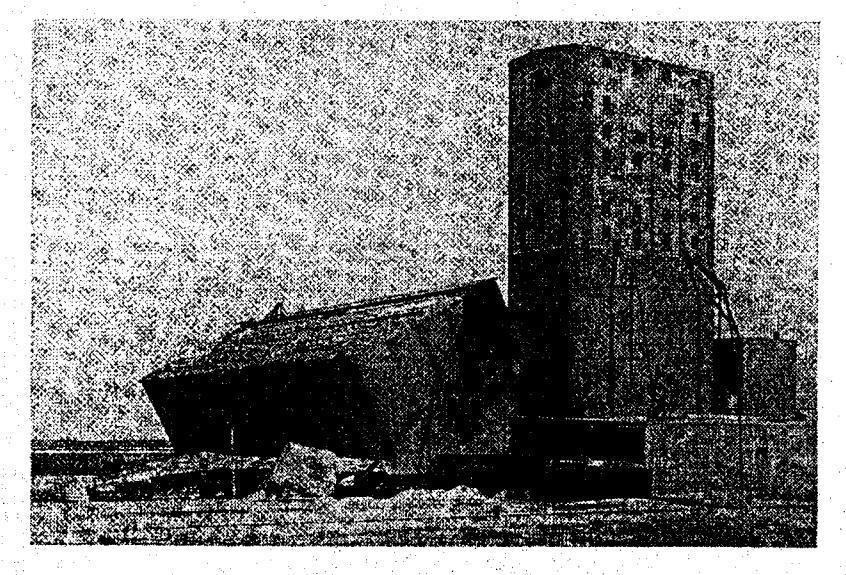
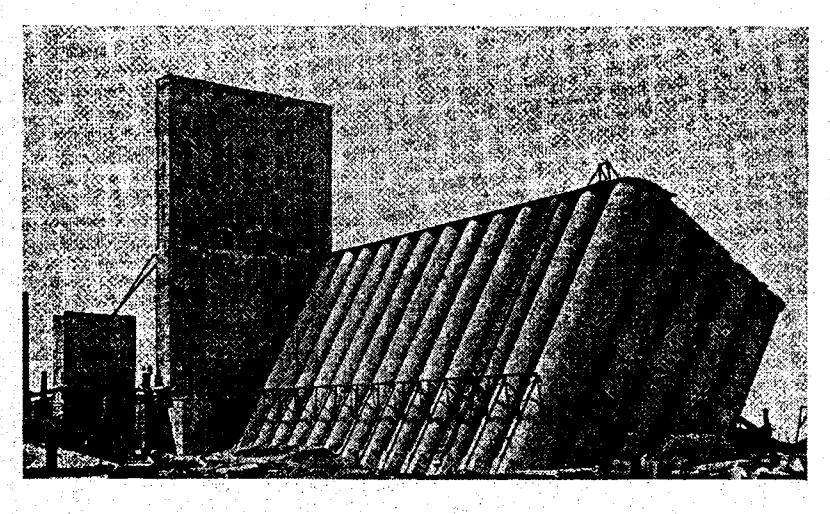
Above: West side of elevator, showing tilt and soil upheaval. Below: East side following foundation failure; early stages of righting operations are shown under way. (Photos: Foundation Company of Canada Limited.)

house. Photographs taken after the failure show that the greatest upheaval occurred on the west side and was considerably more than 5 feet.

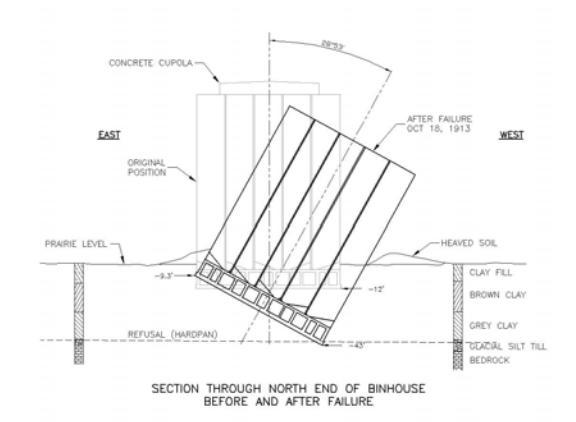
Figure 2. Cross-section of failed binhouse.

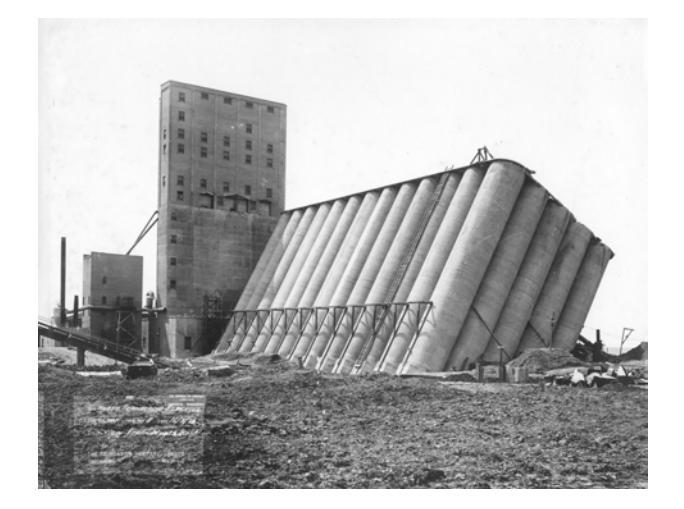
Figure 3 shows the final configuration of the structure following failure.

Figure 3. Binhouse after failure.

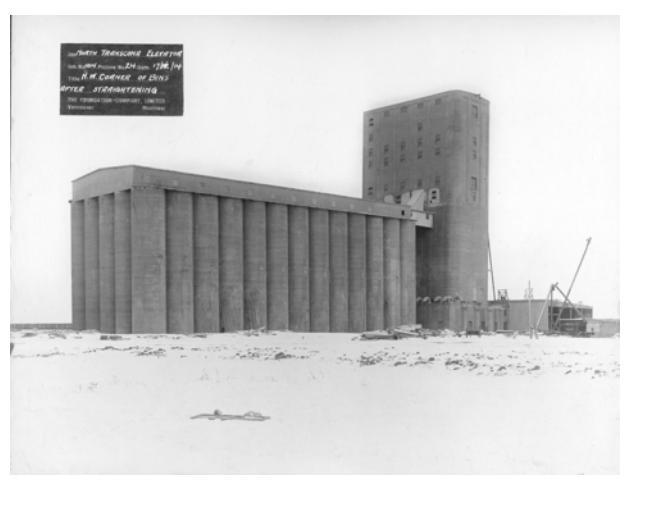
Figure 7. Binhouse after righting.

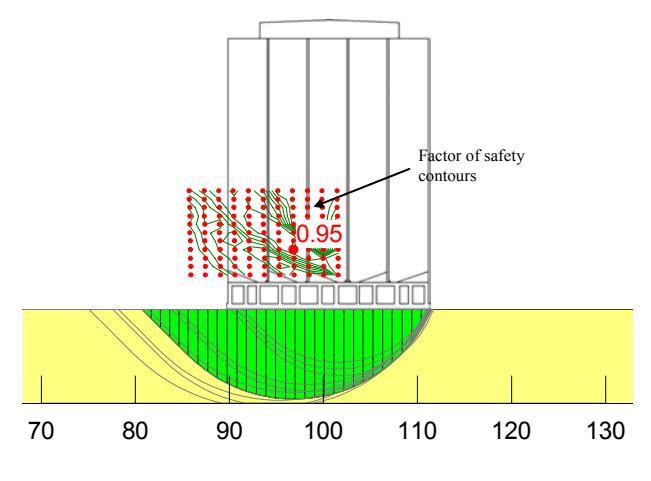
Figure 12. Critical failure surface.
