STABILITY OF SLOPES IN THE SOFT, GLACIOLACUSTRINE DEPOSITS OF THE THUNDER BAY REGION, N.W. ONTARIO.

K.D. Eigenbrod, Department of Civil Engineering Lakehead University, Thunder Bay, Ontario, P7B 5E1

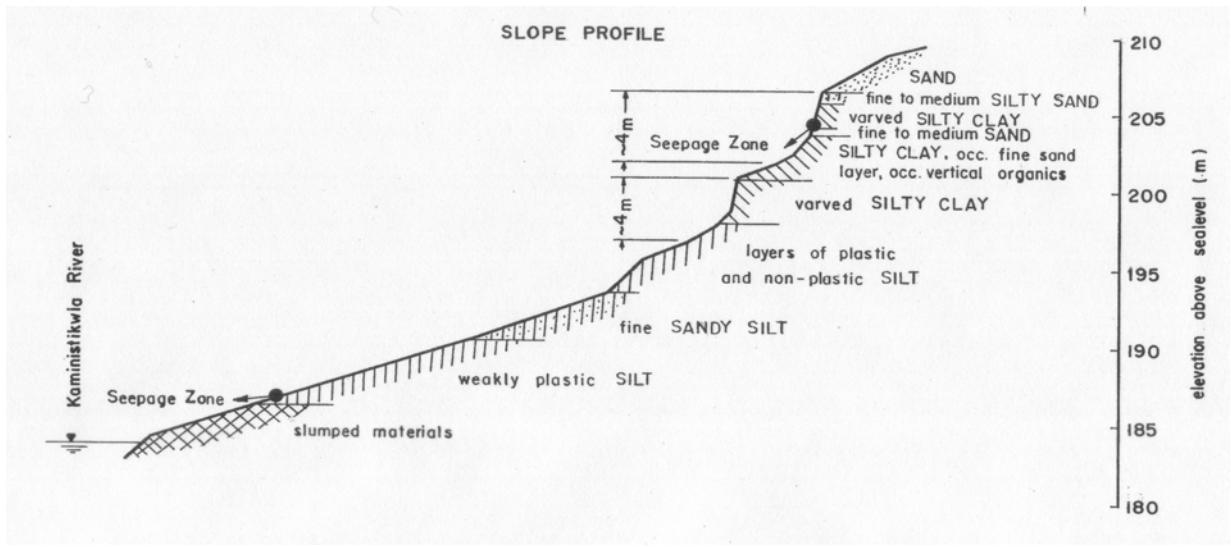
Slopes cut into these deposits are typically fairly steep and only when they are undercut by toe erosion, they experience shallow break-offs or surficial sloughing. A typical section of one of the slopes affected by undercutting along the Kaministiquia River in Thunder Bay (Site 1 on Fig. 2) is shown on Fig. 3. The entire slope is approximately 25 metres high and contains the typical irregular sequence of sands, silts and clays. The clay beds stand in almost vertical benches up to a height of 5.0 metres. The clay benches tend to breakoff in slabs of less than 1.0 metre thickness. The varved clay material often liquefies after break-off, carrying parts of vegetation to the bottom of the slope.

Fig. 3 Lower Kaministiquia River (Site 1). Geological section of typical slope (after DST, 1982).

the Kaministiquia River and its tributaries only shallow slides must be expected as a result of toe erosion by the river. Larger slides are possible, if very large loads were applied to the top of oversteepened slopes. The risks associated with sliding along these slopes are relatively large for locations within the limits of the City of Thunder Bay, where residential development often is close to the valley edge. The risks, however, are predictable, as the destruction of property will proceed at the same rate as the rate of undercutting by the river. Similarly the risk of loss of human life is not very high, as it is more associated with the destruction of engineering structures than with the sliding event. Landsliding can be easily avoided by preventing toeerosion, e.g. by placement of riprap along the toe of the slope for erosion control and by restricting development close to the edge of the river bank. Where existing development is already close to oversteepened slope portions, structures may be abandoned and removed, or alternatively secured by appropriate retaining structures (DST. 1982). Such measures have been successfully implemented along the river slopes in Thunder Bay.

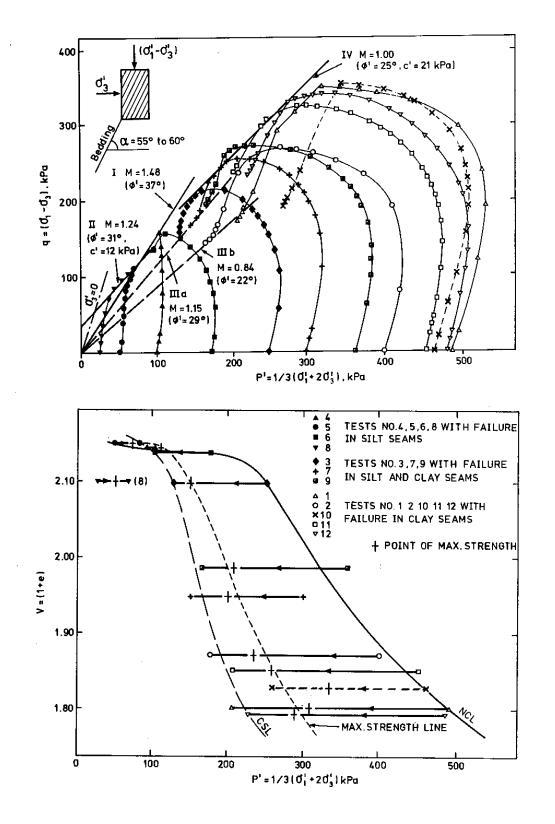
Strength tests, direct shear tests, as well as consolidated isotropical undrained (CIU) triaxial tests with pore-pressure measurements, indicated significant effects of the varved structure on the stress-strain behaviour of the clay (Eigenbrod and Burak, 1991). Different strength parameters were observed depending on whether failure occurred across or parallel to the varves. The failure modes for shear parallel to the varves depended also on the stress levels applied. (See Fig. 4) This behaviour is similar to observations reported for New Liskeard varved clays by Lacasse and Ladd (1977) who termed it "double envelope concept." At low consolidation pressures, below the preconsolidation load of 200 kPa, the specimens generally sheared along the silt seams of the varved clay, indicating that the silt was weaker than the clay at low confining stresses. Dilation resulted in B-values less than one. Slightly anisotropic elastic deformation behaviour with lower stiffness in the horizontal than in the vertical was indicated, for some specimens almost up to the points of failure. The overconsolidated shear strength was characterized by c' = 12 kPa and $\phi' = 31^{\circ}$, the critical-state shear strength for the overconsolidated specimens by c' = 0 and $\phi' = 37^{\circ}$.

At high stress levels, above the preconsolidation load, specimens sheared largely in the clay seams or sometimes in both, clay and silt seams. Anisotropic elastic behaviour was indicated during initial shear. From the pattern of stress paths and low initial porepressure responses it can be assumed that consolidation of the clay seams occurred initially during undrained shear due to internal dissipation of pore pressures into dilating silt seams. A cohesion intercept that was obtained for the normally consolidated clay specimens can be related to carbonate cementation of the varved clay. The critical strength parameters for the normally consolidated varved clay are c' = 0 and $\phi' = 22-29^{\circ}$.

The low initial pore-pressure responses during shearing might explain why slopes in varved Fort William Clay are relatively stable and so far have not exhibited any liquefaction failures. The low horizontal stiffness for varved Fort William Clay might be responsible for large lateral movements that had been observed in the clay for many harbourfront structures in Thunder Bay.

Fig. 4 Fort William Clay (Site 1). Undrained, effective stress paths in q-p' and V-p' space for shear along bedding planes.

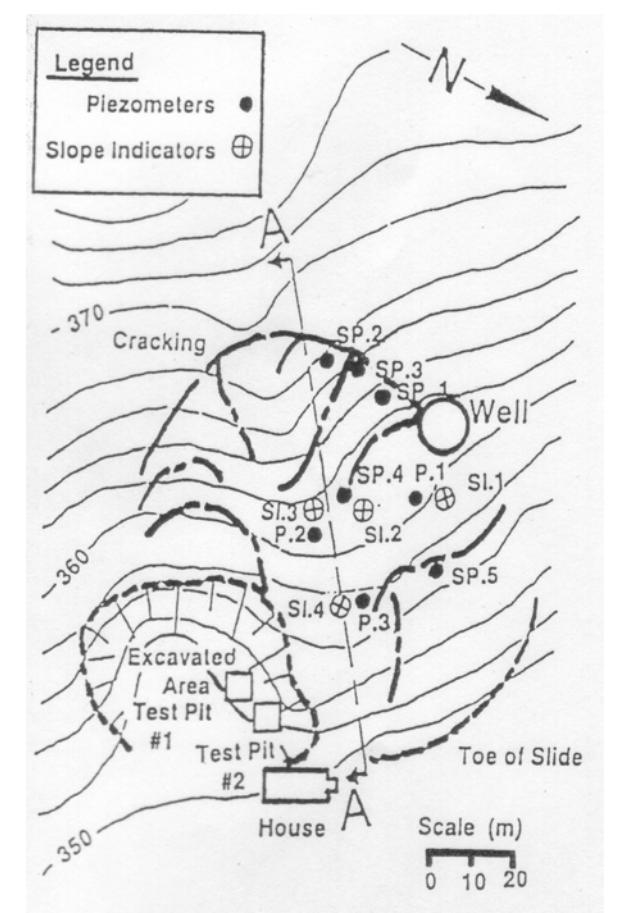
The slide which has exhibited slow, recurrent movements towards the residential building (see Fig. 6) will be presented in this paper. The slide is located along a northeast-facing slope with an average inclination of 3.5 (horizontal) to 1 (vertical). It was reported that material had to be removed periodically from the toe of the slide to protect the building at the base of the slope from the moving soil masses. Fortunately, the movements towards the building slowed down considerably after a pit was excavated by the owner into the slope portion just south of the building through the red clay into the underlying sand deposits. Subsequently, the overlying red clay has been slumping into the cut, redirecting the thrust of the movements away from the building towards the cut. In the area of the slide the clay is about 7-10 m thick. Some seepage was noticed occasionally in the fractured red clay during early summer, whereas the underlying sand never exhibited any free water. A 5 m deep water well located about halfway up the slope and entirely within the red clay has been drawing water almost continuously for more than 20 years. This well had to be reset twice since its initial installation in 1978 due to the ongoing slope movements. The surface of the slide area is dissected by numerous open cracks, further indicating continuous ground movements. A clearly defined toe could be recognized near the bottom of the slope, where the moving soil mass had overridden the underlying stable ground.

Fig. 6 Shallow slides in upper Kaministiquia River valley (Site 2). Site plan of slope failure investigated.

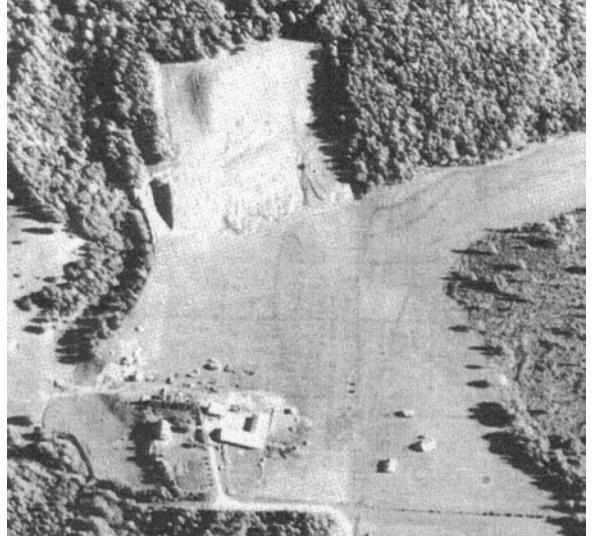
Shallow ground movements can be commonly observed on grassy slopes of the Upper Kaministiquia River valley (Site 2 on Fig. 2), whereas forested slopes appear stable unless they are undercut by natural or man-made causes (Eigenbrod and Kaluza 1999). The slope failures occur in the red high-plastic clays of the area which typically are underlain by massive clean sand and gravel deposits. The slides are characterized by generally well defined boundaries, (See Fig. 5) indicating that the slope failures were initiated in the grass-covered slopes, after they had been cleared of the original forest cover. To date, only two slides impacted on human development: one slide has been infringing on a residential building and its water supply, and another slide is the cause for continuous movements along an embankment of the Trans-Canada Highway.

Fig. 5 Shallow slides in upper Kaministiquia River valley (Site 2). Air photo of typical slide.

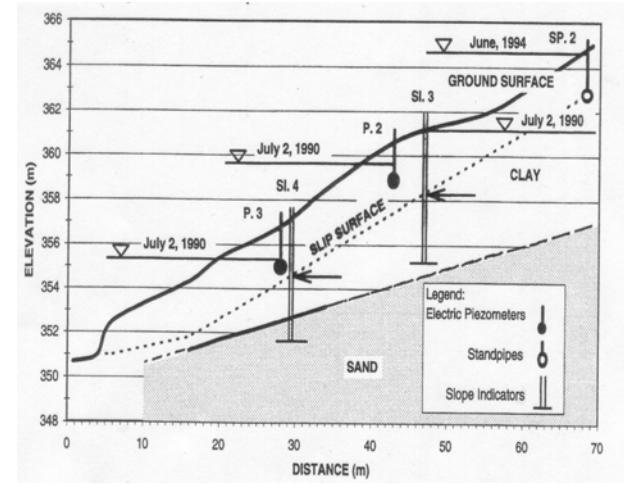
The surficial red clay is a homogeneous, highly plastic silty clay with a liquid limit ranging between 50 and 78% and a plasticity index between 26 and 46%. In the upper 2-3 m the clay is slightly overconsolidated and intensely fractured due to desiccation and frost action. It is medium stiff at a water content between 30 and 35%. Effective strength parameters obtained for the surficial clay portions from consolidated, drained direct shear tests varied between $\phi' = 28^{\circ}$ and 32° at a cohesion $c' \cong 0$, indicating fissured or fully softened conditions (Skempton 1970). In the excavation at the base of the slope occasionally a low-plastic, layered, cemented silt was found between the red clay and the underlying grey sand. The sand is a very clean, fine-tomedium-grained material with a silt content of less than 2%. The sand was found to be guite dense, with a moisture content of less than 5%. Well-defined crossbeddings which were apparent in the excavation can be referred to its fluvial origin. Slope indicators installed in the slope identified shallow intermittent ground movements in the fractured upper zone of the clay deposit (See Fig. 7). This fractured upper clay zone represents a shallow aquifer which is separated by the unfissured lower clay zone from the underlying sand deposits. In-situ permeabilities of the fractured clay were measured to $10^{-6} - 10^{-7}$ m/s. The shallow fractured clay zone provided a reasonably reliable supply of water over a period of more than 20 years, even though it was recharged largely by surface water infiltration.

During the observation period from 1989 to 1994 piezometric pressures in the upper fractured clay zone typically reached maximum values in early summer, at the same time when ground movements were identified. The back analysis of slope movements (using a pore-pressure coefficient $r_u = 0.5$) indicated reactivated movements at fully softened strength conditions (c' = 0, $\phi' = 30$)°. Since fully softened strength rather than residual strength is governing the present movements, it can be assumed that shear movements have not been sufficiently large for the development of residual shear strength and therefore must have been initiated relatively recently.

Fig. 7 Shallow slides in upper Kaministiquia River valley (Site 2). Geological section of slope with location of slip plane.

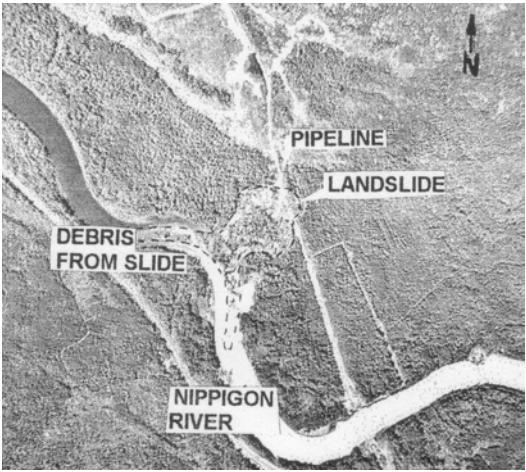
The Nipigon River landslide is a retrogressive slide which occurred in soft sensitive glaciolacustrine deposits along the Nipigon River north of the town of Nipigon (See Fig. 1) on April 23, 1990. The Nipigon River flows south from Lake Nipigon into Lake Superior. Along the course of the river a number of hydro power plants are operated by Ontario Hydro, resulting in operational river level fluctuations.

The slide started at the river bank and extended uphill for about 350 metres with a maximum width of approximately 280 metres. The soil movements were completed within a period of 3 hours, after they severed a fibre optic telephone cable and displaced a gas pipeline laterally by about 8 metres over a length of 75 metres without rupture. The force of the landslide moved debris by about 300 metres upstream and downstream (See Fig. 8), suggesting maximum velocities in the order of 25 km/hr. The temporarily increased silt load in the Nipigon River disrupted the residential water supply further downstream and affected the local lake-trout fishery. Apart from the large 1990 slide discussed here, many smaller slumps and erosion features have been observed along the river banks. No other retrogressive slides of similar extent have been reported in recent history, however, air-photo studies indicated that similar sized landslides had occurred before.

Fig. 8 Nipigon River landslide (Site 3). Air photo of area.

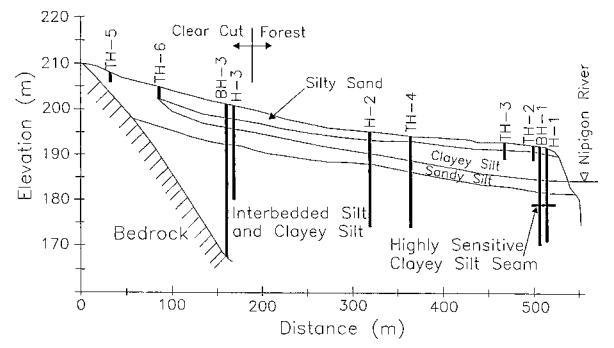
The soil-stratigraphy and the piezometric conditions as delineated from testholes and piezocone testing (Eigenbrod, 1998) are summarized on the geological section Fig. 9. Four distinct soil strata can be identified, dipping gently towards the river. Of particular importance is the sandy silt layer which extends continuously from the uphill rock outcrop to the river bank and probably acts as an aquifer or subsurface drainage for the area. In the upper slope portions the sandy soil layers contain less fines (less than 10%) and are more pervious then in the lower slope where the fine content goes up to 70%. Therefore, surface water from the upper slope portions which infiltrates into the sandy surface layer, may flow into the interconnected lower sandy silt stratum.

Fig. 9 Nipigon River landslide (Site 3). Geological section of slide.

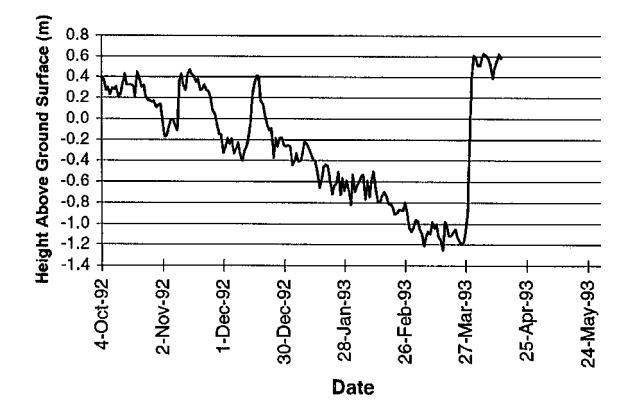
Piezometric Head at 2.4 m Depth at Location TH6

The groundwater conditions at failure are not known, but can be estimated from the piezometric pressures recorded subsequently between May 1990 and September 1993. A general decrease in pore water pressure was observed during the winter months and maximum values in spring and early summer. A sudden rise in piezometric head by 1.8 m within less than a week could be recognized in the upper slope at the end of March 1993 (See Fig. 10). Temperature measurements identified that the ground in the deforested upper slopes was thawed out about two months earlier than in the lower-lying forested slope portions, thus permitting early infiltration of surface water into the ground.

Fig. 10 Nipigon River landslide (Site 3). Pore water pressures at TH6 between Oct. 1992 and April 1993.

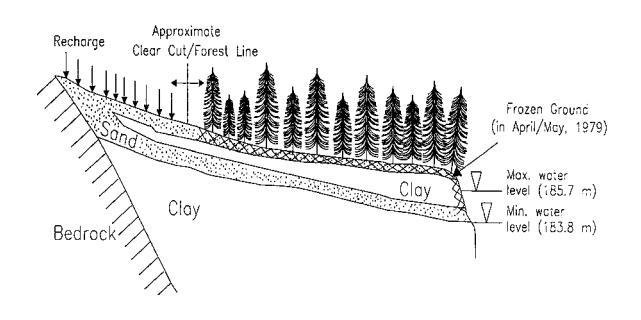
It could be demonstrated (Eigenbrod, 1998), that the retrogressive landslide which occurred in the soft sensitive glaciolacustrine deposits along the Nipigon River in April 1990, was associated with elevated pore water pressures in the slope, which were caused by increased recharge in the upstream slopes and restricted discharge in the lower slopes (See Fig. 11). From a FEM analysis of the flow-conditions in the slope it was concluded that a sudden pore pressure build-up uphill led to pore pressure increases further downhill with maximum pore pressures occurring one month later. In a total-stress FEM analysis a zone of elevated shear stresses could be identified at 6 to 8 metre depth as a result of unloading from the initial slope failure at the river bank. An effective stress evaluation indicated that for the elevated pore water pressures identified in early spring, together with the elevated shear stresses, a potential for liquefaction existed in the lower sandy silt layer, which lead to the retrogressive land slide observed in April of 1990. The potential for failure was not apparent at pore pressures which most likely were valid prior to deforestation of the upper slopes.

Fig. 11 Nipigon River landslide (Site 3). Schematic presentation of slope section with condition leading to high ground water levels at failure.
