Construction of a composite barrier wall/rock shed structure at mile 109.43 of CNR's Ashcroft Subdivision

Tim Keegan, Bruce Willoughby

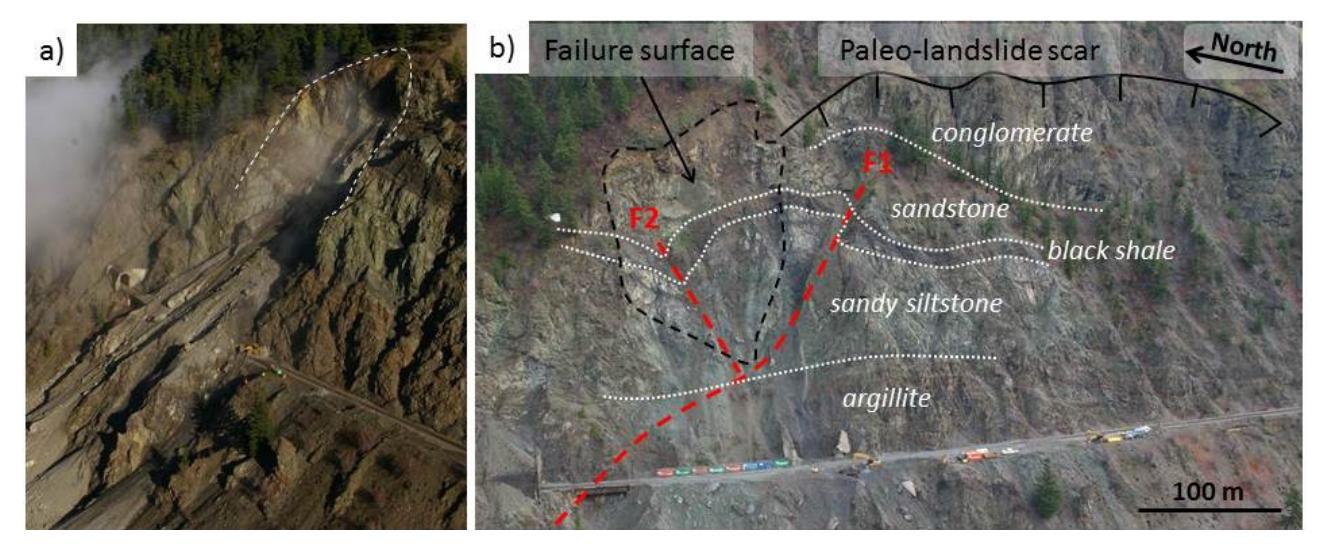
On November 25th, 2012 a 53,000 m³ rockslide occurred along the Canadian National Railway (CNR) track, at Mile 109.4, between Lytton and Boston Bar, British Columbia (Figure 1). The slide covered 70 m of track with up to 10 metres of debris, destroyed a 21 m long concrete rock shed located at the base of a gully with raveling debris, and caused a 4-day service disruption (Figure 2a).

Geomorphological observations highlighted that the rockslide event occurred within the boundary of a paleolandslide, the upper side of the rockslide corresponding to the prolongation of the paleo-landslide scar. Geological and structural mapping revealed the presence of both small scale folds and local faults (F1 and F2) in the sedimentary layers. In addition, the site is located in the vicinity of the major Fraser River Fault. One of the two local faults marks the northern part of the November 25, 2012 rockslide scar (Figure 2b).

Figure 2 November 25, 2012 rockslide. (a) View just after the landslide; (b) post-slide view illustrating the geology of the site, the location of the failure surface, the paleo-landslide scar and faults F1 and F2.

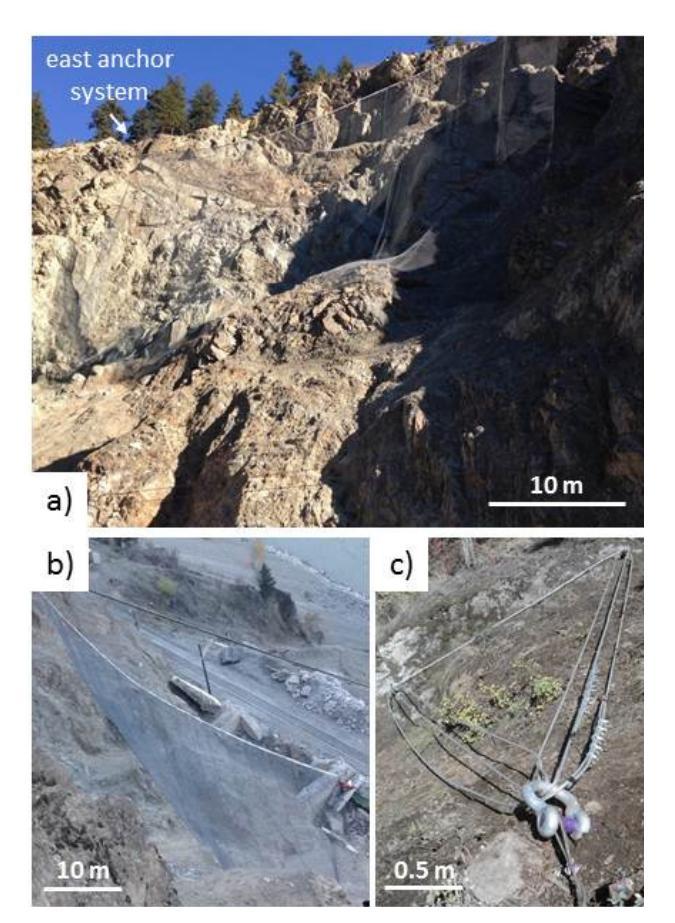
The 60 m wide and 30 m high mesh curtain was installed across the rockslide area in order to protect the rock shed construction site from rock falls (Figures 3a and 3b). This system was intended to guide the rock fall trajectory under a tail drape, minimizing block bouncing movement and dissipating kinematic energy.

The mesh curtain consists of a Geobrugg TECCO high tensile steel mesh connected to a 1" support cable with hooks. The mesh cable is attached to anchor systems on each side; the anchor systems are composed of two and three anchors at the east and west ends respectively, and of cable arrangements allowing even distribution of the load to each anchor (Figure 3c). Pulleys were also installed at locations where the mesh cable changes direction.

Figure 3 Mesh Curtain. (a) View of the curtain across the rockslide area; (b) View from the location of the east anchor system; (c) East anchor system composed of two rock anchors, the cables and the shackle connecting to the main mesh cable.

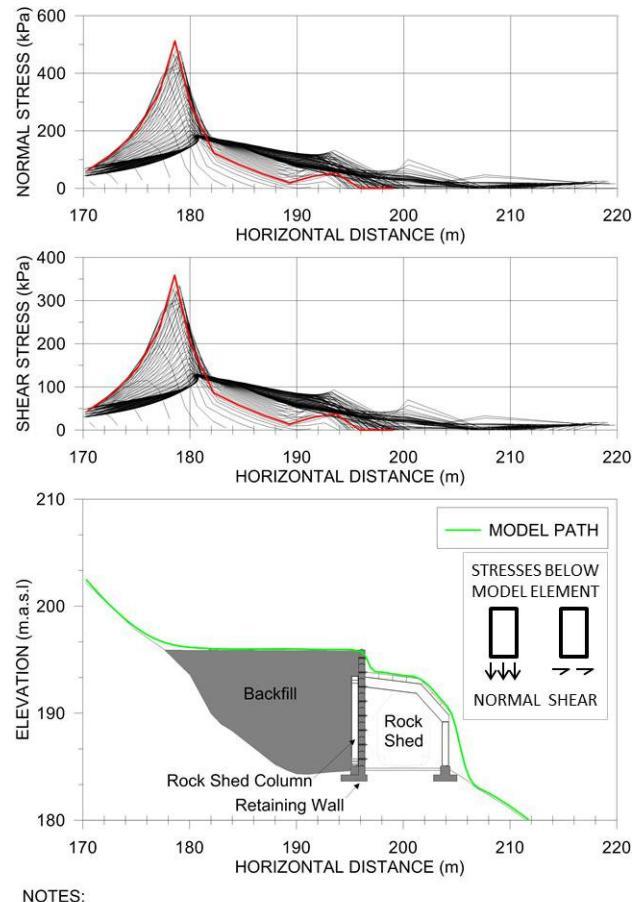
1) PLOTS SHOW TIME STEPS AT 0.1s INTERVAL UP TO 20s MODEL TIME. 2) RED LINE INDICATES TIME STEP WITH PEAK NORMAL STRESS.

Figure 4 DAN-W analyses. The top two figures are DAN-W results for normal stress and shear stress. The bottom figure shows the proposed composite barrier wall/rock shed structure.

The software allowed computation of centrifugal acceleration for each sliding mass element (i.e. element velocity squared/ vertical curvature radius of path). Results showed that peak normal and shear stresses are sensitive to sharp terrain breaks (i.e. changes of the slope of the terrain), due to centrifugal forces generated by the moving mass (Figure 4). Peak stresses occurred in the frontal part of the rock avalanche. Stress magnitudes were sensitive to radius of terrain break and incoming velocity. These findings were used to optimize the design of the new composite barrier wall/rock shed structure to the loading from a rock avalanche hazard.

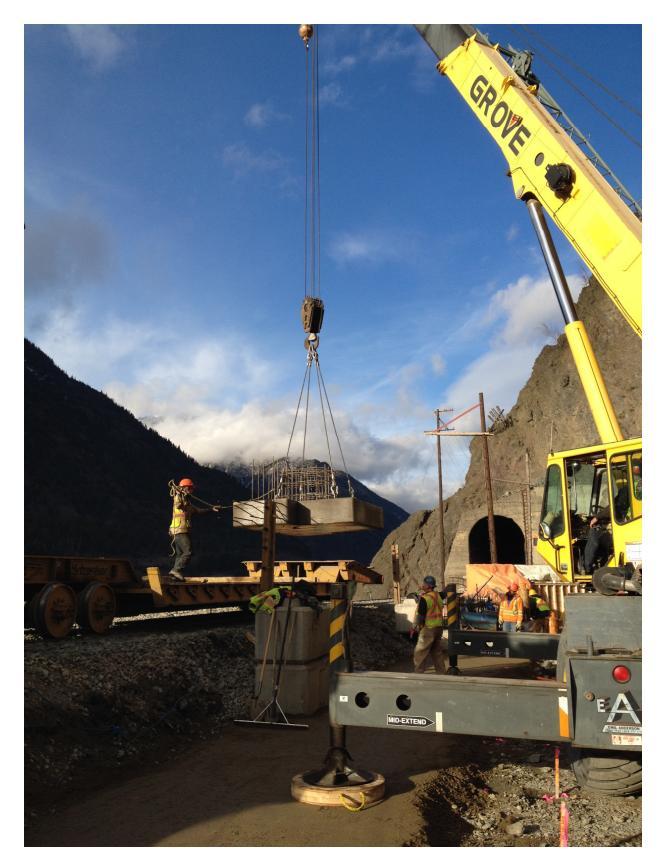
Figure 5 Installing one piece of pre-cast concrete footing along the upstream side of the rock shed.

One of the challenges of the construction of this composite structure along the railway track is to deal with the ongoing train traffic. Our design solution was to use modular components, such as barrier wall concrete panels and rock shed footings, which could be pre-cast and transported to the site (Figure 5).

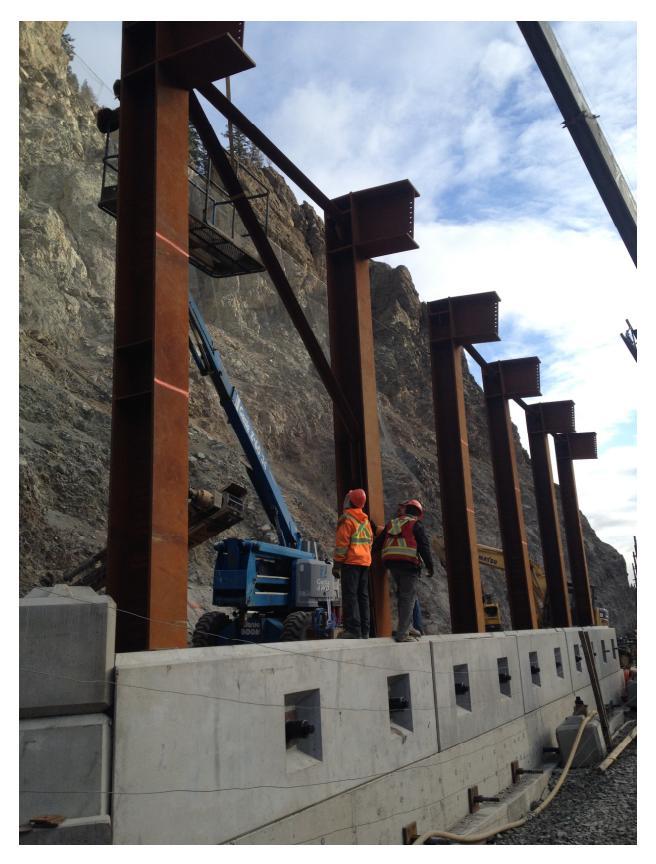
Figure 6 First row of modular pre-cast concrete panels tied back to the bedrock with rock anchors. Installing the bracing between steel columns.

The modular concrete components of the barrier wall were assembled and tied back to the bedrock outcrops using rock anchors (Figure 6). Gravel fill was used for backfill of the wall to absorb a large portion of the impact loads during a future rock avalanche.

Once the impact energy of a future failure is reduced, the rock shed structure is designed to allow the travel of the debris over its roof, down towards the river. It consists of pre-cast concrete footings, steel frames and concrete roof panels (Figure 6). On the downstream side of the structure, the concrete footings were tied with micropiles through the talus and heavily fractured bedrock.
