# RECONNAISSANCE OBSERVATIONS OF THE JULY 24, 2007 ROCK AND ICE AVALANCHE AT MOUNT STEELE, ST. ELIAS MOUNTAINS, YUKON, CANADA

A catastrophic rock and ice avalanche occurred on the north face of Mount Steele, Yukon Territory, on July 24, 2007, depositing debris onto Steele Glacier. In the days and weeks preceding the event, at least three smaller landslides initiated from the same slope. Earlier landslide activity at this location is evident on historical photographs dating back to the 1930s. The July 24 event was one of the largest rock avalanches documented in the St. Elias Mountains in the past century and is one of 16 rock avalanches known to have occurred from rock slopes adjacent to glaciers in the Canadian Cordillera since 1947. Seismic records indicate that it lasted approximately 100 seconds and had a long-period surface-wave magnitude of 5.2. We have initiated research to study the morphology of the landslide deposits, the causes and mechanisms of failure, and impacts on glacier mass balance. Our work highlights the value of multi-disciplinary cooperation for investigating catastrophic events.

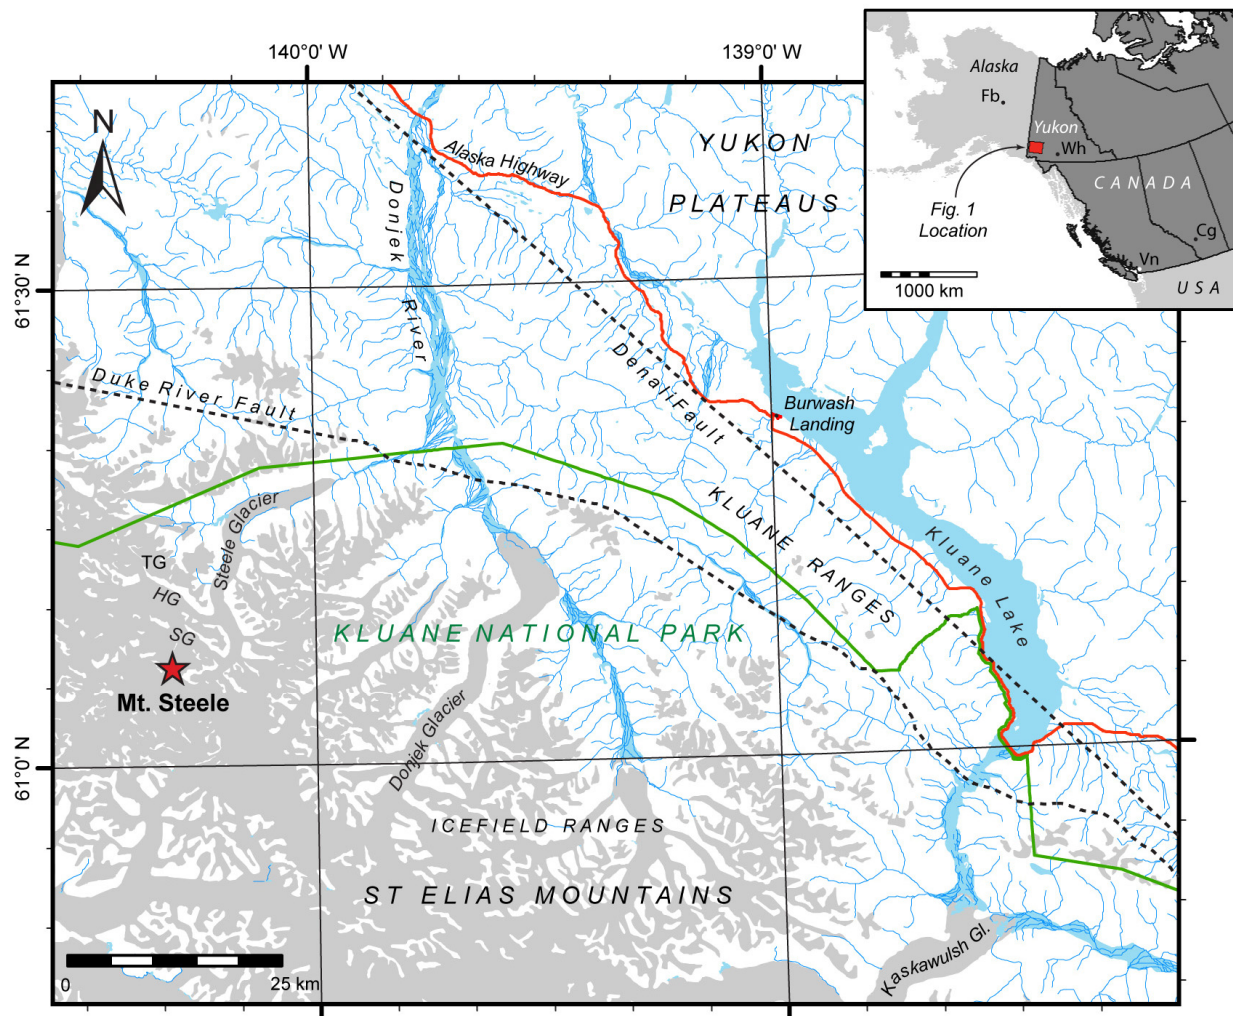
Figure 1. Map showing location of Mount Steele and major physiographic features. SG = Steele Glacier, HG = Hodgson Glacier, TG = Trapridge Glacier. Selected cities shown in inset map (Wh = Whitehorse, Vn = Vancouver, Cg = Calgary, Fb = Fairbanks).

Mount Steele ( $61^{\circ}05'35.4''\text{N}$ ,  $140^{\circ}18'38.4''\text{W}$ , 5067 m a.s.l.) is the fifth highest mountain in Canada and the tenth highest peak in North America. It is located in an uninhabited region of southwest Yukon Territory, in Kluane National Park (Figure 1). The mountain lies within the Icefield Ranges of the St. Elias Mountains, in an area of extremely rugged, snow- and ice-covered mountains that are surrounded by broad valley glaciers.

The Alaska Highway crosses Donjek River about 40 km downstream from its confluence with Steele Creek (Figure 1). The highway is Yukon's main transportation corridor and parallels a proposed natural gas pipeline that would deliver gas from the North Slope of Alaska to markets in the conterminous United States. The nearest settlement to Mount Steele is Burwash Landing (807 m a.s.l.), which is located 76 km northeast of the peak.

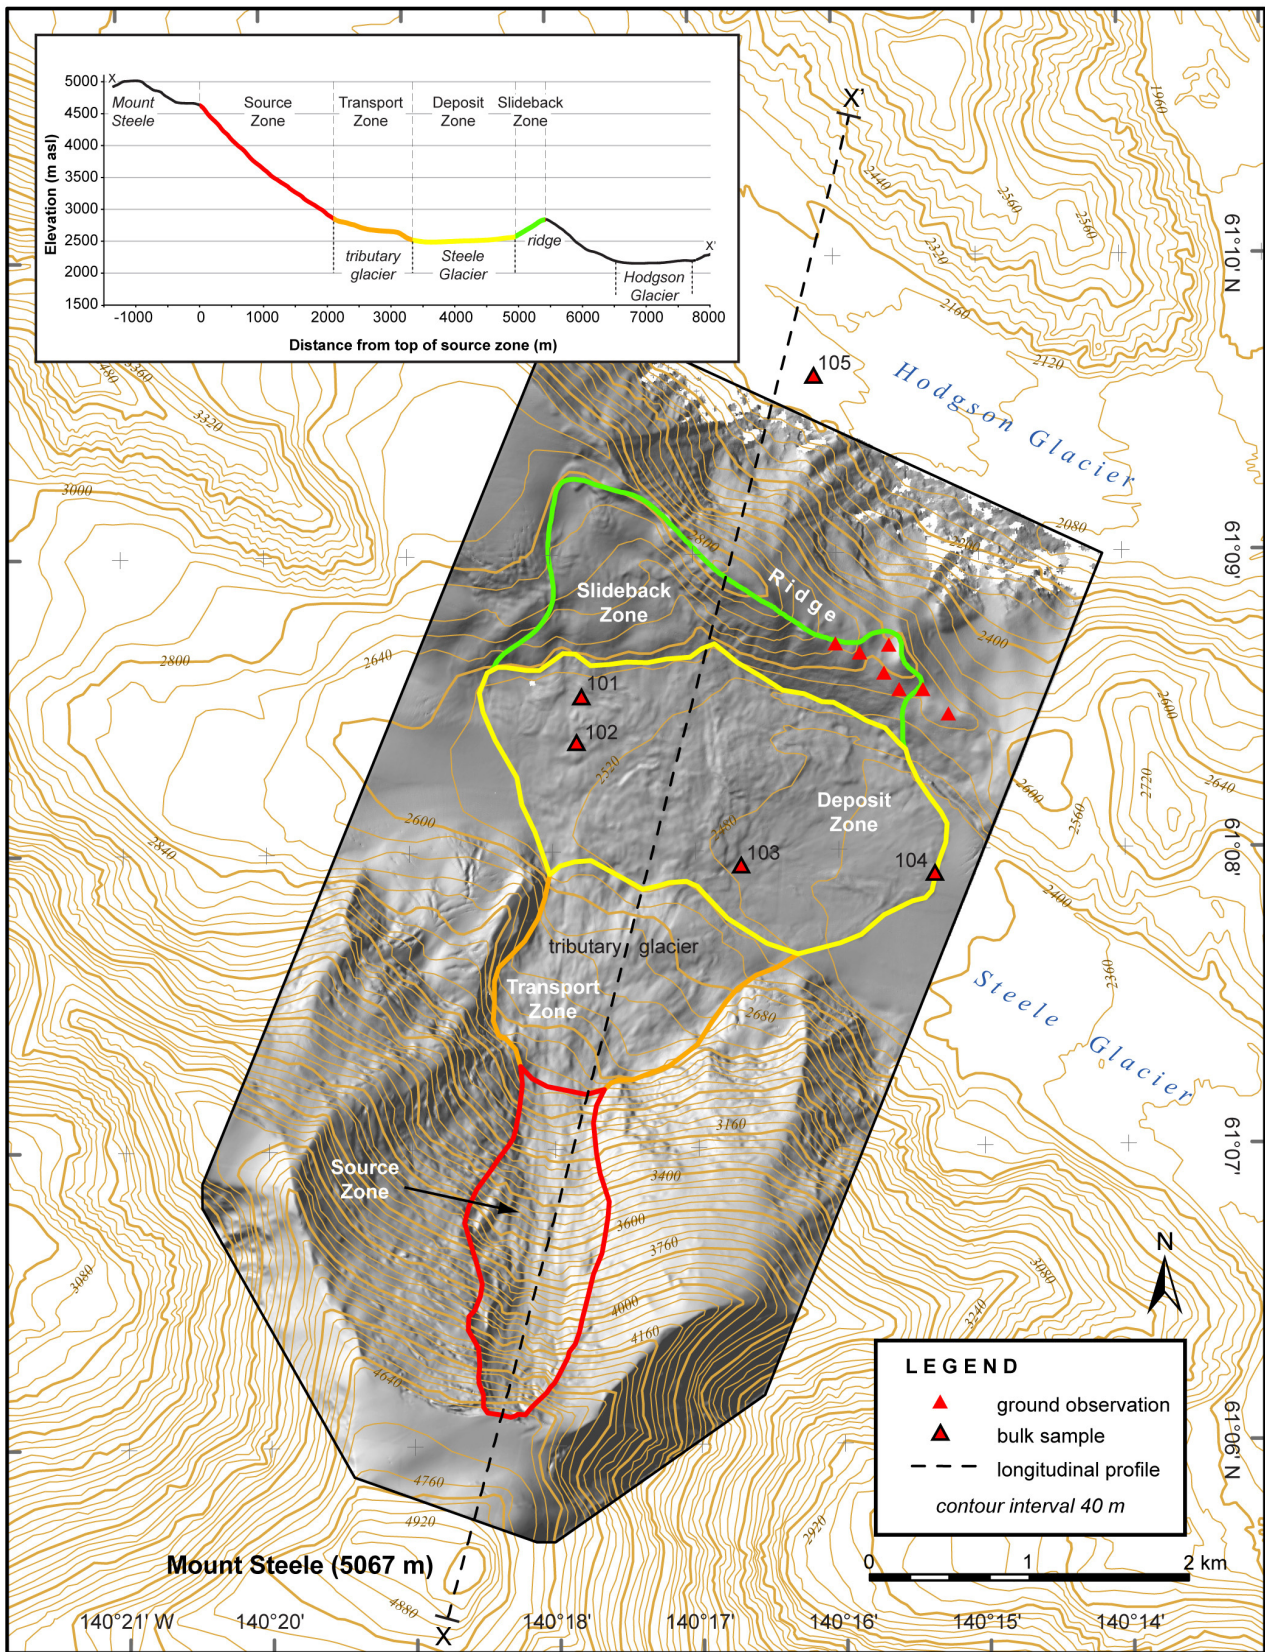
Figure 2. Map of the July 24 rock and ice avalanche site. Hillshade image derived from LiDAR survey data. Contours are generated from 1951 aerial photography (source: National Topographic Database, Natural Resources Canada). Inset shows longitudinal profile along line X-X'.

Due to the extreme ruggedness of the terrain and ongoing landslide risk, detailed ground examination of the source and debris zones was not possible. Nonetheless, the landslide source area and deposit zone were precisely delineated using the LiDAR survey data, together with the GPS survey data and 1:50 000-scale digital national topographic data (Figure 2).

The main event initiated at 4650 m a.s.l. on the north face of Mount Steele, just beneath the edge of a bench about 400 m below the summit (Figure 2). The prominent, curved main scarp is up to 540 m wide. Below the main scarp, a steep gullied slope with an average gradient of  $44^\circ$  descends 1750 m in elevation to a small tributary glacier that flows into Steele Glacier (Figure 2). The entire slope from the main scarp down to the tributary glacier was the source of the rock and ice that failed in the main event.

Some of the coarse avalanche debris reached the crest of, but did not overtop, the 275 m high ridge on the north side of Steele Glacier. This material descended back down onto Steele Glacier in a process we refer to as “slideback” (akin to fall back described by Heim in 1932) (Figure 2). This led to significant thickening of the avalanche deposits at the base of the ridge (Figure 4a).

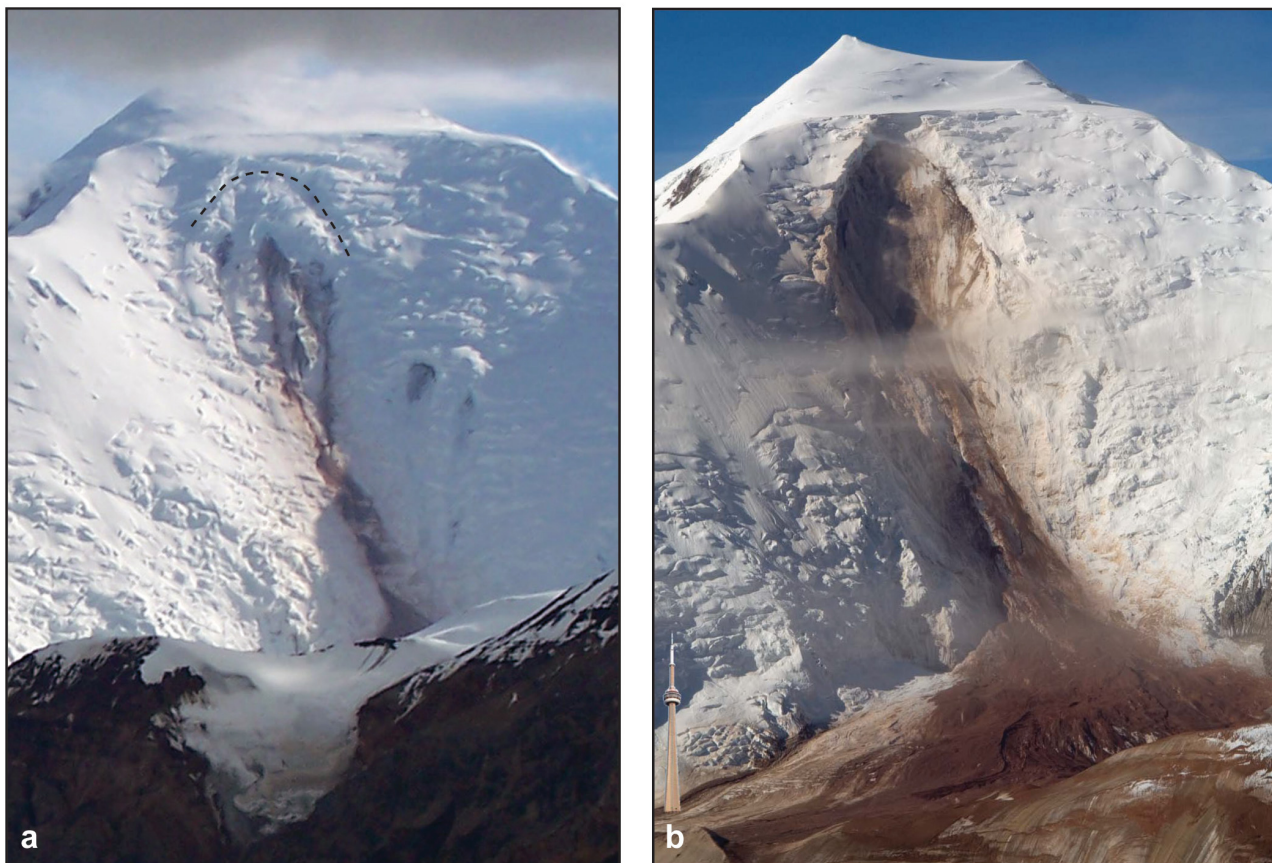
Figure 3. The north face of Mount Steele, showing the location of the rock and ice avalanche source zone. (a) Photo taken on July 14, 2007, showing fresh debris from small landslides that had recently occurred in gully system. Also note large crevasse (dashed line) above gully system, outlining slab of ice that failed on July 22, 2007 (photo by A. Schaeffer). (b) Source zone scar produced by July 24 main event. Note CN Tower (553 m tall) superimposed for approximate scale (photo by P. von Gaza, August 2, 2007).

On July 22, at approximately 13:25 h local time (Pacific Daylight Time), the glaciologists at Trapridge Glacier witnessed a large ice avalanche that initiated when a slab of ice broke away from the north face below the crevasse noted a week earlier (Figure 3a). The slab rapidly fragmented as it descended the steep slope, and the avalanche deposited ice and snow over approximately 2 km<sup>2</sup> of Steele Glacier. At the leading edge of the avalanche, a plume of fine airborne ice and dust particles climbed the 275 m high ridge on the far side of Steele Glacier and traveled down to and across Hodgson Glacier, a total distance of at least 8 km (Figure 2). During aerial surveys flown over the next two days, the debris was estimated to consist of 5% rock and 95% highly fragmented ice and snow; no large fragments of ice or rock were observed.

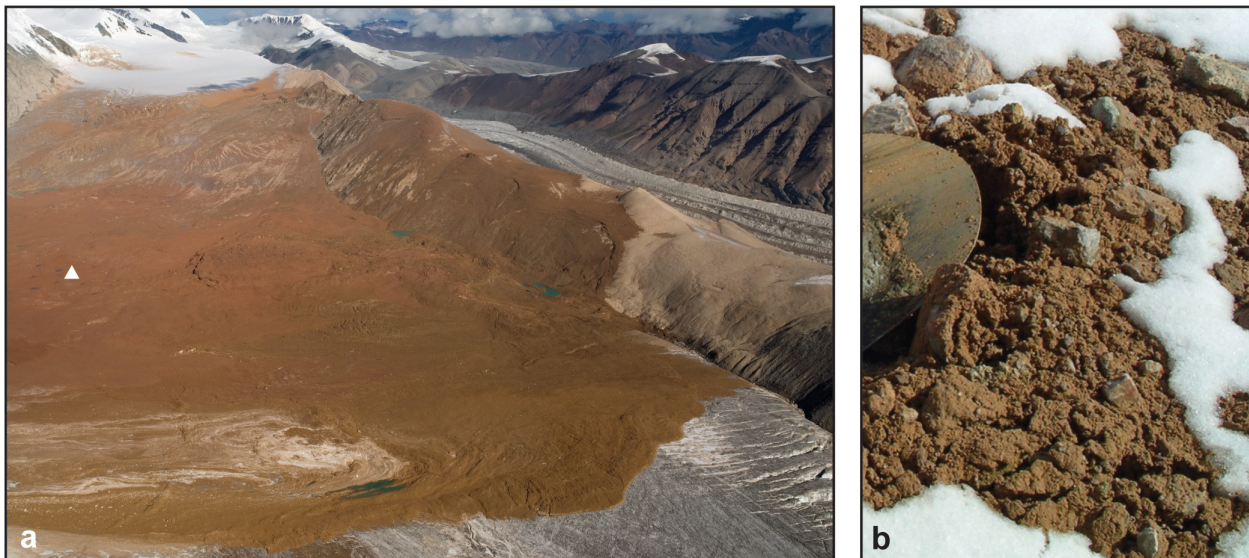
Figure 4. Debris deposited on Steele Glacier by the July 24 rock and ice avalanche. (a) View to northwest, showing ridge that impeded runout and caused slideback of material onto Steele Glacier (photo by P. von Gaza, August 2, 2007). (b) Surface of debris sheet at bulk sample site 102 (approximate location shown with white triangle in photo "a"). The fine texture of the debris is typical of the entire deposit (note standard shovel blade for scale) (photo by P. Lipovsky, August 12, 2007).

The July 24 deposit is much finer than typical rock avalanche deposits (Figure 4b). This, in combination with the aforementioned physical characteristics of the rock fragments in the debris, suggests that the source rock mass was intensely fractured before it failed. Only scattered boulders were observed in aerial surveys of the debris, and none of these was larger than 3 m across. Several large ice blocks, up to 2 m across, were also observed near the crest of the ridge separating Steele and Hodgson glaciers. The solid portion of four bulk samples collected on August 12 average 62% coarse fragments (>2mm), dominantly of pebble size. The remaining fine-grained material consists, on average, of 72% sand, 20% silt, and 8% clay.

Seven to 35% of the bulk sample mass was water, which is assumed to represent snow and ice that was incorporated into the avalanche. Although no surface water was visible within the debris sheet on photographs taken the day after the main event, numerous small ponds had developed in and adjacent to the debris sheet by August 2 (Figure 4a).
