Explicit estimation of rock slope failure likelihood for hazard assessment and safety engineering near Canmore, AB

Renato Macciotta, Chris Grapel, Jason Duxbury & Tim Keegan
Klohn Crippen Berger, Edmonton, AB, Canada
Roger Skirrow
Alberta Transportation, Edmonton, AB, Canada

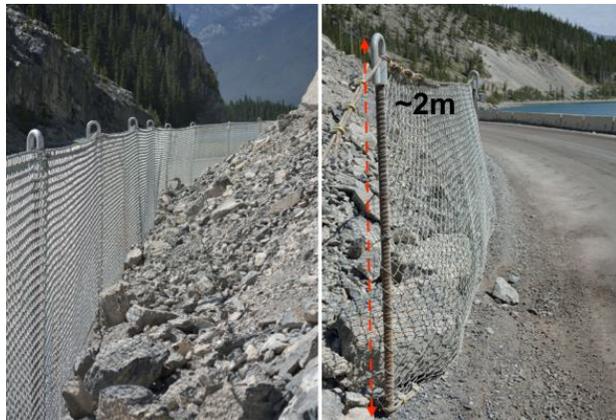
Figure 6. accumulation of rock debris contained by existing 2m-high fence at sector D and E in Figure 2

Blocks at the toe of the talus slope varied from weathered, sub-angular blocks to fresh (no to imperceptible weathering), angular blocks. These fresh, angular blocks were considered to have detached from the rock face within the last 3 to 5 years. Some angular, fresh blocks, equal and less than 0.3 m in equivalent diameter were found adjacent to the highway (between the roadway and the talus slope and east of the road, adjacent to the barrier at the lake side - Figure 5). A subset of these blocks could be blocks that have been encountered on the road and have been moved to the side of the road. Between 40 and 60 rock blocks (estimated) with equivalent diameters between 0.3 m and 0.6 m were found to have been contained by the existing 2m high catch fence (downslope sectors D and E – Figure 6). These blocks would have travelled downslope to the road surface if not for the catch fence.

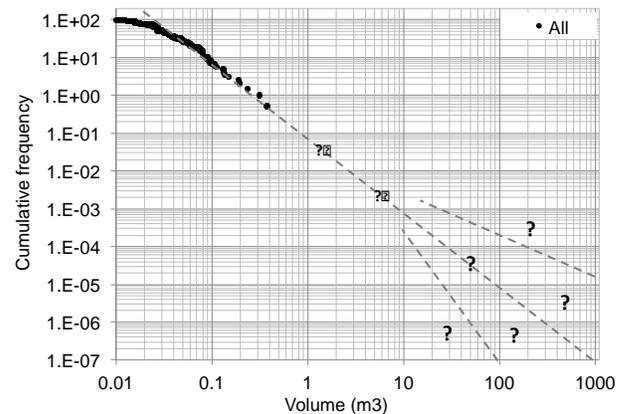
Figure 10. Cumulative frequency of blocks reaching the highway

assumption that rock blocks reach the highway almost daily at the S042 between February and June, with a few occurrences (once or twice a month) the rest of the year. This would equate to approximately 100 blocks equal or smaller than 0.3 m³ each year reaching and potentially blocking the highway at Site S042. This information was used to produce the cumulative frequency plot of rock falls reaching the highway (Figure 10).

There is much uncertainty regarding extrapolation of the best fit lines in Figure 10 to volumes over 10 and 100 m³. There are less than a handful of blocks visible at the S042 site that suggests failures larger than 100 m³. It can be argued that this is representative of the post-glacial activity of the slope (approximately 10,000 years), which would correspond to a frequency of 10⁻⁴ per year. These frequencies are only crude estimates of past activity, and current slope deformation processes and level of rock mass disaggregation need to be considered for estimating the likelihood of failures larger than 100 m³. This information, the field observations described and the frequencies in Figure 10 were used to elicit failure likelihoods and estimate probabilities for different ranges of

rock slope failure volumes reaching and potentially blocking the highway. These are summarized in Table 3. Likelihoods for rock fall volume ranges are calculated from Figure 10 by subtracting the cumulative frequency of the upper volume boundary from the cumulative frequency of
