Case Study of the 1982 Rapid Reactivation of the Goddard Landslide along the Canadian Pacific Railway near Ashcroft, British Columbia

Kristen M. Tappenden
Thurber Engineering Ltd., Edmonton, Alberta, Canada
David F. Wood
David F. Wood Consulting Ltd., Sudbury, Ontario, Canada
C. Derek Martin
University of Alberta, Edmonton, Alberta, Canada

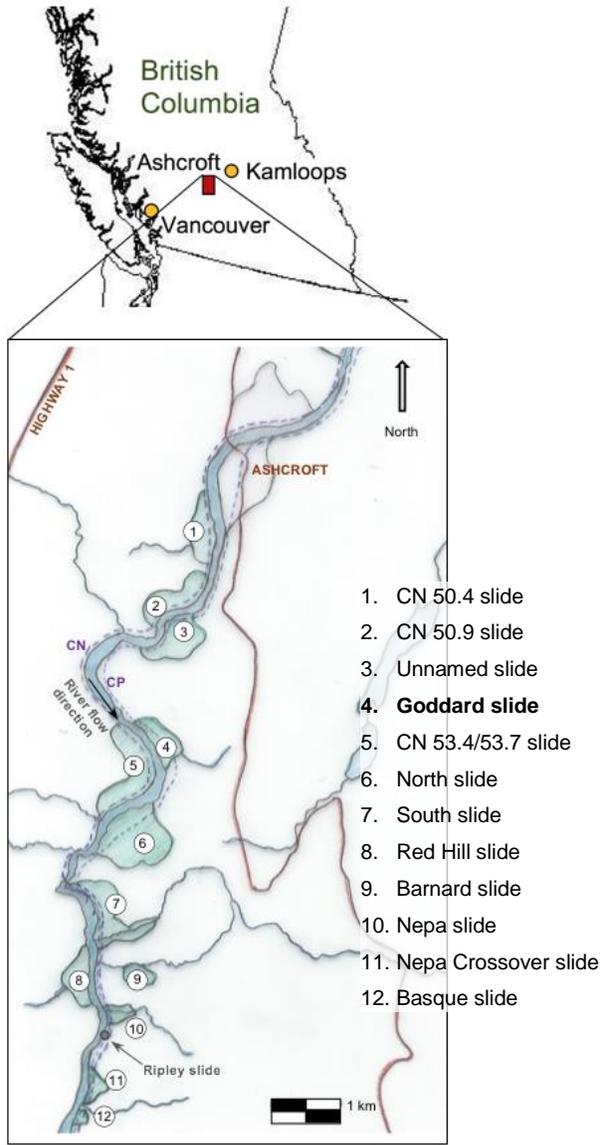
Figure 1. Map of the study area showing large landslides along the Thompson River Valley within approximately 10 km south of the village of Ashcroft.

Groundwater isotope testing, recently undertaken at the site of the smaller Ripley landslide (Figure 1), indicated that groundwater within the bedrock aquifer derives from a distal source (Tappenden 2017). Artesian porewater

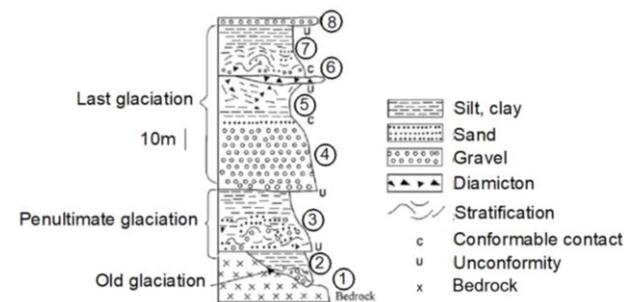
Figure 2: Generalized stratigraphy of Quaternary sediment fill in the Thompson River Valley at Ashcroft (modified from Clague and Evans 2003).

Hutchinson (1988) described compound slides as being of such geometry that failure is only made kinematically admissible by the development of internal displacements and shears, with the velocity of the slide reflecting the brittleness of these internal failures. Their geometry is otherwise locked in-place and generally reflects the presence of a heterogeneity, typically a weak layer (Hutchinson 1988)—in this case, the pre-Fraser glaciolacustrine sediments of unit 2 (Figure 2).

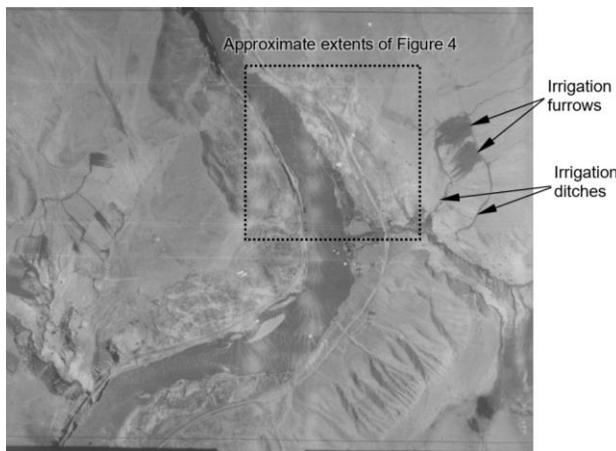
Figure 3: 1928 aerial photo showing the Goddard landslide and upslope ditch-and-furrow irrigation; National Research Council, roll A291 #55.

Red Hill Landslide (No.8) of 1921, and the Goddard Landslide (No.4) of 1982 (Tappenden 2016). Figure 3 displays the earliest aerial photo of the Goddard landslide, dating from 1928, with irrigation ditches and furrows still clearly visible above the slide.

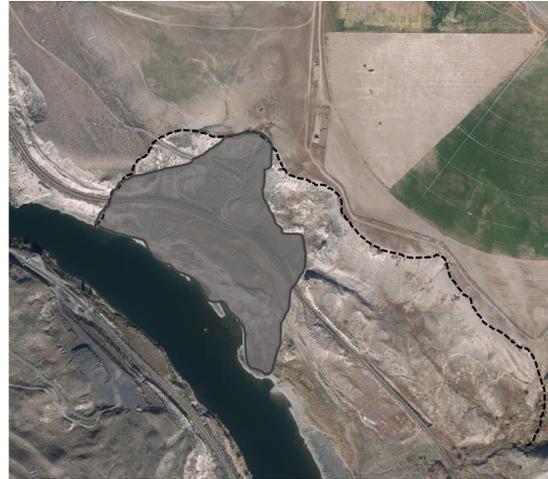
Figure 4: 2015 aerial photo of the Goddard landslide on the east bank of the Thompson River (courtesy of CN rail); shaded area corresponds to the limits of the 1982 reactivation (as per Eshraghian et al. (2007)), dashed line delineates broader extents of an older, possibly ancient landslide feature.

The volume of the 1982 Goddard landslide was approximately 2 Mm³ (Eshraghian et al. 2007). Figure 4 displays a 2015 aerial photograph of the Goddard landslide. The area that failed in 1982 is located within a larger, possibly ancient, landslide feature, as delineated by the dashed line (Brawner 1982, Wood 1982, Thurber Consultants Ltd. 1984). The landslide of 1982 occurred at the same location as a similar landslide in 1886, three years after the original construction of the CP track near the toe of the slope (Cambie 1895, Stanton 1898, Thurber Consultants Ltd. 1984).

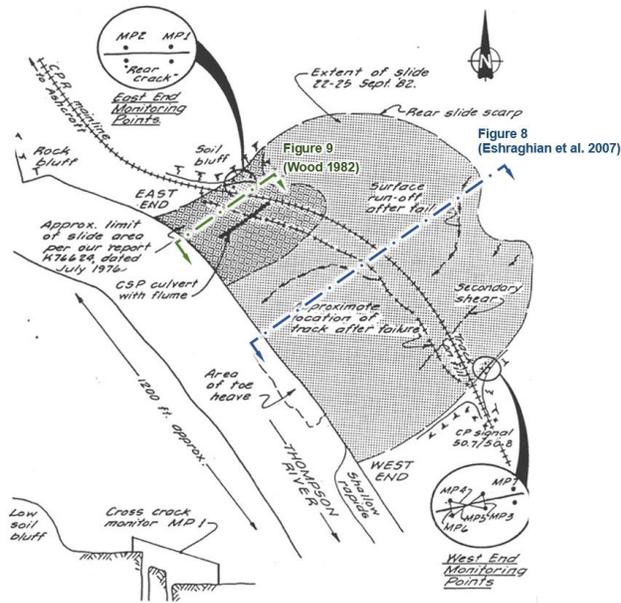
Figure 5: Sketch plan view of the 1982 Goddard landslide; note location of monitoring point MP-1 on the north flank of the landslide (modified from Wood (1982)).

Following a train derailment at the location of the Goddard landslide on September 23, 1982, Wood arrived on-site and began recording surface offset measurements from monitoring point MP-1, located near the railway tracks at the north flank of the landslide (as depicted in Figure 5) (D. Wood, personal communication, 2016).

Cruden (1974) suggested that when brittle materials reach a critical crack density, such that the cracks begin to intersect, the intersections grow at an accelerating rate and lead to failure (Cruden 1974). The Goddard landslide of 1982 was preceded by very/extremely slow slope movements in 1974 (Morgenstern 1986) and October 1976 (Golder Associates 1977, Morgenstern 1986, Porter et al. 2002), which produced surface cracking in the vicinity of the culvert shown in Figure 5 (Golder Associates 1977).

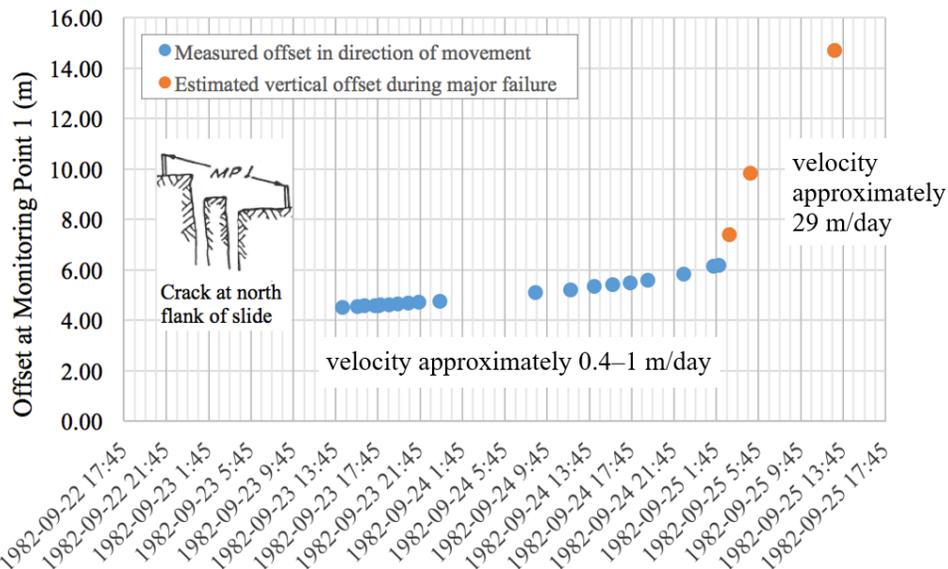
Figure 6: Cumulative surface displacement at north flank of 1982 Goddard slide, as determined from surface offset displacements recorded by Wood (1982).

Surface displacement measurements recorded by Wood (1982) beginning on September 23, 1982, indicated movement rates at the north flank of the slide (MP-1) were 24 to 40 mm/hour (0.44 to 0.95 m/day), as plotted on Figure 6. These accelerated to a maximum rate of movement in the early morning of September 25, 1982 of approximately 1.2 m/hour (29 m/day), based on vertical offset measurements made at MP-1. The offset measurements show a classic exponential form associated with the transition from decelerating to accelerating stages of deformation.

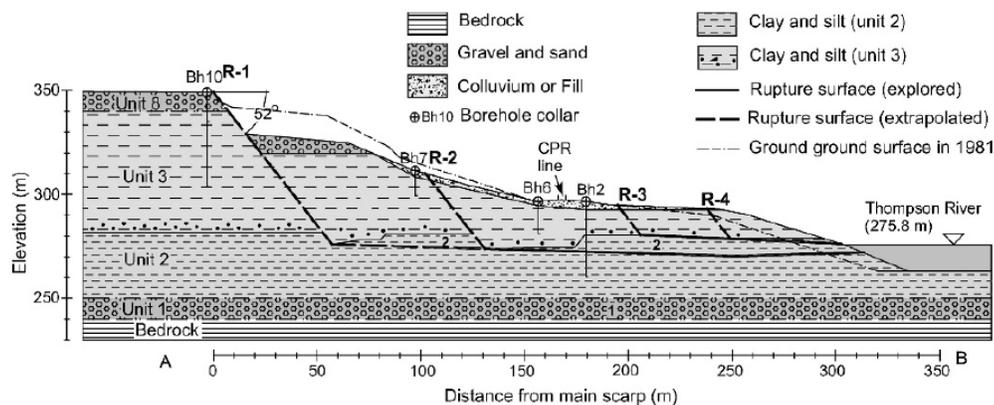
Figure 8: Simplified stratigraphic cross-section of the 1982 Goddard landslide, with pre-slide surface profile indicated by the dashed line (Eshraghian et al. 2007); location shown on Figure 5.

As depicted on a cross-section of the 1982 Goddard landslide prepared by Eshraghian et al. (2007) (Figure 8), the slope moved on two rupture surfaces as a multiple compound translational earth slide; the deeper rupture surface was located in the pre-sheared glaciolacustrine unit 2 deposits. The overlying unit 3, however, of which the main body of the slide was comprised, was described in borehole loggings as hard to very hard silt of low plasticity, with partings of fine sand and clay, having a high strength exhibited by Standard Penetration Test blow counts in the range of 42 to greater than 100 (refusal) (Klohn Leonoff Consulting Engineers 1986). There is a marked contrast between the hard, surficial silts of unit 3 comprising the slide mass, compared to the ductile, pre-sheared clay partings of unit 2 which form the bounding slip surface.

The travel angle of the Goddard landslide, based on the cross-section prepared by Eshraghian et al. (2007), was approximately 14 degrees (inverse tangent of scarp height to toe of the slide). This is within the range of residual friction angles of 10 to 15 degrees measured in ring shear laboratory tests on the unit 2 glaciolacustrine clays comprising the rupture surface (Bishop 2008). For a wedge of frictional soil sliding on a horizontal rupture surface with a water-filled tension crack at the rear, the stable slope angle is approximately equal to the internal friction angle of the soil; however, movement requires that the rear crack be filled with water such that cleft water pressures are exerted (Cruden 2003). Morgenstern (1986) was of the opinion that antecedent precipitation contributed very significantly to the magnitude of the 1982 slide, noting that substantial rain fell while the Goddard slide was in progress, and that the pressure of water-filled cracks likely contributed to the movements.

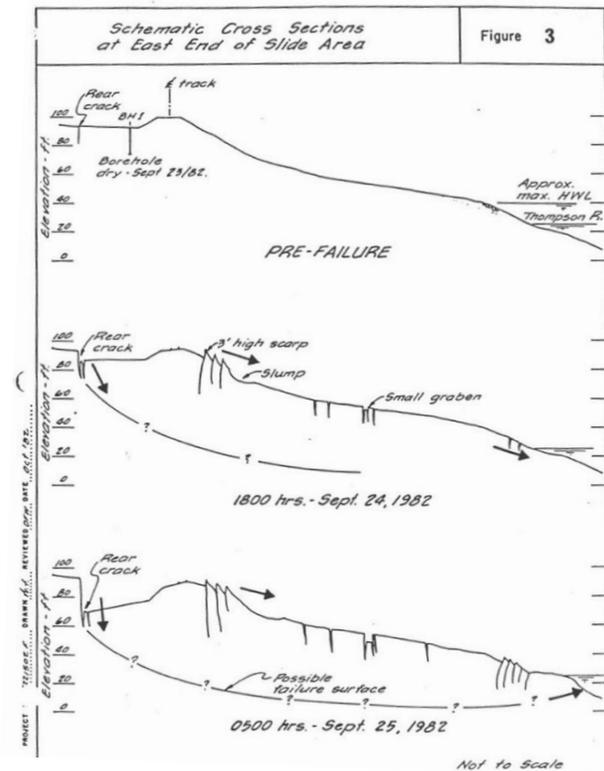
Figure 9: Schematic cross sections of the 1982 Goddard landslide before, during and after failure (Wood 1982); location shown on Figure 5.

A sketch of the Goddard landslide immediately prior to, and during, the 1982 reactivation was prepared by Wood (1982) based on his firsthand observations, and is presented in Figure 9. The slide has the characteristic features of a compound failure, with internal shearing of the slide mass evidenced by the numerous cracks forming scarps and grabens. David Wood (personal communication, 2016) recalled substantial internal deformation and “chaotic” behavior of the moving mass during the 1982 Goddard landslide. The rapid velocity of the 1982 Goddard landslide may have resulted from the brittleness of these internal failures.

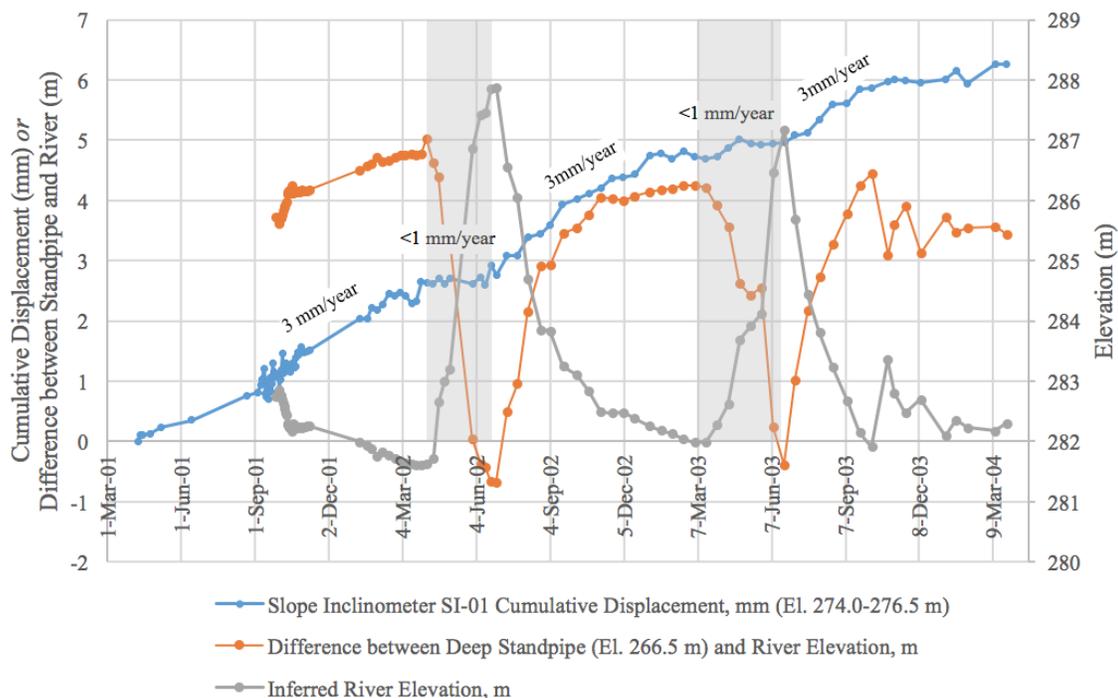
Figure 10: Relationship between CN 50.9 landslide displacement (deep shear zone, el. 266.5 m), Thompson River elevation, and deviation of bedrock pore pressure elevation from river level (Tappenden 2017). Figure prepared based on instrumental data provided by BGC Engineering Inc., with the permission of Canadian National Railway.

Rupture surfaces in the CN 50.9 landslide are located at 275.7 m and 280.9 m (Eshraghian et al. 2007). Incrementally higher rates of movement (3 mm/year) were recorded on the deeper rupture surface when the river was falling, as opposed to when the river was rising (<1 mm/year) (Figure 10). The seasonally high river levels serve to substantially reduce, if not equilibrate, the upward gradient of porewater pressures measured near the toe of the landslide, while upon recession of the river, movements at a rate of 3 mm/year are re-established as soon as the

gradient is greater than zero (Figure 10). These data suggest that the movements are not simply due to saturation and erosion at the toe of the landslide, but are related to the direction of the groundwater flow. Wood (1982) observed "silt boils" in the Thompson River during and following the 1982 Goddard failure, which may be interpreted as evidence of upward groundwater seepage emanating from the confined aquifer and being expelled through the submerged toe of the landslide.

Rapid river drawdown may also be suggested as a trigger for renewals of movement at the Ashcroft Thompson River landslides, but this explanation overlooks the importance of groundwater seepage from the confined aquifer that is produced by the interplay of the river level and the artesian porewater pressures illustrated in Figure 10.

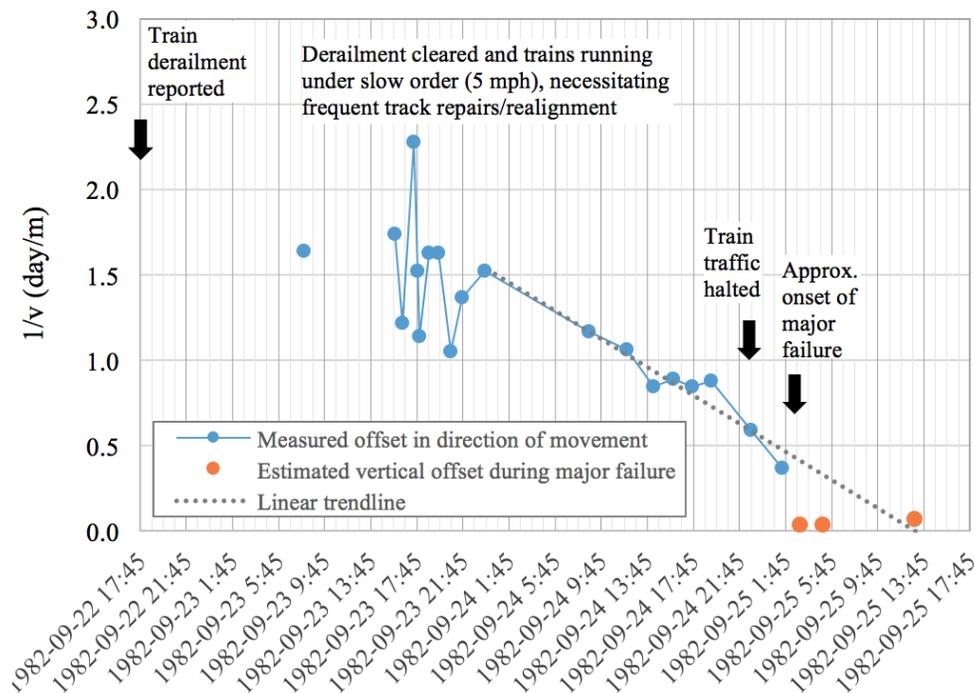
Figure 7: Inverse velocity of surface offset displacements during 1982 Goddard slide, with linear trendline established using surface displacements recorded by Wood (1982) from approximately 27 hours prior to onset of major failure.

Fukuzono’s (1985) inverse velocity method is applied to Wood’s (1982) surface offset measurements from the Goddard 1982 slide in Figure 7. As evident in Figure 7, the

$1/v$ data initially do not show a coherent trend; the data then begin to linearize, commencing at approximately 23:40 hours on September 23, 1982, indicating that rapid failure may be imminent. The linear portion of the plot (from 23:40 hours on September 23 to 01:30 hours on September 25) is projected to intersect the horizontal axis at time 13:00 hours on September 25, 1982. The actual onset on rapid failure occurred just ten hours earlier at approximately 3:00 hours on September 25, 1982 (Wood 1982).
