Application of high-resolution remote sensing to landform evolution in Central Nepal following the 2015 Gorkha earthquakes

ABSTRACT

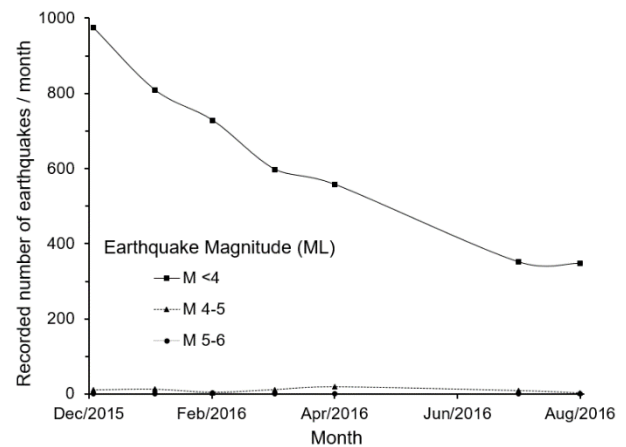
Figure 2. Number of earthquakes recorded by the NSC between December 2015 and August 2016 across Nepal, northern India and southern Tibet. In the time period presented, no earthquakes with magnitudes (ML) exceeding 6 were recorded.

Due to the proximity to the MCT, Sindhupalchok along with the neighbouring districts forms an area of seismic clustering evident on epicentral maps (National Seismological Centre (NSC) 2016). Hundreds of earthquakes with local magnitudes (ML) less than 4 are recorded on a monthly basis in Nepal, northern India and southern Tibet with a further 5 to 20 ML 4-5 earthquakes monthly (Figure 2). The records available are incomplete

but provide a good indication of the level of seismic activity along with the general decay with time since the 2015 earthquake sequence.

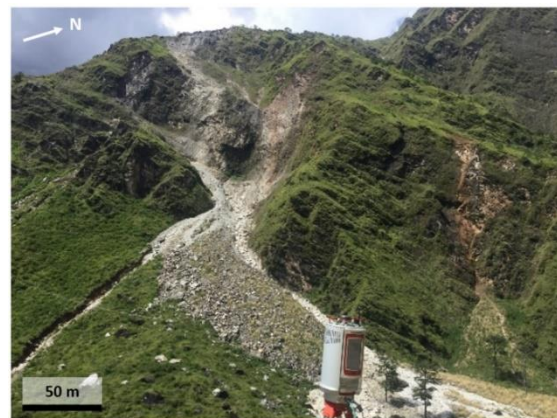
Figure 3. Tushare landslide (October 5, 2017).

Tushare (Figure 3) is located on the west side of the Araniko Highway and Bhote Koshi river approximately 4.5 km south of the border with Tibet. It is within 25 km of the epicentres of the two main aftershocks (Figure 1). The slope is approximately 560 m in height ranging from 1250 masl to 1810 masl with an average slope angle of approximately 42°. At midslope, an approximately 70 m high subvertical rockface is observed.

Figure 4A shows change between September 20, 2012 and November 6, 2016. As evident in Figure 3, the slope at Tushare is governed by three dominant, highly persistent (>20 m) discontinuity sets (ISRM 1978). Outcrops of bedrock following these discontinuity surfaces control where material was eroded and subsequently deposited during the earthquake triggered landslides.

10 m wide and incised up to 4.5 m in the 2017 monsoon. The TLS data in concert with photography from 2017 (Figure 3) suggest that an avulsion may be developing at the apex of the landslide debris and could continue in subsequent monsoon seasons.

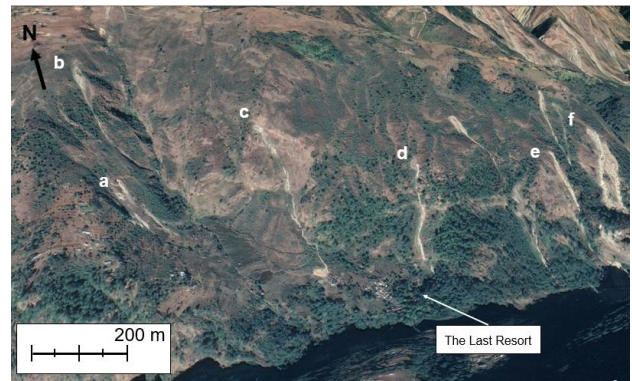
Figure 5. Slopes above The Last Resort from Google Earth imagery dated December 8, 2017. The letters correspond to the features shown on Figure 6.

prior to this date. The mapped extent of landsliding at each site was 0.4 km² along the ridge surrounding Tushare and 0.03 km² at TLR, including the failures denoted a-d in Figure 5, Figure 6.

TLR (Figure 5) is located on the north side of the Araniko Highway and Bhote Koshi river approximately 9 km south of the border with Tibet. As with Tushare, it is within 25 km of the epicentres of the two main aftershocks of the 2015 earthquakes (Figure 1). TLR is located at an elevation of approximately 1200 masl and is on the lower half of a slope which extends from the Bhote Koshi River, in the canyon below TLR, up to approximately 1950 masl.

The slope above TLR experienced several mass movements during the 2015 earthquake sequence including reactivation of pre-existing failures visible on pre-earthquake satellite imagery.
