Identifying and Characterizing Rock-Slope Hazards at the Railway Subdivision Scale Using 3D Remote Sensing Data

Richard D. Carter, D. Jean Hutchinson, David A. Bonneau
*Department of Geological Science and Geological Engineering, Queen's University,
Kingston, On.*
Dave Gauthier
BGC Engineering Inc., Kingston, On.

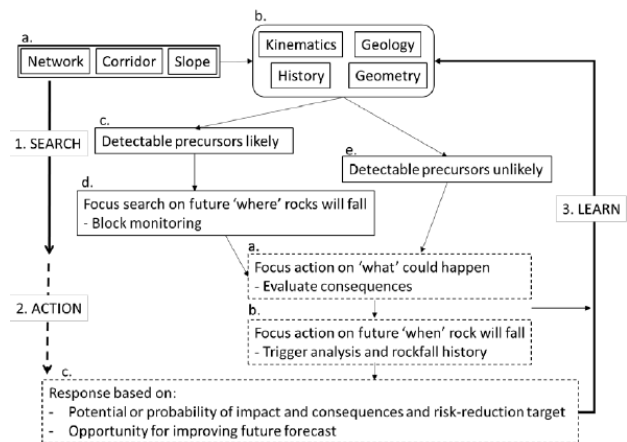
Figure 2: Rockfall forecasting framework taken from Gauthier et al (2017)

Gauthier et al (2017) outline a framework for the study of rockfall hazards through remote sensing data collection and analysis, shown in Figure 2. The work carried out in this study fits into the searching phase of that framework—here, we’re looking to evaluate slope conditions to identify where rockfalls are possible and to identify evidence of rockfall activity to identify where they are likely. The ideal output of this phase is a reasonable plan to help focus further investigation of slopes with higher hazard potential through remote sensing.

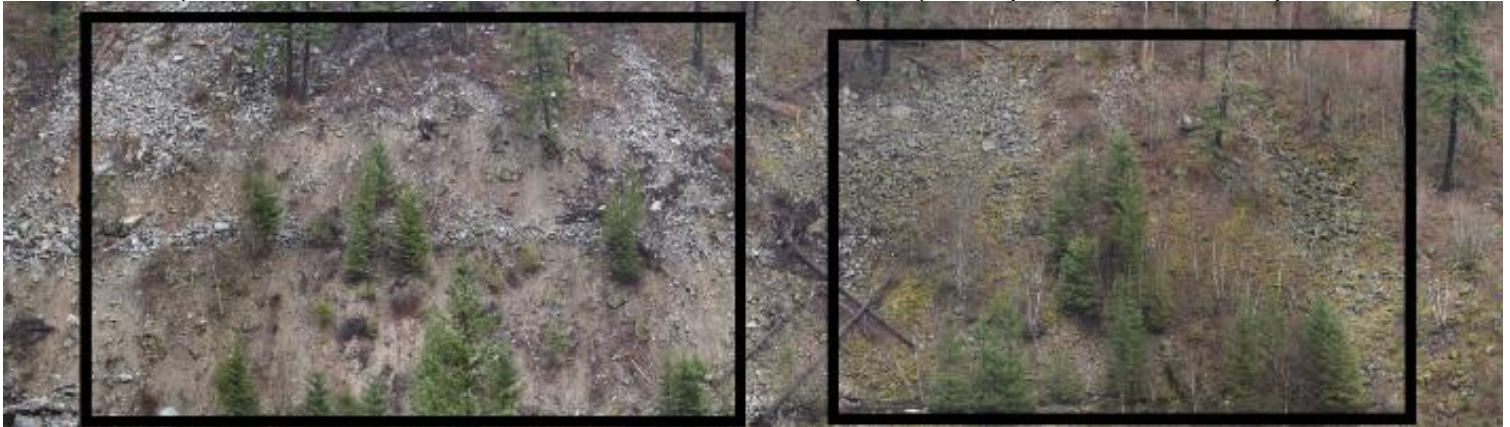
Figure 4: In the box on the left, a talus deposit which has clearly been recently active as noted by the disturbed surficial material. In the box on the right, another deposit immediately adjacent which is covered in vegetative growth, and does not contain disturbed terrain, both of which are indications of a lack of recent activity.

to the Fraser and Yale faults, produce talus benches in many locations. Rockfall activity in the area is predominantly sourced from these features. Vegetation acts as an indicator of recent rockfall activity on such benches—benches below recently-active slopes consist of sparse vegetation, whereas benches below inactive slopes are covered in moss, shrubs and sporadic tree growth. Figure 4 shows the clear difference between recently active

and recently dormant talus benches characteristic of the region. It is within reason to suggest that this difference in the colour signatures of talus deposits could be used to further inform decision making based on evidence of activity or lack thereof within a talus deposit. This is not to say that vegetated talus deposits are not hazardous—merely that vegetative cover is one potential data input which can be used to determine how frequently and
