Steep creek hazard mitigation case studies: some lessons learned from past events

Emily Moase, Alex Strouth & Matthias Jakob
BGC Engineering, Vancouver, BC, Canada

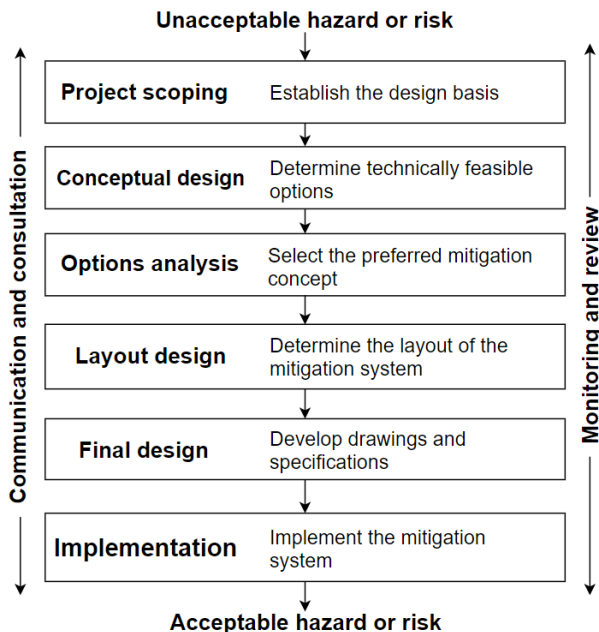
Figure 1. Recommended mitigation design approach (adapted from Moase, 2017).

Practitioners in some countries follow phased design approaches when developing debris-flow mitigation systems. These design approaches are documented in national technical guidelines, such as the National Institute for Land and Infrastructure Management (NILIM) Technical Notes in Japan, the Geotechnical Engineering Office (GEO) reports in Hong Kong, and the Torrent and Avalanche Control Service (WLV) guidelines in Austria (NILIM, 2007a, 2007b; GEO, 2017; WLV, 2017). A similar phased design approach was developed by Moase (2017) for use in Canada (

Figure 1). The authors have found this approach to be useful for several consulting projects.

Design begins with the Project Scoping phase, which seeks to establish the design constraints and objectives. This phase relies heavily on the accuracy and

Conceptual Design and Options Analysis phases involve identifying and comparing the many possible mitigation strategies, and ultimately selecting a preferred concept for more detailed design. The goal of these phases is to identify a mitigation concept that meets the constraints and objectives established during Project Scoping.

The goal of the Layout Design phase is to select the location, length, width, and height of the structural elements. A detailed understanding of the interaction between debris-flow or debris-flood processes and the different design elements is needed.

Final Design and Implementation phases involve developing final detailed drawings and specifications, and constructing the mitigation elements. Geotechnical and structural (e.g. concrete, steel) stability are evaluated and addressed by the design details. Reviews during construction evaluate if actual field conditions encountered are consistent with the design assumptions and intent.

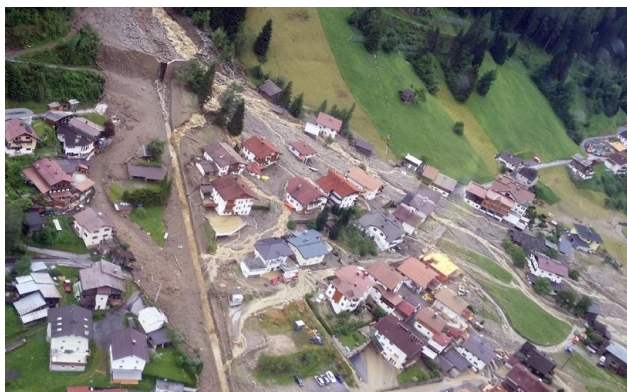
Figure 2: Debris-flow damage on Schallerbach following the June 2015 event. Photograph by [Feuerwehr Landeck](#).

On June 8, 2015, a 100,000 m³ debris flow filled and overtopped a 1,500 m³ debris basin on Schallerbach (Schaller Creek) in Tyrol. This event caused extensive damage in the village of See (Figure 2). The existing barrier and basin were not destroyed. However, the storage capacity was undersized by a factor of almost 70.

In 2016, a re-designed barrier was constructed to replace the overtopped structure. The new barrier is 24 m high and can store 50,000 m³ of debris. It cost approximately \$18.5 million CAD (€12.55 million, 2016 dollars). This example highlights the importance of a hazard assessment that estimates the magnitude and frequency of debris flows prior to mitigation design.

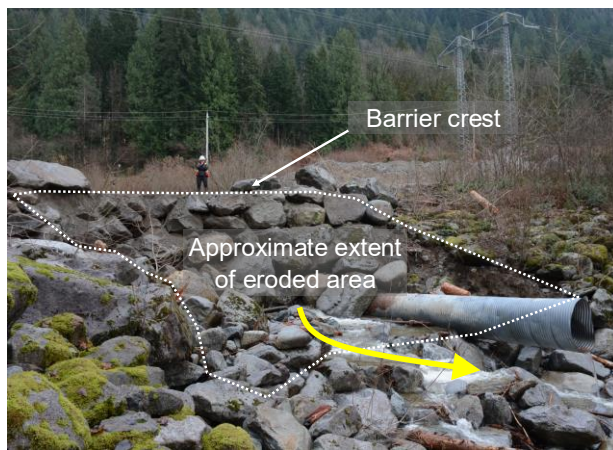
Figure 4: Looking upstream at the partially reconstructed Patterson Creek barrier following overtopping during the November 2017 event. Photo by J. Park, December 2017.

In November 2017, a rain-on-snow event in the upper watershed triggered debris flows on Patterson and several neighbouring creeks. There was no avulsion in this event, but the debris overwhelmed the basin and overtopped the debris barrier, causing erosion on the downstream face (Figure 4). The upstream face of the barrier is protected with concrete, which likely contributed to preventing erosion of the structure.

These events provide two lessons: Layout of design elements particularly on the lower fan needs to consider the potential for upstream avulsion. Barrier and basins designs, unless they can be dimensioned generously, should include elements that accommodate overtopping; often this would be a protected overflow spillway or an outlet structure.

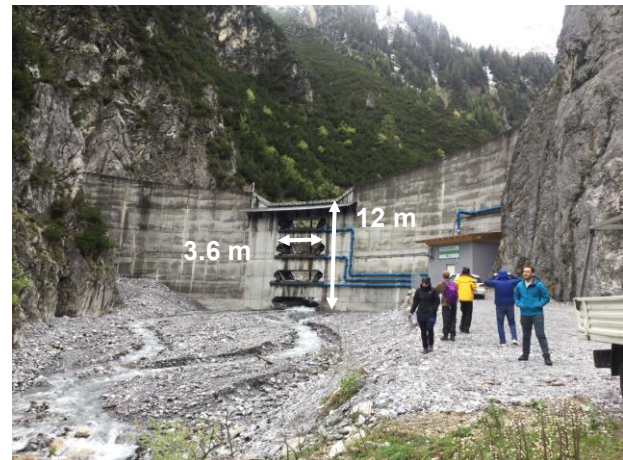
Figure 6: Debris-flow barrier on Schnannerbach in Austria. Photograph by E. Moase, May 2016.

Schnannerbach flows through Schnann, in Tyrol, Austria. A debris flow in the early 1990s prompted the construction of a barrier in the upper watershed, approximately 400 m above the town. The barrier is a concrete gravity-arch structure with four 3.6 m wide horizontal slots and a graduated crest; construction was completed in 1991 (Figure 6).

The barrier functioned as designed during near-yearly events in the 1990s. However, a subsequent debris flow in 2005 passed through the slots “as if the barrier wasn’t even there”, causing damage in the village below (pers. comm., Christian Weber, 2016). The barrier retained approximately 13,000 m³ of sediment, but allowed a further 20,000 to 25,000 m³ to pass (Gems et al., 2014). The 2005 debris flow may have been finer grained than most of the debris flows that occur on Schnannerbach.

Since the 2005 event, several techniques have been tried to decrease the slot size of the Schnannerbach barrier, including installing a steel grid. However, the grain size of debris flows on the torrent continues to be highly

variable, and the steel grid caused too much sediment capture during coarse-grained events. In spring 2016, a new experimental system was installed in the barrier. It consists of rubber balloons, installed in the slots, which can be remotely filled with water to block the slot openings in the event of a fine-grained debris flow or debris flood. The system can be remotely activated by the mayor of Schnannerbach, on the advice of the WLV, based on weather data and a real-time video feed from the dam. The balloons were developed using a physical model in collaboration between WLV and Austrian academics, but had not been tested by a full-scale debris flow, as of the time of the primary author's visit in May 2016.
