CHARACTERISING LANDSLIDE RISK IN CANADA

Stephen G. Evans, Geological Survey of Canada, 601 Booth Street, Ottawa, Ontario K1A 0E8

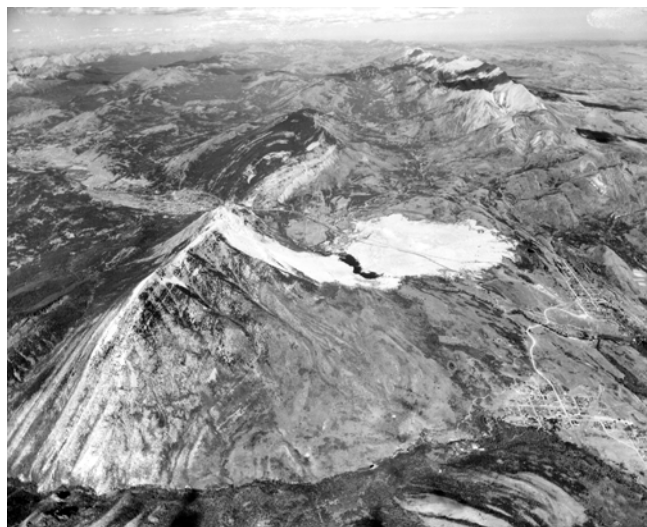
Figure 1. Aerial oblique photograph, taken in September 1944, of Turtle Mountain, Alberta, and the 1903 Frank rock avalanche (NAPL T31L-213).

2003 marks the centenary of the Frank Slide (McConnell and Brock, 1904; Figure 1) which occurred on April 29th, 1903. The rock avalanche killed at least 70 people and remains Canada's worst landslide disaster (Evans, 1997).

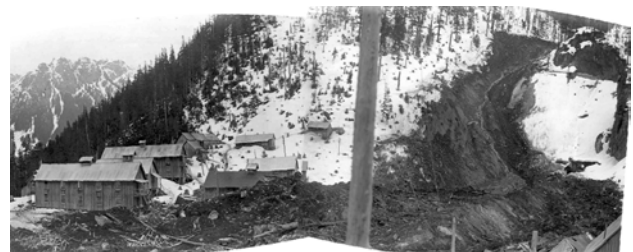
Figure 2. A panorama of contemporary photographs of the 1915 Jane Camp landslide disaster showing source area at top right and impact on mining camp buildings, including bunkhouses at left (Photographs courtesy of Britannia Museum and Vancouver Public Library).

Jane Camp was established in 1903 within Jane Basin, a cirque-like bowl, within the watershed of Britannia Creek (Evans, 2000a) and in 1915 housed a substantial number of miners in bunkhouses and miners' families in other buildings (Figure 2).

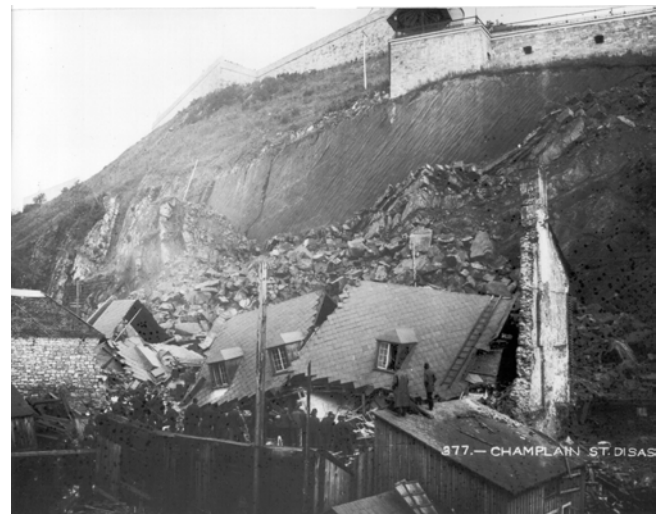
Figure 3. Contemporary photograph of the September 1889 Champlain Street landslide disaster, Québec, Québec. 50 people were crushed to death in the houses at the base of the failed rock slope, below the walls of the Citadel. (Public Archives of Canada Photograph 131073).

The 1889 rockslide on Champlain Street, Québec City occurred when a large portion of the rock slope, about 85 m in width, fell from beneath the King's Bastion onto houses on the south side of Champlain Street destroying 7 houses (Figure 3) and killing about 50 people (Baillairgé 1893; Drolet et al. 1990)). These deaths brought the total deaths on Champlain Street to 93 in four landslides since 1841 (see Appendix). The volume of the 1889 rockslide was in the order of 53,000 m³ (Baillairgé, 1893). The presence of "dangerous fissures" in the slope had been reported by C. Baillairgé, City Engineer of Québec City, as early as January 1880. Houses closest to the rock face had been demolished following this report but those on the other side of Champlain Street, those struck in 1889, had been allowed to remain despite the conclusion that houses on both side of the street were in potential danger. In returning its verdict, the coroner's jury found that the deaths were due "to the gross and culpable negligence of the Federal authorities of

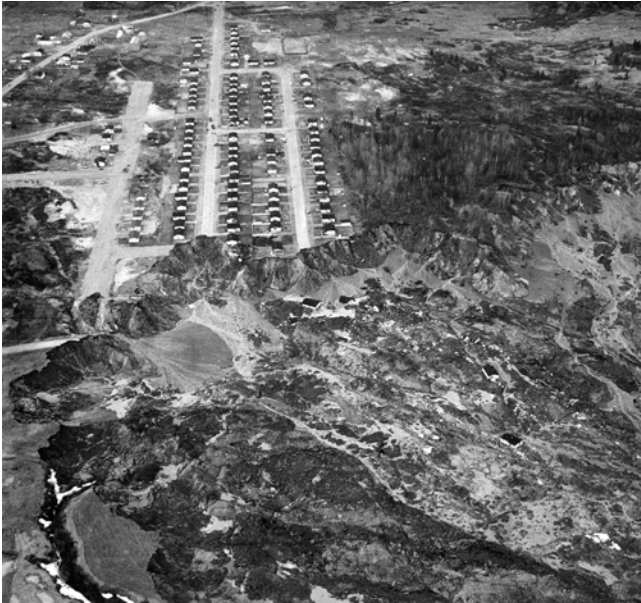
Figure 4. The St-Jean-Vianney landslide, Québec, May 4th, 1971. Oblique aerial view of the upper part of the landslide scar. Approximately 40 houses were engulfed by retrogression and 31 people died in the Leda Clay earthflow. Some displaced houses are seen in the debris below the scarp. (Canadian Forces Photograph taken on May 7th, 1971).

Dame de la Salette landslide and displacement wave (Ells, 1908; Lapointe, 1974), and the 1971 St. Jean-Vianney landslide (Figure 4; Tavenas et al., 1971; Potvin et al., 2001). At least 17 landslides in excess of 10^6 m^3 took place in the sensitive marine sediments of the St. Lawrence Lowlands in the period 1842-2000 (Evans et al., 1997), the most recent being the 1996 St. Boniface landslide ($8 \times 10^6 \text{ m}^3$; Demers et al., 2000).

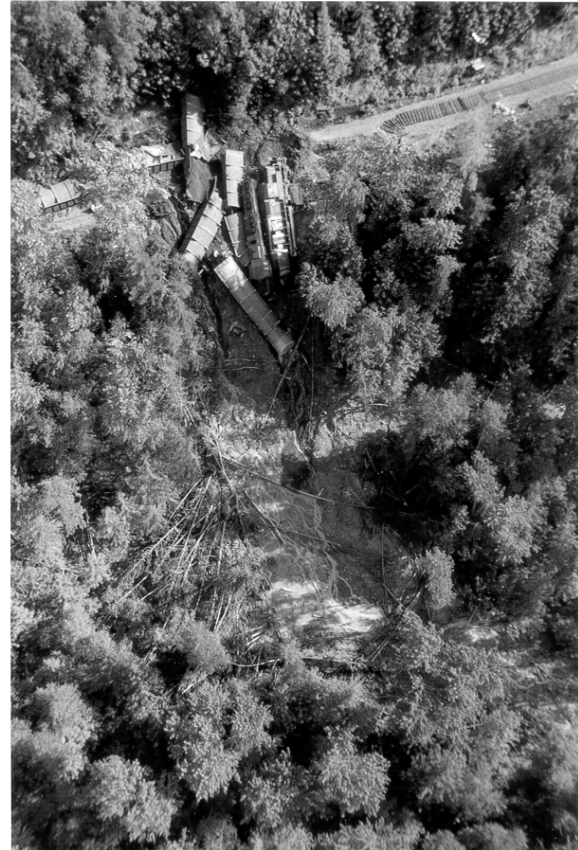
Figure 5. The 1998 failure of a railway fill constructed from glaciolacustrine silt near Creston, British Columbia. The failure, triggered by sustained heavy rainfall, was transformed into an extremely rapid flowslide which swept into the forest below the track up to a distance of 80 m (Transportation Safety Board, 1998).

Failures in built slopes that are part of Canada's infrastructure have significant economic impact through losses of equipment, the costs of reconstruction and those associated with delays and demurrage (Figure 5; Evans, 2001).

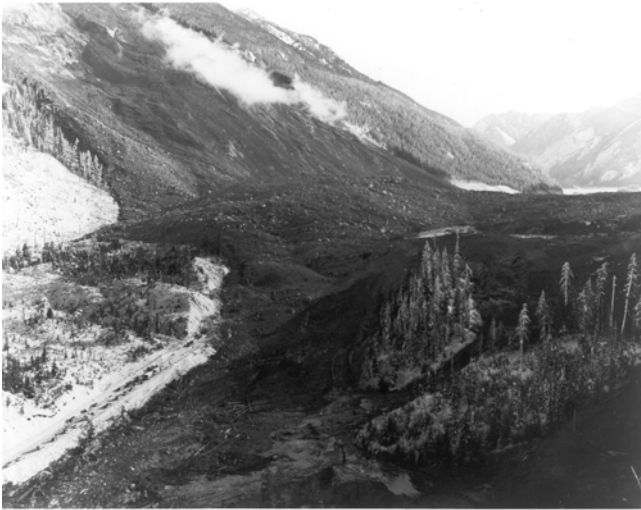
Figure 6. Aerial view of the 1965 Hope Slide, British Columbia shortly after it occurred. The debris filled up the valley bottom and buried BC Highway 3. Note vehicles at bottom left for scale. Four people were killed in the landslide (British Columbia Archives Photograph).

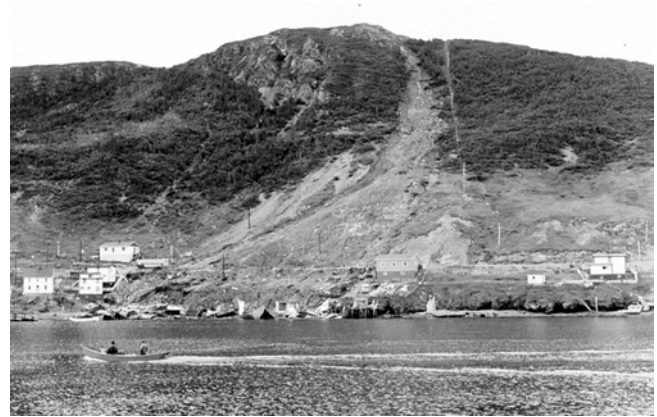
Figure 7. The August 1973 Harbour Breton debris avalanche, Newfoundland. The debris avalanche swept into homes adjacent to the seashore killing 4 people (Photograph courtesy of D. Liverman, Geological Survey of Newfoundland and Labrador).

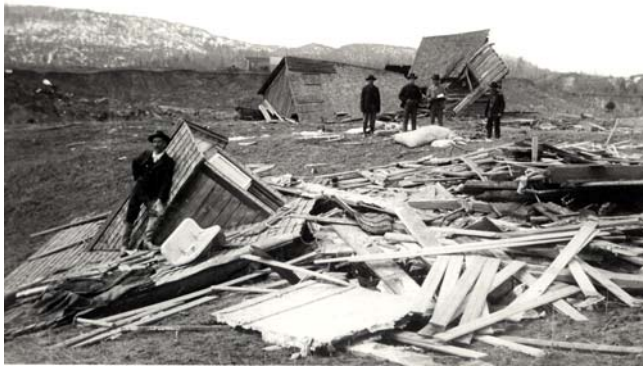
Figure 9. Destruction caused by the displacement wave generated by Leda Clay landslide at Notre-Dame-de-la-Salette, Québec in April 1908. Landslide occurred on opposite bank of Lièvre River. 33 people were killed (National Archives of Québec Photograph).

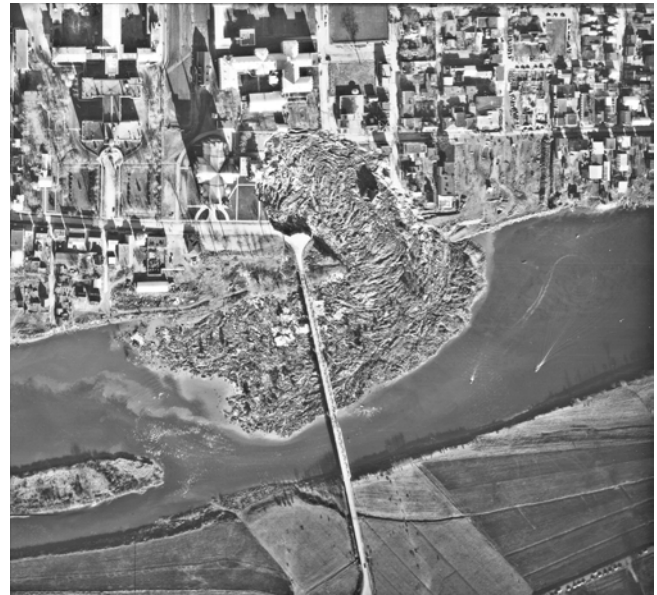
Figure 10. Impact of landslide on community: the November 1955 Nicolet landslide, Québec, a rapid earthflow in Leda Clay. Three people were killed in the landslide which partially destroyed a church complex. The 147-year-old Cathedral of St-Jean-Baptiste, which stood on the edge of the crater, had to be demolished following the landslide. Total damage was estimated to be in the order of \$10M (1955)/\$71M (2002) (Province of Québec 377-24)

Landslides in Leda Clay have impacted on a number of communities in Québec (e.g., Grondin and Demers, 1996) resulting in the destruction of homes, community buildings (Figure 10), farmland, and the transportation infrastructure (Figure 11). Indeed, the first recorded fatal landslide in Canada occurred at St-Pierre-de-la-Rivière-du-Sud, Québec in 1771. One person was killed when a farmhouse was buried in the debris of a retrogressive earthflow (Evans et al., 1997). In eastern Ontario, four major earthflows occurred along a 20 km reach of the South Nation River near Casselman, between 1895 and 1993 (Evans and Brooks, 1994; Lawrence et al., 1996). The landslides resulted in the loss of productive land. Prior to the 1993 Lemieux landslide, the village of Lemieux had been removed to mitigate the risk of potential losses from future landslides which had been established through geotechnical investigation. The 1993 landslide occurred within 700 m of the former townsite (Lawrence et al., 1996). It is noted that

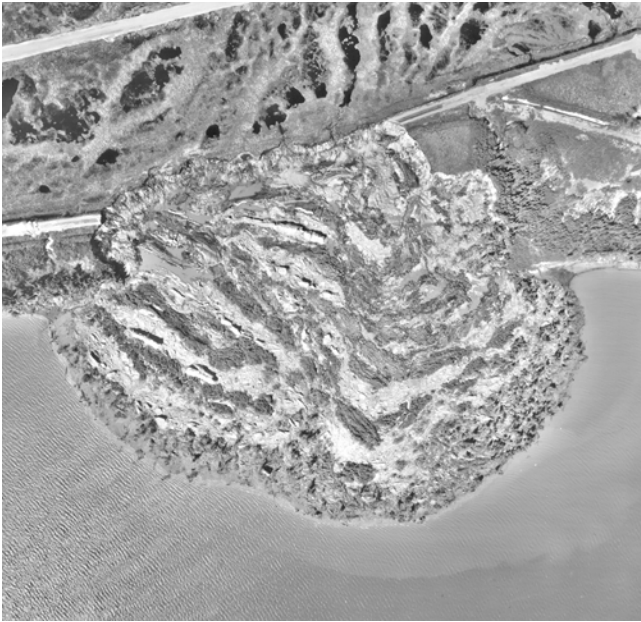
Figure 11. Impact of landslide on highway infrastructure: the 1980 Havre St-Pierre landslide, a retrogressive earthflow in Leda Clay on the north shore of the St. Lawrence, that severed Québec route 138 (AeroPhoto AP8035-087).

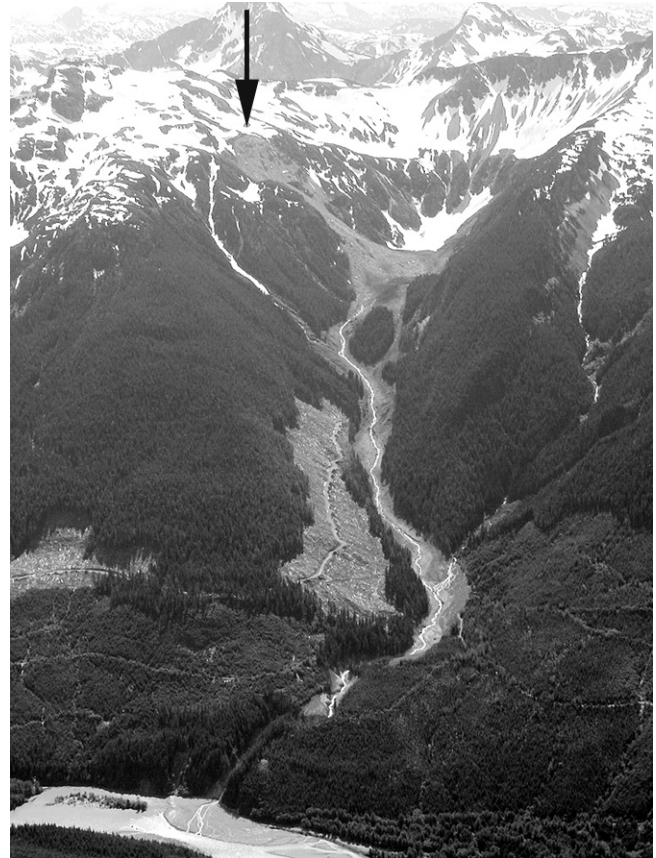
Figure 12. Oblique aerial photograph of 2002 rock avalanche - debris flow in the Coast Mountains, British Columbia. Initial failure volume was ca. $1.4 \times 10^6 \text{ m}^3$. The rock avalanche and debris entrained from the channel travelled 3.7 km from the base of the failed slope and dammed the Zymoetz River (centre bottom left). Source of rock avalanche is indicated by arrow. Just above the river the debris ruptured a natural gas pipeline supplying Terrace, Kitimat and other areas in northwestern British Columbia. Total direct and indirect costs associated with the event are approximately \$33.4 M (Schwab et al., 2003).

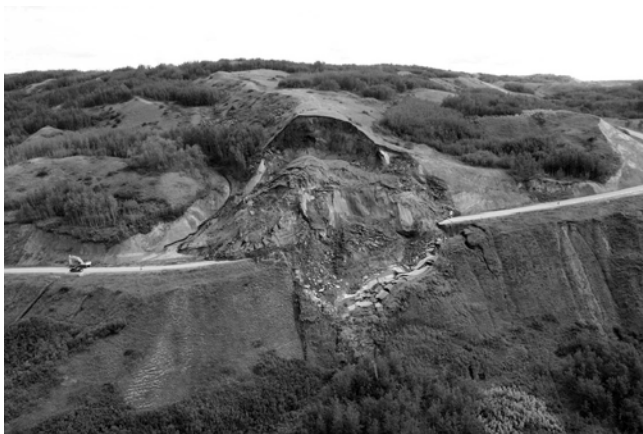
Figure 14. First phase of landslide in glaciolacustrine silts and clays, Beaton River valley, near Fort St. John, B.C. (Raymond et al., 2003). The landslide severed BC Road 103 in 2001 interrupting agricultural and oilfield traffic. Soon after this photograph was taken, the landslide developed into a more complex failure (photograph courtesy of BC Ministry of Transportation and Highways).

Landslides in glaciolacustrine sediments have impacted on communities and infrastructure (Figure 14) in the many parts of Canada underlain by these Pleistocene sediments (Karrow and White, (Editors) 1998). Cases have been documented in northern Québec (e.g., Eden, 1964), northern Ontario (e.g., Nicholl, 1928; Radhakrishna et al. 1992), the Prairie Provinces (e.g., Baracos and Graham, 1981, Miller and Cruden, 2002) and British Columbia (e.g., McCarty and Cavers, 1998; Polysou et al., 1998; Clague and Evans, In Press). Ice rich glaciolacustrine sediments are a major landslide hazard to northern pipelines (Dyke, 2001) traversing permafrost terrain.

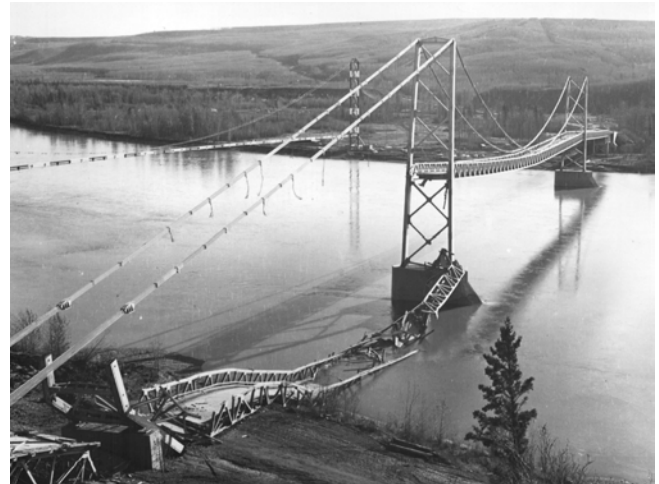
Figure 15. The 1957 collapse of the Peace River Bridge, Alaska Highway, Taylor, British Columbia, caused by sliding of the north anchor block (left foreground) in Cretaceous bedrock (photograph courtesy of the North Peace Historical Society).

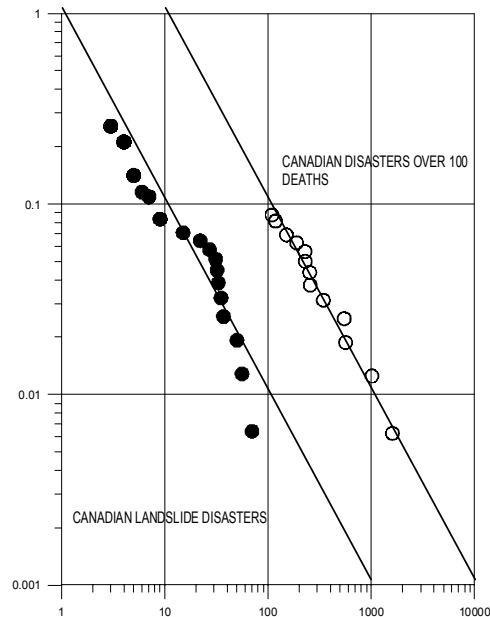
Figure 16. The Fatal Landslide risk envelope for Canada compared for the Disaster Risk Envelope for Canada, which includes the major disasters in the period 1840-2000. Regression lines with $b = -1$ have been superimposed on the data plot.

In the Canada Landslide risk envelope (Figure 16), the probability of fatalities is related to the number of fatalities in an event through a power law (Equation 2)

Importantly, the Canada landslide risk envelope (Figure 16) derived from the historical database in the Appendix is
