CHANNEL MORPHOLOGY CONSIDERATIONS IN EVALUATING FLOOD AND EROSION CONTROL STRUCTURES

L. S. Hundal, AMEC Earth & Environmental Limited, Calgary, Alberta
R. W. Costerton, BC Rivers Consulting, Kamloops, British Columbia

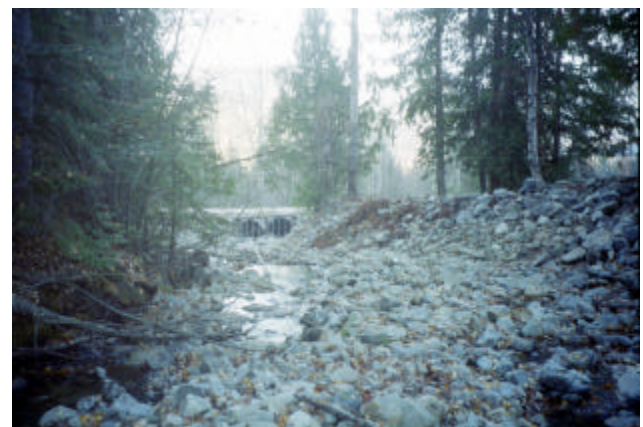
Figure 1. View downstream showing Russell Creek aggradation at road crossing.

Russell Creek is a steep (8% to 10%) alluvial fan stream subject to debris flows. The drainage area is relatively small (23 km²) and the watershed responds quickly to rainstorms. The flooding mechanisms are: (1) Overbank flow and potential channel avulsion at the fan apex; and (2) flooding and avulsion at the four road and railway crossings located in the mid to lower portions of the fan, which constrict the channel and restrict sediment conveyance. The stream channel is heavily aggraded resulting in a streambed elevation higher than the fan surface (the streambed is actually at a higher elevation than the top of the setback dike, in some sections). There is a significant amount of instream large woody debris in the upper third of the fan. Although no significant changes in channel location have occurred within the last fifty years, road crossings now exacerbate natural depositional processes since they impede sediment conveyance.

The existing structure was constructed in 1999 and structure is in good condition and will function well for directing overbank flow back towards the main channel. Some repair and additional improvement to the structure may be required if an avulsion occurs and the channel were to relocate adjacent to the structure. However, flooding and erosion could also occur at any of the four bridge/culvert crossings. The crossings are usually cleared out after a flood - no regular dredging is undertaken.

(C) Crossings that restrict sediment conveyance increase channel aggradation and increase the risk of channel avulsion locally. These impacts alter the natural process channel aggradation, avulsion and relocation.

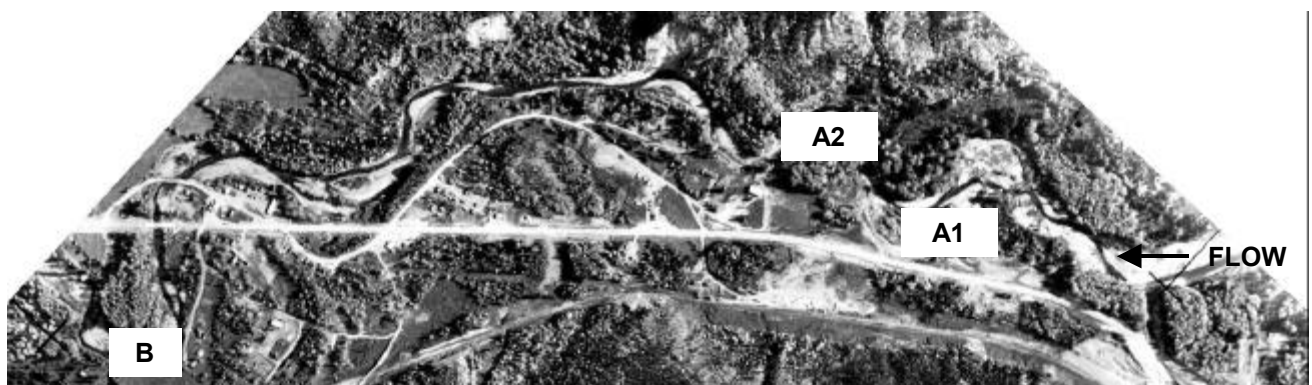
Naver Creek at Hixon (65 km south of Prince George) is indicative of the flooding and erosion problems encountered on these streams. As shown on the airphoto below, significant channel movement occurred at 'A1' and 'A2', where the meanders have migrated 100 m. The meanders at 'A2' and 'B' have cutoff and resulted in a channel shift of 100 m.

Figure 4: 1958 Aerial Photo of Naver Creek at Hixon

Initially, river training works were built at 'A1' to direct the channel back to its old course, after downstream meander progression had occurred. The original works failed and the present works, consisting of riprap bank protection and a top of bank berm, were built at the existing stream bank location to prevent further erosion and overbank flooding. The berm is open-ended, hence, it is intended to reduce flooding and the amount of debris deposited on the floodplain. It is not intended to block all overland flow.

The stream conveys a considerable amount of woody debris during floods. Part of the reason for building the berm was to prevent debris from piling up on the floodplain where the community center sports fields are located. Debris jams likely were a significant factor in the previous channel instability at this location. There was a large flood in 1993 that caused considerable damage within the watershed including damage to roads, private property and erosion protection works. Flood damage was due in part to large amount of bedload and debris within the channel.
