# THE USE OF REPEAT TERRESTRIAL PHOTOGRAPHY IN THE STUDY OF LANDSLIDE HAZARDS

K.D. Hincks, University of Alberta, Department of Earth and Atmospheric Sciences, Canada

D.M. Cruden, University of Alberta, Department of Civil and Environmental Engineering, Canada

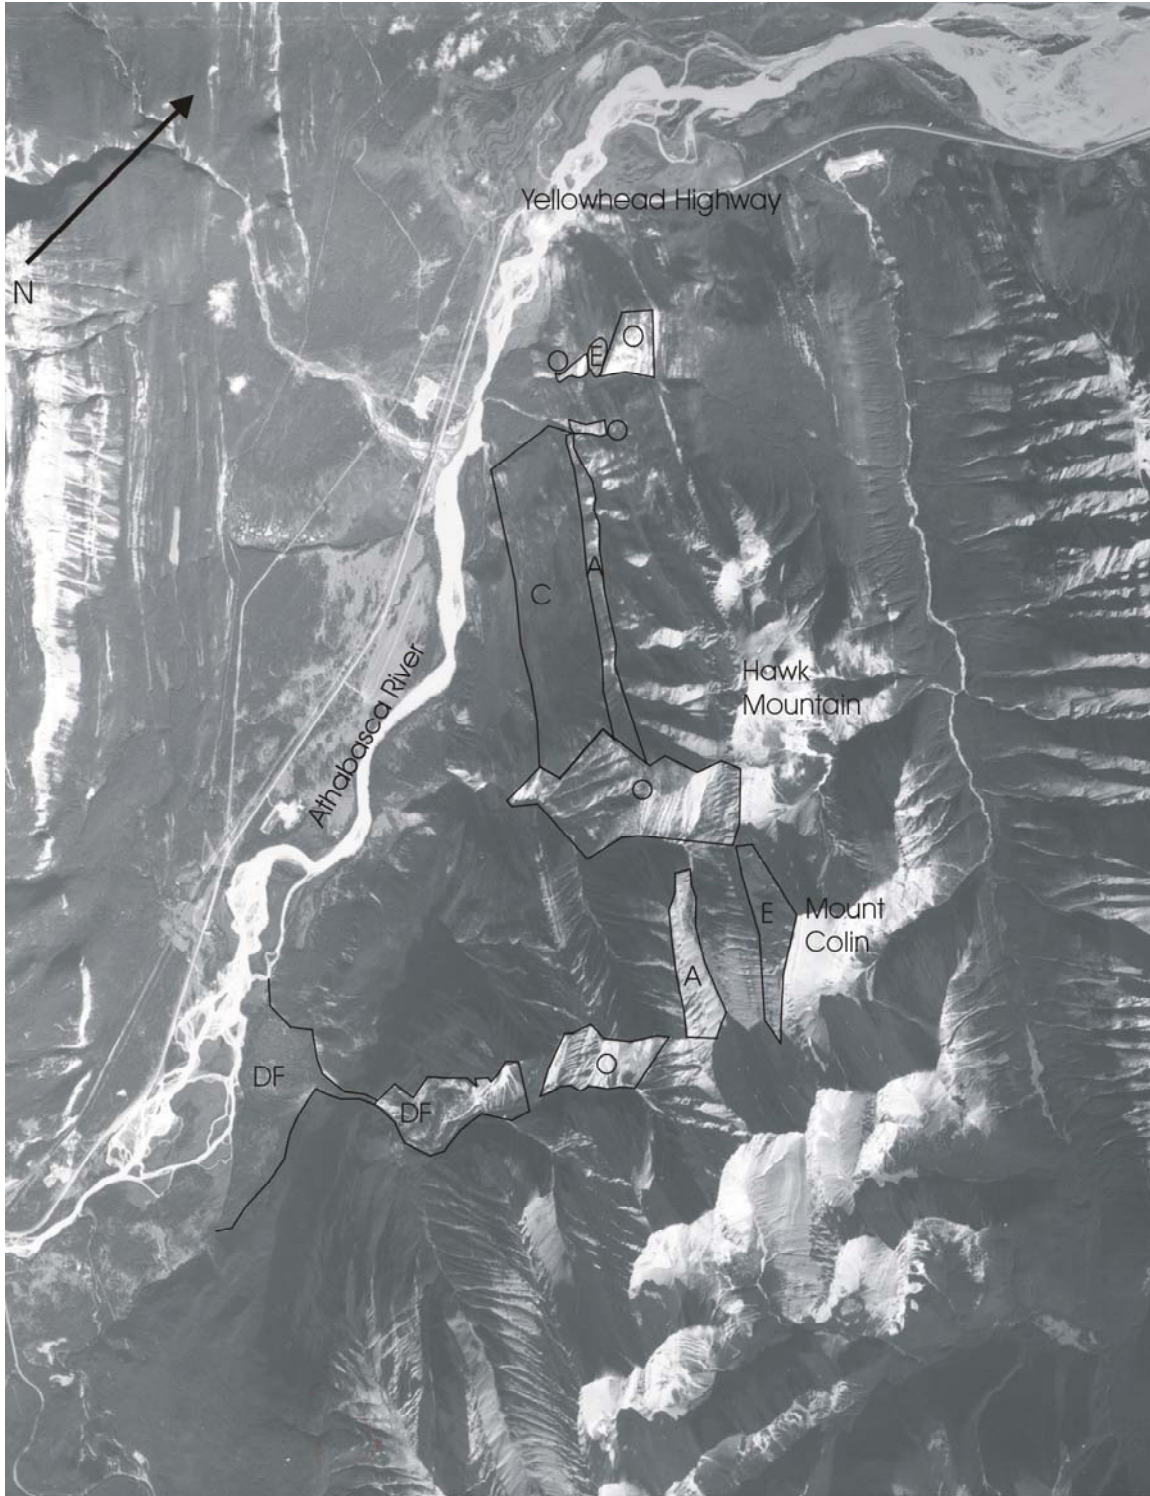
Figure 1 – The west slope of the Colin Range, Jasper National Park, showing areas of exfoliation, E; orthoclinal toppling, O; cataclinal toppling, C, anacinal toppling, A and debris flow deposits, DF, overlain on part of aerial photograph A23025-138, Natural Resources Canada. Scale 1:60 000.

Hincks spent the summer of 2002 in the Colin Range of Jasper National Park mapping slope movement phenomena. Modes of movement that were observed within the area include toppling and rock fall, exfoliations and debris flows. Specific locations of these phenomena are highlighted on sets of the Bridgland photos to determine whether or not the repeat photos are useful in the determination of landslide hazards (Hincks, 2003). Figure 1 is an airphoto showing areas where slope movements occur within the Colin Range of Jasper National Park.

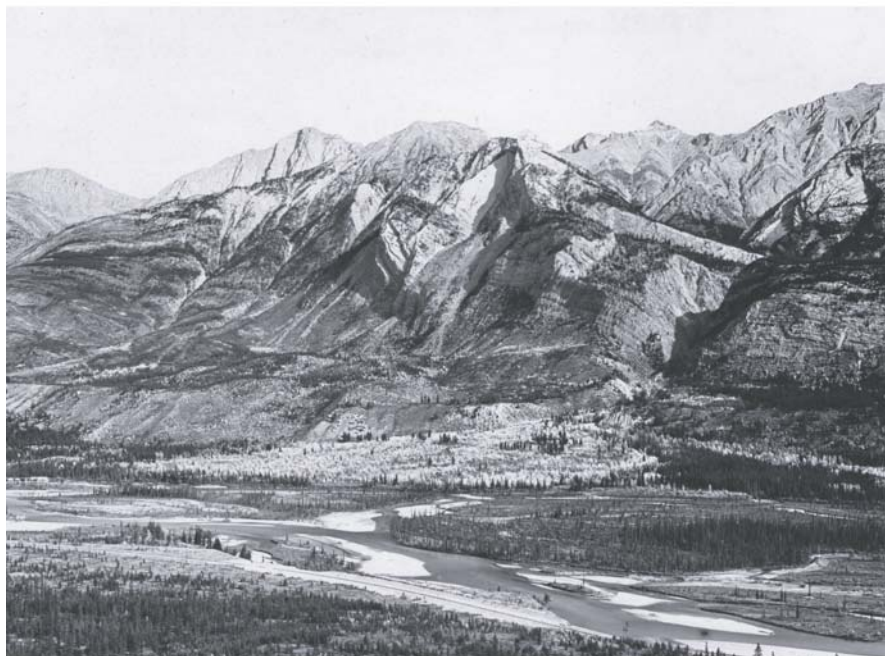
Figure 5 – Higgs and Rhemtulla repeat photograph number 460 showing the area of Debris Flow Creek. The canyon of the creek can be noted by the lack of vegetation, and the lateral moraine is present in the foreground of the photograph.

Figure 6 – Bridgland photograph number 460 showing the area of Debris Flow Creek. The north wall of the canyon can be noted by the lack of vegetation, and the lateral moraine of the Athabasca Glacier is present in the foreground of the photograph, and is cut by the creek.

As can be seen in the set of photographs of Figures 5 and 6, the vegetation in the area of Debris Flow creek has changed over the 84 year time period. This change is especially noted on the alluvial fan of the creek. Minor changes can be observed in this area between the two photos. The first area where slope movement can be inferred is the area on the north side of the creek, where vegetation is not present on either of the photographs. This is an area of colluvial deposits which are constantly being reworked by the creek and by further mobilization of the colluvium under gravitational forces. This area is one of the main contributors to the periodic debris flows that occur at this location.

Another area where change can be observed on these photographs is the area where the creek cuts through the till deposits, left from the retreat of the Athabasca Glacier (Mountjoy, 1974). The till face on the south side of the alluvial fan has been altered between 1915 to 1999. This change is easier to see when the photos are enlarged as digital files, and compared closely.
