# STYLE AND SEQUENCE OF MOVEMENT OF A LANDSLIDE IN SENSITIVE GLACIOMARINE CLAYS AT MINK CREEK, NORTHWESTERN BRITISH COLUMBIA

Marten Geertsema, BC Forest Service, Prince George, BC  
David M. Cruden, University of Alberta, Edmonton, Alberta  
James W. Schwab, BC Forest Service, Smithers, BC

## Abstract

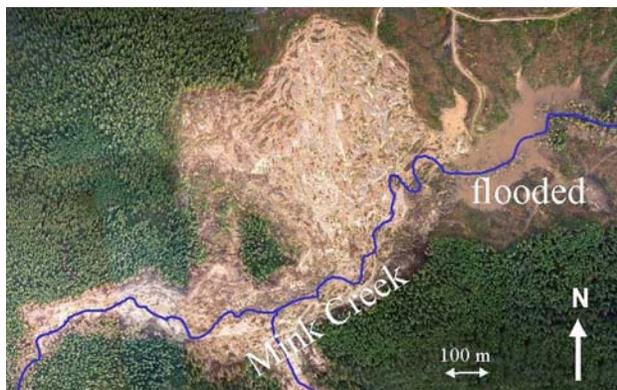
Figure 2. Aerial overview of the Mink Creek landslide in April 1994.

The displaced material of the Mink Creek landslide covers an area of 43 hectares. The zone of depletion occupies 23 ha of this area, while the zone of accumulation fills 1.2 km of valley downslope of, and downstream of, the zone of depletion (Figure 2). To the east the landslide is bounded by a preslide gully. To the west, a 1 ha remnant of undisturbed forest separates the landslide from a

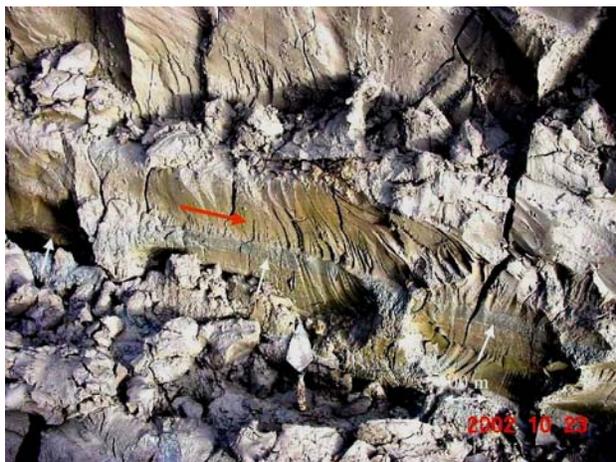
Figure 7. A trench on the butte (zone 6b) exposes a rupture surface (white arrows) in a blue stratum. Red arrow indicates direction of movement.
