# A FRAMEWORK FOR MONITORING THE SOUTH PEAK OF TURTLE MOUNTAIN – THE AFTERMATH OF THE FRANK SLIDE

Rodney Stewart Read, RSRead Consulting Inc., Okotoks, Alberta, Canada

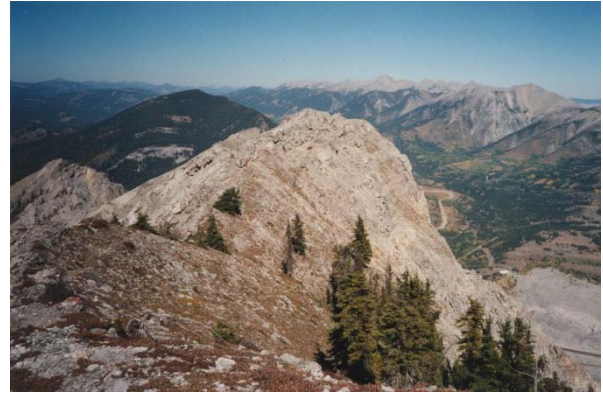
Figure 2. View of South Peak looking north towards Bluff Mountain from Third Peak.

rock volume of about 5 million cubic metres that poses a geotechnical hazard to the valley below (Figure 2).

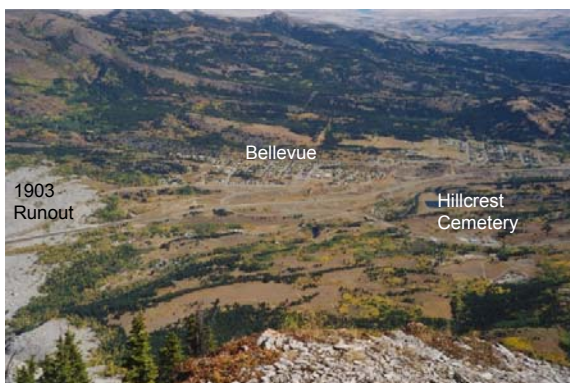
Figure 3. View looking east from South Peak of the potential runout area associated with a future rock avalanche from South Peak.

The area of attendant risk (Figure 3) is bounded by the 1903 Frank Slide runout area, Bellevue to the east, and the Hillcrest cemetery to the south. This area currently contains residences, transportation corridors, recreational facilities, commercial buildings, historic sites, agricultural activities, and utilities. Further development in this area is also possible because there are currently no land use restrictions in place outside the 1903 Frank Slide runout area (BGC 2000).

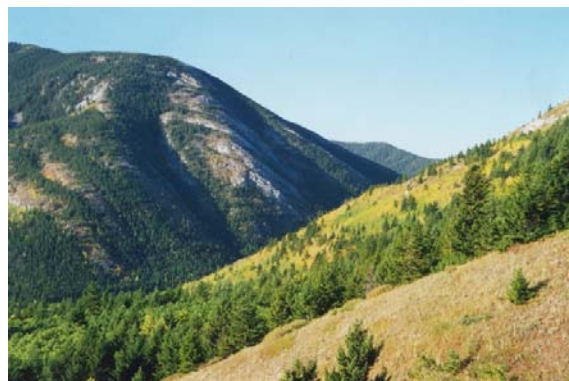
Figure 4. Turtle Mountain Anticline exposed in Hillcrest Mountain looking south across Drum Creek (BGC 2000).

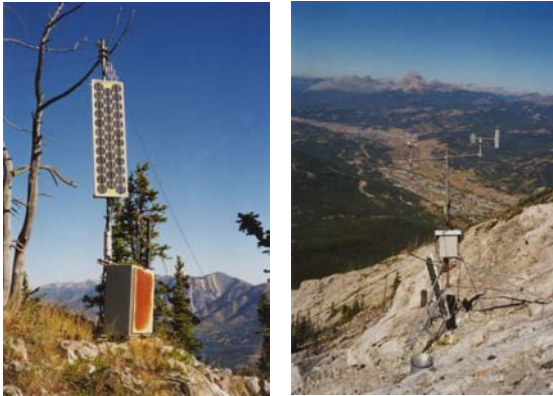
Figure 8. Seismic station (left) and weather station (right) near the summit of South Peak (BGC 2000).

In 1981, Alberta Environment installed a seismic monitoring array on the east flank of Turtle Mountain. The array comprised six seismometers in two linked triangular sub-arrays (Bingham 1996). The system used low power radio telemetry (Figure 8) to transmit data to an acquisition system at the FSIC. The seismic monitoring system recorded nearly 350 local events between 1983 and 1992 from different sources including local earth tremor events, rockfall events, blast events, teleseisms, sonic events, noise, and other unidentified sources.

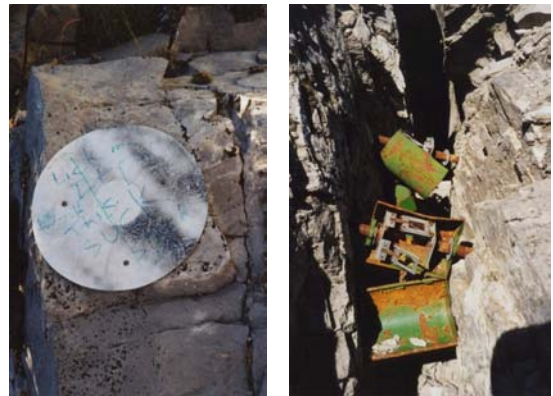
Figure 9: Defaced photogrammetric targets (left) and vandalized Moiré crack gauges (right) observed during the 1999 BGC field investigation (BGC 2000).

Subsequent monitoring of Turtle Mountain included displacement measurements using high-precision photogrammetry (Fraser & Gruendig 1985; Chapman 1986), electronic distance measurement (EDM) surveys (Anderson & Stoliker 1983), and strain gauges (Peterson & Cruden 1986). Meteorological observations were also recorded at a solar-powered weather station (Figure 8) on the mountain. Regular monitoring of Turtle Mountain was discontinued by the early to mid-1990's. Historical instruments and monitoring stations were located and inspected in 1999 as part of a field investigation (BGC 2000). It was found that many of the instruments had been damaged or destroyed (Figure 9).
