Geotechnique and Natural Hazards

A symposium sponsored by
The Vancouver Geotechnical Society and
The Canadian Geotechnical Society
May 6 - 9 , 1992

First Canadian Symposium on Geotechnique and Natural Hazards

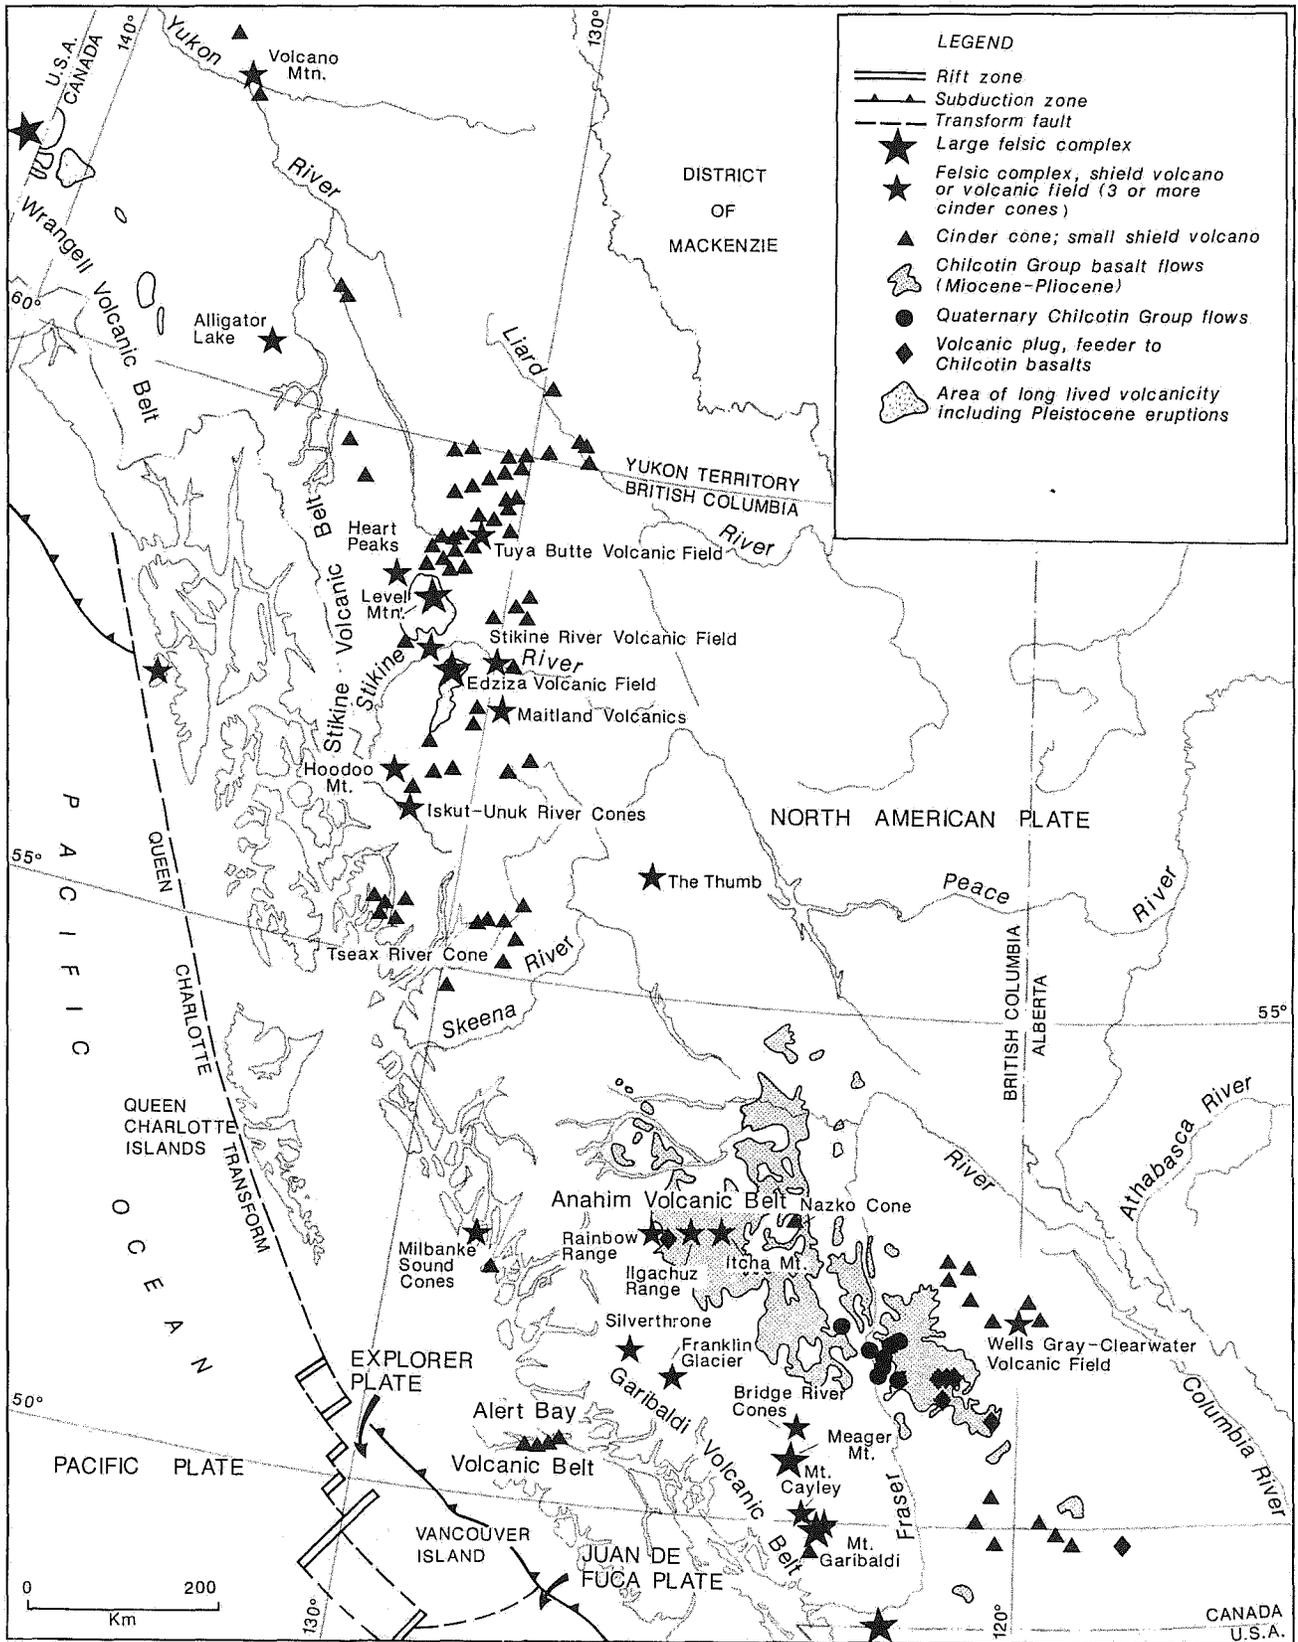
Figure 1 -- Quaternary volcanic vents in the Canadian Cordillera.

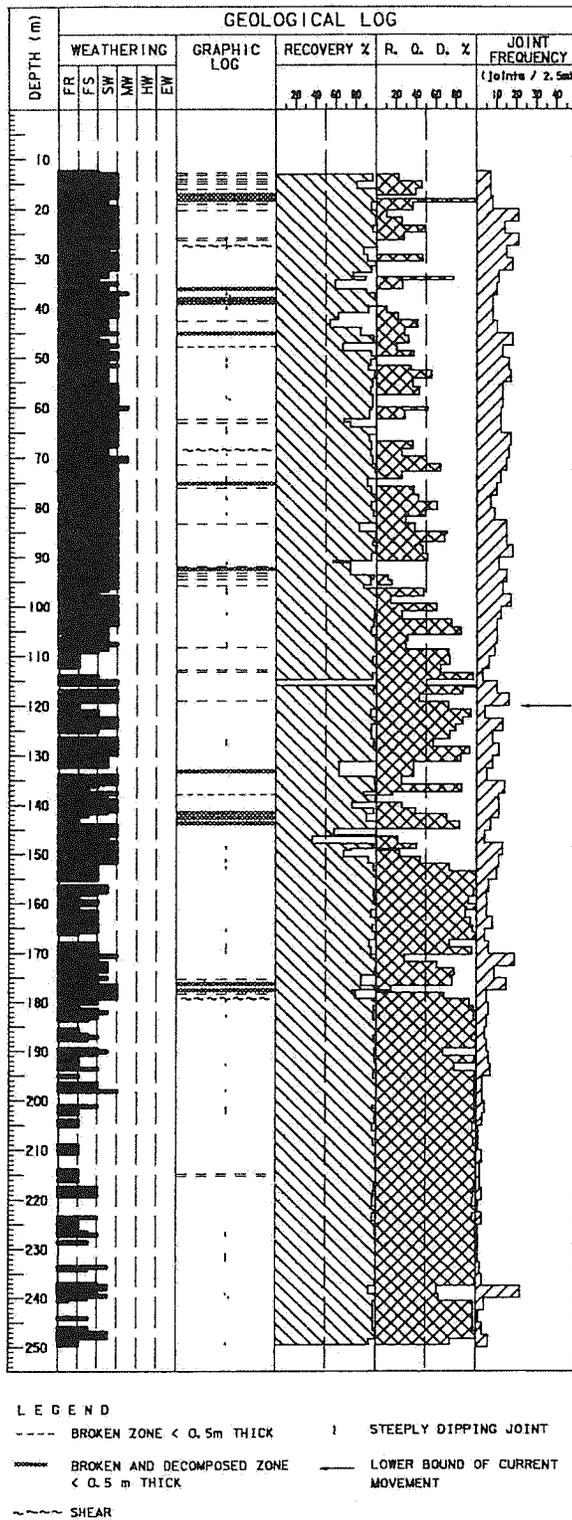
FIGURE 3
TYPICAL GEOLOGICAL LOG
VERTICAL DRILL HOLE (S1)

Shear zones spaced 20 to 40 m apart are generally less than a few metres in thickness but can be continuous for hundreds of metres. Irregular, discontinuous, clayey, gouge zones less than 10 mm thick within a zone of increased fracturing and/or soft granular rock less than a few metres thick are characteristic. The shear zones strike roughly across the slope (+- 45°) and dip steeply. Where seen at depth, the apparent

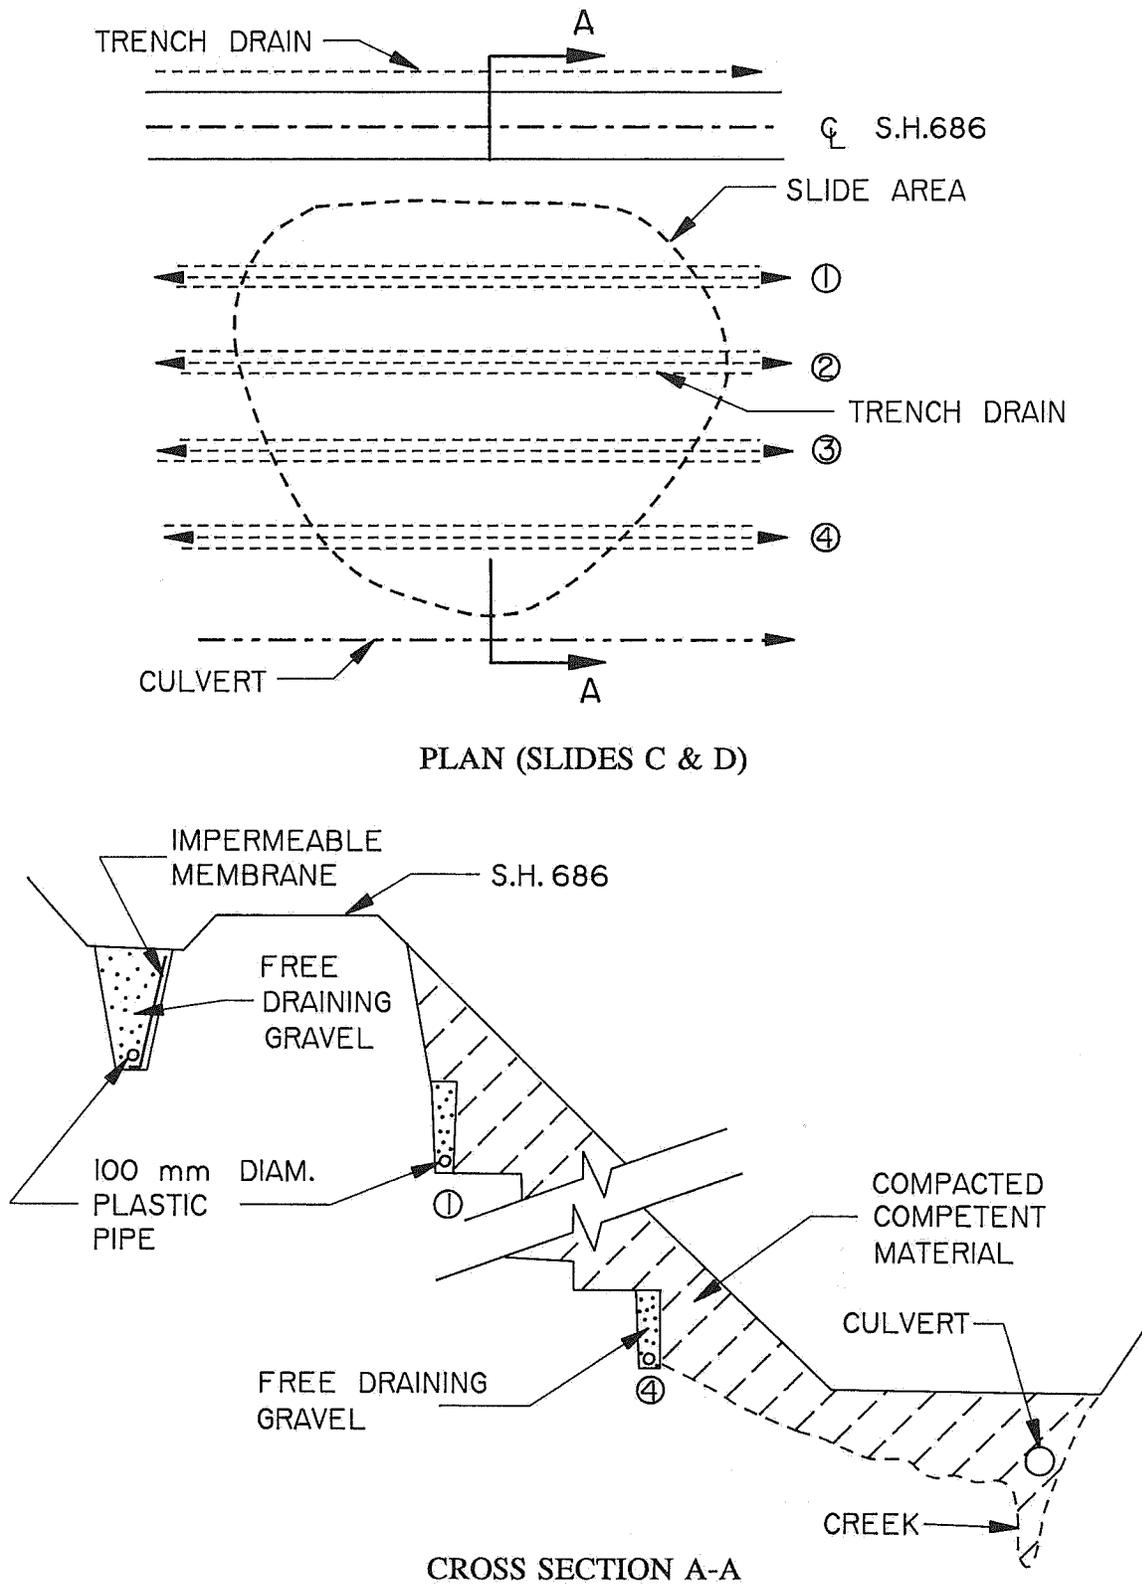
FIGURE 4 SLOPE RECONSTRUCTION & DRAINAGE MEASURES

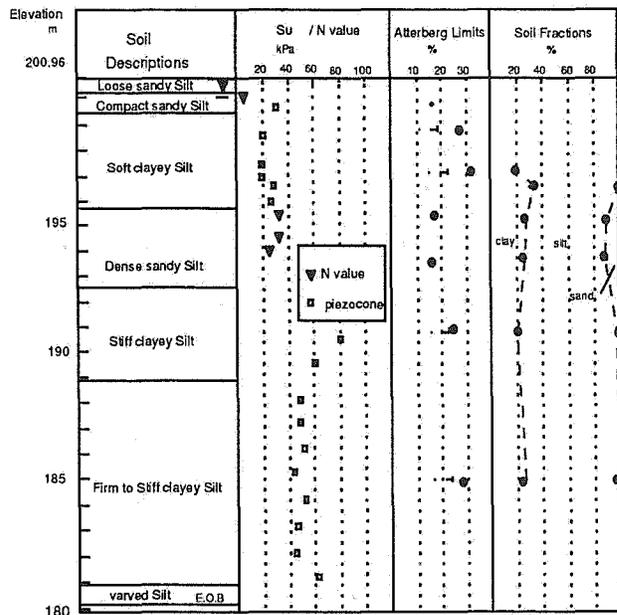
Figure 3c
Borehole 3 Profile

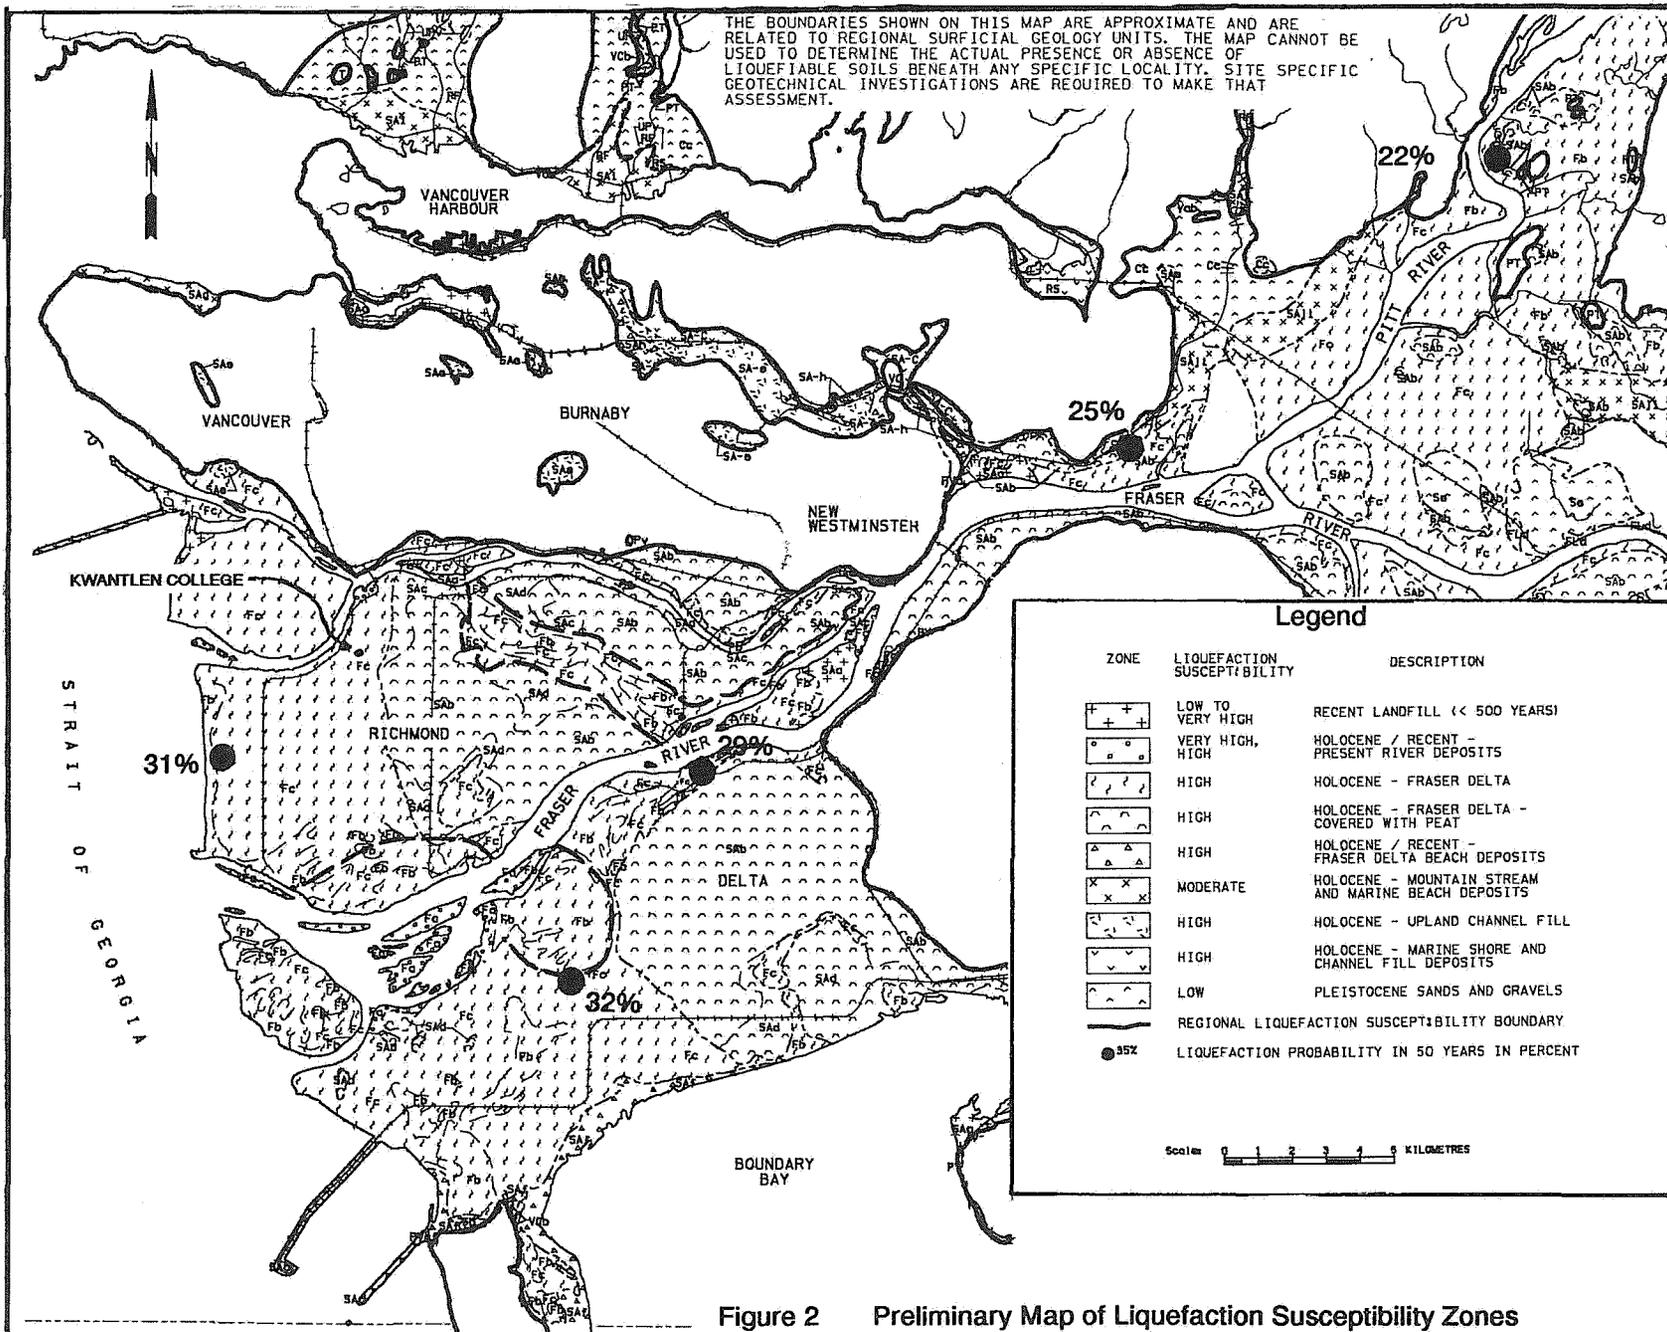
Figure 2 Preliminary Map of Liquefaction Susceptibility Zones

Unit 4 - Peat This organic layer, shown as Units SAb, c, d on Figure 2, varies from 1 to 10 m thick and is found in the eastern portion of the delta. The peat layer typically has a

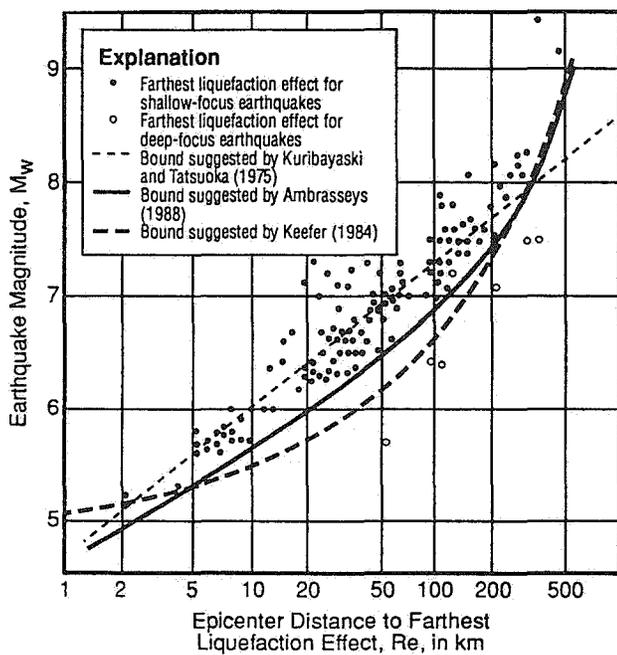
Figure 5 - Magnitude Versus R_e (Youd[3])

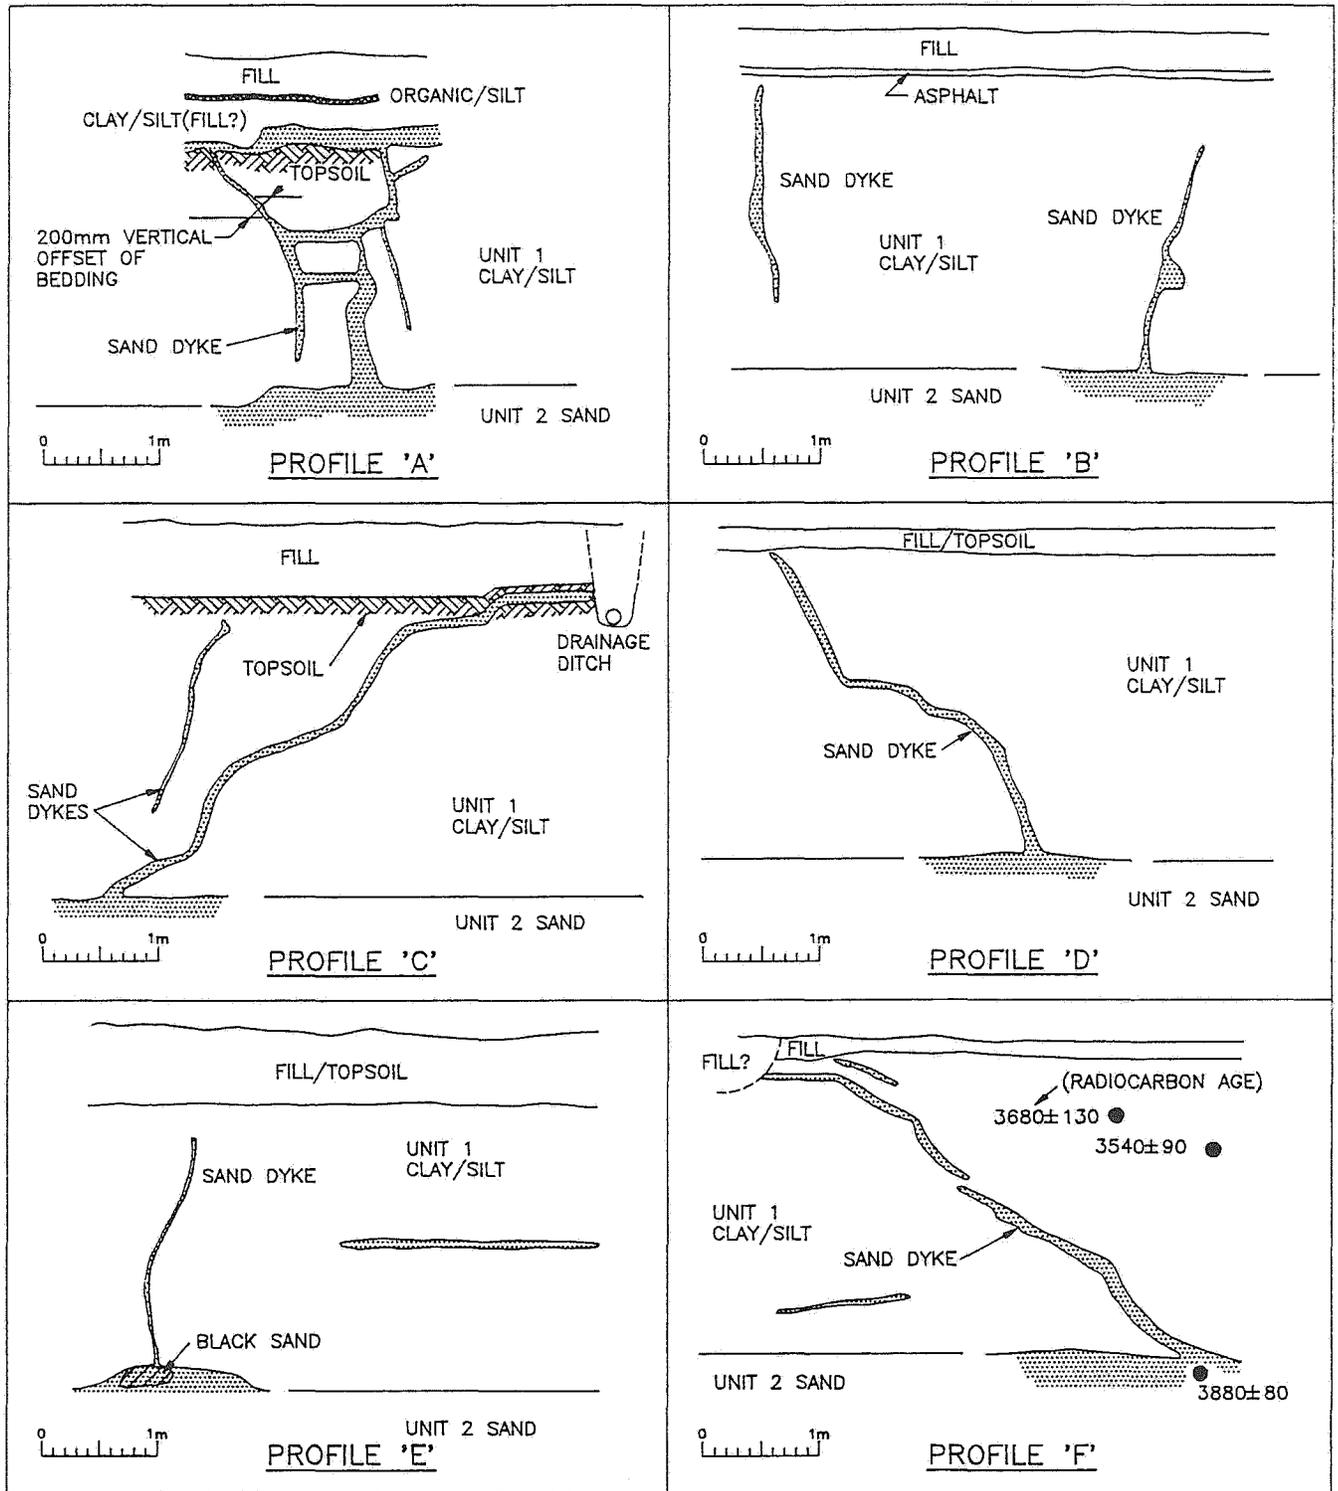
Fig. 4 Profiles of Sand Dykes

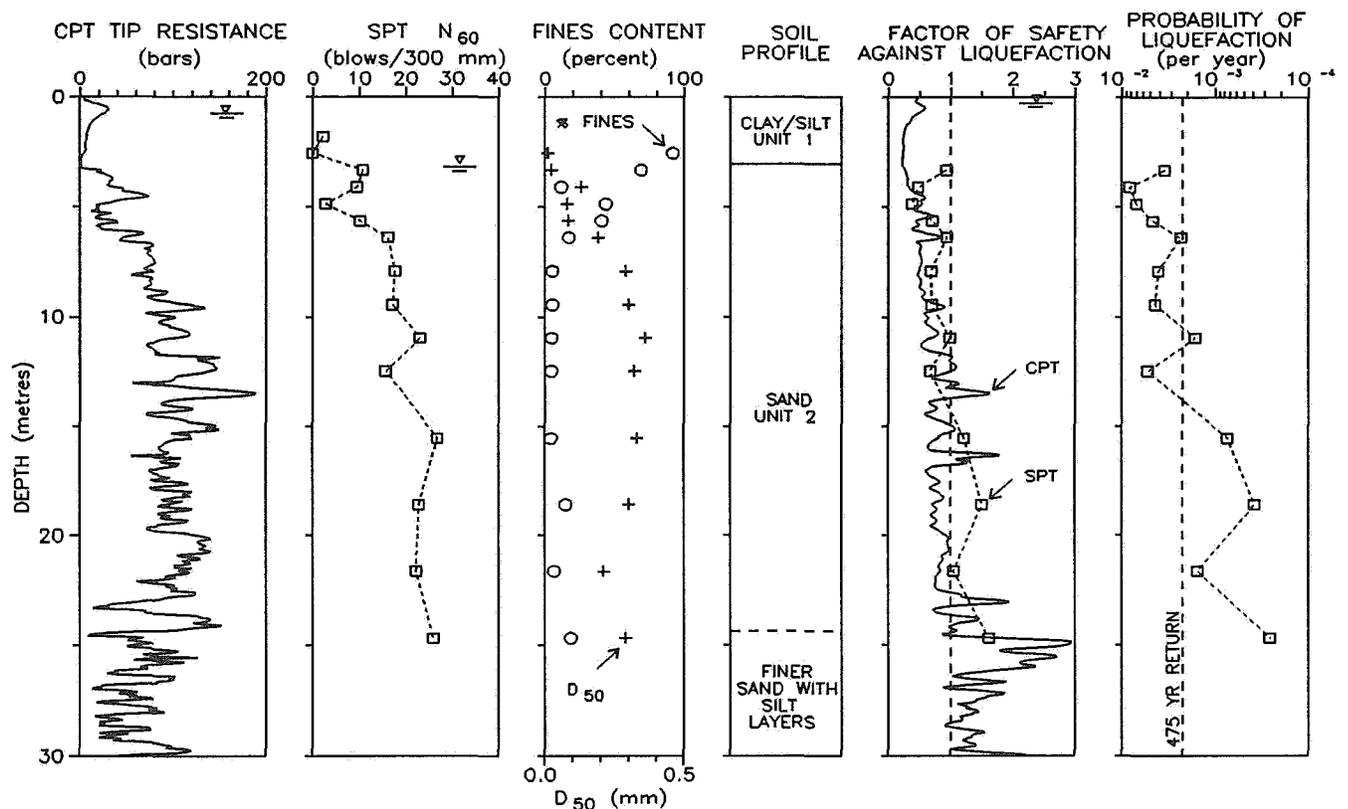
Fig. 6 In-situ Test Data and Liquefaction Potential at Location A

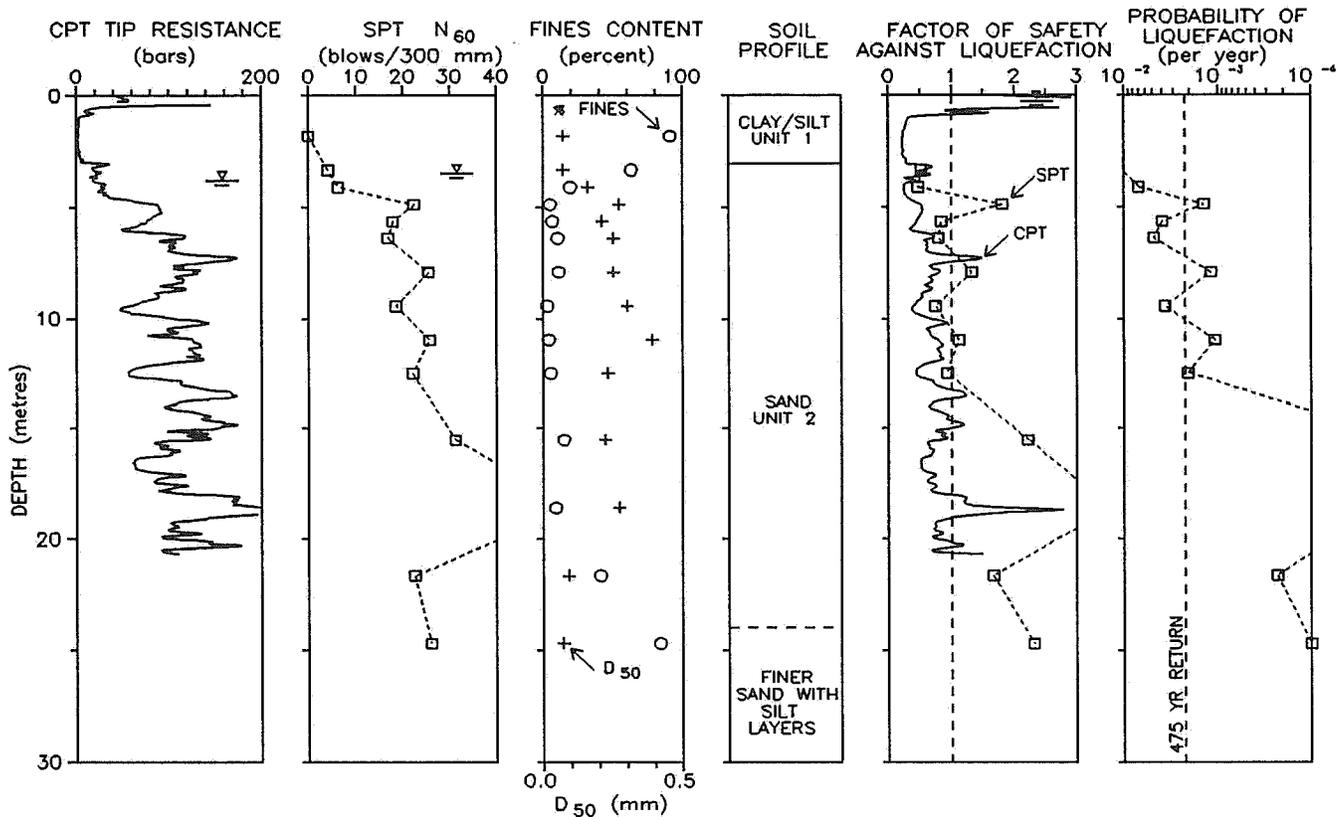
Fig. 7 In-situ Test Data and Liquefaction Potential at Location B

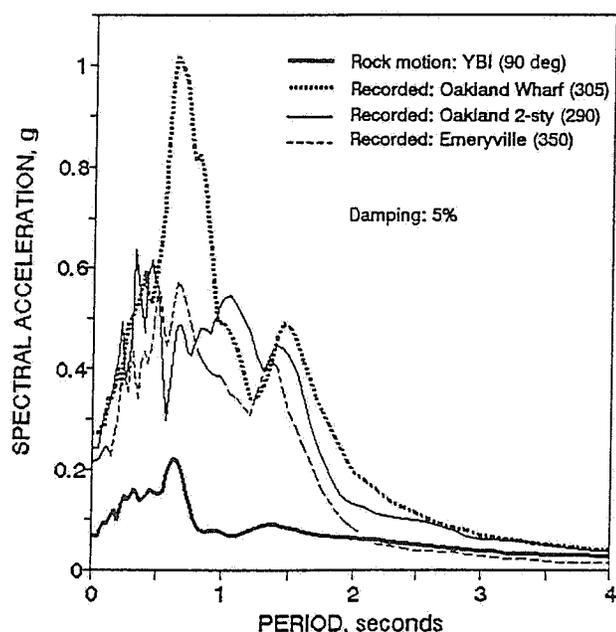
FIG. 3 -- Response spectra for three deep soil sites in the Oakland area: 1989 Loma Prieta earthquake

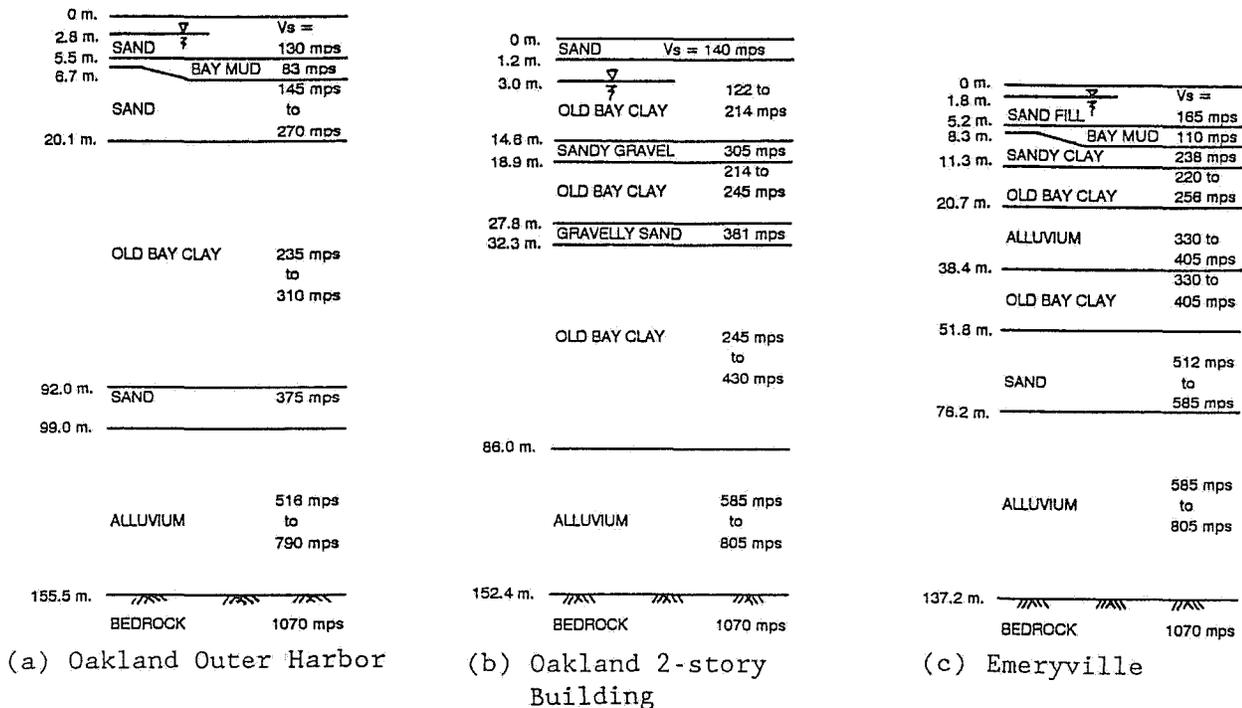
FIG. 4 -- Soil profiles used in dynamic response analyses

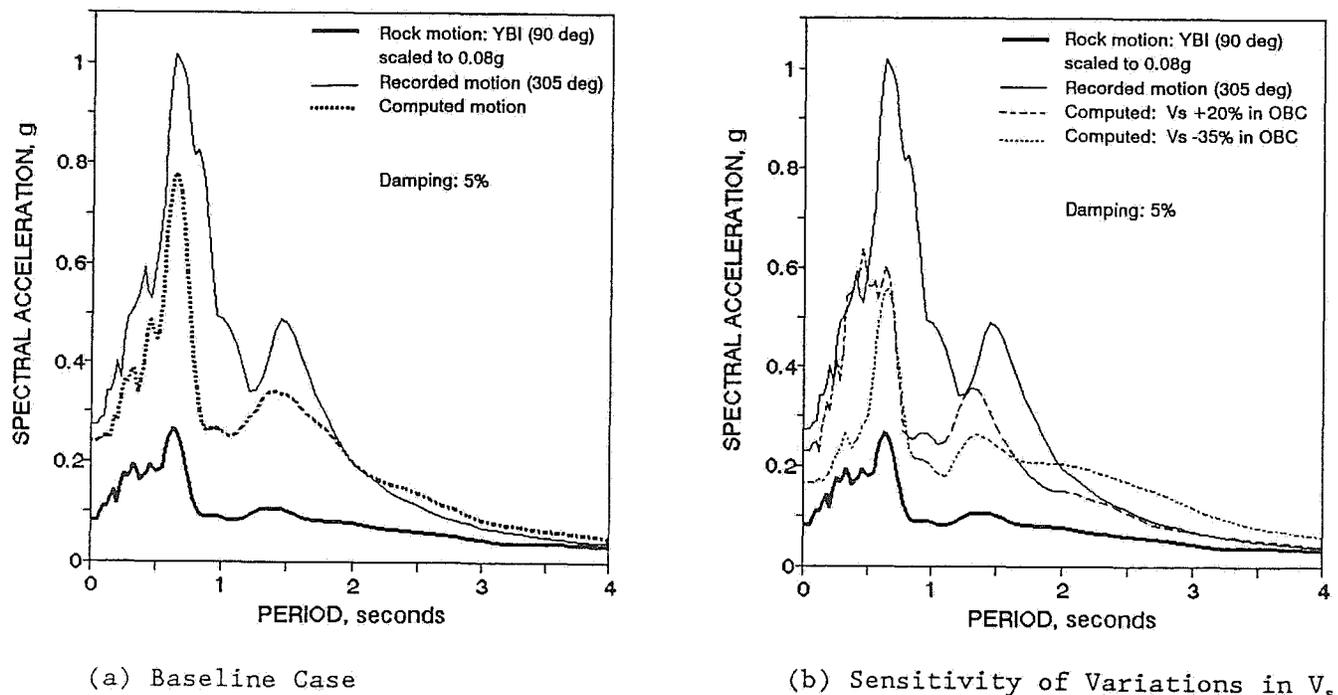
FIG. 5 -- SHAKE computed response spectra: Oakland Outer Harbor

The program SHAKE [13] was employed to investigate the seismic response of the three strong motion sites in the Oakland

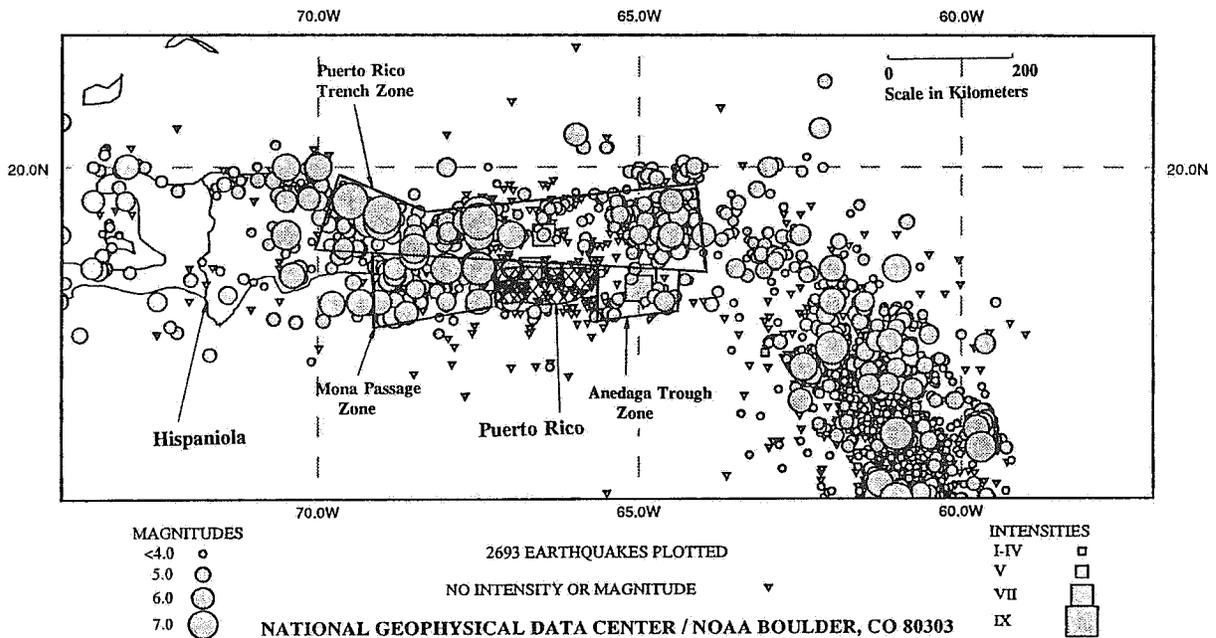
Figure 2. Regional earthquake activity and designated area sources.

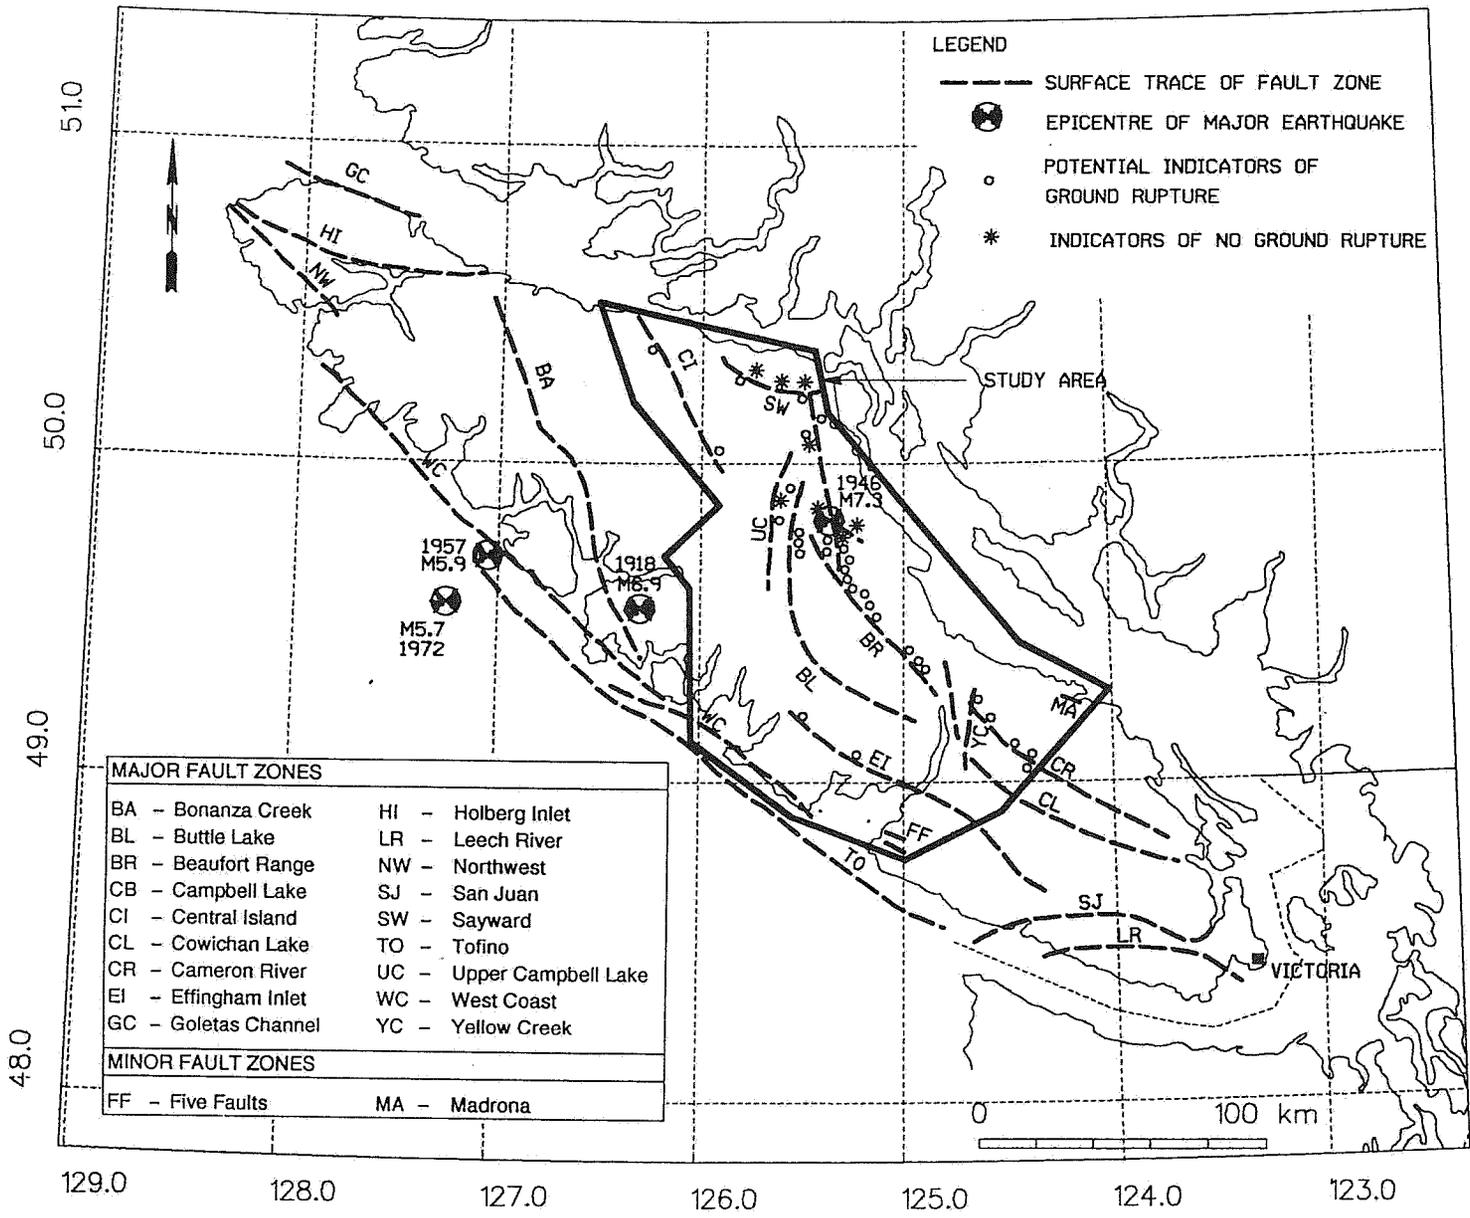
FIG. 1 - Major fault zones on Vancouver Island, major recorded earthquakes near study area, and potential indicators of ground surface rupture or no ground surface rupture within study area.

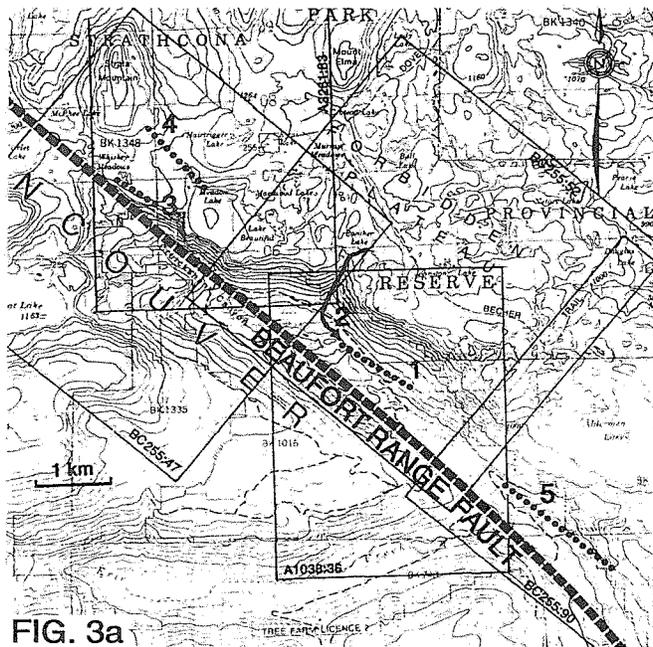
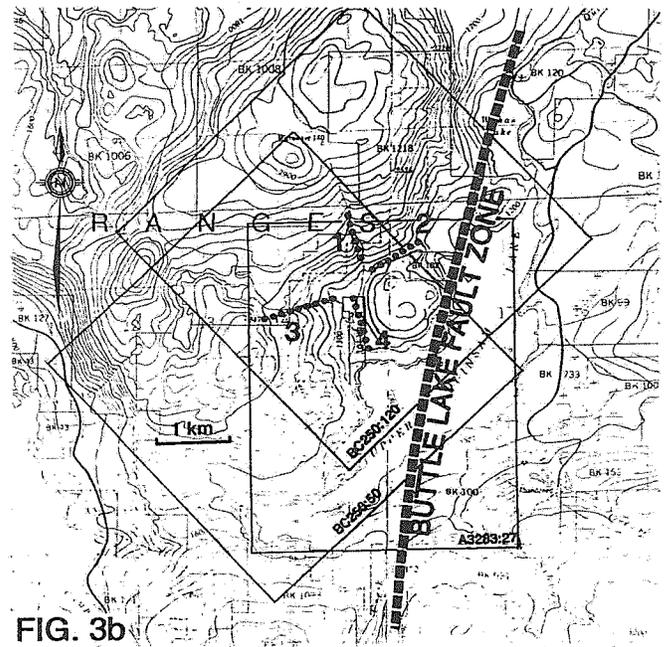
FIG. 3a

FIG 3 - Typical features possibly indicative of recent ground surface offset. Fig 3a: Beaufort Range Fault Zone, map ref. NTS 92F/11. Large antislope scarp (1), aligned with short reach of creek (2); fresh-looking scarp (3). Other lineations are: linear clearing of trees (4); lineation ending in small rock canyon (5). Fig 3b: Buttle Lake Fault Zone, map ref. NTS 92F/13. Distinct lineations (1 to 4) forming a conjugate fracture system, with no. 2 appearing as a very fresh-looking scarp in both 1946 and 1931 photos.

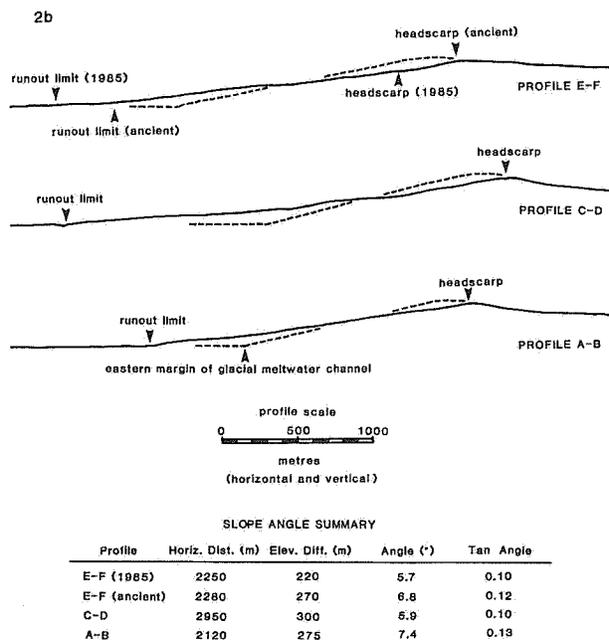
Figure 2: Little Doctor Lake Slide site map (a) and profiles (b)

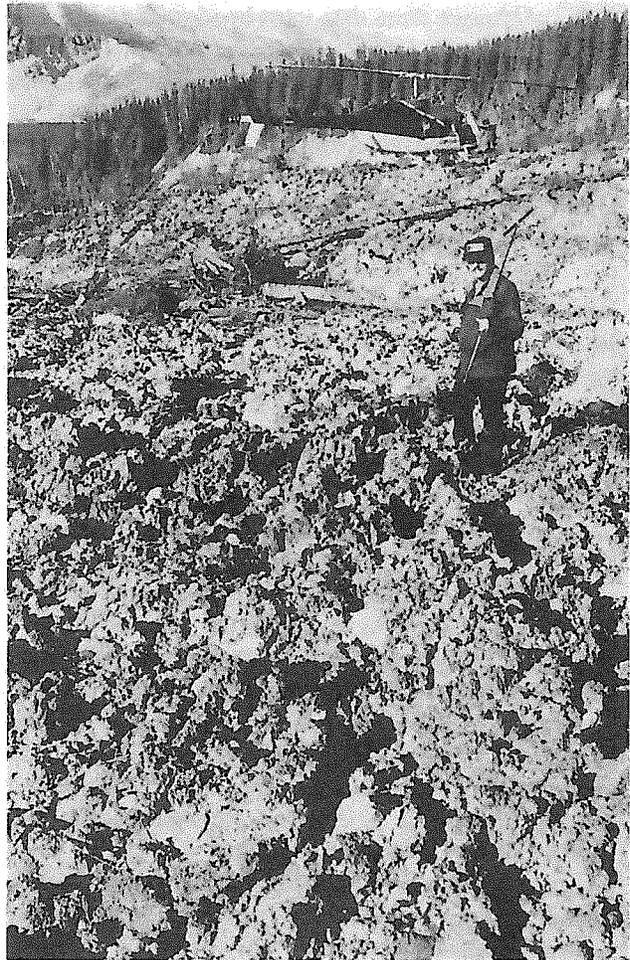
Figure 4: Ground surface at the approximate midpoint of the 1985 slide.

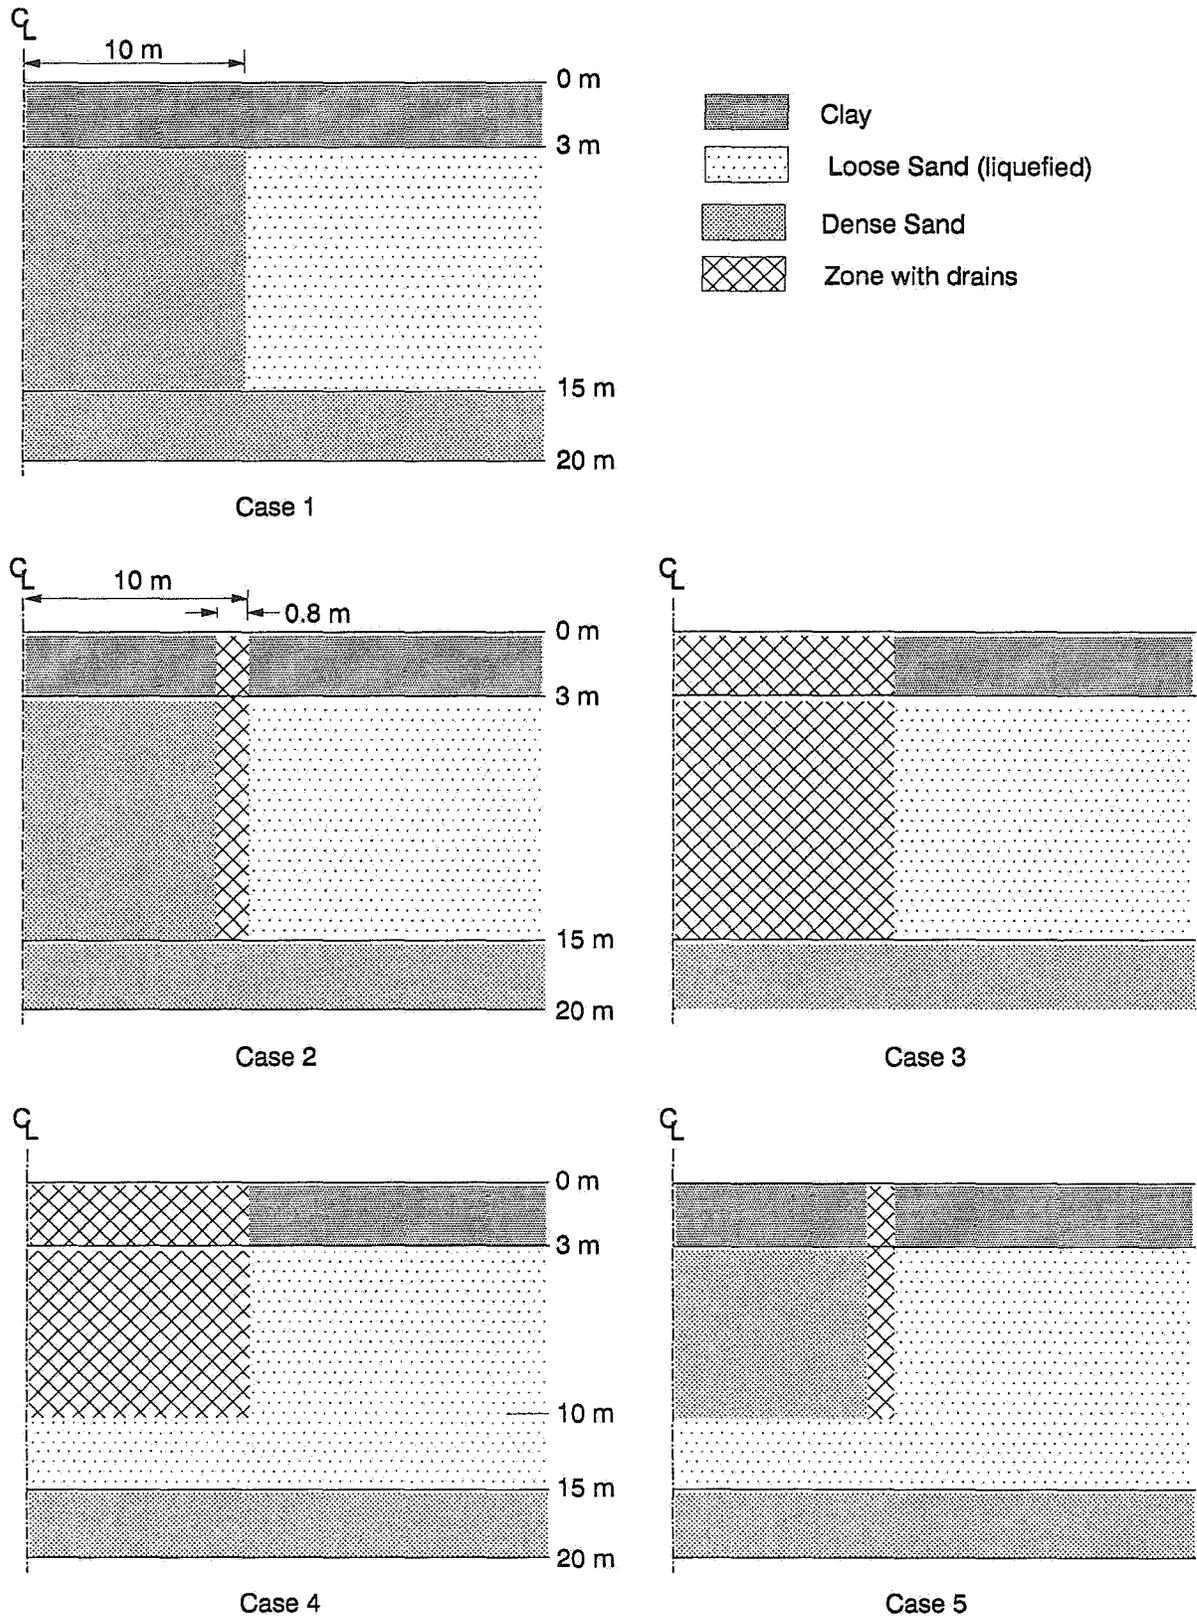
Fig. 2. Details of the Cases Analyzed

Case 1 - Densification was assumed to the full depth in the loose sand (15 m). No drainage system was assumed. This case may represent a field condition where densification is achieved using timber piles without any drainage provisions.

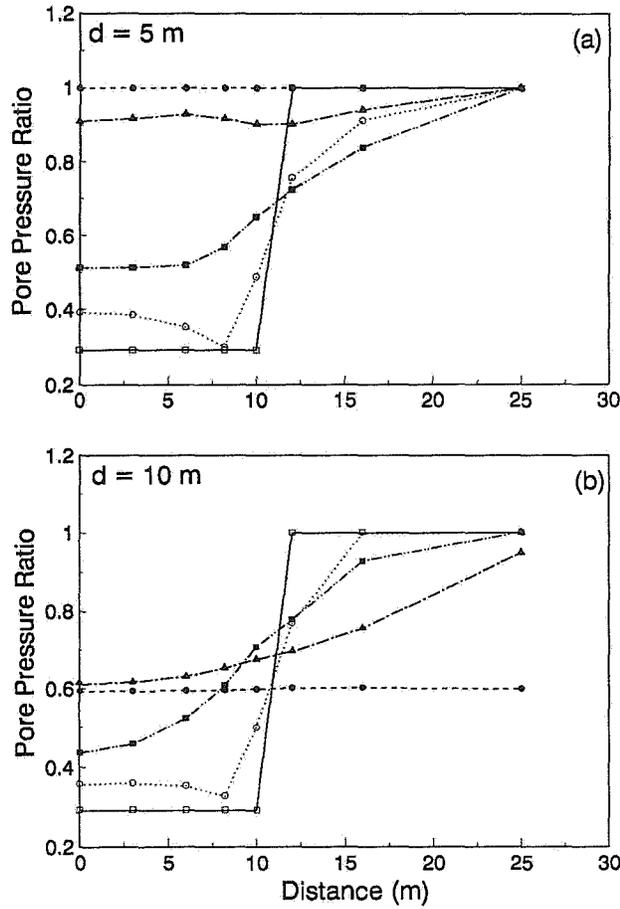
Fig. 3. Variation of Pore Pressure Ratio for Case 1

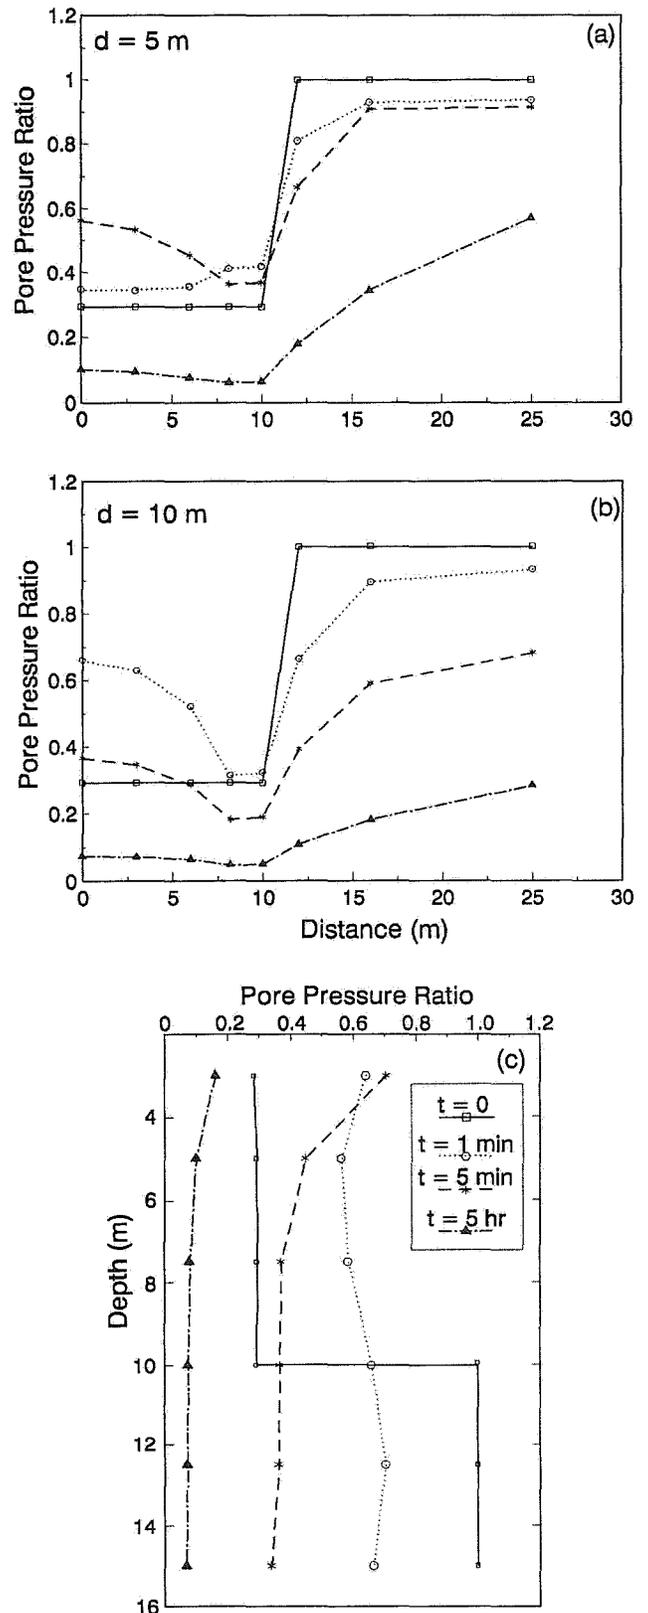
Fig. 7. Variation of Pore Pressure Ratio for Case 5
