Geotechnique and Natural Hazards

A symposium sponsored by
The Vancouver Geotechnical Society and
The Canadian Geotechnical Society
May 6 - 9 , 1992

First Canadian Symposium on Geotechnique and Natural Hazards

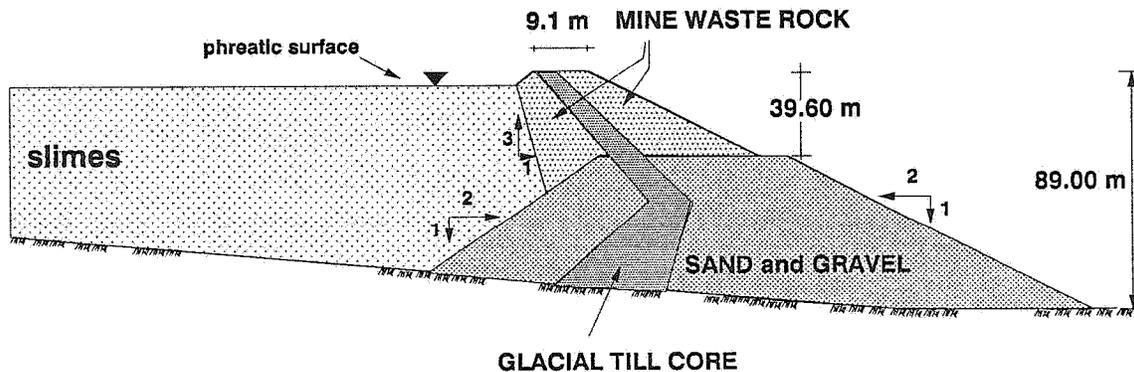
Fig. 1. Geometry and soil types of the tailings dam.

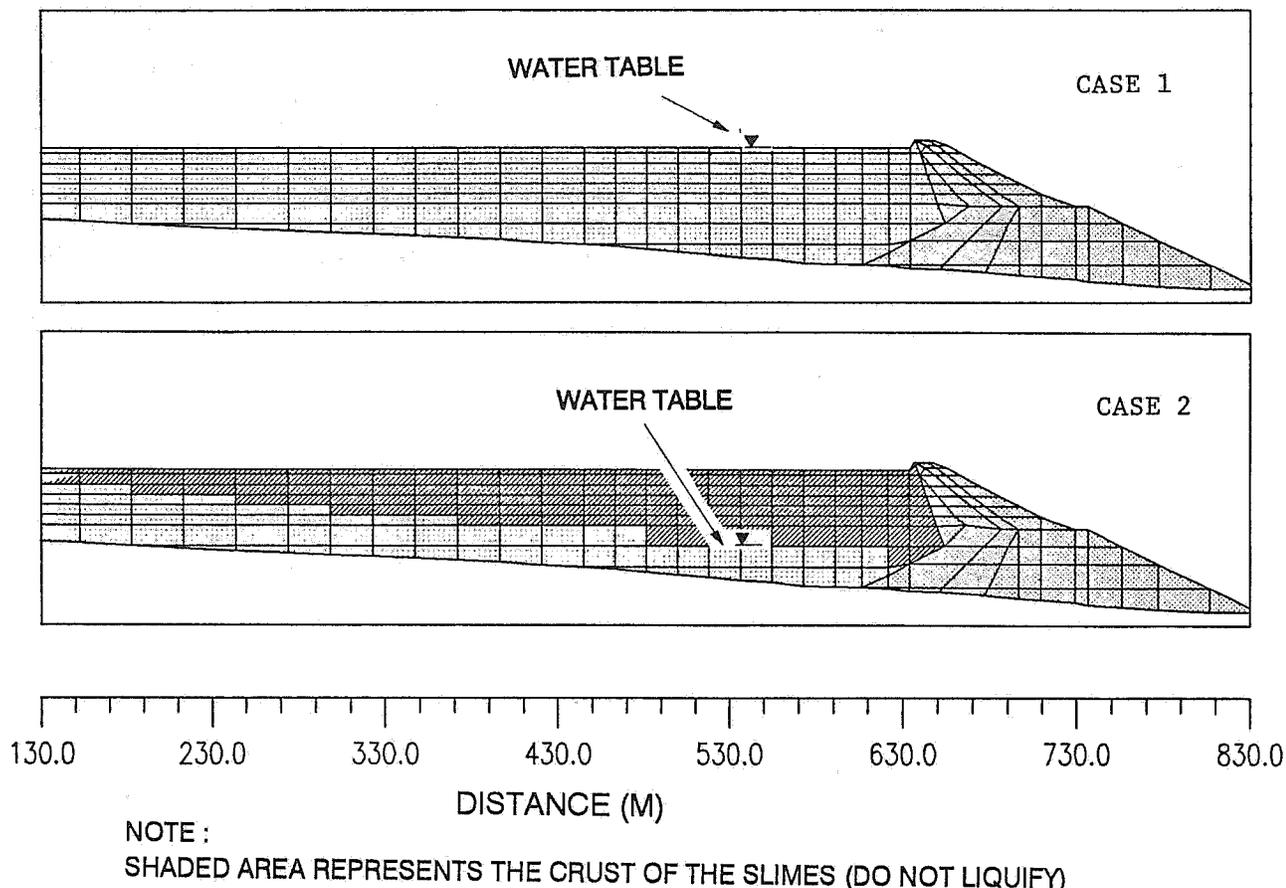
Fig. 3. Finite element mesh, soil types and groundwater conditions.

Peak horizontal ground accelerations ranging from 0.2g to 0.6g were considered with corresponding peak ground velocities of 0.2 and 0.6 m/second. Tailings to the full height were examined with the water table at the surface as well as several lower levels. Only two water table conditions will be shown here: *Case 1* - Water table at the surface of the tailings; and *Case 2* - the lowest water table considered. The finite element mesh, the soil types, and the water table for these two conditions are shown in Fig. 3. It is assumed that tailings above the water table will not liquefy and that tailings below the water table will liquefy to the base of the impoundment. The zones of liquefaction are shown in Fig. 3 for both cases.

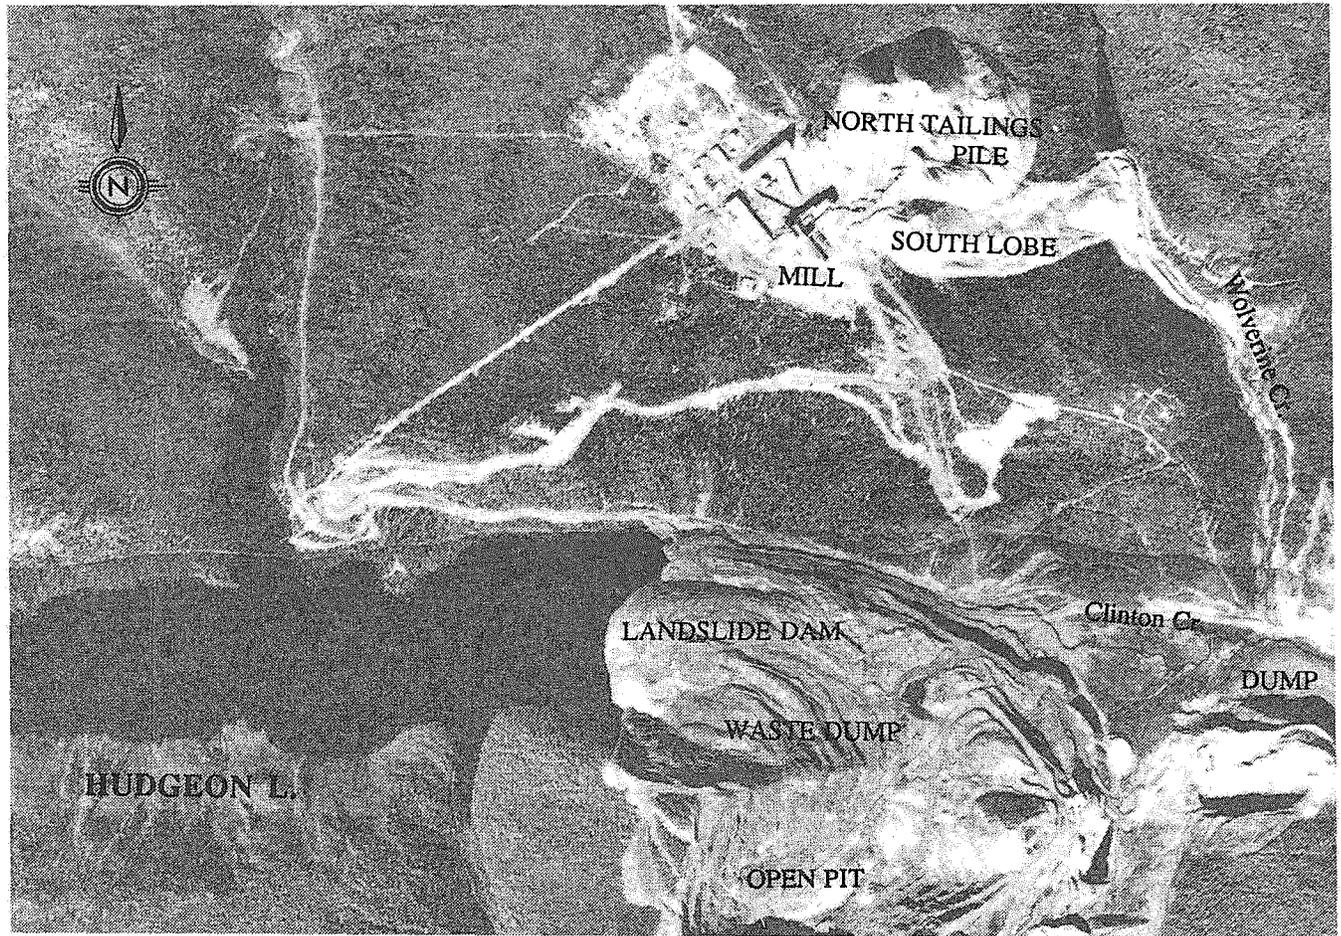
Photo 2: Aerial photograph of the mine area in 1976 showing Hudgeon Lake and blockage of the Wolverine Creek valley by the failure of the south tailings pile.

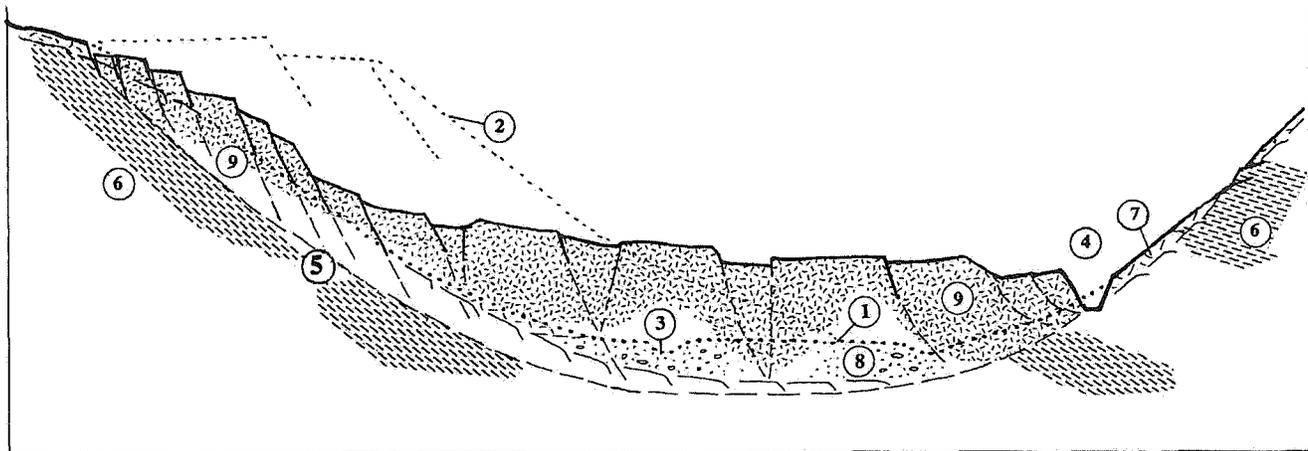
Figure 2: Clinton Creek Landslide Dam, looking upstream.
 1- original ground surface, 2- initial configuration of waste dump, 3- original creek channel, 4- present creek channel, 5- probable slip plane, 6- bedrock (shale), 7- colluvium, 8- alluvium, 9- slide debris

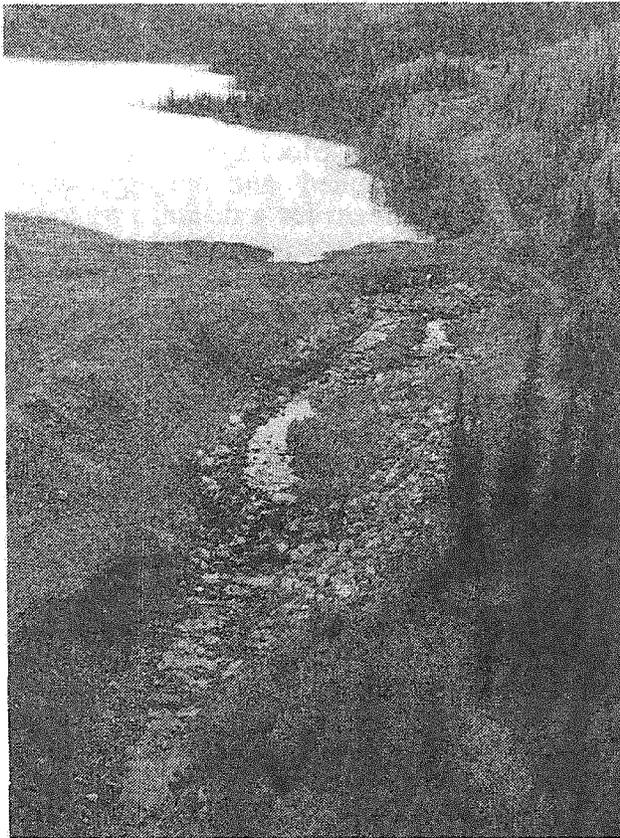
Photo 3: View of the Hudson Lake outlet and armoured channel.

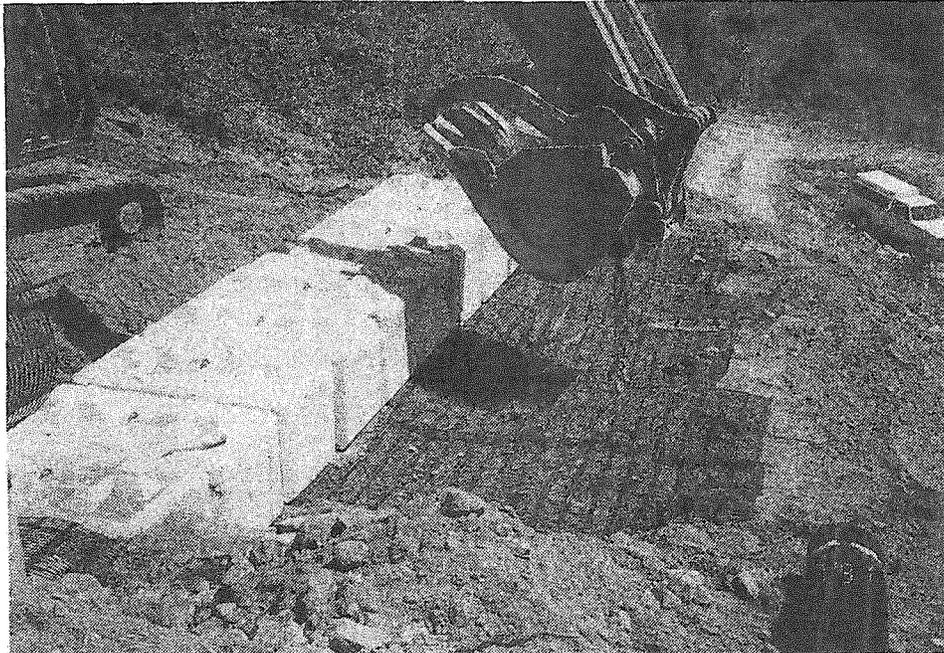
Fig. 6. Installation of Concrete Lock-Blocks and Tensar Geogrid

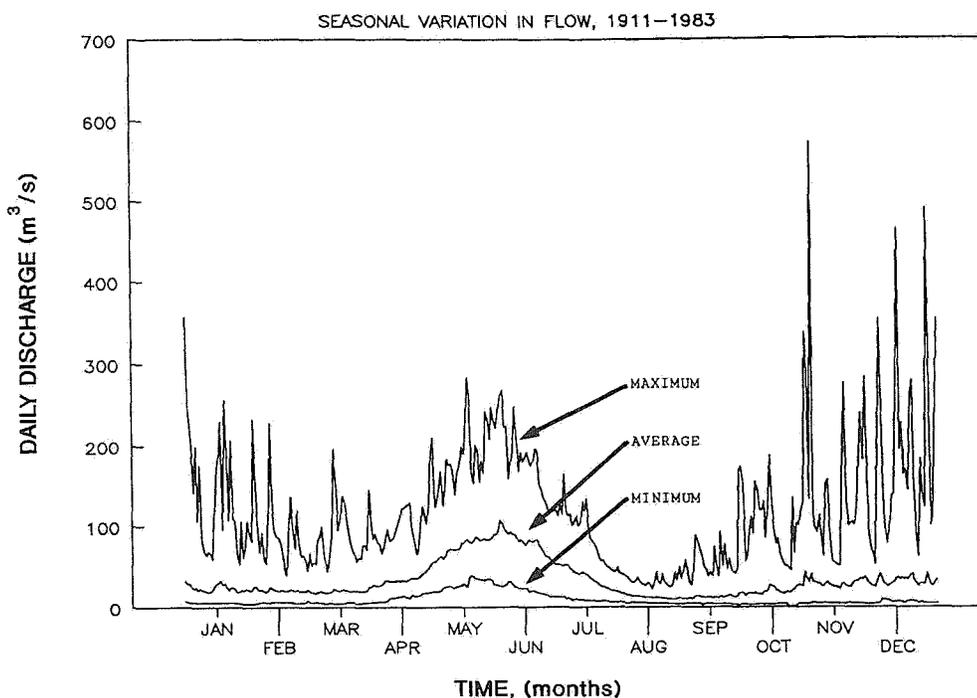
Figure 1 - Seasonal variation in discharge, Coquihalla River near Hope.

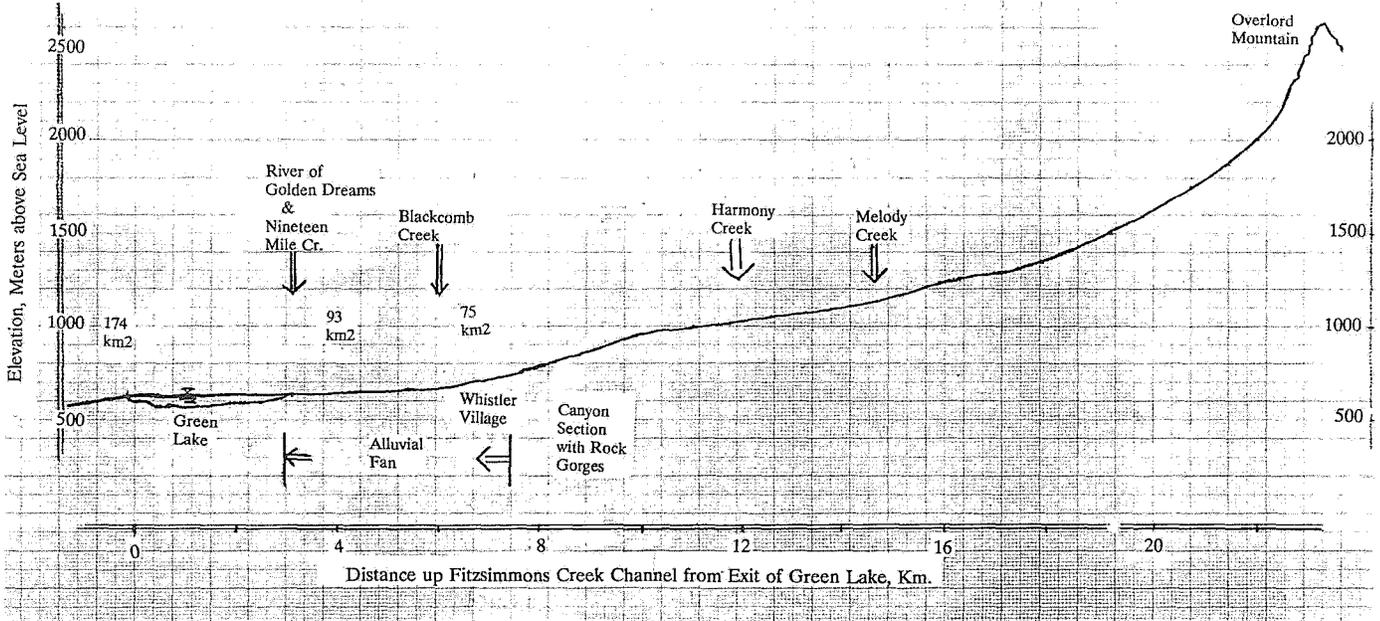
Figure 1. Profile of Fitzsimmons Creek, Whistler, British Columbia

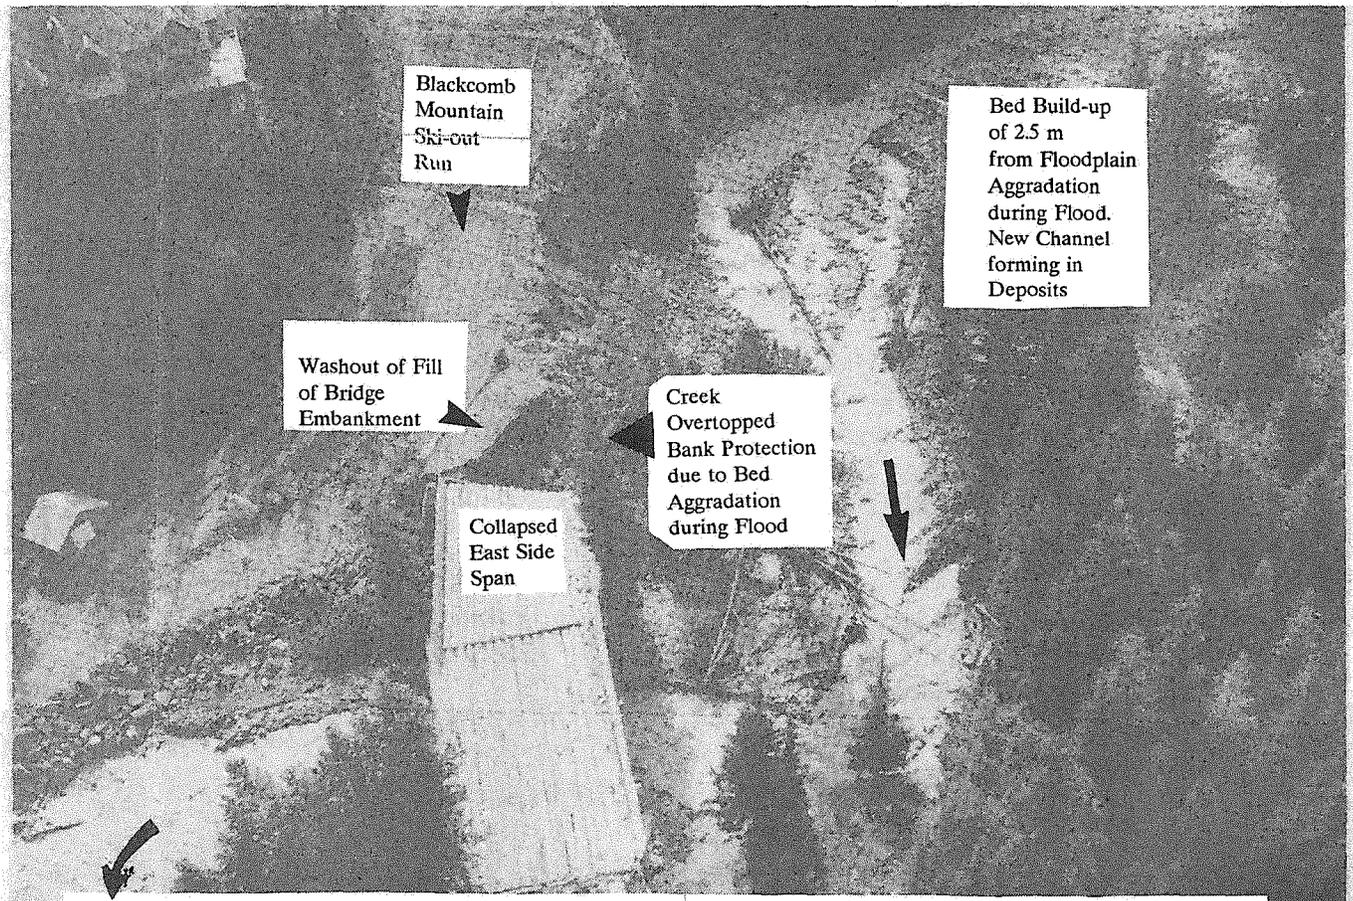
Figure 3. Failure of Fill Embankment and Abutment of Skier Bridge, Whistler, B.C.

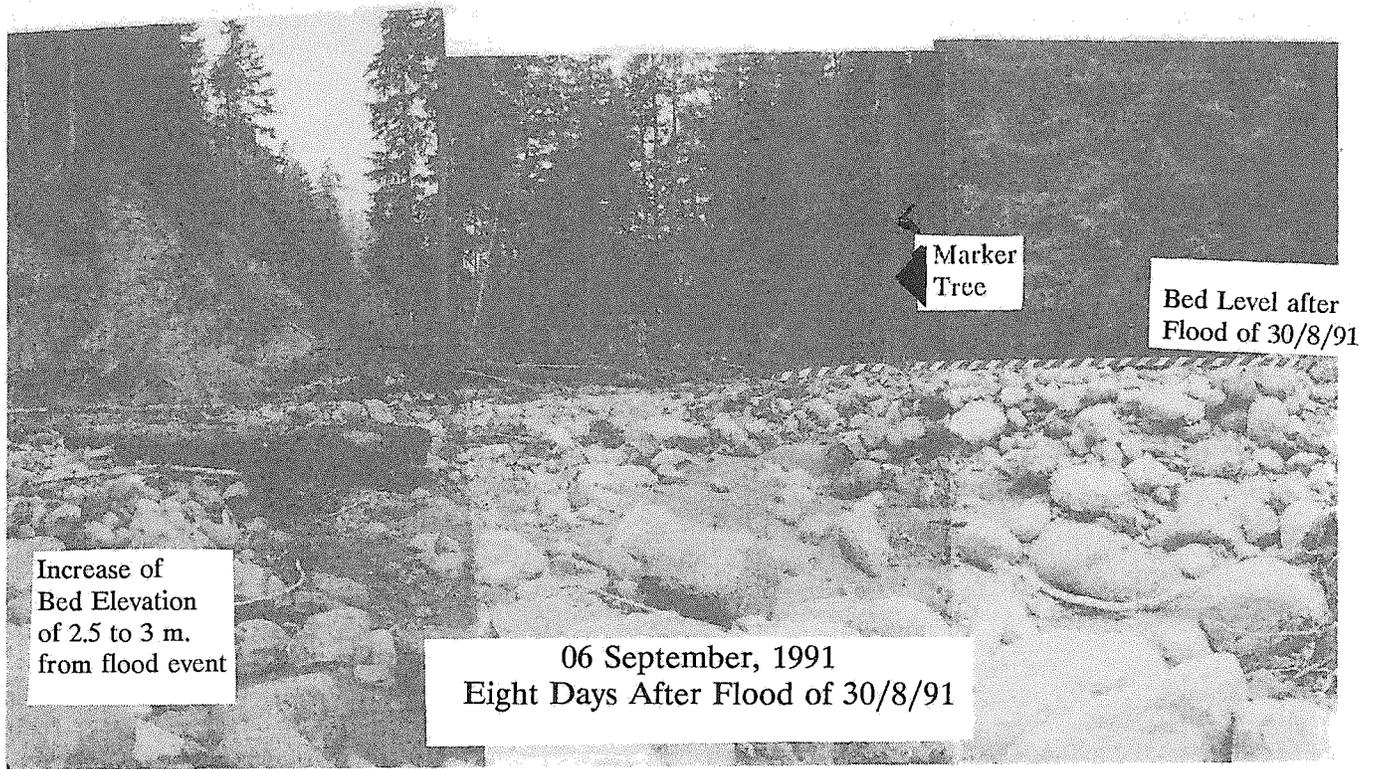
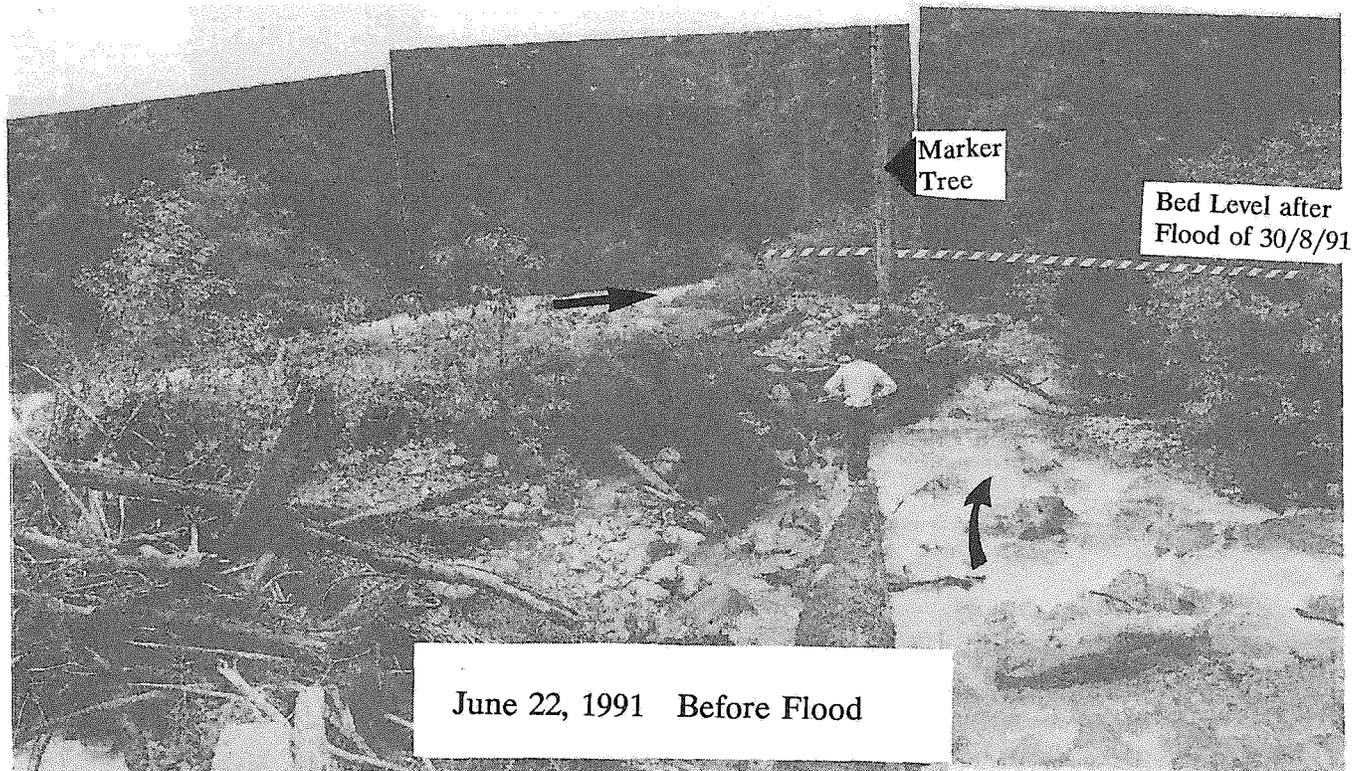
Figure 2. Bed of Fitzsimmons Creek in Canyon Section, 450 m Upstream of Skier Bridge

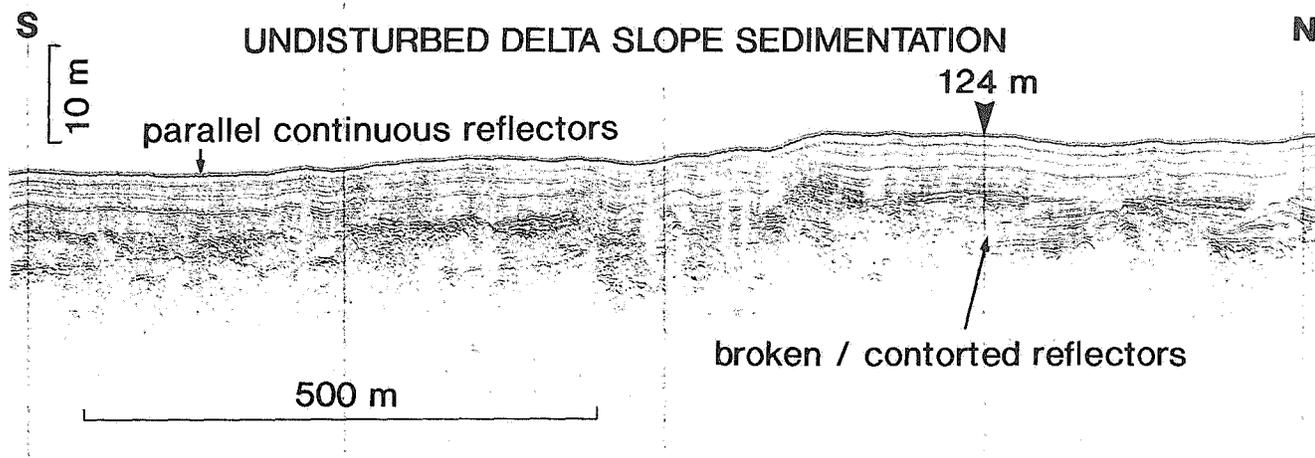
Fig. 2. Hunttec high-resolution seismic record showing parallel continuous reflectors typical of undisturbed delta slope sediments.

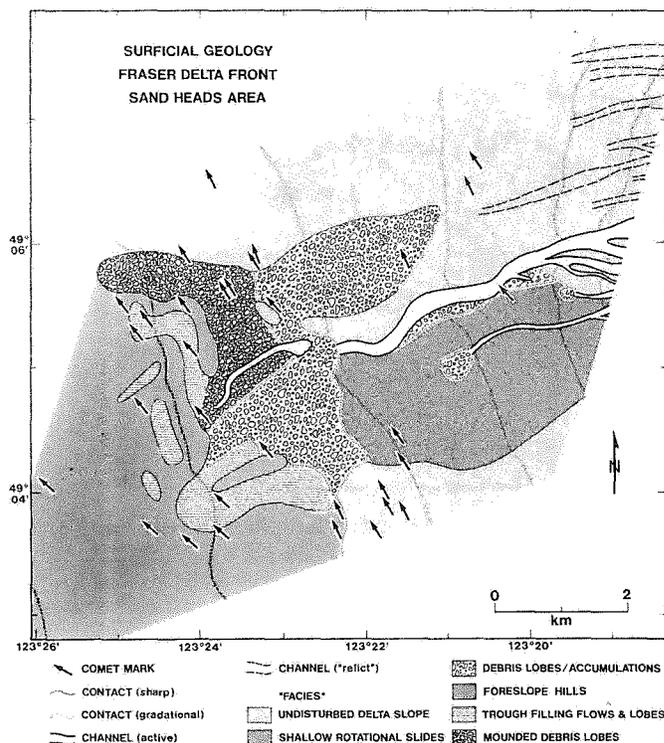
Fig. 3. Surficial geology map of submarine channel and failure complex seaward of Main Arm. The slope is dissected by a series of "active" and "relict" submarine channels, with sandy density flow deposits at the base of the active channels. Further explanation provided in [12].

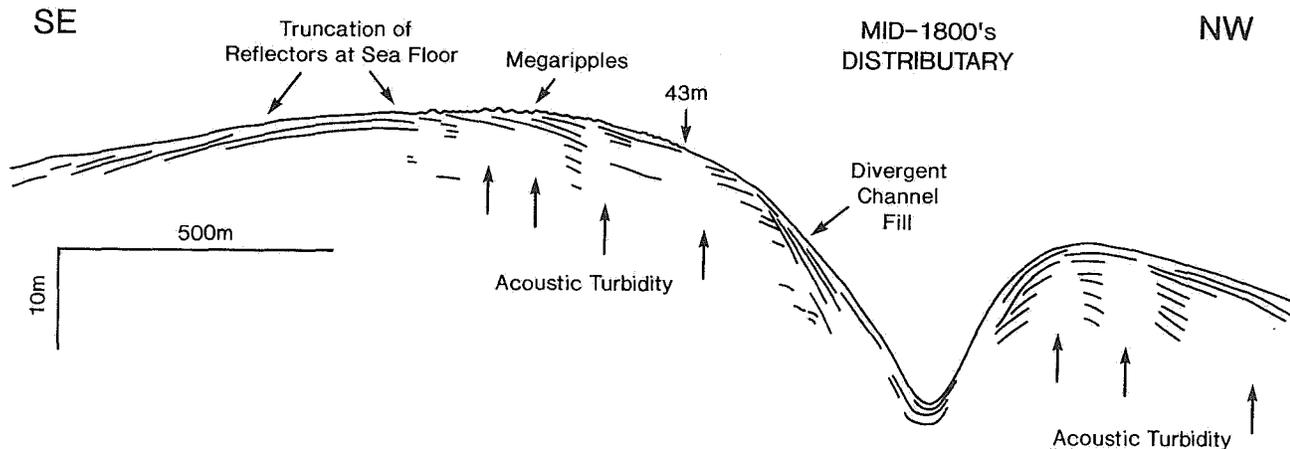
Fig. 4. Interpretation of Huntco high-resolution seismic profile showing delta slope channel cross-section on Roberts Bank, seaward of former main channel position in mid-1800's [9]. Note truncation of reflectors at the seafloor, and divergent geometry of channel fill muds.

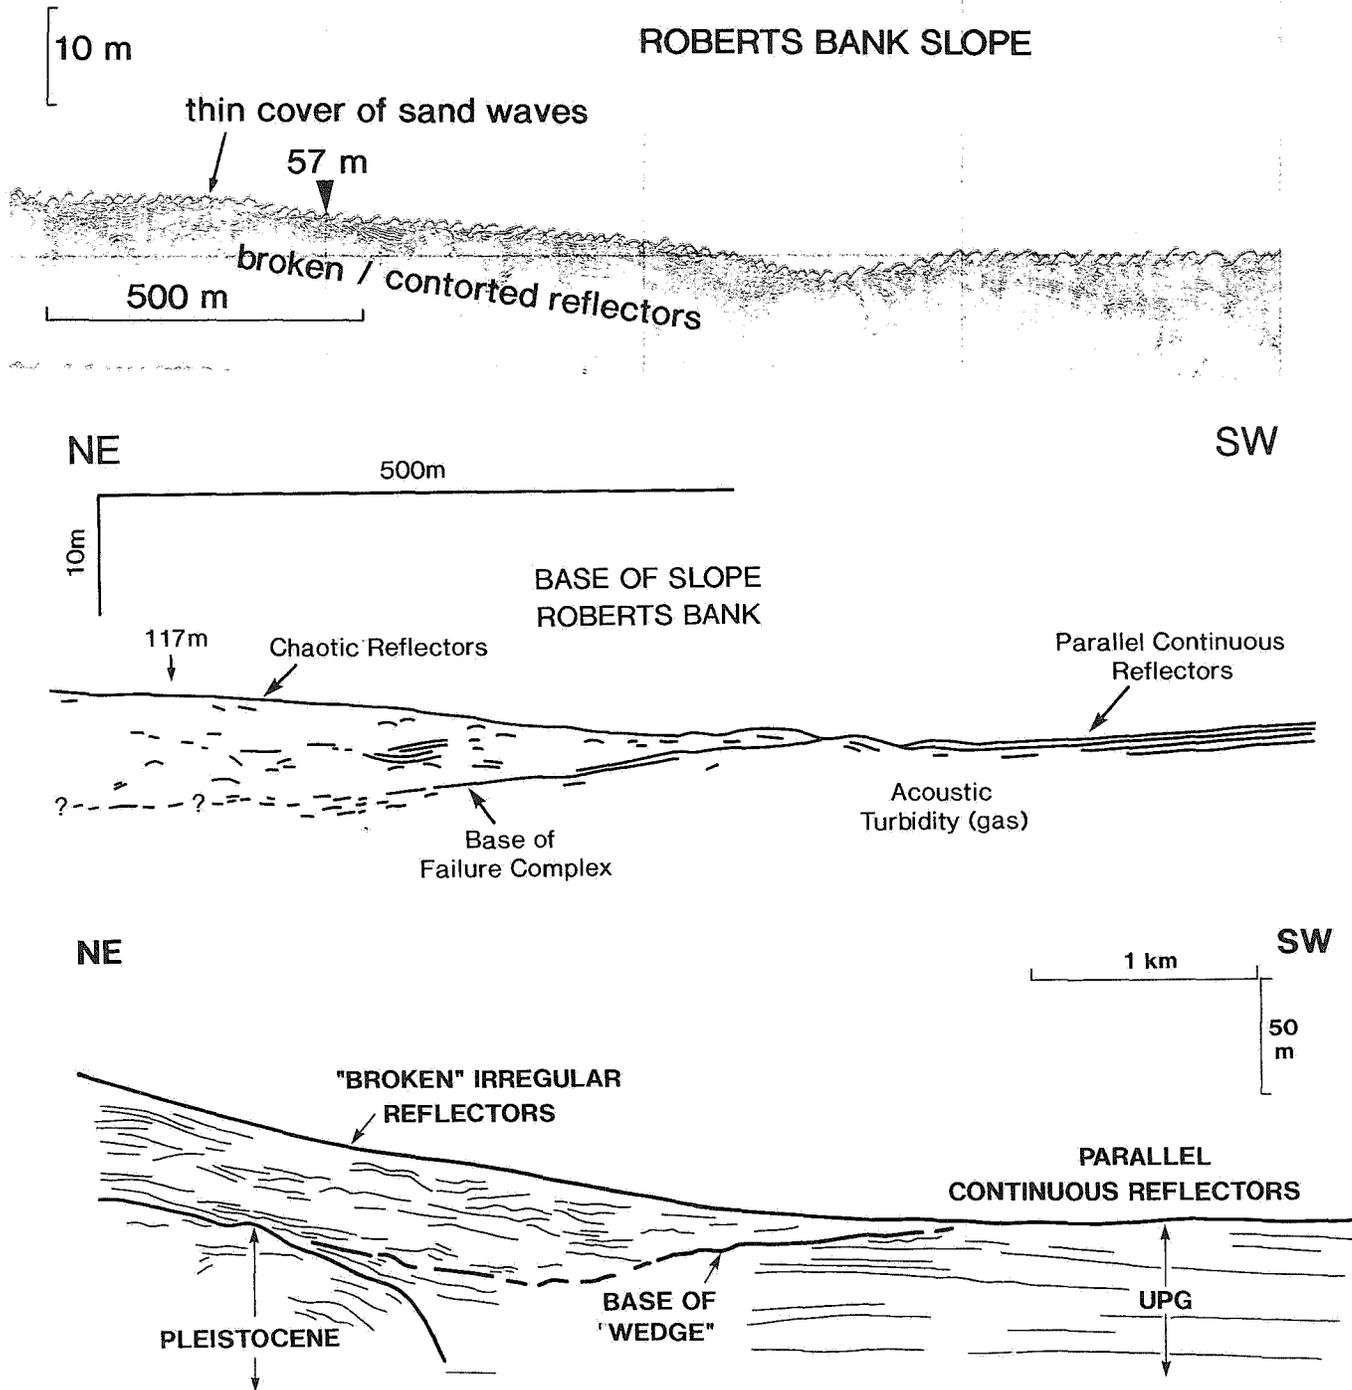
Fig. 5. a) Huntex high-resolution seismic profile over sandwave field showing "thin skin" of sandwaves over contorted parallel reflectors. b) Interpretation of Huntex high-resolution seismic profile of failure deposits (chaotic reflectors) at base of southern Roberts Bank slope. Chaotic reflectors overlie parallel continuous reflectors. c) Interpretation of airgun seismic record of Roberts Bank slope showing wedge-like feature, at least the upper portions of which are failure deposits.

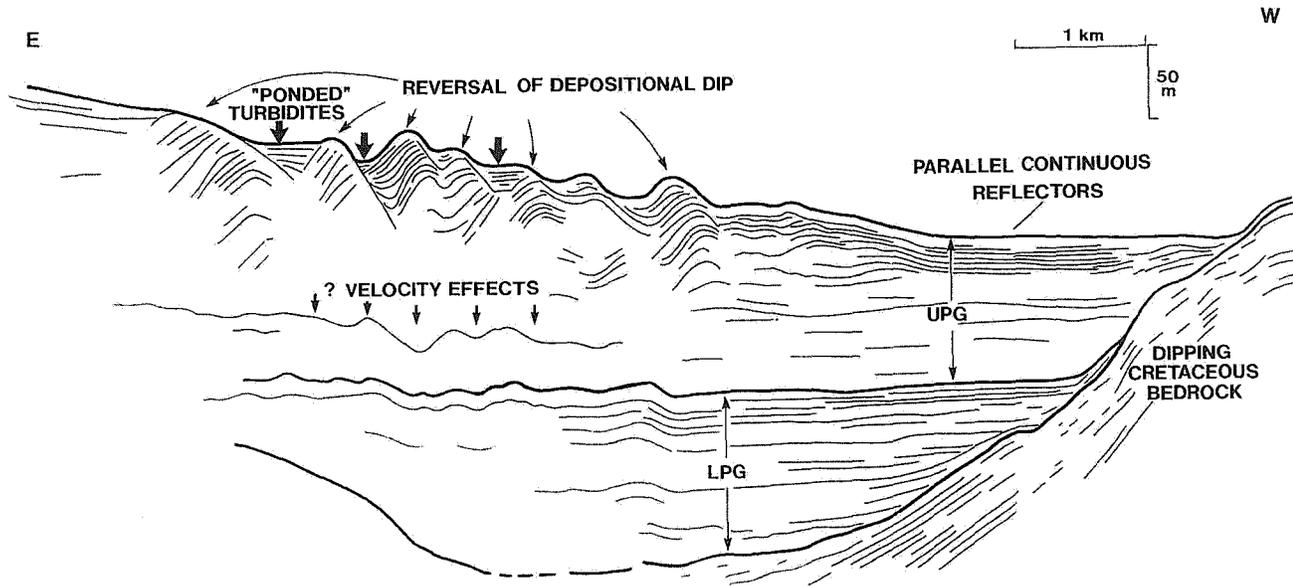
Fig. 6. Interpretation of airgun seismic profile showing internal structure of Foreslope Hills. See [14] for further description.

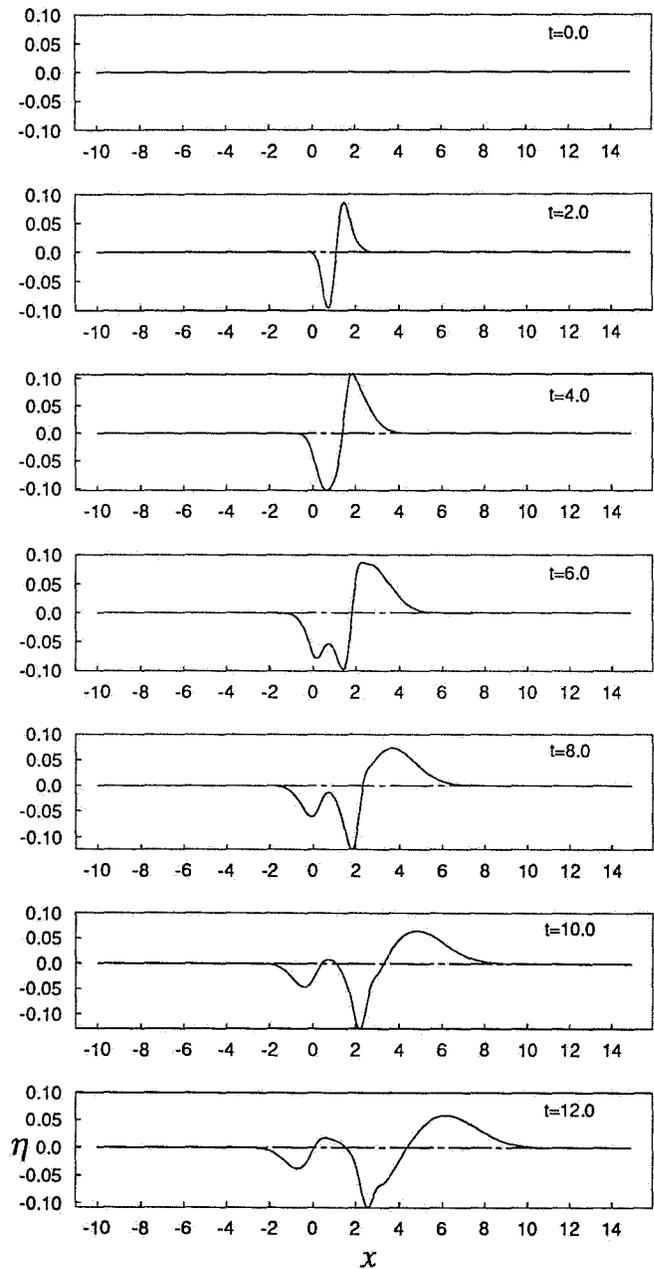
Fig.7 Evolution of surface waves, $D_c=0.20$

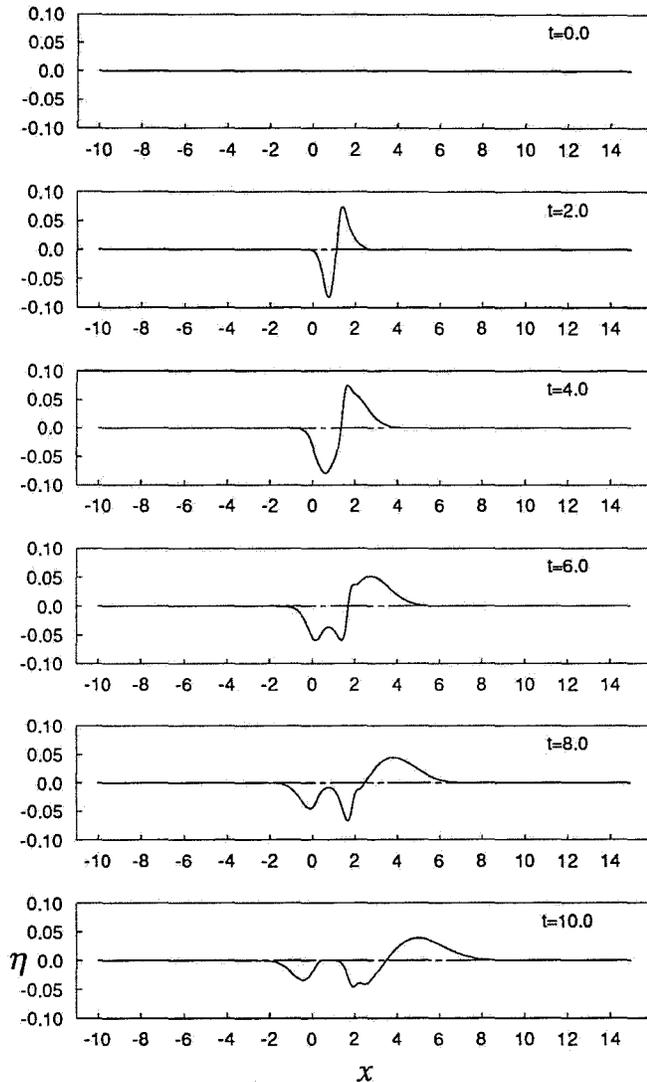
Fig.8 Evolution of surface waves, $D_c=0.35$

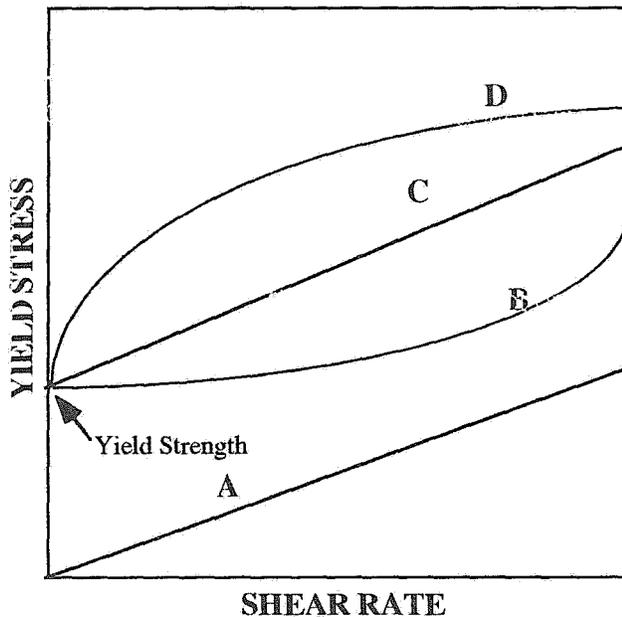
Figure 1. Typical flow curves for yield stress fluids: (A) Newtonian, (B) dilatant, (C) Bingham and (D) pseudo plastic (modified from Nguyen and Boger [9]).

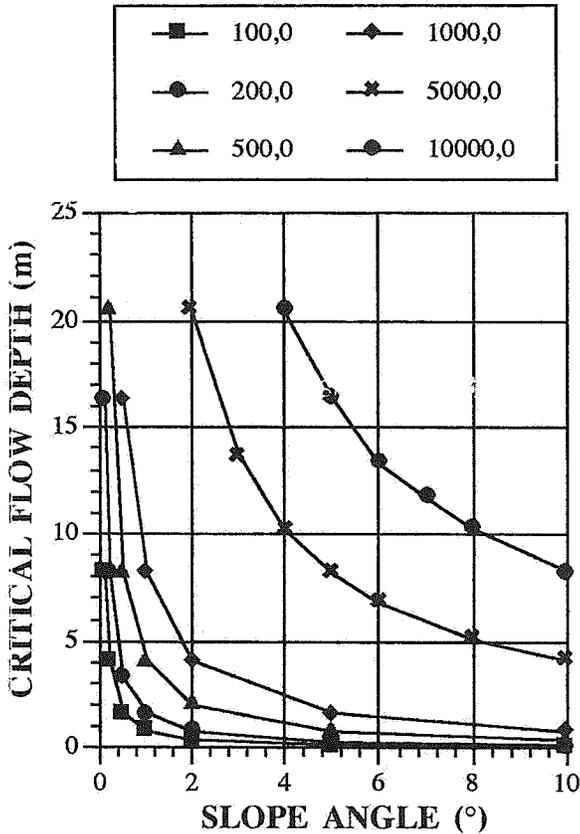
Figure 11. Slope angle and critical flow depth for various values of the yield strength (at an effective unit weight of 6 kN/m^3).

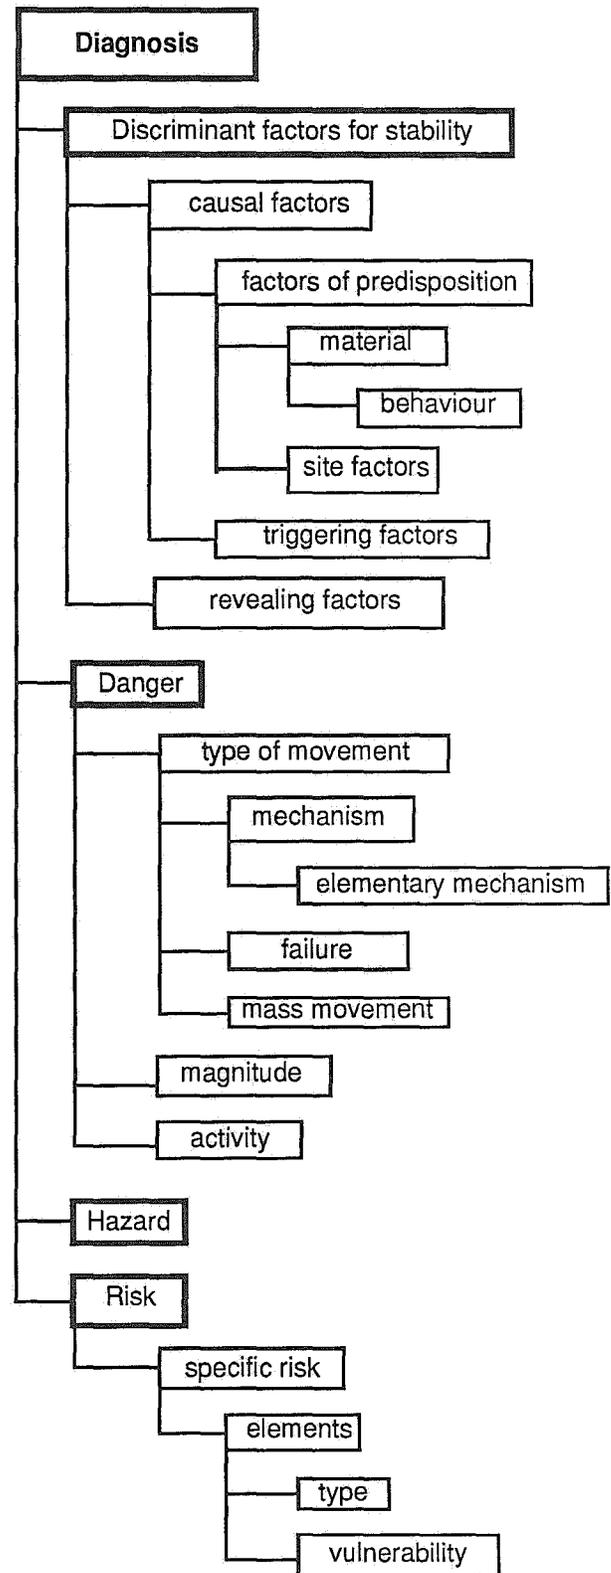
FIG. 1 -- Components of slope stability risk analysis
