Review of Historic Floods in Hungary and the Extent of Flooded Areas in Case of Levee Failures

Laszlo Bodi

Laszlo Nagy; Attila Takacs

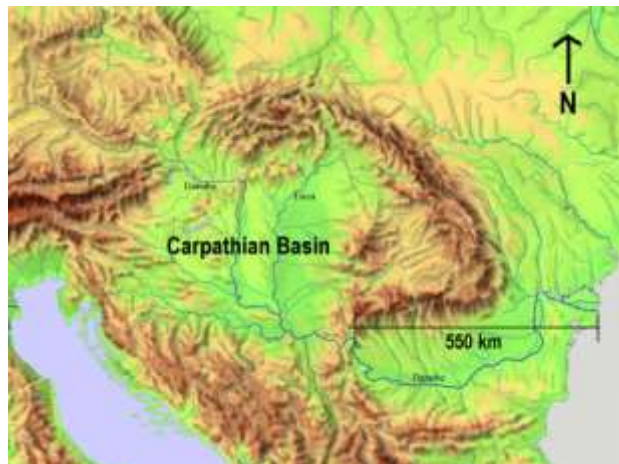
Figure 1: Topography of the Carpathian Basin

The Carpathian Basin's 330,000 km² area is an unrivaled geographical and hydrological unit, located in the 1,000 km long central section of the Danube River, as shown on Figure 1.

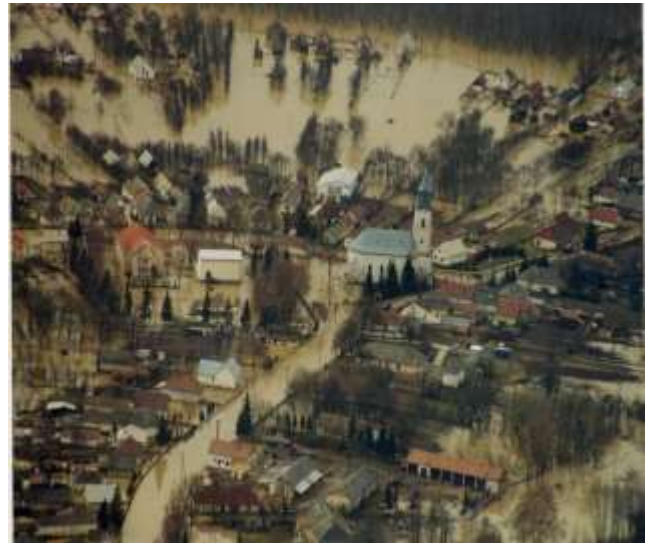
Figure 3: The inundated town of Gulács in 2001

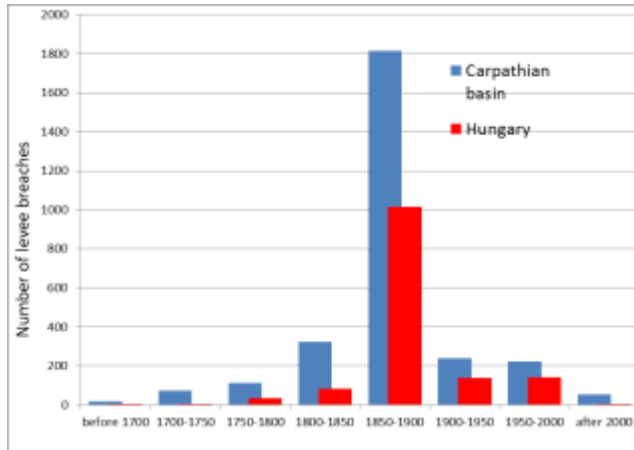
Figure 4: Distribution of levee failures for 50-year periods

Based on historic data, details of 2,858 dam failures were collected to date, out of which 1,433 (50.1%) have been recorded within the present day territory of Hungary. The distribution of failures within the countries sharing the Carpathian Basin is shown in Table 3. Distribution of levee failures for fifty-year time periods during more than 300 years is shown on Figure 4.
