Landslides on ice-rich slopes – a geohazard in a changing climate

Ryan R. Lyle, P.Eng.

Cementation Canada Inc., North Bay, Ontario, Canada

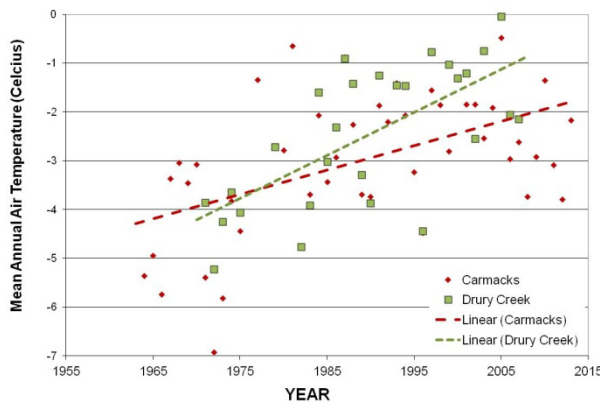
Figure 3: Average annual air temperature for Drury Creek and Carmacks stations (data from Environment Canada)

Average annual air temperatures are plotted for both stations in Figure 3. The Carmacks data from 1964 to 2013 show an overall warming trend of 0.5 °C / decade. The trend from the patchy Drury Creek data is even more dramatic with a warming rate of nearly 1 °C / decade; however, this is likely exaggerated as many of the gaps in these data are from colder years recorded in the Carmacks data.

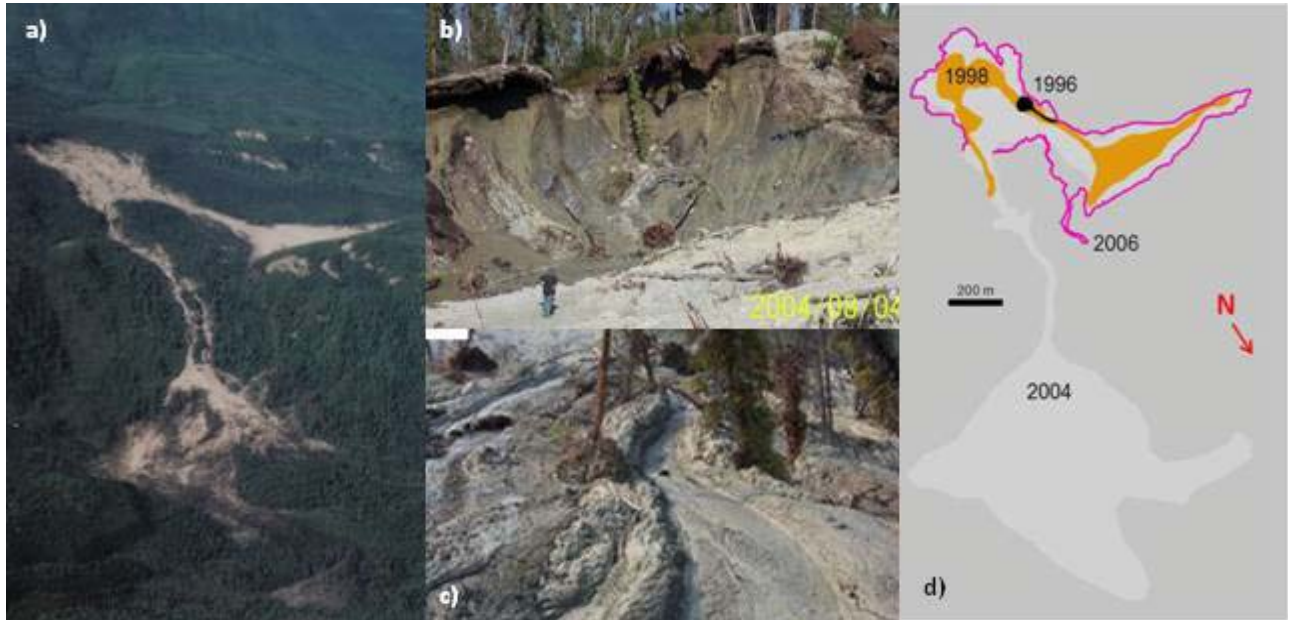
Figure 4: Magundy River Landslide: a) overview looking south (top scarp is 350 m wide, elevation change from top scarp to depositional area is about 350 m; total runout is 1.8 km to toe of lower depositional fan) b) active thaw slump area – north scarp (note 4th author for scale); and c) active debris flow (channel width is approximately 1 m across) d) footprint of the MRL in 1996 (black), 1998 (orange) and 2004 (light grey). Upper zone was mapped in 2006 (pink line). (photographs R.Lyle, August 2004)

The Magundy River Landslide (MRL), shown in Figure 4, is located at 62°08.5'N latitude and 134°11.4'W longitude on a 10-20° north-facing slope. The top of the failure stands at an approximate elevation of 975 m elevation. It was previously classified as a bi-modal flow (Lyle et al. 2005) following the classification of McRoberts and Morgenstern (1974) and Tart (1996). Harris (1987) describes bi-modal flow as a landslide that can be divided into two distinct morphological sectors – an upper headscarp, where ablation and erosion releases sediment (Figure 4b), which slides, flows or falls down into a gently inclined mudflow lobe, where it flows away (Figure 4c). Bi-modal flows are termed ‘retrogressive thaw slump’ by van Everdingen (1998). Two other landslides in the Central Yukon: the Surprise Rapids Landslide (Ward et al., 1992) and Pelly River Landslide (Ward and Jackson, 2000; Mollard and Janes, 1984) share similar morphology and process as the MRL.

Two substantial channels, with distinct depositional areas (Figure 4c) have been eroded by the debris flow. There are two surficial units, with similar texture, exposed in the landslide: a colluvial layer of variable thickness overlying denser glacial diamicton (till). The colluvium consists of reworked till, and is thin or absent in some areas. Multiple organic horizons, separated by diamicton layers, were found in one active scarp, suggesting previous debris flow activity.

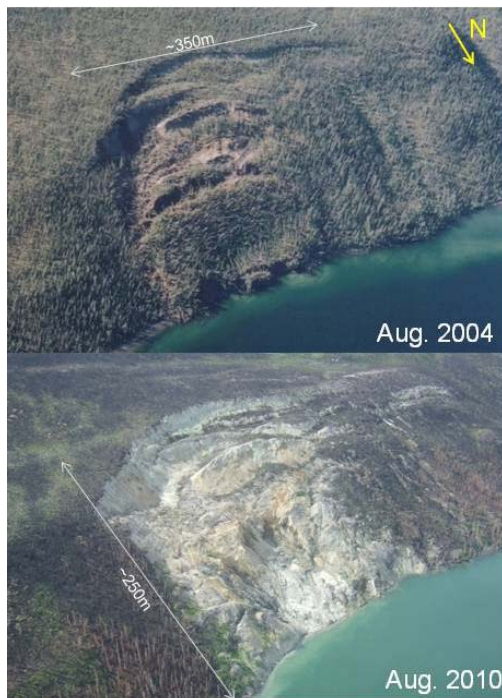
Figure 5. YT Landslide – overview showing significant changes from 2004 (top) and 2010 (bottom) (Photographs by D.J. Hutchinson and J. Koch)

The YT Landslide (YTL) is located on a north-facing slope, along the south shore of Little Salmon Lake (Figure 5). It is situated at a latitude of 62°10.7'N and a longitude of 134°30.7'W and an elevation of 700 m (at the top of the failure). Overall, the YTL is thought to be a rotational soil slump. However, much of the documented movement is translational with both toppling and flow behaviour occurring at the lake's edge and where massive ice is exposed. The slump has put ice-rich sediments in contact with the lake; the resulting thermal erosion accelerates the overall movement. Given the variety of processes, the YTL is classified as a complex landslide in surficial sediments. More recently it appears to be widening to the west, this process has accelerated since forest fires destroyed the surrounding forest cover in 2009.

In plan, the landslide is approximately 250 m long, from the lake shore to the top scarp (Figure 5). An

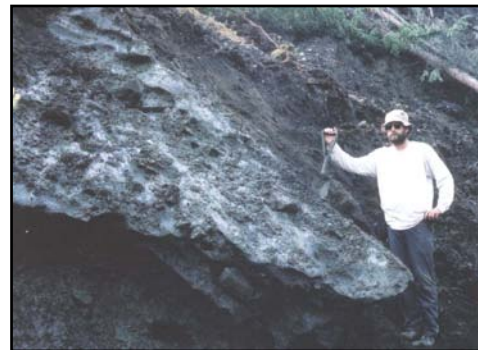
Figure 7. Massive ice found in the lower blocks of the YT Landslide (Photograph by D.J. Hutchinson, August 2004)

The site stratigraphy is partially exposed in the numerous scarps and extensional cracks, but reconstruction of a detailed stratigraphic section is hampered by the extensive surface disturbance. The following units were described in detail by Lyle (2006). A thin layer of organic material and/or a colluvial veneer overlies much of the slope surface. The top scarp exposes the edge of a very gently sloping till plain (over 10 m thick). This is underlain by an ice contact sequence (greater than 15 m thick) of dense (apparently unfrozen) glaciofluvial and frozen glaciolacustrine sediments containing mm-scale ice lenses. The majority of the glaciofluvial material is highly oxidized. Underlying these McConnell-aged sediments is a diamicton interpreted to be a pre-glacial debris flow or colluvial apron, dated at >47,000 years BP. Many massive ice lenses were found in this unit. Clasts found in the diamicton are composed of poorly sorted, angular psammitic schist and/or quartzite (likely local bedrock). The sediment exposed at the lake margin is a colluvial mass derived from the described stratigraphy. It contains greater than 50 percent ice by volume, mostly in massive ice lenses (Figure 7).

The origin of the massive ice found in the lower portion of the YT Landslide is open to debate. Most evidence points to segregated/intrusive ice, as such ice can form in any orientation and dimension. The presence of massive ice at the bottom of the slope within highly permeable glaciofluvial sands and gravels showing signs of groundwater flow, beneath a less permeable cap (till and permafrost), is highly indicative of an open system pingo environment, common in other parts of the Yukon and central Alaska (Mollard and Janes, 1984). Sand and gravel inclusions and other impurities were found in the massive ice which indicates expulsion of impurities during two-sided freezing when water is injected into permafrost.

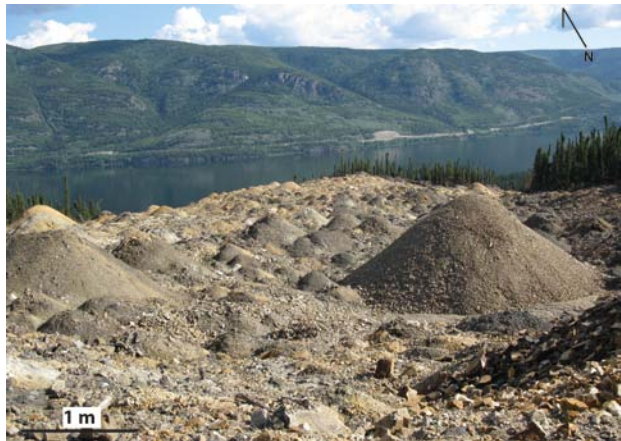
Figure 8. Overview of mounds in the middle section of the Little Salmon Lake Landslide (Photograph M-A Brideau July 2009).

The LSLL can be divided in three parts based on their morphology. The upper part consists of large (10 m high x 10 m long x 20 m wide) slump blocks with vegetation still present on them. Two sag ponds were observed between back-rotated slumped blocks. The second part of the deposit in the middle of the landslide consists of hundreds of conical mounds of distinctly variable colour and varying in height from 0.3 m to 10 m (Fig. 9). The majority of the mounds are composed of disintegrated bedrock with a single constituent lithology, including yellow quartzite, grey schist and dark grey graphitic schist while others were composed of brown gravel-size surficial material. Where the material in the mounds is derived from two lithologies, the contact between them is sharp. A thin layer of tephra is observed in the soil layer still present on top of some mounds. The materials comprising the mounds are generally clast-supported, although occasionally consist of exclusively fine-grained clay-rich material. The clasts primarily consist of medium gravel to small cobbles, with occasional larger cobbles up to 50 cm. The average slope angle of the conical features is between 35° and 37°. These correlate well with the previously reported values for gravelly material (e.g. Rahn, 1969; Burgess, 2002). The third part of the landslide consists of the channelization of the debris in its lower parts (Figure 8). Occasional mounds were found in these sections but they were less frequent than in the central portion. The characteristics of the deposit were more typical of debris flows, where the grain-size distribution of the deposit was finer (matrix-supported in some cases) with woody debris and levees lining the sides of the channel.

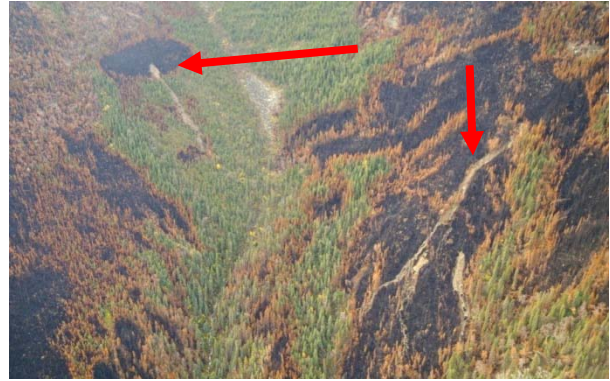
Figure 10. Small landslide activity immediately after the 2009 fire (Photograph P. Lipovsky September 25, 2009).

The August 2009 forest fire that swept the slopes south of Little Salmon Lake adds an interesting dynamic to the current slope stability of the area. Forest fires rapidly alter surface temperature and soil moisture conditions during and immediately following the fire. On permafrost slopes, active-layer depths then rapidly increase and often cause small-scale, shallow, active-layer detachment slides in the first year following the fire (Lipovsky et al., 2006; Coates, 2008). Over 40 such landslides occurred within 1 month of the 2009 Little Salmon Lake fire. Two of these slides are shown initiating in isolated burned patches in Figure 10, illustrating the strong causal relationship between the recent forest fire and landslide initiation. It remains to be seen if further large landslides will develop as a result of these disturbances. If massive ground ice, like that found at the YTL, LSSL and MRL is exposed by these small scale landslides, larger landslides may develop.
