Instability and geotechnical problems of steep rock slopes east of Cairo

Azza M. Elleboudy

ABSTRACT

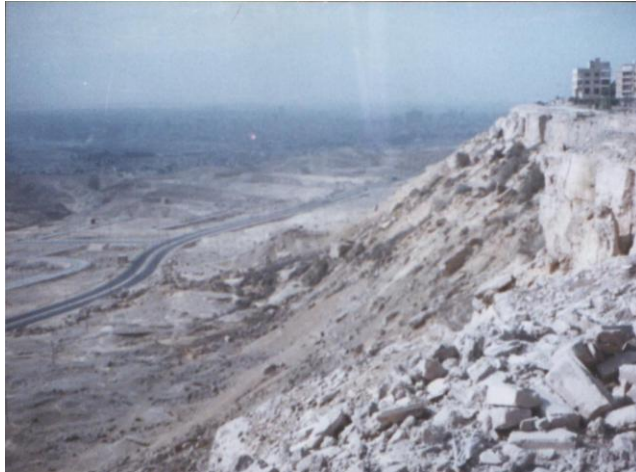
Figure 2. Rockfalls along the western cliff

A new suburban area has been developed on Mokattam plateau that overlooks Cairo from the eastern side. The plateau level is higher than the average elevation of Cairo by 180 m. Cracks in buildings located near the cliff were noted and rockfalls along the western and southern edges of the plateau frequently occurred (Figures 2 and 3).

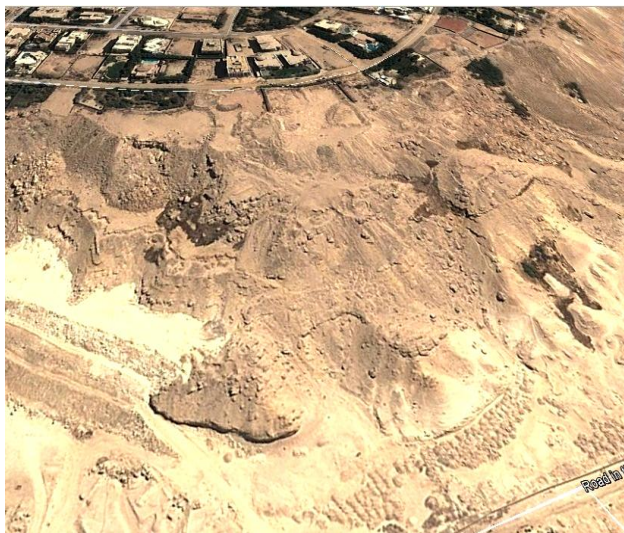
Figure 3. Sattellite image of Mokattam rockfall

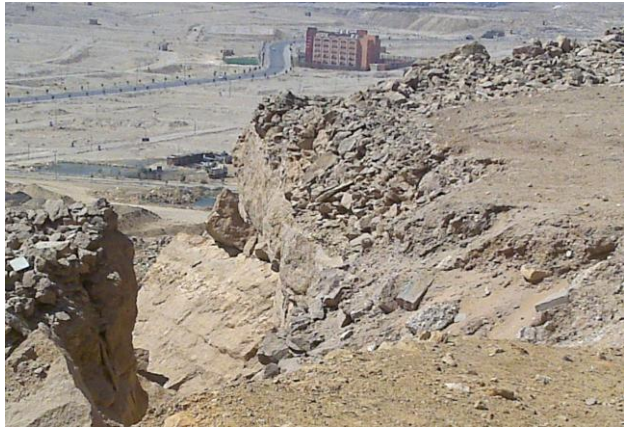
Figure 4. Newly detached rock mass at Mokattam cliff

Rockfalls are caused by the loss of support from underneath or detachment from a large rock mass (Figure 4) due to various factors. Progressive deterioration of the western and southwestern rock slopes has occurred in recent years after the rapid urban development of Mokattam Plateau. At least four major rockfalls took place along the cliffs since 1960. Buildings on the cliff were endangered and cracked due to loss of foundation support (Figure 5). The main road bordering the western cliff was damaged. Many parts of the road cracked and fell down the slope (Fig. 6). The

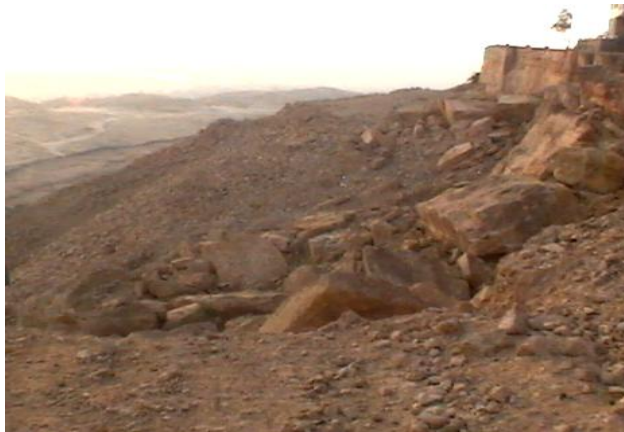
Figure 5. Endangered building due to slope failure

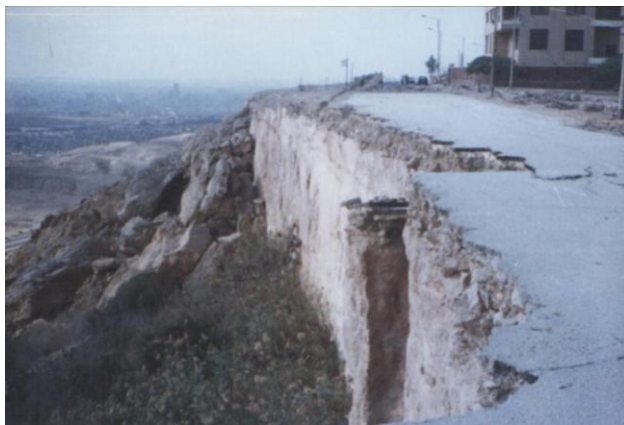
Figure 6. Road collapse at the western edge of Plateau

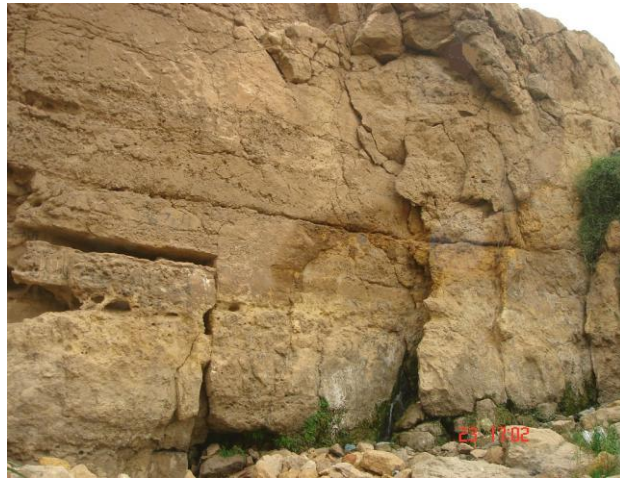
Figure 7. Seepage through rock cracks

One of the most influential factors was the remarkable change in the moisture regime in such arid rocks. The seepage of water through rock layers and fractures was obviously noticed on the face of the slope. Therefore, constructing watertight pipes with flexible joints, leakage proof sewer system, and a proper drainage network for quick removal of percolating moisture to direct the surface water away from the cliff are important.

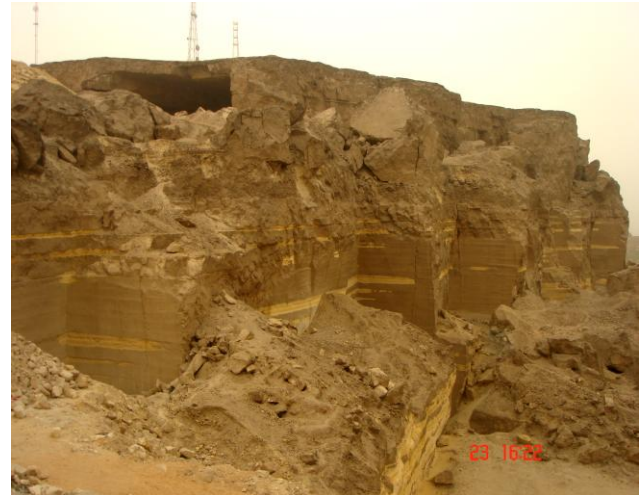
Vertical rock cutting and blasting that take place in adjacent quarries may remove support for overlying or overhanging rock resulting in conditions conducive to rockfall (Figure 8).

Figure 8. Quarries in Mokattam Plateau

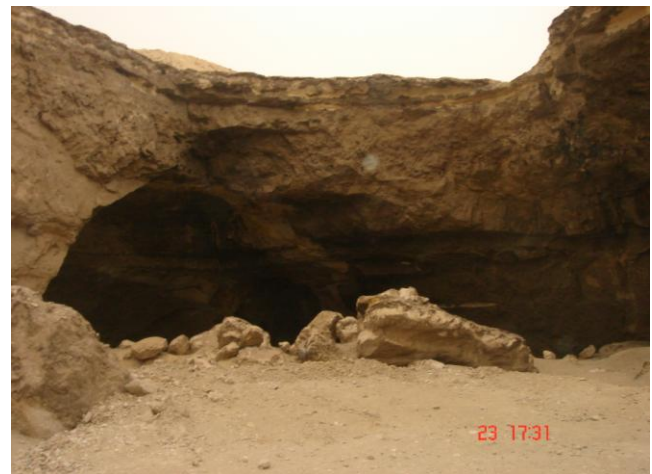
Natural man-made caves and caverns are spread in Mokattam Plateau limestone formation. They comprise zones of weakness in rock structure (Elleboudy, 1999a). Their presence adds to the rockfalls causative factors, especially if they exist near the cliff. An example of these caves is shown in Figure 9.

Figure 9. Caves in Mokattam

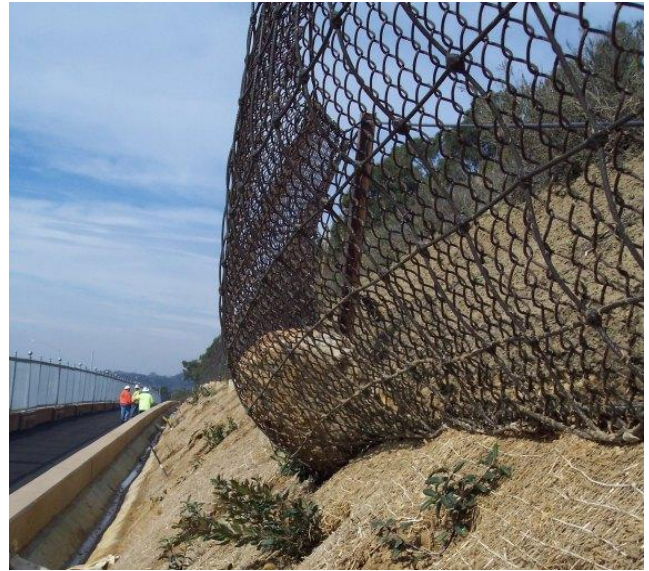
Figure 11. Guard mesh protecting road from rockfall

Guard mesh could also be used at the toe of the slope to capture the falling rocks. Steel-net systems consist of wire-ring nets or diagonal-rope nets, steel cables could be utilized as fences to separate the rock slope from roads or other structures threatened by the rockfall, and

trap the falling rocks before causing any damage (Figures 11 and 12).

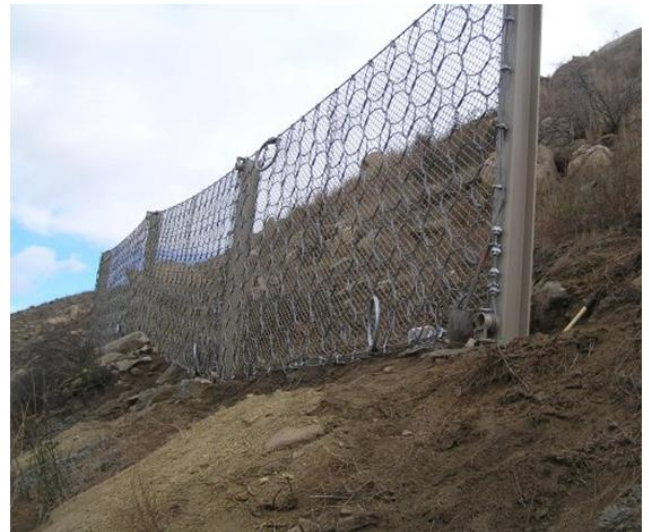
Figure 12. Catch fence of wire-ring net near slope toe

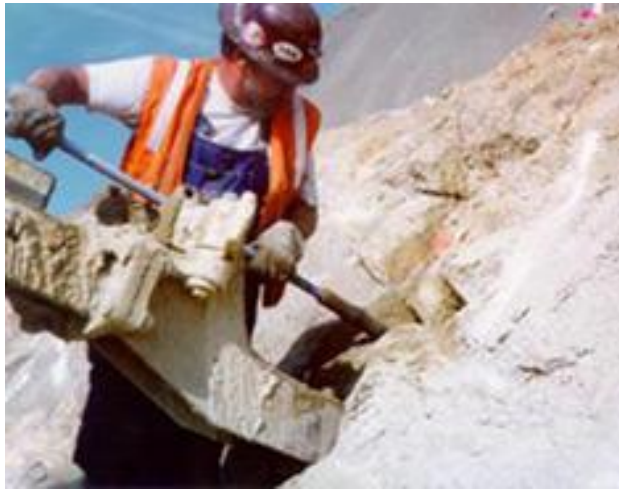
Figure 13. Rock Anchor on slope face

Rock anchors are applicable when compressive, uplift or pull-out forces, or lateral supports are required to

stabilize a structure or rock mass on-ground or underground. Active anchors support the rock fully and immediately, while passive ones develop increasing support with the deformation of the rock (Figure 13).
