Special solutions in hazard mitigation

Ahren Bichler

Gernot Stelzer

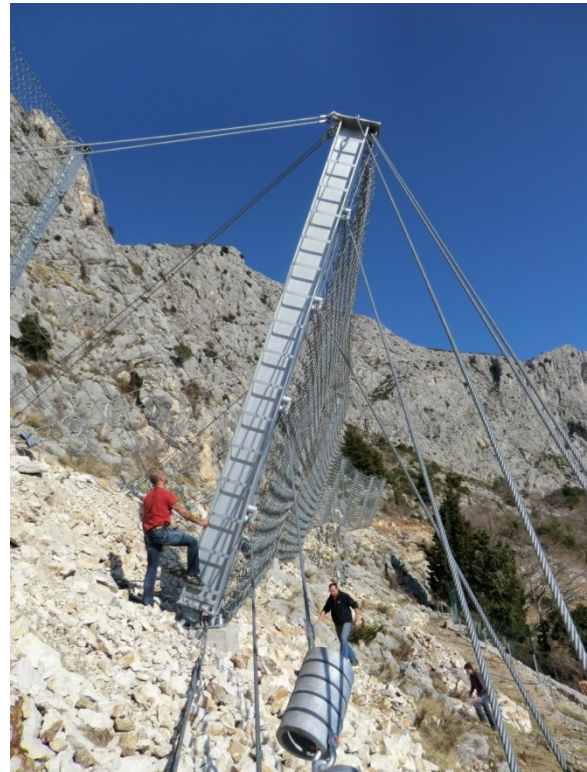
Figure 1. An example of an 8.5 m high post that exceeds the allowable height under current guidelines.

A decision by the project engineers was made to construct 3000 kJ hinged systems with heights of 7 m and 8.5 m and 5000 kJ hinged systems with heights of 8 and 8.5 m at these sites (Figure 1). According to ETAG 27, the respective systems are only certified for heights between 5 – 6 m and 6 – 7 m. To help offset the increased tendency for the post to buckle due to its length, a heavier profile was verified and used for their fabrication. Other, on-site adjustments to the layout, e.g. anchor spacing, were also necessary to accommodate the increased height.

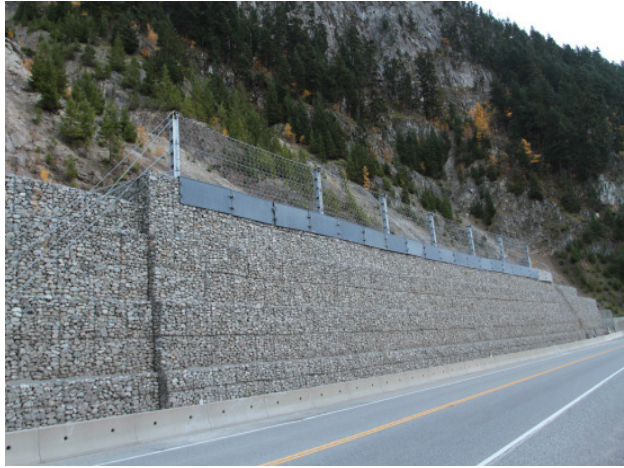
Figure 2. Fixed-rotation system installed on a double-sided MSE wall.

As such, a further revision was deemed necessary. In 2011, the Ministry tendered the design for a rockfall catchment fence to be installed along the top of the wall (Figure 2). The design should take into account a 2000 kJ impact as well as a distributed avalanche load of 25 kPa along the entire length of the structure. Further requirements were that the system have a fixed-rotation about the axis of the post (i.e. a hinged connect between the post and base plate was deemed impractical) and that a traditional foundation for the posts such as soil/rock anchors or a concrete base was not allowed since it may compromise the integrity of the wall system. Instead the post needed to be secured to large steel cap plates that would serve as the foundation but also as protection of the top of the wall.

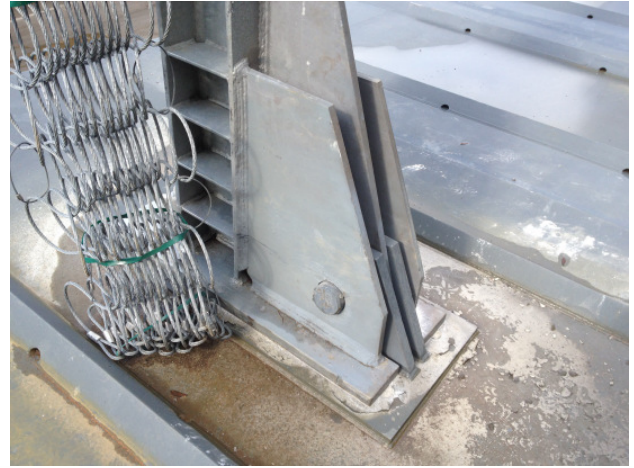
Figure 3. Adapted base plate for connection to foundation.

welded to the cap plate. The counter plate consists of two, vertical and parallel steel fins with an approximate 100 mm hole through their centre. The base of the post has three fins with the same orientation and holes. To mount the post, it is slid into position and a 100 mm steel pin is inserted, passing through all five fins and secured with a bolt (Figure 3).

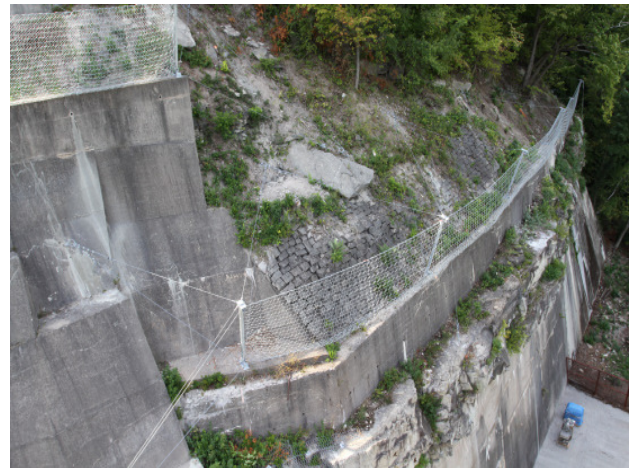
Figure 4. Floating rockfall catchment fence on pre-existing concrete wall.

A second example of where foundation requirements led to the selection of a non-standard system comes from a site in Ontario where a series of 100 and 250 kJ rockfall catchment fences were necessary to secure an area at the base of a steep slope comprised of a mixture of natural and man-made features. The optimum positioning of the system was by placing it on top of a pre-existing concrete wall (Figure 4). Since the existing wall was old and no records were available, it was decided that the transfer of force from the fence to the wall was not allowed. As such, a system incorporating a floating base plate was required, which was based on ETAG 27 certified systems.

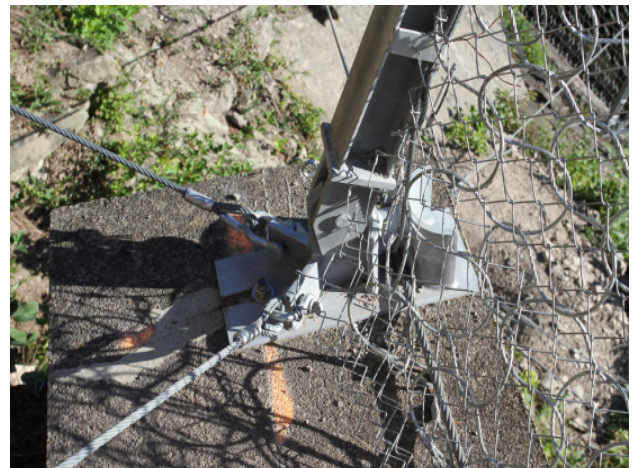
Figure 5. Adapted base plate for floating foundation.

The floating base plate consists of a standard base plate with two additional fins and a slot (Figure 5). Two tie back cables are installed to the base plate and are led to the upslope retaining anchor that also secures the head of the post via two additional tie back cables. The slot in the base plate is for a temporary bolt used during installation to keep the plate in position. During an impact, the base plate is free to move slightly forward while the forces are led to the anchor by the ropes.

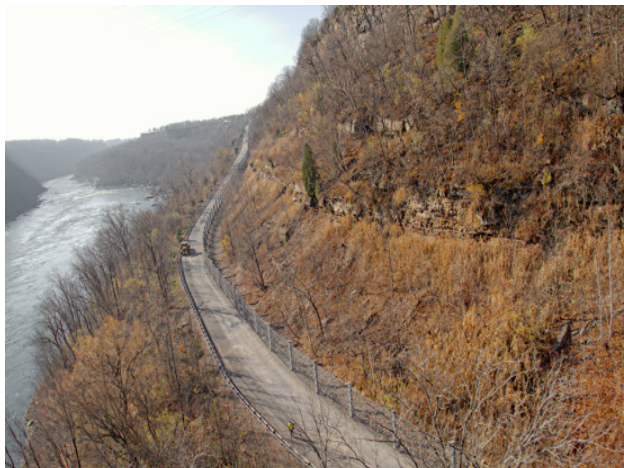
Figure 6. Fixed-rotation rockfall catchment fence installed at edge of access road.

Also from Ontario comes an example where limitations on the construction foot print of a rockfall catchment fence led to adaptations meant to help control the elongation of the system. At this site, a combination of 500 kJ and 1000 kJ systems were necessary to protect vehicle access to a vital site (Figure 6). The road is endangered from a rock escarpment above it, but the land between the road and the initiation zone has restrictions that eliminate the possibility of constructing mitigation measures on the slope. As such, it was only possible to erect a barrier immediately adjacent to the road, and where no upslope tie back anchors could be installed. The result was modified fixed-rotation, WLV-tested systems.

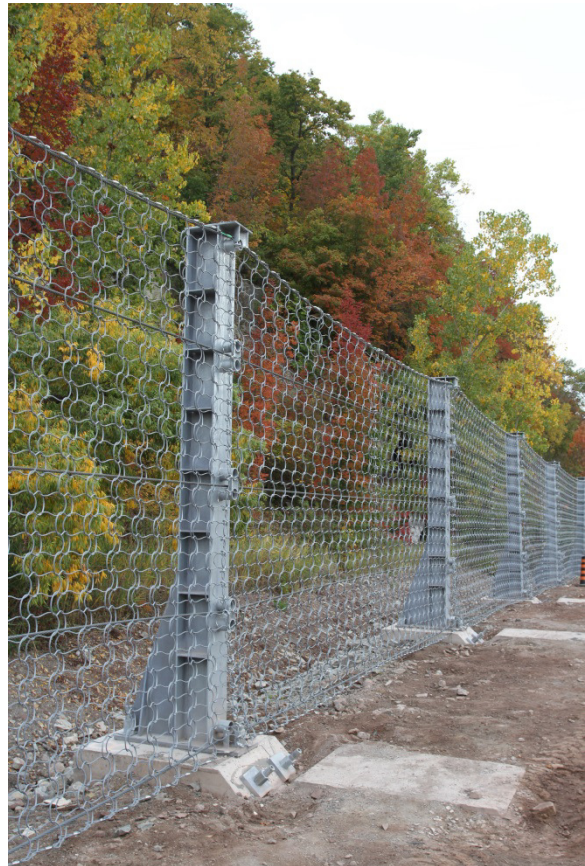
Figure 7. Reinforced catchment fence with additional middle bearing ropes.

To achieve this reduction for the 1000 kJ system, additional bearing ropes were added along with a reduction in the post spacing to 8 m (Figure 7). Similarly, an additional bearing rope was added to the 500 kJ system. The appropriate changes to the anchorage and foundations were made in order to accommodate the extra anticipated forces.

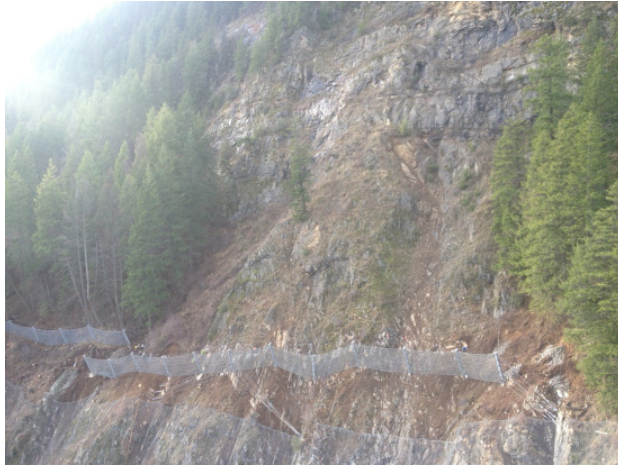
Figure 8. Rockfall catchment fence crossing avalanche path (photo courtesy of Jim Guinn, Mountain Rock Stabilization).

Near Nelson, British Columbia, an example of adaptations of a rockfall catchment fence to accommodate snow loading conditions can be found. At this site, a hinged 3000 kJ rockfall catchment fence was deemed necessary by the British Columbia Ministry of Transportation and Infrastructure to protect Highway 31, running alongside Kootney Lake, from falling rock and debris originating from bluffs above the road. In addition, the fence crosses an avalanche path that is approximately 80 m wide (Figure 8). The subsequent loading scenario required that the fence be designed to withstand a static load of 54 kN/m over the lower 3 m of fence height and a dynamic load of 49 kN/m over the upper most 1 m.

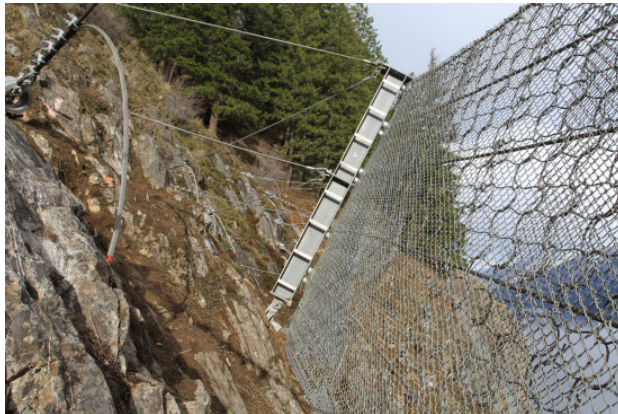
Figure 9. Reinforcement of post using retaining ropes connected at mid-height.

To be able to withstand the given design loads, several adaptations were required to the ETAG 27 certified system: the post spacing was reduced to approximately 8.4 m, a larger beam profile was selected for the post and additional tie back cables were used to secure the middle of the post as well as the post head (Figure 9). The middle tie back cables were fitted with brake elements to help absorb energy but also to allow movement of the post during an impact.

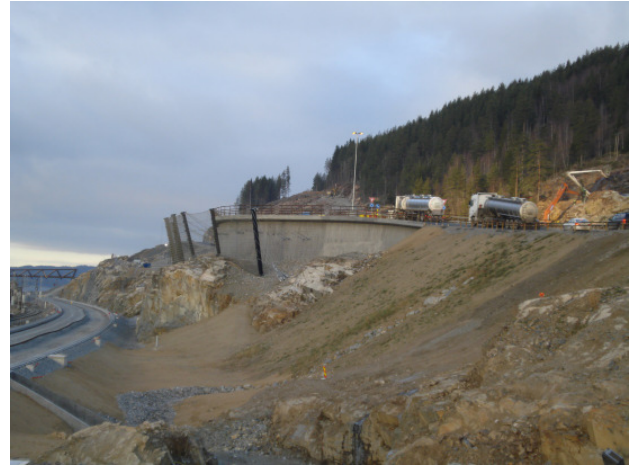
Figure 10. Rockfall catchment used for preventing vehicles from landing on railway (photo courtesy of Marco Toniolo, Pfeifer Isofer).

In Norway as part of the E6-Dovrebanen highway project, a corner of a round-about required a barrier to prevent cars and semi-tractor trailers (in particular logging trucks) from leaving the road and ending up on a railway located approximately 15 m down a steep embankment (Figure 10). In addressing the problem, it was important to the client to minimize the visual impact of any structure.

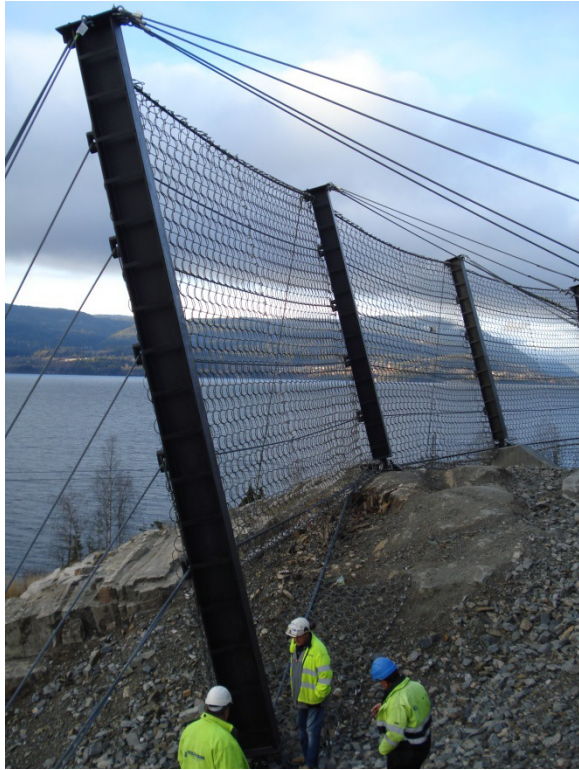
Figure 11. Varying height of posts to adapt to topography.

In the end, it was decided to construct a hinged 5000 kJ barrier, based on an ETAG 27 certified product. Alterations were required to adapt the system to the required height, the rough topography as well as the convex curve of the road. One of the restrictions was that the top of the fence should be level and not exceed a defined height. The result was the need for posts of varying heights between 6.0 and 8.5 m with heavier than normal beams (Figure 11), as well as special anchor plates to safely guide the lower bearing ropes along the ground surface so that no gaps are formed and the rope is protected during an impact. Large diameter cables were also required on the downslope side to prevent the posts from falling upslope due to the curvature of the fence line and also from forces during an impact.

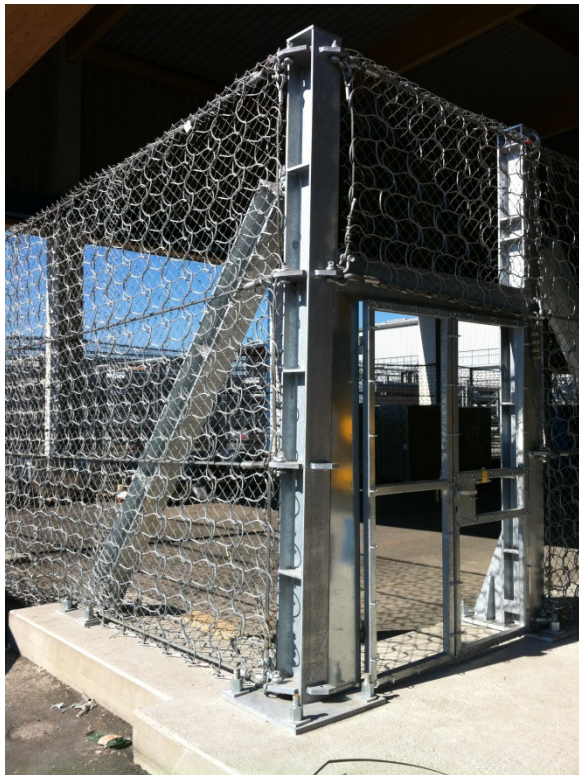
Figure 12. Custom building enclosure for protection from explosions.

A WLV-tested 500 kJ fixed-rotation rockfall catchment fence was used as the basis for the design. Major adaptations were made with regards to the posts, bearing rope configuration and anchorage. These adaptations are primarily the result of layout and access requirements. The fence must enclose a building and so make 90 degree corners as well as have access through the fence for workers (Figure 12). Lastly, lateral anchorage for bearing ropes was not possible due to space constraints.
