Spatial and temporal analyses using Terrestrial LiDAR for monitoring of landslides to determine key slope instability thresholds: Examples from Northern Ireland and Canada

Andrew D.F. Bell, Dr Jennifer M. McKinley

School of Geography, Archaeology and Palaeoecology, Queens University Belfast, BT7 1NN, Northern Ireland, UK

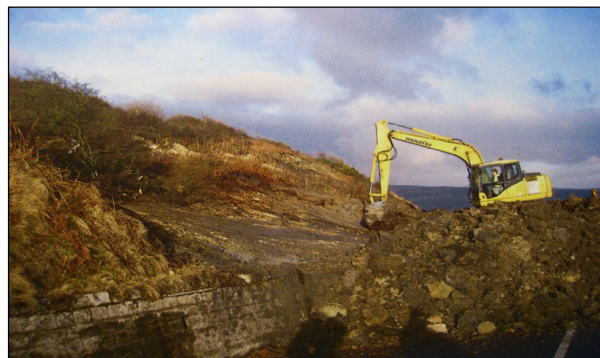
Figure 1. Landslide debris at Straidkilly on A2 Coast Road

The Antrim Coast Road stretching from the seaport of Larne in the East to the famous Giant's Causeway in the North has a well-deserved reputation for being one of the most spectacular roads in Europe (Day, 2006). Despite this beauty, since construction in the 1830s there have been a number of locations along the road that have experienced instances of geotechnical instability, including rock falls at Garron Point and mudflows at Minnis North (Hutchinson et al. 1974). This paper examines a small (6000m²) active flowslide at Straidkilly Point, North of Glenarm Village, on the A2 coastal road. More recently Straidkilly Point has experienced increased instance of instability, which has resulted in large volumes of debris being deposited on the A2 Coast Road, forcing road closures. Figure 1 illustrates one such failure event on 25th January 2010. Figure 2 illustrates the Leica HDS300 Scanstation on site during a monitoring period, with Table 1 detailing data and scan statistics.

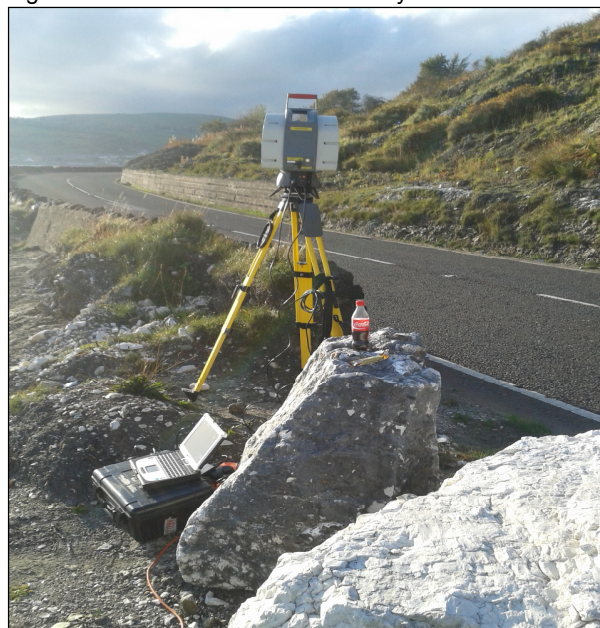
Figure 2. Leica Terrestrial LiDAR scanning of Straidkilly Point, Northern Ireland.

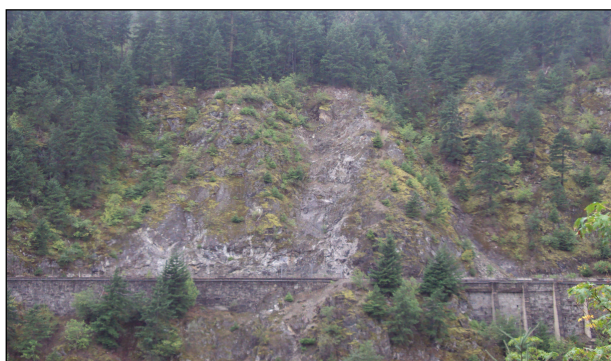
Figure 3. Cascade Rockfall site viewed from across the Fraser River from TLS scanning location

The study area at Cascade M3 (Cascade Mile 3) is a representative site of the Cascade subdivision located along the Fraser River valley, Southern British Columbia, Canada (Figure 3). 'Rockfall is one of the most significant geohazards encountered by railways along the Canadian Rockies' (Lan et al., 2010:213). Previous assessments in the area discuss methodologies for the application of LiDAR for spatial modeling approaches for hazard assessment (Lan et al., 2010). Rockfalls are frequent, having had an impact on the railway since construction, with records of the location of rockfalls dating back to the 1940s. The study area is dominated by intrusive rocks of quartz diorite and granodiorite with geotechnical conditions such as the lithology, weathering of bedrock, joint spacing/orientation and groundwater infiltration influencing the triggering of rockfall events (Wieczorek et al., 2008; Lan et al., 2010). The highest rockfall frequency is in February, corresponding to the highest number of freeze thaw cycles. Table 2 illustrates the date and

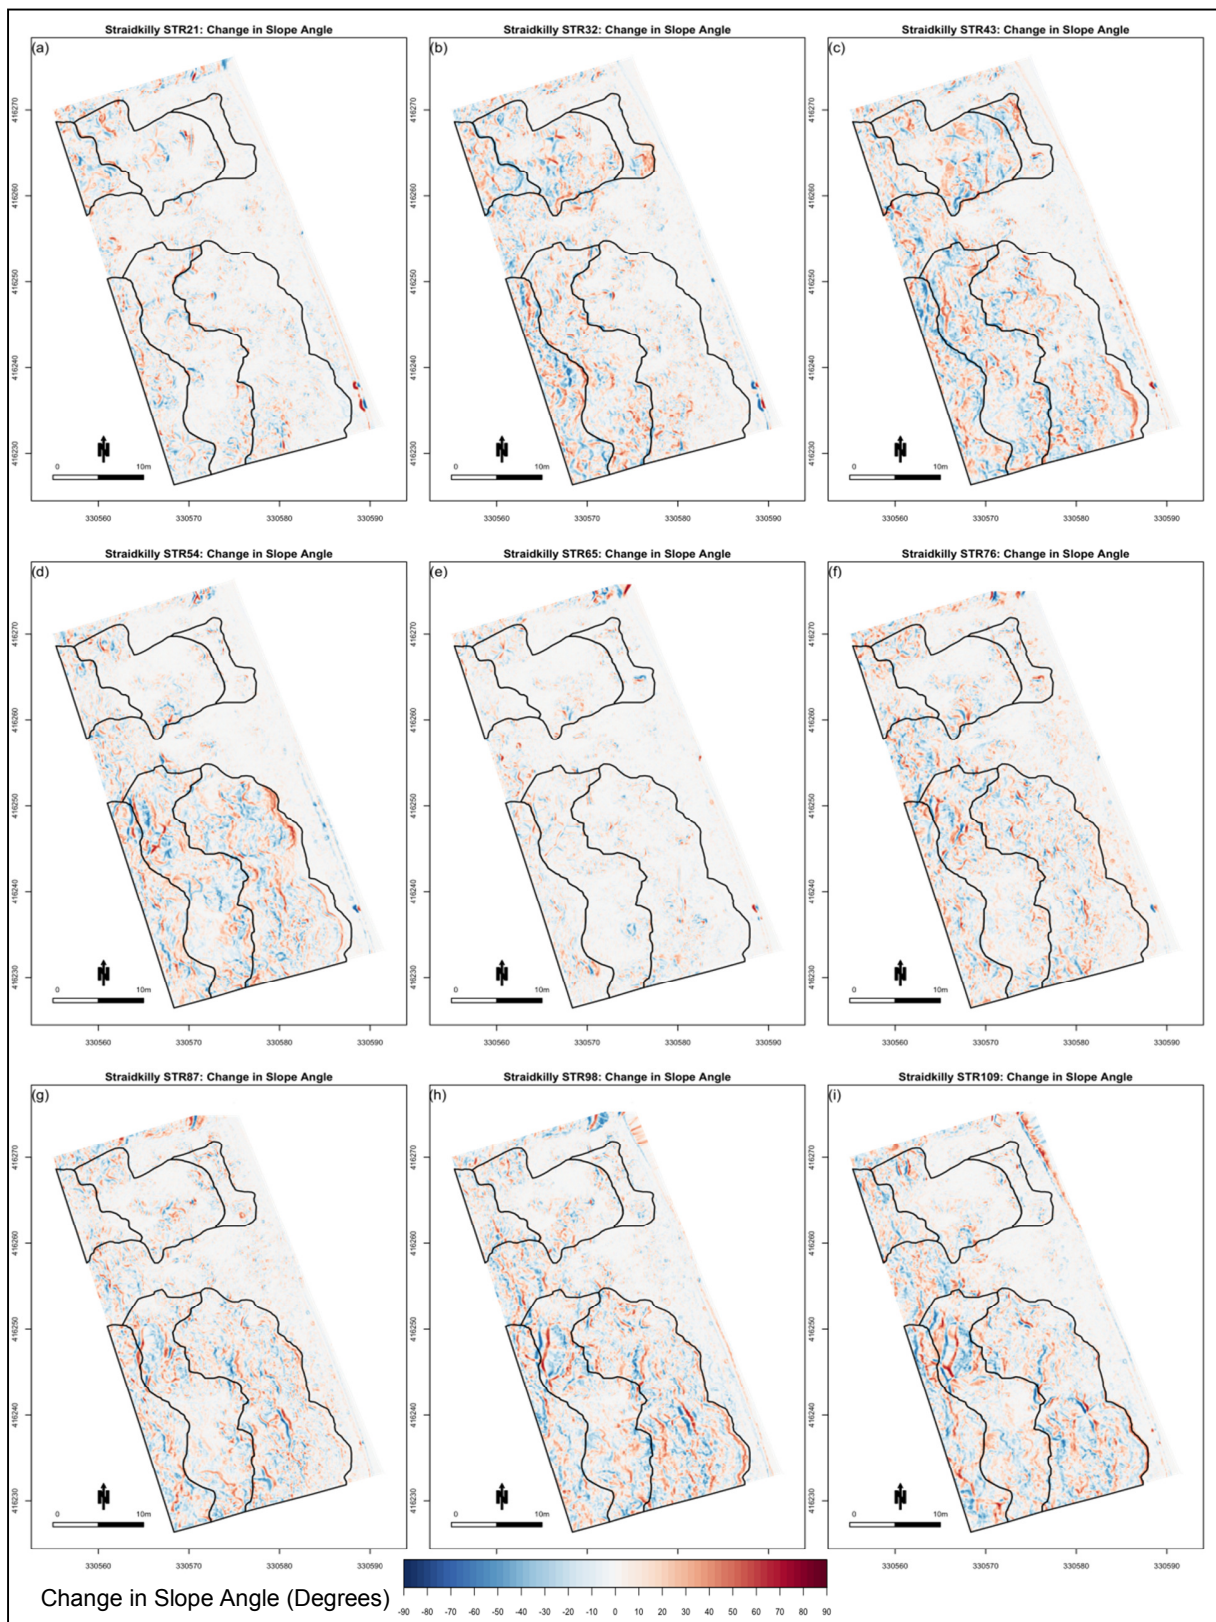
Figure 7: Spatial distribution of temporal changes in slope angle STR1 to STR10, Sector A & B, Zones I – VI for reference. Blue = decreases in slope angle, red = increases in slope angle

Figure 6&7 depict the spatial distribution of changes in slope angle over the monitoring period with Sector A, Zone I (Figure 6a), experiences limited changes until STR4, illustrated by a distinct peak at lower slope angles. Subsequent density of slope angles follow this with further peaks evident at lower slope angles, $\sim 30^\circ$ to $\sim 40^\circ$, at STR5 and STR6. Similar response is found for Sector B, Zone IV (Figure 6d) with a wider base, suggesting larger spread of values, at STR1 and STR2, following decreases in density of higher slope angles, a response to depletion of material. This suggests there has been a distinct drop in higher slope angles occurring as a result of slope deformation (consolidation).

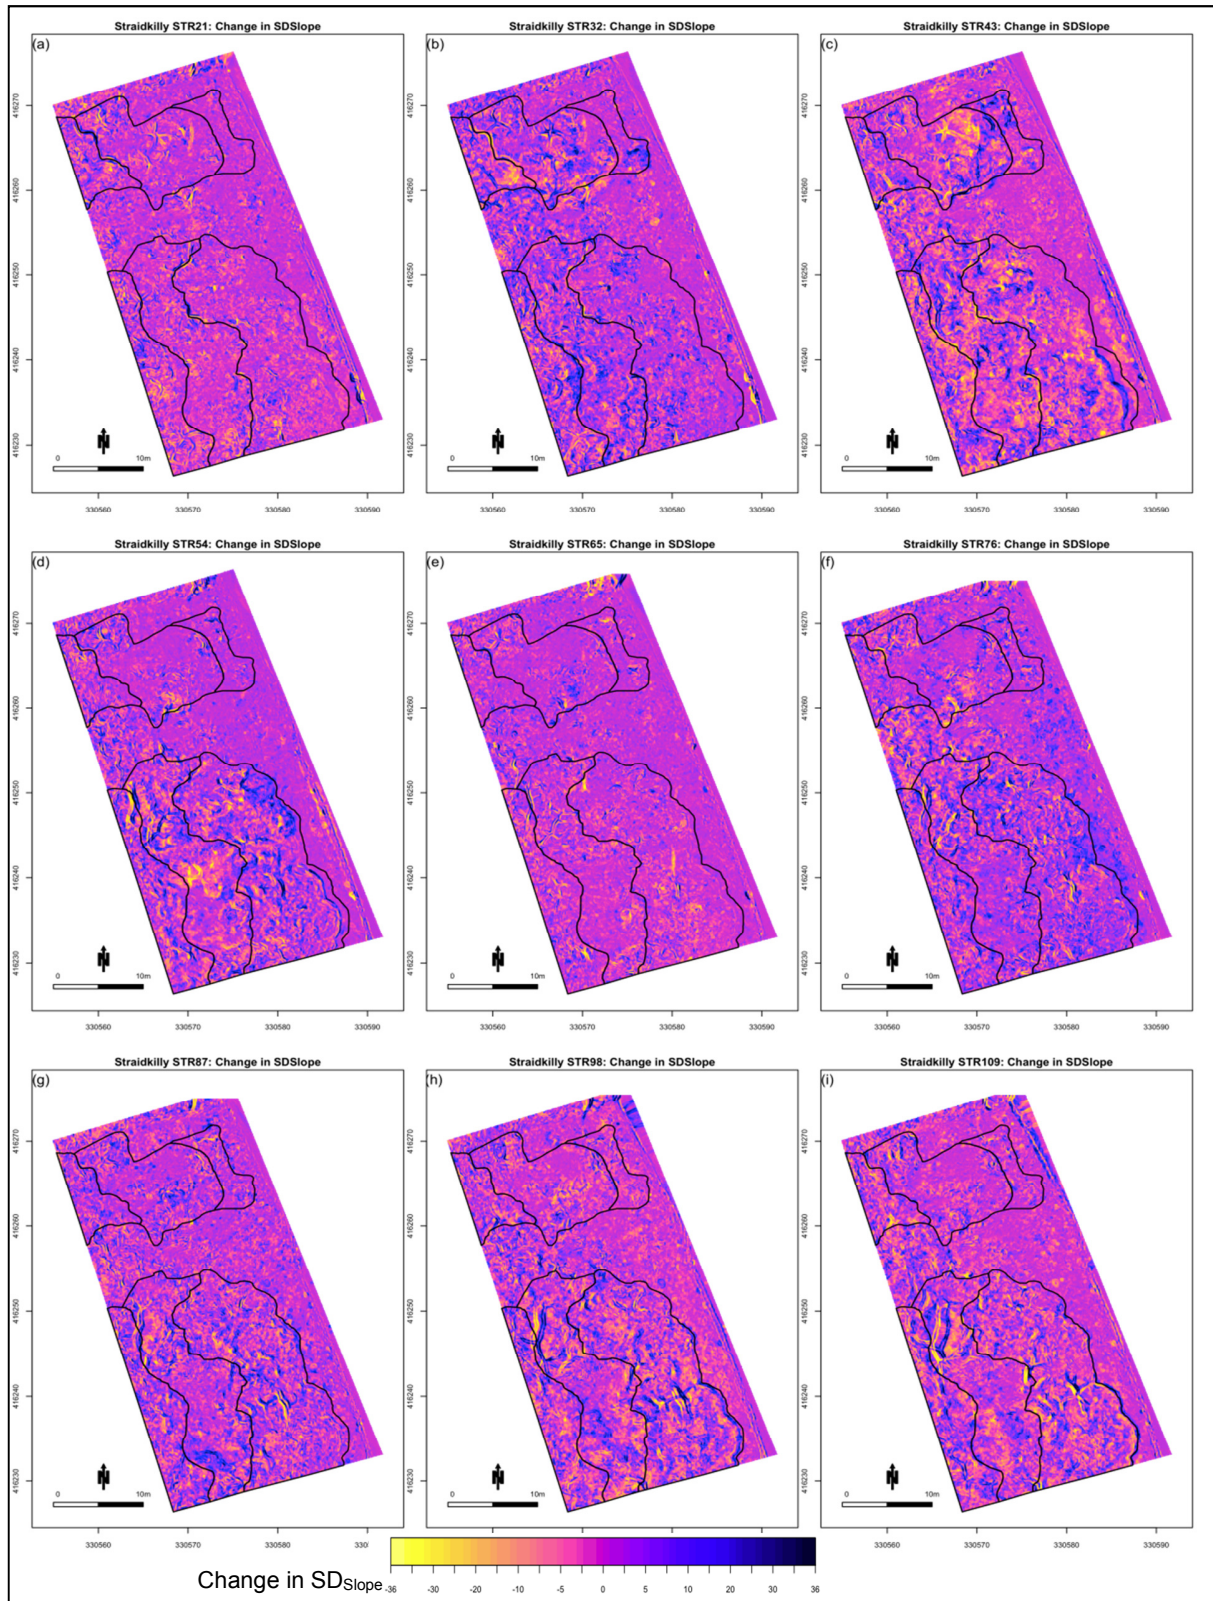
Figure 8(a-i). Temporal spatial distribution of changes in SD_{Slope} for Straidkilly TLS monitoring. Morphology Zones I to VI provided for reference

Figure 8(a-i), depicts the spatial distribution of SD_{Slope} over the TLS monitoring period. SD_{Slope} displays decreased roughness as a result of failure of minor scarps located at the top of the slope at STR21 and STR32, Zone I (Figure 8a&b). Increased roughness (red hue), is apparent further down the slope for STR32, Zone II (Figure 8b). STR43 displays an interesting pattern with green hues indicating decreases in roughness in responses to depletion of material. This spatial distribution impacts in Zone II with increased SD_{Slope} associated with accumulation of material. Accumulation at the foot of the flowslide is typified by distinct increases in roughness. Large deviations are present for SD_{Slope} at STR54 (Figure 8d) illustrating distinct spatial pattern of decreased roughness for Zone II which can be linked with increased roughness, due to accumulation of material, at the base of the slope in Zone III.

Further spectral responses are evident in Sector B, Zone IV to VI, STR32 to STR 43 (Figure 8a-c). Complex patterns of decreased SD_{Slope} are evident for Zone IV, indicating the depletion of material, with increased SD_{Slope} apparent in Zone V. Further developments in relation to the spatial characteristics are identified by decreases in Zone V with further failures, leaving smoother terrain behind, with increased roughness at Zone VI at the base of the slope. Zone II increases are present in two phases for STR32 and STR43 respectively indicating the effectiveness of the SD_{Slope} in characterising areas of increased roughness. Further evidence of SD_{Slope} response to slope deformation is illustrated in Sector A; STR87, STR98 and STR109 with decreases in SD_{Slope} characterised by increased further downslope in Zone III.

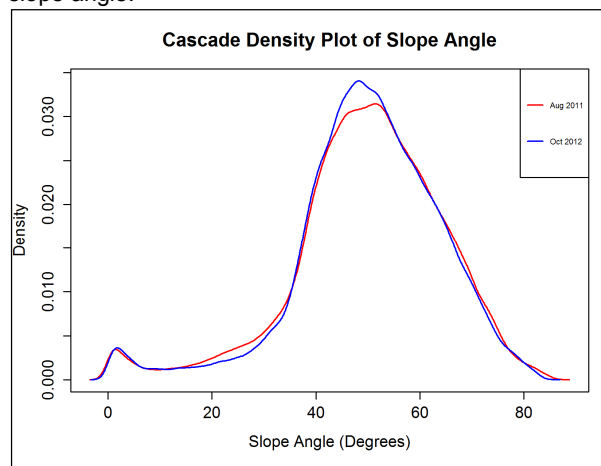
Figure 11. Density curve of spatial distribution of slope angle for Cascade from TLS August 2011 to October 2012

Figure 10 illustrates significant increases in slope angle as a result of failure, due to formation of new rock scarps on site. The spatial distribution of changes in slope angle are extracted from the black polygon located in Figure 10 for the area undergoing the most significant movement. Reductions in density of higher slope angles is apparent from August 2011 to October 2012 (Figure 11). With a higher proportion of lower slope angles in October 2012 highlighting changes in structure of the slope. SD_{Slope} (Figure 12) displays a similar density distribution, with reduction in roughness post failure. This validates the findings in Section 4.1 for responses of the spatial parameters as a result of slope failures at Cascade.
