Analysing ground temperatures and geomechanical mapping of the 2008 Signaldalen rock slide. A case study from Northern Norway

R. Frauenfelder (1), K. Isaksen (2), J. Noetzli (3), M.J. Lato (4), H.C. Smebye (1)

(1) Norwegian Geotechnical Institute, Oslo, Norway

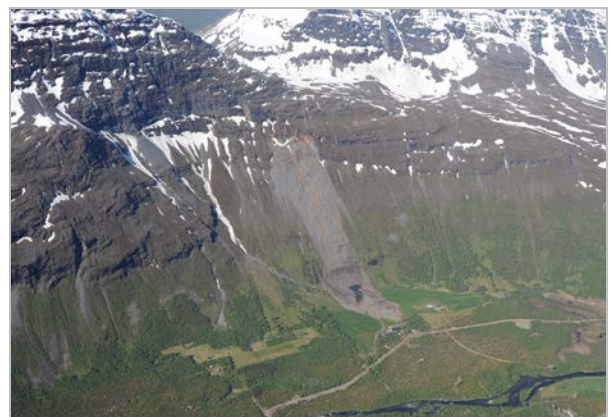
Figure 1. Signaldalen rock slide as seen from helicopter on 28.7.2009 (Photograph by courtesy of G. Kristiansen, NVE region nord).

In the morning of June 26th, 2008 a rock slide detached from the northeast facing slope of Polvartinden at 16.18N/19.95E, a 1275 m high mountain in the Signal valley, Troms county, Northern Norway (Figure 1). The rock slide endangered two farms and several recreation cabins, and it permanently destroyed a considerable amount of livestock pastures (Figure 2).

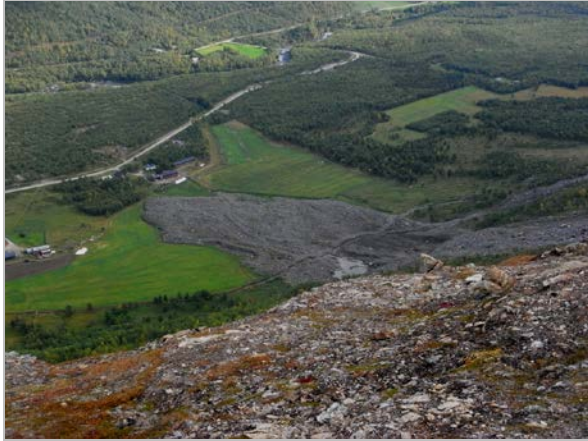
Figure 2. Runout area of the Signaldalen rock slide (Photograph by courtesy of G. Kaiser).

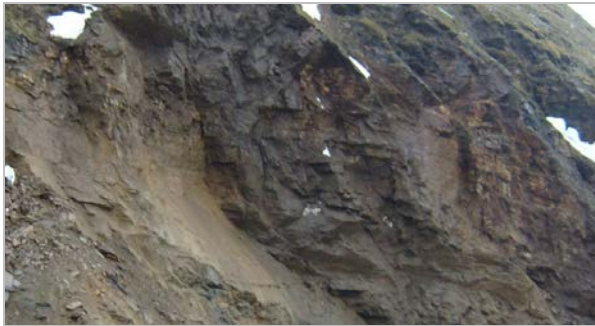
Figure 3. Visible in situ ice (white and greyish spots in centre of image) observed in the rock slide detachment zone on June 26th, 2008. This photo was taken a few hours after the event (Photograph: K. Brattlien, NGI).

Visible in situ ice was observed in the detachment zone just after the rock slide event (Figure 3). This observation led to the hypothesis that warming or degrading of permafrost could have played a role in the timing and the magnitude of the event. Therefore, a temporary temperature monitoring system was put in place and repeated surveying of the detachment zone and the adjacent slopes was carried out between 2009 and 2013.

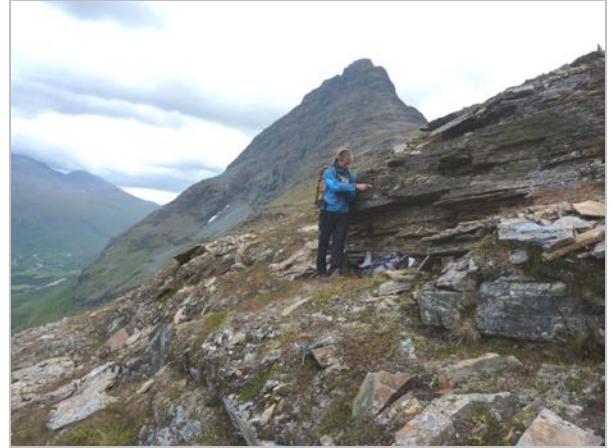
Figure 4. Logger installation in rock outcrop.

Nine temperature loggers (type M-Log5W and redesigned UTL-1) were installed in vertical rock faces on rock outcrops and along small cliffs with different aspects (Figure 4), while five loggers (UTL-1, UTL-3) were placed directly into the soil material (Figure 5). One additional logger was installed in the valley floor in order to monitor air temperature (Figure 5).

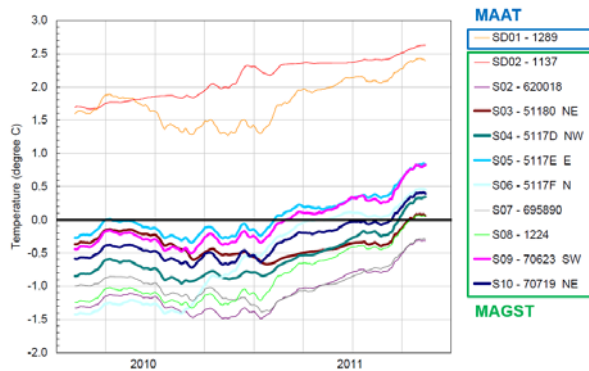
Figure 6: MAGST (respectively MAAT for SD01) for 2009–2011 calculated by a 365-day moving average filter showing, among others, the high correlation of rock (near) surface temperature with air temperature.

2009/2010. For the vertical rock face sites, the lowest MAGST was recorded at the north facing site in 2009/2010 (Figure 6).

The MAGST between 2009–2011 (Figure 6) indicate warm/marginal permafrost at several of the sites, and yield an estimated mean lower limit of permafrost at around 600-650 m a.s.l., an altitude which coincides with the upper limit of the detachment zone.

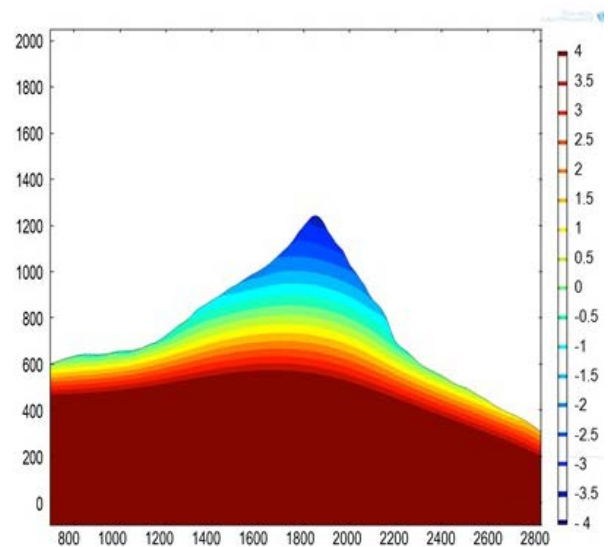
Figure 8. 3D transient heat modelling of the subsurface temperature field. Figure shows a slice from South (left) to North (right).

Results of the 3D transient heat conduction modelling show an aspect dependency with a slightly lower permafrost limit in northern exposition as opposed to slopes exposed to the South (Figure 8).

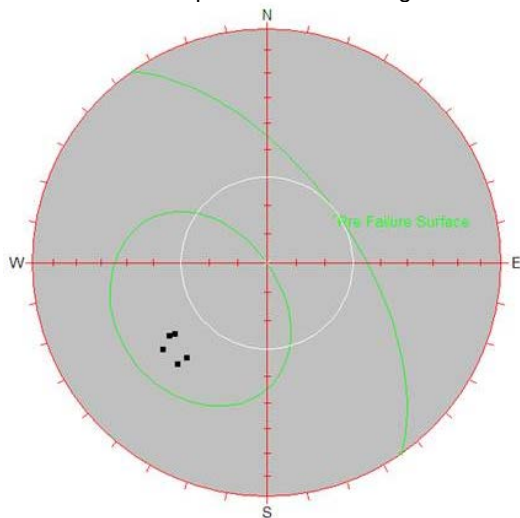
Figure 9. Kinematic analysis of bedding planes for sliding failure. The white circle represents an estimated friction cone of 30° and the green cone represents the sliding daylight window for the associated pre failure surface.

Understanding the principle mechanism behind the failure involves a kinematic evaluation of the failure scarp. Figure 9 illustrates an equal area stereonet. Plotted on the stereonet are the poles to the bedding surface.

The bedding planes have been identified as the failure surface from the LiDAR data and photographic interpretation. The extraction of the orientation of the bedding surface and the orientation of the natural slope ("Pre Failure Surface") are determined directly through measurements using the LiDAR data.

The green line in Figure 9 represents the orientation of the natural slope surface, and the green circle represents the corresponding daylight window. The white cone depicts an estimated friction surface of 30°s. Poles that are contained outside of the white circle but within the green circle are kinematically unstable and represent potential sliding failure planes. This stereonet demonstrates that the bedding surface orientation is steeper than the estimated friction angle but shallow enough to daylight with respect to the slope face. Thus meeting the kinematic requirements of sliding failure and posing a potential rockfall hazard (see e.g., Hasler et al., 2012).
