# Mapping the inaccessible with LiDAR and gigapixel photography: a case study from Norway

## ABSTRACT

This paper presents a case study on the the field work and data analysis performed in order to assess the slope for potential rockfall hazard source zones.

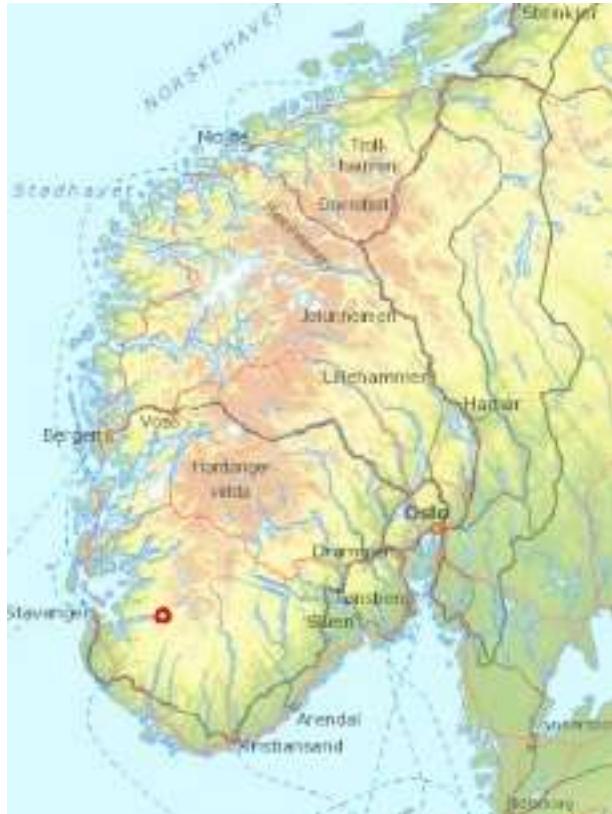
Figure 1. Lysefjorden, outlined in red, is located in south-west Norway.

Norway is a rugged country extensively covered by mountainous terrain. The topography lends much of the country vulnerable to natural threats including landslides, rockfalls, tsunamis, and snow avalanches. The mountainous regions of Norway currently exploit this extreme topography as a means to generate hydroelectric power. With aggressive plans for future development and exploitation, these installations are and will be inherently exposed to natural threats. The Norwegian Geotechnical Institute (NGI) has numerous demanding tasks to assess rockfall hazards from clients operating and expanding in these regions. An example of such a task is NGI's ongoing work for Lyse, who is building a new power plant in Lyseboten (Figure 1).

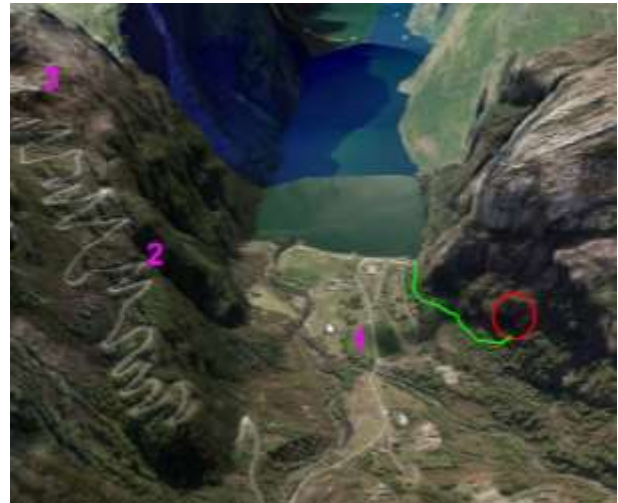
Figure 2. Orthophoto of the Lysefjorden valley. The red circle outlines the tunnel portal, green line is the new road to be constructed, the numbers 1-3 represent TLS and gigapixel imaging locations (imagery from <http://www.norgei3d.no/>).

The construction planned on site is to consist of building a new road, a tunnel, a cavern, and penstocks inside the fjord walls. Typically in Norway, hydroelectric power stations are built within the mountain and all penstocks are tunneled, not constructed as surface pipes, in contrast to, for example, the Niagara hydroelectric generating stations in Canada and the USA. The approximate location of the planned construction is outlined in Figure 2 superimposed on a 3D rectified orthophoto of the fjord mouth.

Terrestrial LiDAR Scanning (TLS) is a 3D imaging technique that creates a high-resolution surface model of the scanned area. TLS data was collected from three locations (Figure 2), which enabled the merging of the datasets into a single model to minimize occlusion in the surface model (Lato et al. 2010). The TLS scanner used in this project is an Optech IIRIS-LR scanner with a range of over 2000 m, allowing the entire slope to be scanned at a high resolution. The 3D model was referenced using visible objects in the model, such as houses that were surveyed using dGPS. The transportation of the TLS equipment was done using helicopter as the survey sites are inaccessible by foot or car.

The TLS data was collected across the entire fjord wall above the proposed location of the tunnel portal and surface road construction sites. The data was collected at a minimum resolution of 100 points per square meter. The data from scan location 3 (Figure 2) was unusable as the TLS equipment was exposed to extreme winds at the top of the mountain; the winds caused the equipment to vibrate, which resulted in highly inaccurate data. Fortunately the data from scan locations 1 and 2 provided optimal results.

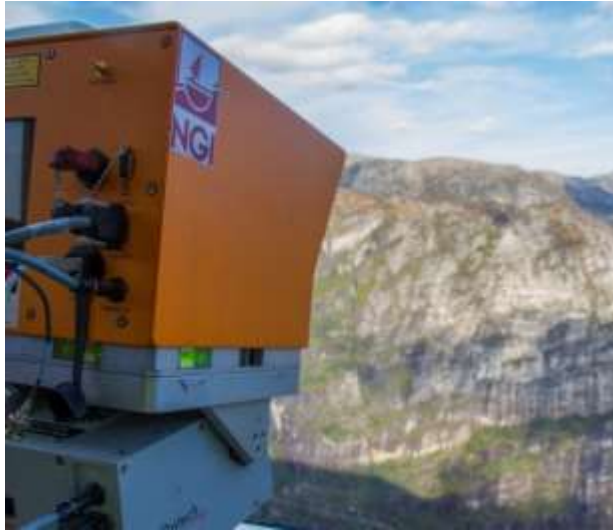
Figure 4. Optech Ilris LR terrestrial scanner.

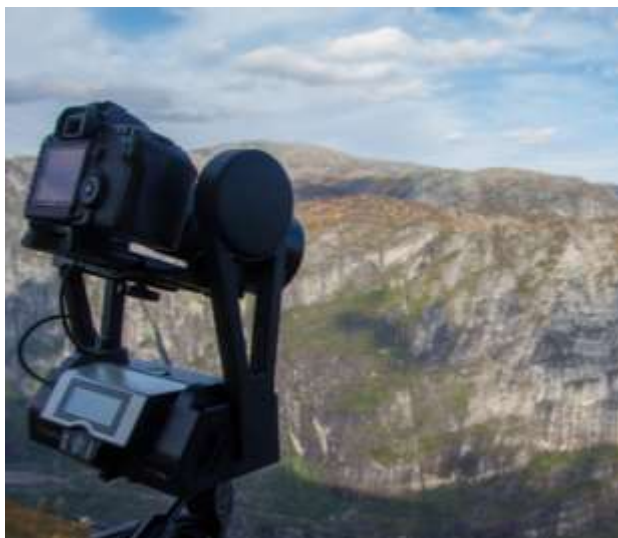
Figure 5. Gigapan robot with Canon 5D MkII and a 135mm f/2.0 L prime lens at data collection location 3 (Figure 2).

Gigapixel photography is a term referring to the generation of 2D photographs with gigapixel resolution (over one billion pixels), as opposed to the common megapixel resolution images produced by standard digital cameras and photography techniques. The GigaPan head used in this project robotically controls any DSLR camera to optimally collect individual photos, which are later combined into a single gigapixel panoramic photo. The robot pans and rotates the mounted DSLR camera at specific intervals determined by the camera body and focal length of the lens in order to produce images with minimal offset distortion.

The camera used in this project is a Canon 5D MkII fit with a 135 mm f/2.0 lens. The photographs were collected at ISO 200, f/8.0, and 1/400<sup>th</sup> of a second. The most critical component of generating a high quality gigapixel image is in the quality of the individual input images.

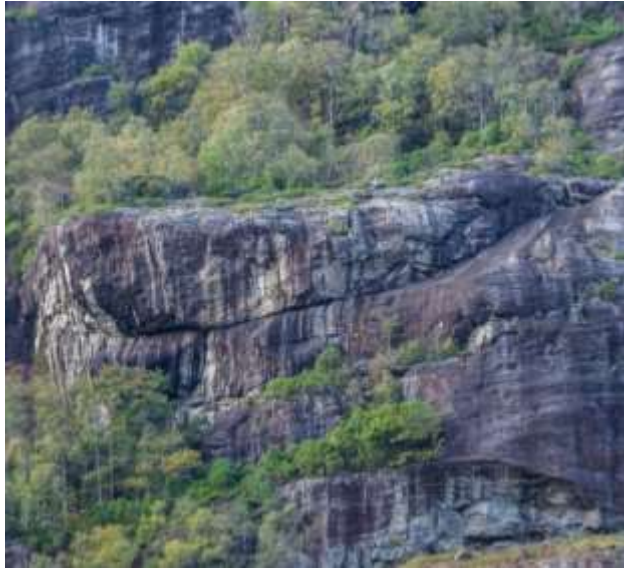
The source zone outlined in the purple box is a planar sliding wedge type failure characterized by a sliding surface approximately 60 m wide dipping at an angle of  $35^\circ$ . The source zone is illustrated in Figure 7 (gigapan image).

Figure 7. Source zone visualized in the gigapixel photograph, purple outline in Figure 6.

If the mass were to fail as a single event the approximate volume would be  $4000 \text{ m}^3$ . This potential sliding failure source zone exhibits no signs of recent movement or active failures. Directly to the right of the potential hazard is what appears to be the sliding surface of a historical failure; this further suggests the potential for future failure.

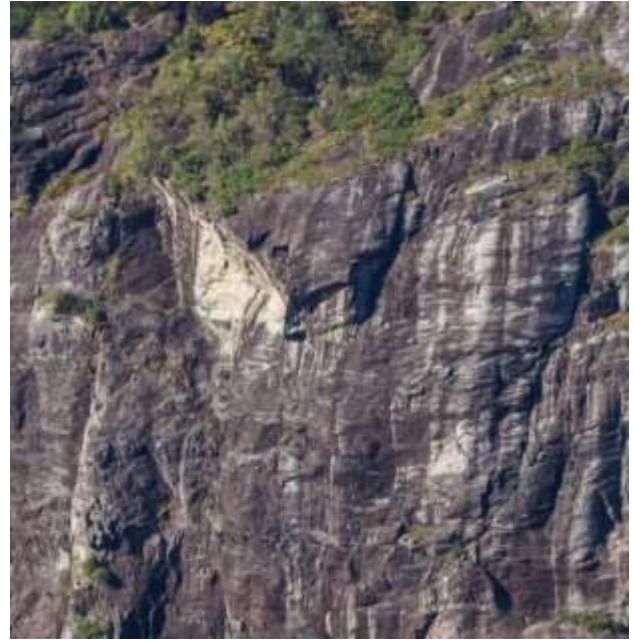
The source zone outlined in the blue box is a planar sliding wedge type failure characterized by a sliding surface approximately 25 m wide dipping at an angle of  $60^\circ$ . The source zone is located directly to the left of the proposed tunnel portal. The estimated volume of the source zone that has not yet failed is  $1200 \text{ m}^3$ . The source zone is illustrated in Figure 8 (gigapan image). The left side of the source zone has failed in the recent past as can be identified by the unaltered white rock surface along the sliding plane. The potential source zone appears fractured and it could be expected that smaller individual failures may precede a larger event.

Figure 8. Source zone visualized in the gigapixel photograph, light blue outline in Figure 6.

The size, location, and orientation of the potential source zone makes mitigating against the hazard extremely challenging. The rockmass in both instances cannot be supported without extreme measures, and the tunnel portal cannot be protected by standard systems such as rockfall fences or rockfall sheds due to the large mass of the potential failure volumes.

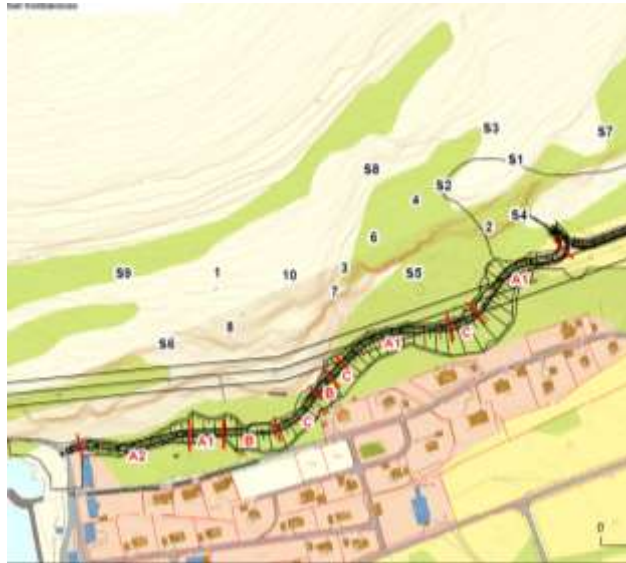
Figure 9. Topographical map with all mapped rockfall hazard locations on the slope face and ranked zones of hazard impact marked along the planned road construction route.

The zones identified in the 2D and 3D analyses were plotted in ArcGIS and their spatial relationship with the construction of the road and tunnel portal were examined (Figure 9).
