# Mosquito Creek Debris Flood Barrier – The First Line of Defence in Protecting the Public from Geohazards

Charles Hunt, M.Sc., P.Eng., ACSM., Jamie Stirling, M.Sc., P.Geo., Jack Price, EIT., ACSM  
*Tetra Tech EBA, Vancouver, BC, Canada*  
Fiona Dercole, Michelle Weston  
*District of North Vancouver, North Vancouver, BC, Canada*

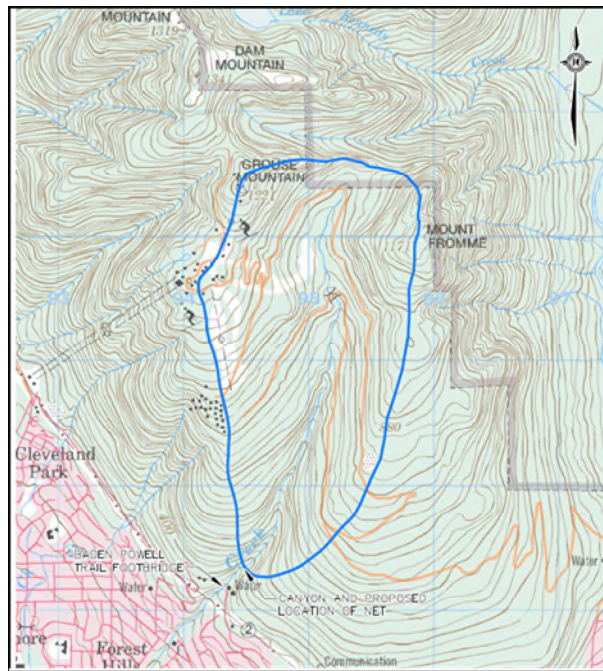
Figure 1. Location map of Mosquito Creek in the District of North Vancouver, British Columbia, Canada. The catchment area at the debris net is 4.31 km<sup>2</sup>.

The average gradient of Mosquito Creek between the Baden Powell Trail Footbridge and the bedrock canyon (approximately 220 m) is 15%. The catchment area at this location is approximately 4.31 km<sup>2</sup> (Figure 1). This reach of the creek has a step-pool morphology dominated by boulders on the bed and banks with a limited floodplain area on both banks.

The area of the Mosquito Creek basin at the point of the potential debris net location was estimated to be 4.31 km<sup>2</sup> as illustrated on Figure 1. Based on this information, the volume of wood debris might be expected to be between 43.1 m<sup>3</sup> and 4310 m<sup>3</sup> for a coniferous forest such as the Mosquito Creek basin.

The first phase consisted of a walkover survey of the creek from the Baden Powell Trail Footbridge upstream to where the deactivated logging road crosses the creek mainstem (Figures 1 and 2). This survey focused on evaluating the quantity of LWD in the creek and the amount which could be mobilized in various flow events.

Adjacent to this sediment wedge on the east valley slope are several landslide paths, some of which are old (POI 21) while others are still actively depositing material directly into the creek (POI 23). Upstream of this area the channel gradient and valley side slopes flatten as shown by the contours on Figure 1. As a result, there are fewer jams and slope instabilities.

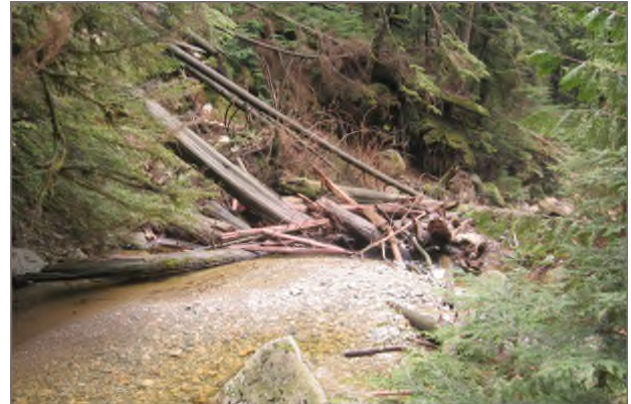
Photo 1 illustrates typical log jams, averaging approximately 10 m<sup>3</sup> each. Jams smaller than this estimated volume were not POI referenced as they were too frequent to document. Typical eroded slopes and small landslides result in about 5 to 20 m<sup>3</sup> of sediment being deposited directly into the channel.

Photo 1. Looking downstream at a typical medium sized debris jam creating a sediment wedge behind the jam.

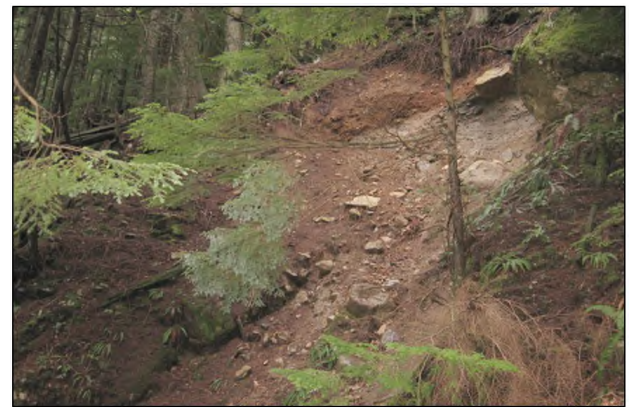
Photo 2. Looking upslope at a typical medium sized landslide that has deposited sediment and debris directly into the channel.

Photo 2 shows a shallow landslide exposing the underlying bedrock. These are typical along the mainstem, and these events were effective in depositing large volumes of sediment and debris directly into the channel.

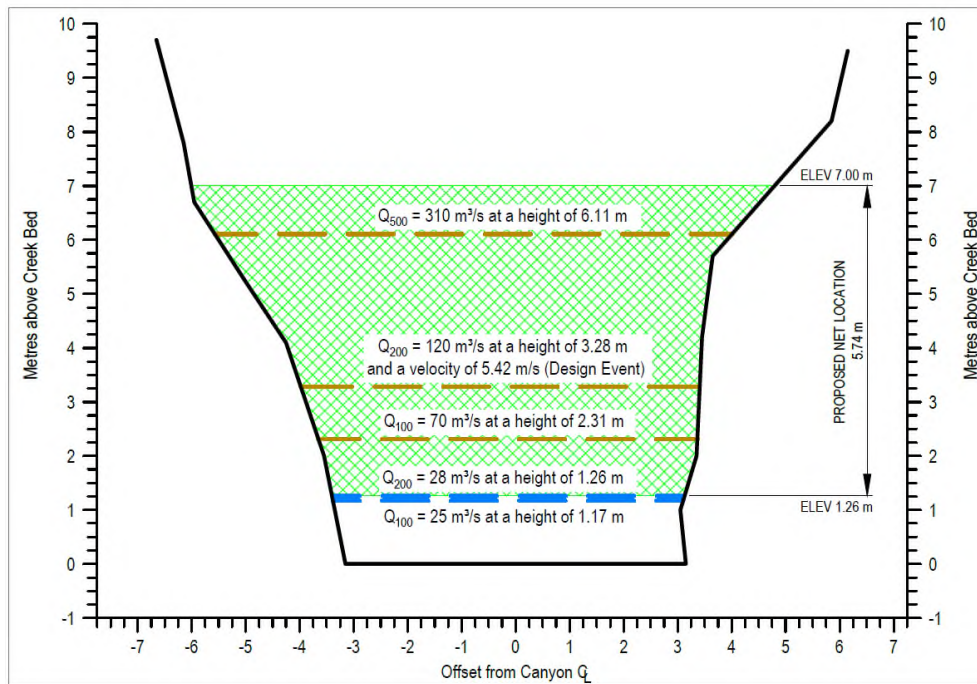
Figure 3 is a cross section illustrating the estimated depth of various events at the debris net location in the bedrock canyon.

Figure 3. Estimated depths of various events at the location of constructed debris net.

The 200-year clear water event depth of 1.26 m was used for the positioning of the bottom of the net. This reduces the frequency of regular maintenance associated with debris removal from behind the net.

In order for the net to be able to contain the design debris volume of 1,500 m<sup>3</sup>, the top of the net position was set at an elevation of 7 m above the creek bed.

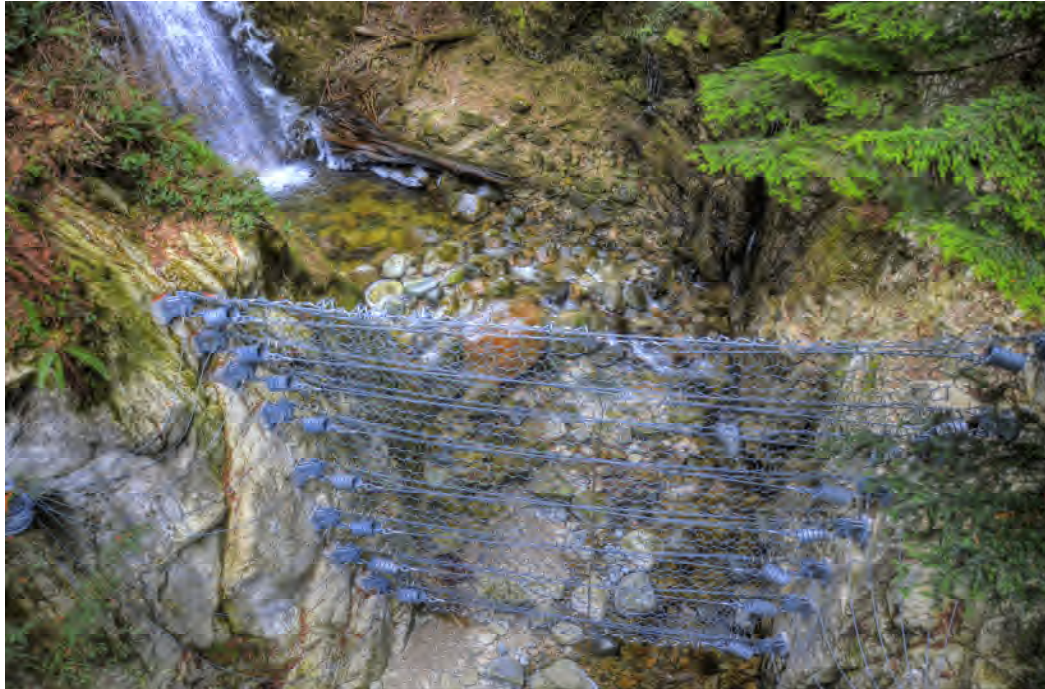
Photo 3. Looking upstream from above at the completed debris net located within the bedrock canyon.
