Real time detection of rock fall events using a microseismic railway monitoring system

D. S. Collins, Y. Toya, Z. Hosseini & C.-I. Trifu
ESG Solutions, Kingston, Ontario, Canada

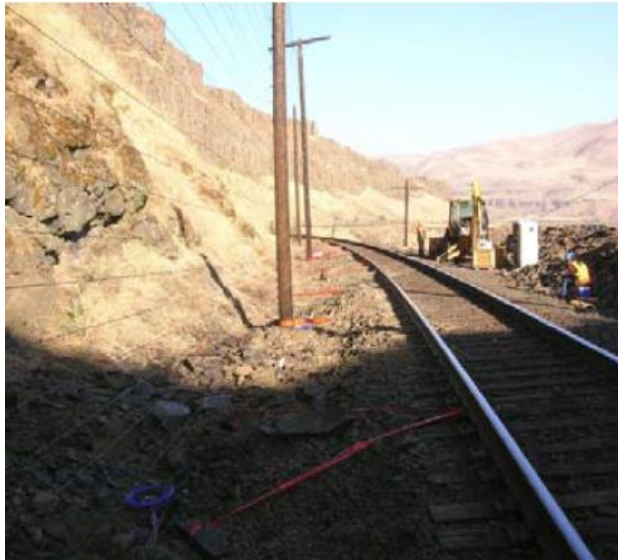
Figure 1. The location for Array 1. Microseismic sensors are installed at 5-8 feet from the railway track near to the location of the electric fence. The white box to the right is the location where the signals are collected and analyzed.

Array 1 was installed in September 2008 along a 250 foot length of railway track (Figure 1) that was prone to rockfall events (Figure 2). A total of 12 uniaxial geophone sensors (frequency 15-1000Hz) were installed at a distance of 5-8 feet from the rail track. The sensor cables connect to a small water resistant splice box and a trunk cable running parallel to the tracks. The trunk cable passes to a junction box where the signals are digitized continuously at 5000Hz sampling and 24 bit resolution.

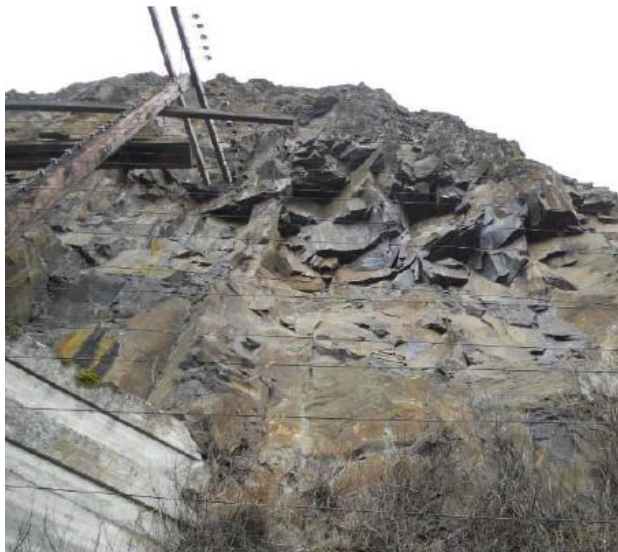
Figure 2. Photo showing the steep rock slope beside the railway tracks in the vicinity of the MRMS sensor Array 1.

A known rockfall event occurred on December 17 2010. The main rock involved in the rockfall appears to have fallen from a cliff face at a height of about 20m (Figure 2). Figure 4 shows the approximate 200kg rock that fell. The system recorded the initial rockfall activity and the main rock impact. The rock had sharp edges that cut the trunk cable between sensors 2 and 3 (Figure 5). To prevent damage, sensors and cables should be installed 0.5 – 1.0 feet below surface as shown in Array 2.

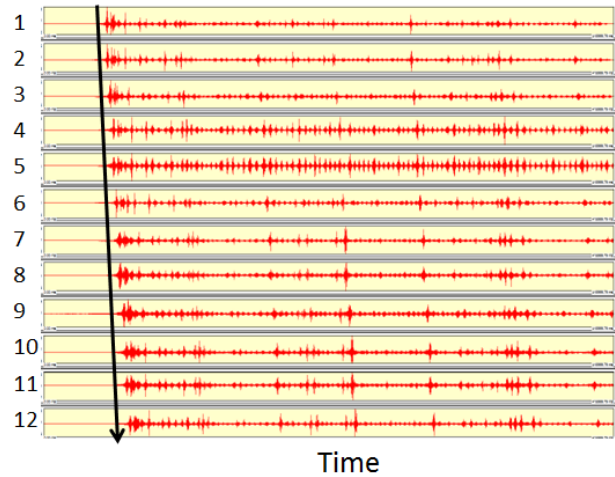
Figure 3. Waveforms recorded on the 12 sensors of Array 1 showing all sensors to be functioning correctly. The signals are due to a train passing and show that the train passed from the top sensor to the bottom one at a relatively constant velocity.

Figure 3 shows signals that indicate all 12 sensors are functioning correctly following the installation. In this example, a train has passed by, and the signals at each sensor show a similar character with a slight offset in time as expected due to the velocity of the train travelling along the tracks past each sensor from number 1 to 12.

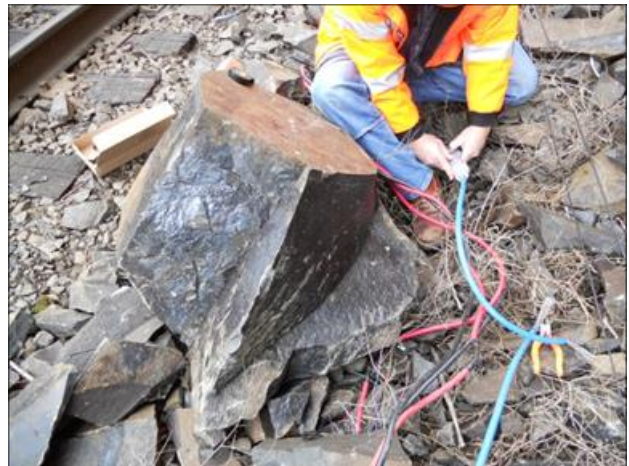
Figure 4. The approximate 200kg rock that fell on December 17 2010.

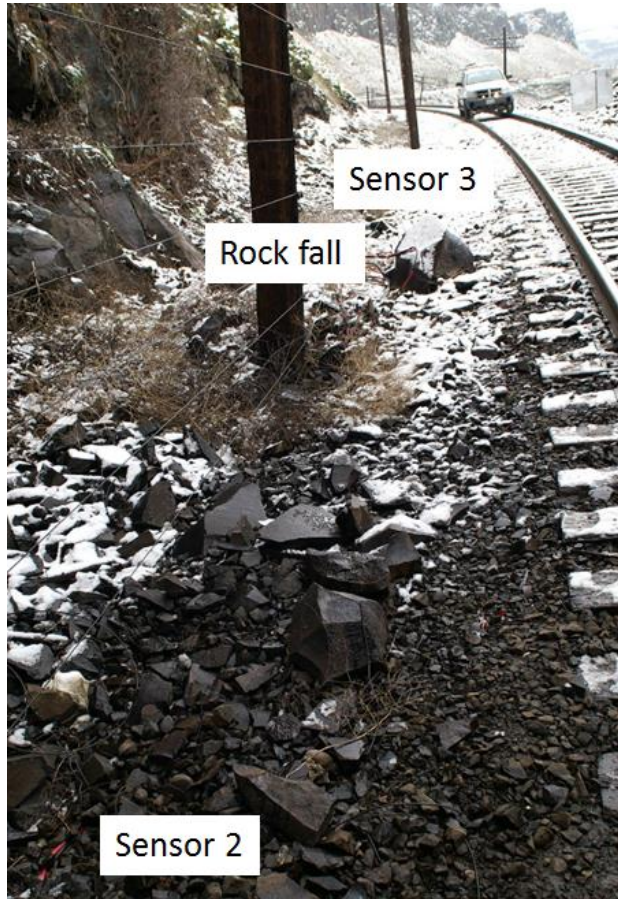
Figure 5. Photo showing the location of the approximate 200kg rock in relation to sensor 2 (bottom left) and sensor 3 (top right).

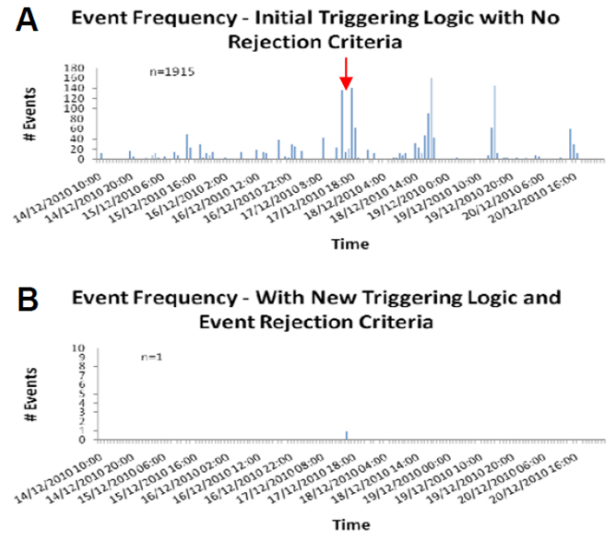
Figure 6. Event-time histograms with 1-hour windows using (A) initial triggering parameters; and (B) enhanced triggering logic and event rejection criteria. The time of the rockfall on December 17 is marked with an arrow in A.

An analysis was performed of a one week period of continuous data (December 12-20 2010) from the system that included the rockfall. Using a standard threshold exceedence logic (3 times above sensor background noise levels), a total of 1915 triggered events were extracted from the dataset. The event triggers were classified into five types (passing train, car on tracks, electrical noise, small seismic event, rockfall event) based on the specific seismic characteristics of each type. By optimizing the triggering logic and implementing an event rejection function, the single rock fall event was uniquely identified (Figure 6).

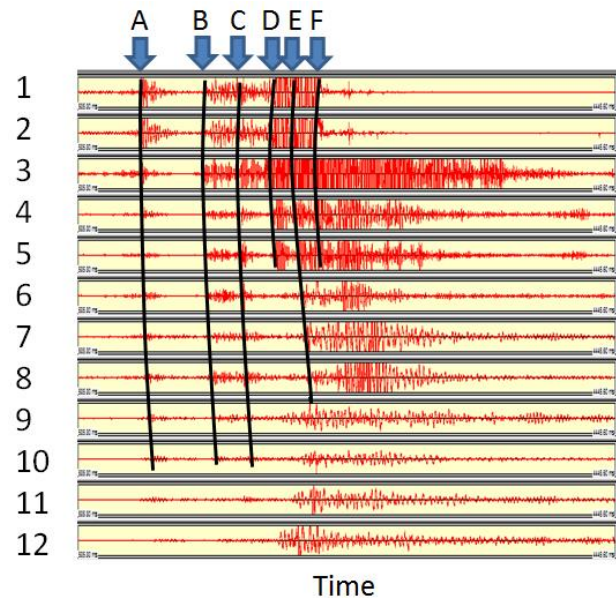
Figure 7. A five second capture of the microseismic waveforms centered around the time of the rock fall. The sensors are identified as 1-12. The black curved lines marked A-F are each interpreted microseismic events related to rock impact and all originate near to sensors 1-3. Marker F identifies when the cable to sensors 1-2 was cut by a large 200kg rock fall. The times marked A-E are rock fall activity before this.

Figure 7 provides more details about the rockfall event. The time marked by F is when the trunk cable was cut by the fallen rock. Interestingly five other impacts can be interpreted at markers A-E. The black lines interpret the time moveout curves of the energy arriving at each sensor, and show that all markers A-F were due to impacts near to sensors 1-3. This can be interpreted as a 2 second rock fall involving the large 200kg rock and possibly smaller pieces. The large rock may have hit at time D and bounced resulting in E and F.

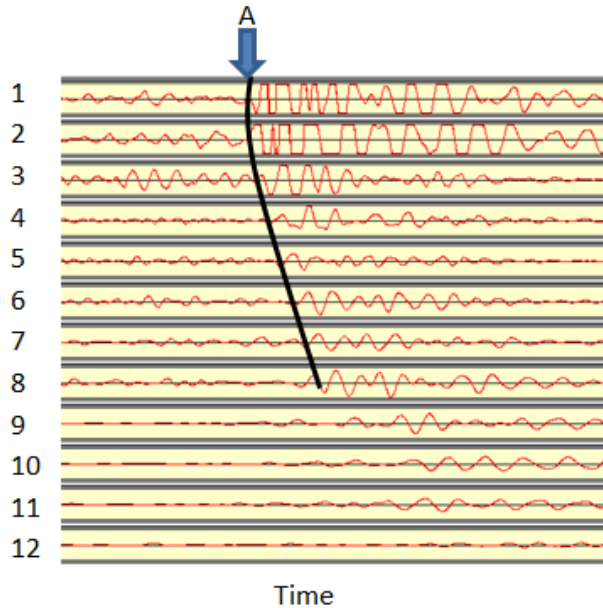
Figure 8. A 0.5 second time capture highlighting the waveforms related to a rock impact event occurring near sensors 1 and 2. Marker A is the same as the one identified in Figure 7.

Figure 8 shows more details of the seismic signals at marker A in Figure 7. The seismic signals in time, frequency and amplitude are characteristic of a small rock fall impact event. This event occurs about 2 seconds before the larger amplitude rockfall event associated with the 200kg rock.

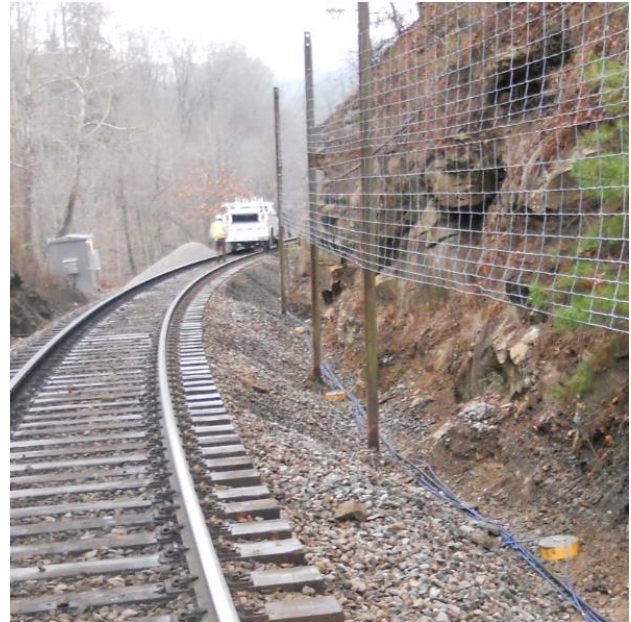
Figure 10. Photo identifying the location of some of the sensor for Array 2. The sensors are placed in a natural trench 5-8 feet from the railway line and near to the electric fence. The sensor cables pass through a conduit under the railway line and into the hut on the left of the figure where the digitization electronics is housed.

Figure 10 shows more details of the site with the sensors installed about 5-8 feet from the railway line. The sensors are spaced 35ft apart and mounted along a natural trench beneath the electric fence. Figure 11 shows the steep cliff and overhanging rocks along the monitored railway segment.

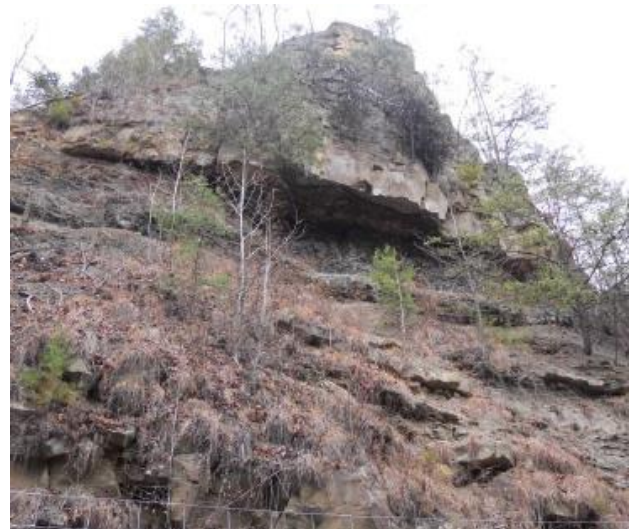
Figure 11. Photo showing the high rock slope above the location of Array 2.

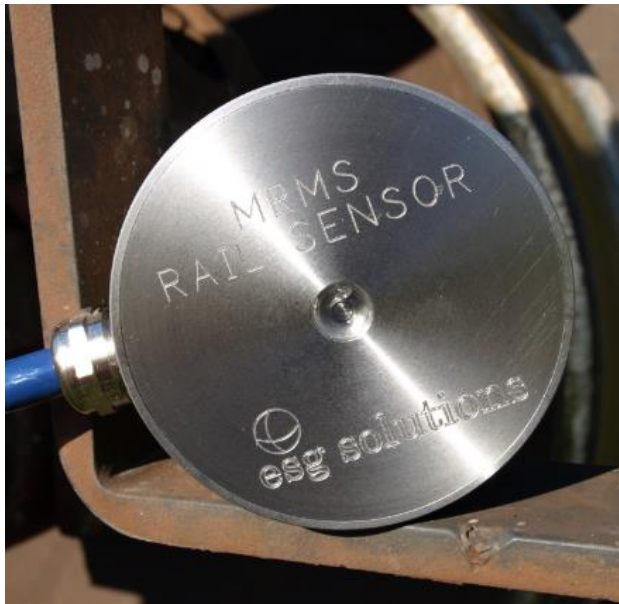
Figure 12. Photo of the end sensor before installation, highlighting the bubble level in the center and fully integrated design.

The sensors for Array 2 are a fully integrated sensor cable design (Figure 12) with no separate splice box, that significantly speeds up installation time. The disc shaped sensor was pressed into a 1ft diameter concrete base

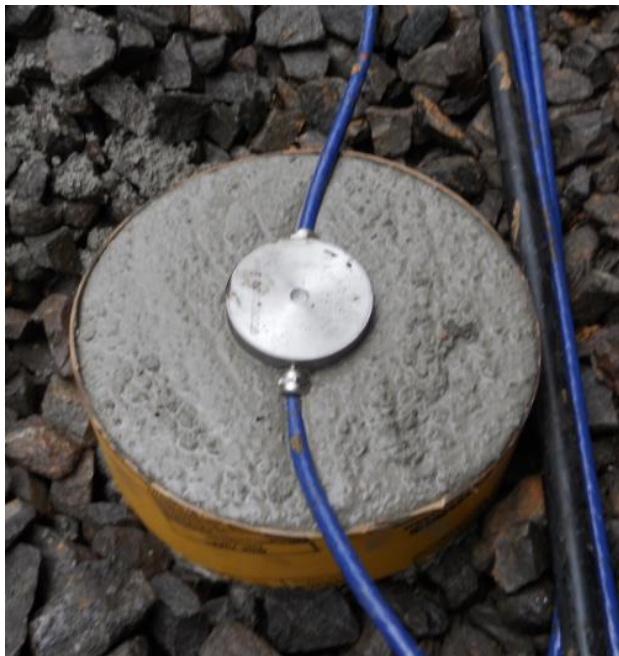
Figure 13. Each sensor was cemented in place to ensure good coupling to the ground and a horizontal orientation.

(Figure 13) using the bubble level to ensure horizontality. The sensors were subsequently covered with sand and gravel.

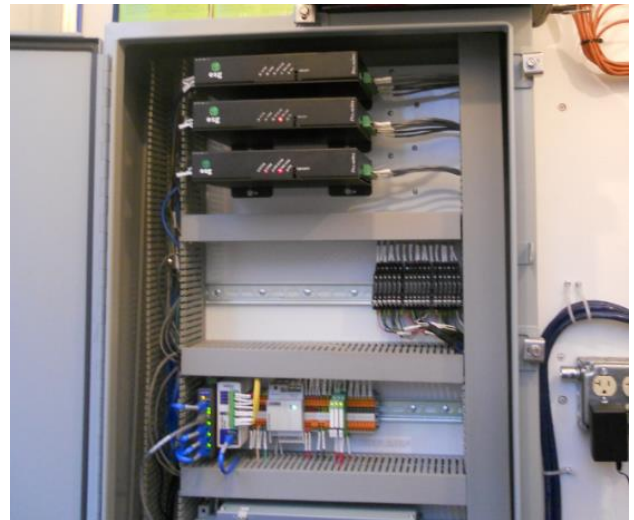
Figure 14. Photo showing the MRMS junction box inside the railway hut. Signals from the sensors are continuously digitized and analyzed for potential alarms (certain trigger criteria). The system also performs regular checks of system health. A webrelay unit allows mechanical control over switches such as railway lights.

The analog seismic signals pass by trunk cable to the acquisition junction box (Figure 14) installed in a railway hut. The signals are digitized at 5000Hz and 24-bit resolution and synchronized to GPS time. A laptop computer stores all data to a ringbuffer harddrive and performs real time analysis of the continuous data. The

analysis allows an alarm to be issued if certain user set signal characteristics are exceeded. A separate alarm is issued if system health checks identify an issue with any of the sensors, power, or junction box equipment.

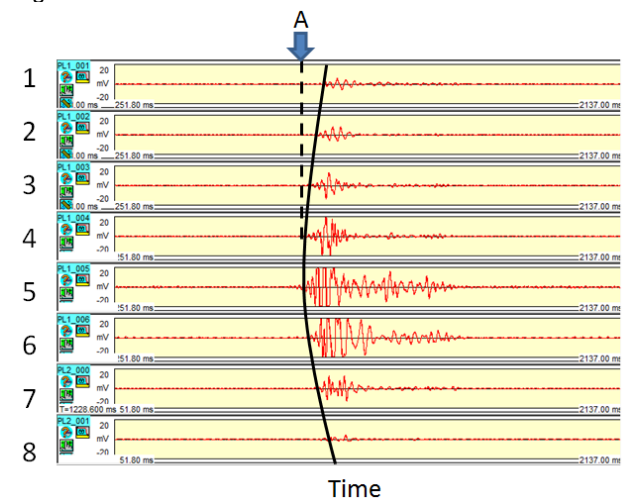
Figure 15. The signals recorded over a 2 second time window by Array 2 during a calibration impact test. The black line is the interpreted moveout curve and shows the impact test to originate at time A near sensor 5 as expected.

A rock fall simulation was performed using a loader bucket dropping on the track. Figure 15 displays the recorded seismic signals associated with this impact test at sensor 5. The seismic signals and interpreted moveout curve in black clearly show the unique type of signal characteristics and time response for an impact source. As expected, there are a number of similarities of this calibration test response to the rockfall response in Figures 7 and 8.

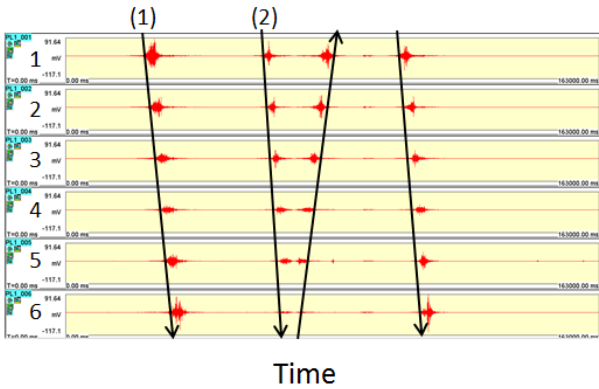
Figure 16. Signals recorded over a 163 second time period from 6 sensors in Array 2. The red arrows interpret signals associated with vehicles passing the sensors. Since the distance between sensors is known, the speed of each vehicle can be accurately determined.

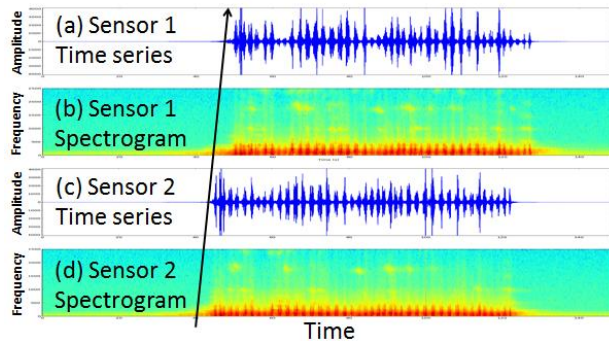
Figure 17. Time signals in blue recorded over a 145 second time period associated with a train passing two of the sensors in Array 2. Each train creates a unique seismic signature related to the number of cars and the load of the cars as they pass over joints along the railway track. The figure also shows the spectrogram of the signals identifying the variation in frequency content from 0 to 2500Hz (warm colors are high spectral amplitude, cool colors are low).

The response of a train passing two of the sensors in Array 2 is displayed in Figure 17. The signals indicate that the train took over a minute to pass by each sensor, and the characteristics of the seismic signal can be used to indicate how many cars were in the train and the relative load in each car. The spectrogram (frequency versus time graph) of each signal shows a characteristic signature which could be used to identify a train.
