Listening for Landslides: Method, Measurements and the Peace River Case Study

Alister Smith & Neil Dixon

School of Civil and Building Engineering, Loughborough University, Leicestershire, UK

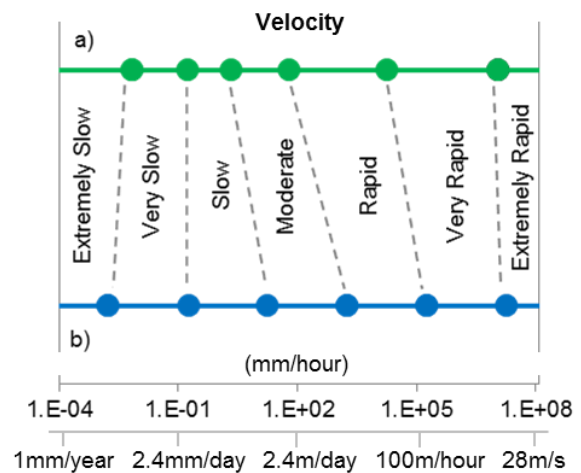
Figure 2. Landslide velocity scale after a) Transportation Research Board (1978) and b) Anderson & Holcombe (2013, p92)

Dixon & Spriggs (2007) found that by applying displacement rates that were separated by orders of magnitude (i.e. slow, moderate and rapid as in Figure 2) to active waveguide models in the laboratory, the magnitude of AE rates generated were also separated by orders of magnitude, and proportional to the displacement rate applied. This research demonstrated for the first time

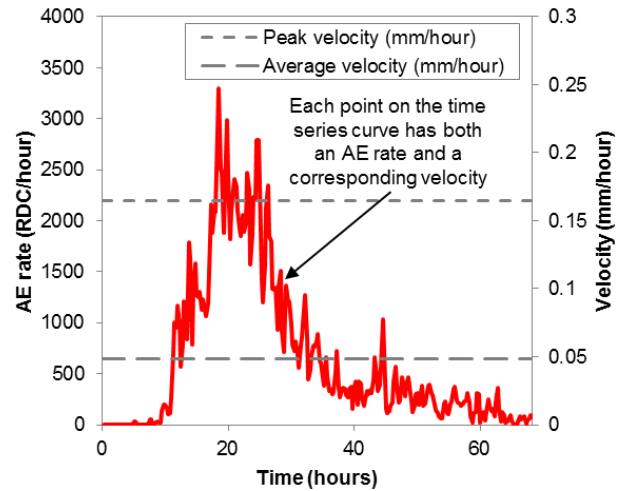
Figure 8. AE rate- and derived velocity- time relationship for reactivation event at Hollin Hill after Dixon et al. (2014a)

The sporadic nature of the AE rate data is due to slip-stick deformations taking place between the gravel particles within the backfill as interlock is overcome and regained. Indeed it would be assumed that the velocity-time profile of the slope movement would be a smoother curve of moving averaged values. Interrogation of the velocity profile for the event in Figure 8 yields an event

duration of roughly 60 hours, with a peak velocity of 0.16mm/hour and an average velocity of 0.05mm/hour. This event would be classified as 'very slow' according to Transportation Research Board (1978). The systems apparent sensitivity at relatively small displacement rates indicates that the technique is suitable for detection of changes in relative slope stability in response to destabilising (e.g. climate related) and stabilising (e.g. remediation) events, and as an early warning system.

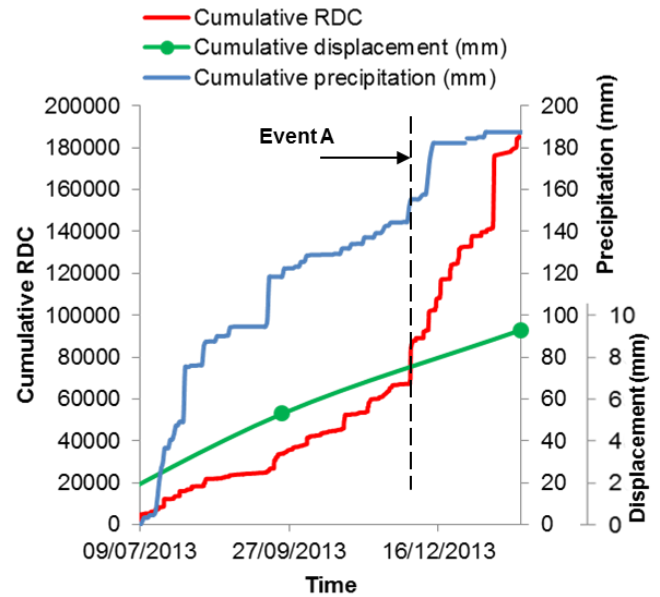
Figure 15. Cumulative RDC-, displacement- and precipitation- time, with Event A highlighted

Figure 15 shows cumulative RDC, cumulative displacement (from S110-8) and cumulative precipitation for the initial monitoring period. Of note are the steep increases in the cumulative RDC record (i.e. the 'S' shaped curves). These show periods of increased AE rates followed by reduced AE rates, and can define periods of slope movement as described in section 3.2. A sample event (Event A) which was preceded by a period of precipitation (snow) has been selected and is shown in Figure 16 at a larger scale.

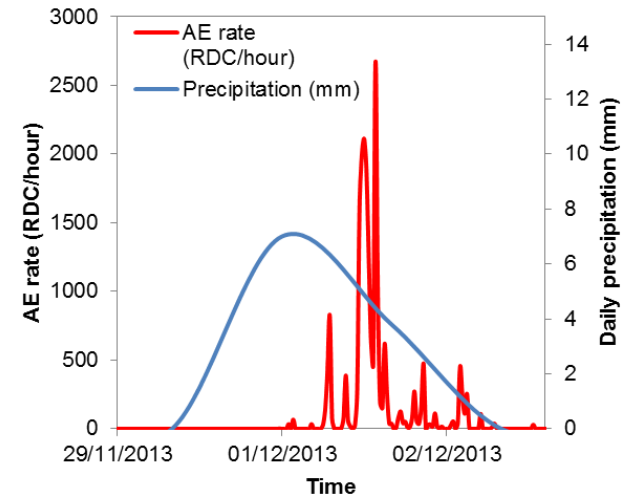
Figure 16. AE rate- and precipitation- time for Event A

It can be seen that the AE generation is triggered by preceding precipitation. The AE rate (RDC/hour) rapidly increases towards a peak and then decreases, and the curve exhibits a similar shape to the deformation events

described in section 3.2. The increased AE rates in Event A were sustained for 1.5 days indicating they were generated in response to a period of slope movement. However, as continuous measurements of slope deformation were not available it is an assumption at this time that Event A was generated by sub-surface straining of the active waveguide in response to slope movement. Another hypothesis is that seepage effects are superimposed on the AE time series, and the elevated levels of AE activity in Event A could be in response to seepage through the active waveguide gravel column; either via groundwater flow through relatively permeable stratum, or infiltration from the ground surface.

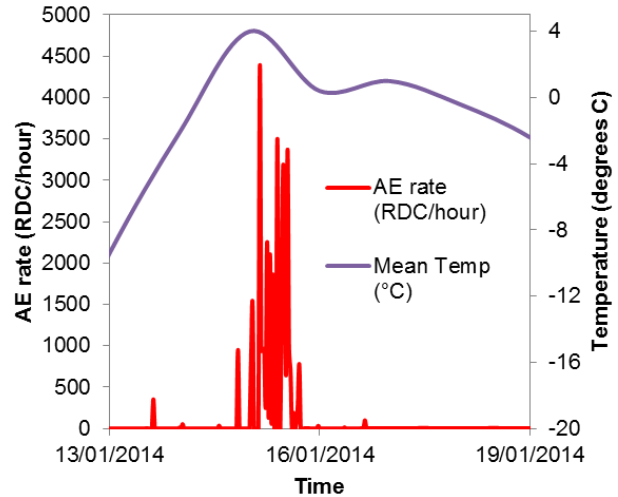
Figure 18. AE rate- and temperature- time for Event B

The increased levels of AE activity in Event B are hypothesised to be caused by temperature changes, causing for example; physical expansion and contraction of the surface cover and/or near surface soil inducing AE within the frequency range that the sensor monitors. There is a strong possibility that many of the AE events detected after the temperature dropped below freezing could be caused by the cycles of extreme temperature changes.
