Gone Like a Ghost: The Ghost Glacier failure and subsequent outburst flood, Mt. Edith Cavell, Jasper National Park

Rupert Wedgwood
Parks Canada, Jasper, Alberta, Canada

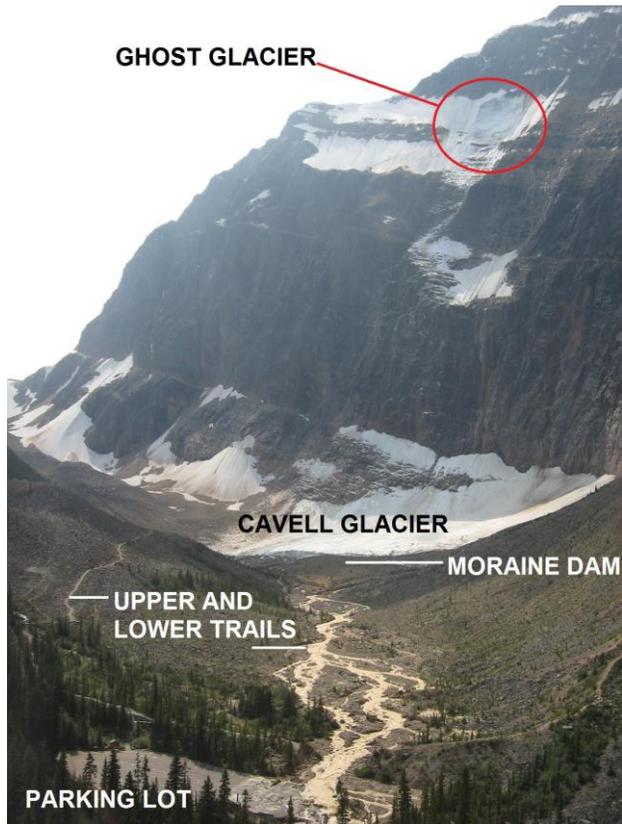
Figure 1 The Mount Edith Cavell day use area. The picture shows the relative positions of the parking area (bottom), the meadows trail (mid left). Prior to the GLOF a trail followed the valley bottom to the Cavell Tarn (hidden from view) below the north face (Park Canada G.Lemke)

There are two main glaciers on the north face of the Mount Edith Cavell. The Angel Glacier is a hanging glacier flowing from a cirque below the peak and was formerly confluent with Cavell Glacier that occupies the area at the foot of the near vertical north face (figure 1). In the 1700s Cavell Glacier extended downvalley to the present parking lot. During the 20th century (See Luckman References) the glacier has receded upvalley and thinned, resulting, after 1960, in the formation of a proglacial lake into which Cavell Glacier now calves. The

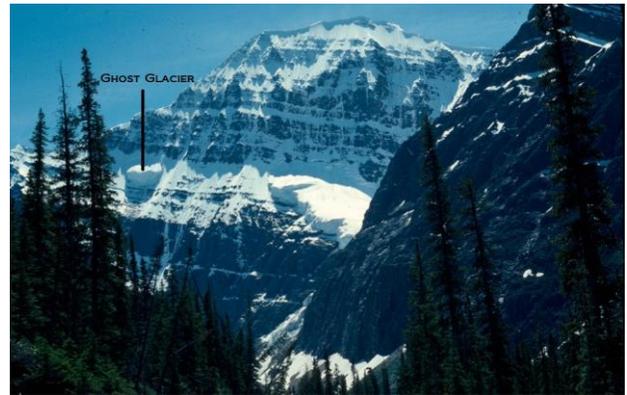
Figure 2 The Ghost Glacier prior to August 10th 2012 (Parks Canada, Jasper Park archive)

During the night of August 9th or the early morning of August 10th approximately 60% of the Ghost Glacier released from the north face of Mount Edith Cavell. Figures 2 and 3 show the before and after images of the Ghost Glacier's location. The displaced ice fell approximately 1,000 m onto the Cavell Glacier (Figure 4) and into the Cavell tarn (elevation 1,775 m), located approximately 600 m from the base of the north face, producing a glacial lake outburst flood (GLOF). The estimated volume of the displaced ice ranges considerably from a maximum 200,000 cubic meters to a minimum of 100,000 cubic meters. It is likely the volume was close to 125,000 cubic meters. The estimated average ice thickness of the failed glacier material was 20 m. The ice entered the tarn from the southeasterly edge of the Cavell Glacier displacing a huge volume of water across 170-180 m of the downvalley shoreline (Figure 4).

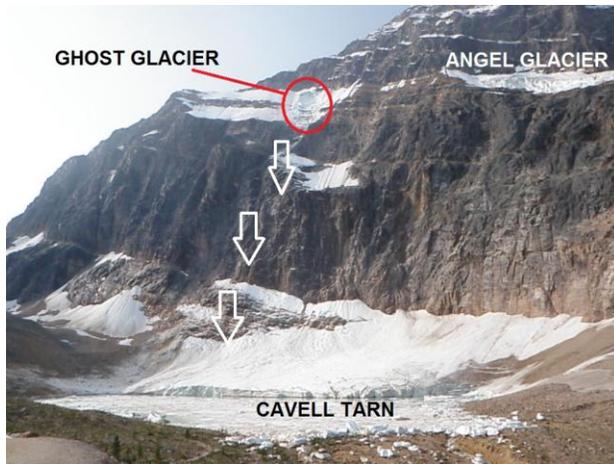
Figure 4 Cavell tarn is located below the north face of Mount Edith Cavell. The arrows show the trajectory of the icefall. Ice blocks can be seen on the shore having been lifted from the tarn by the surging waters of the GLOF (Parks Canada R.Wedgwood)

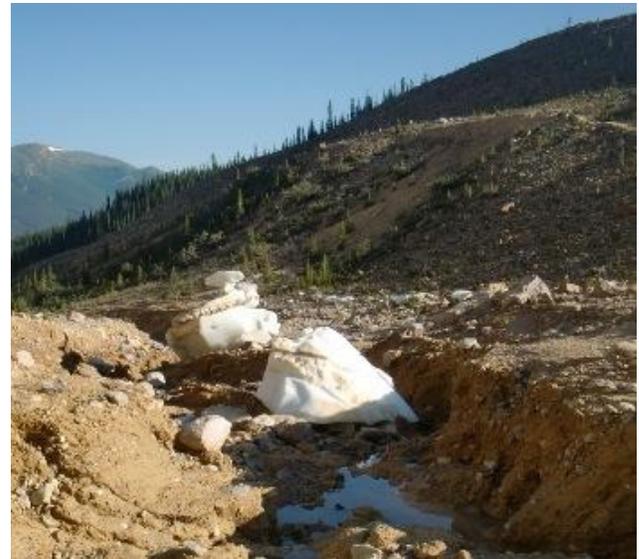
Figure 6 This August 11th image shows ice blocks up to 4.5 m high, weighing approximately 60 tm, which were lifted out of the tarn by the surge and deposited in the enlarged channel downstream of the tarn. (Parks Canada R.Wedgwood)

The channels cutting across the flanks of the moraine dam were considerably enlarged, one up to 5 m deep and 30 m wide, by the exiting water. Massive blocks of glacier ice (Figure 6) were carried into the larger channel. The two overflow channels ran down the relatively steep face (ca. 9 degrees) before joining, about 205 m from the tarn. At this point the water fanned out over the outwash plain to a width of 75 m and a likely flow depth of 2 m.

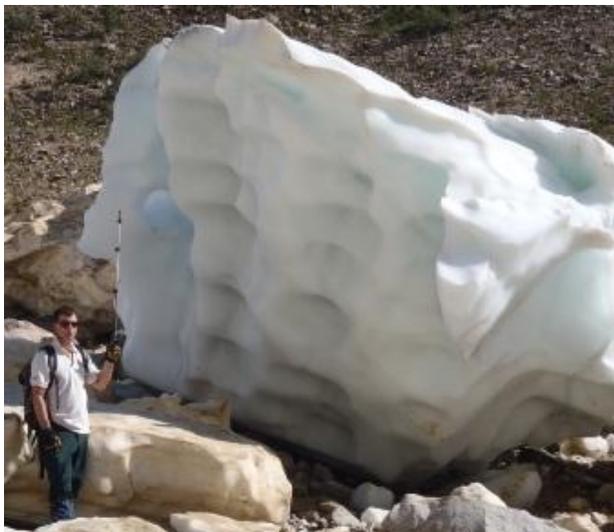
Figure 5 One of several large glacial ice blocks washed onto the moraine dam along the shoreline of the tarn (Parks Canada R.Wedgwood)

Ice blocks of up to four and a half meters high, weighing approximately 60-80 mt, were lifted out of the tarn by the surge (Figure 5). Warning signs, positioned at the shoreline, were blasted out to the side by the surge wave and/or air blast. The waters ran downhill over the moraine plug at the tarn outflow carrying ice blocks with it. The overflow from the tarn was carried down the former, now considerably enlarged, stream channel from the tarn and a second, new channel with a slightly lower ingress, was cut across the moraine dam approximately 50 m west of the former channel.

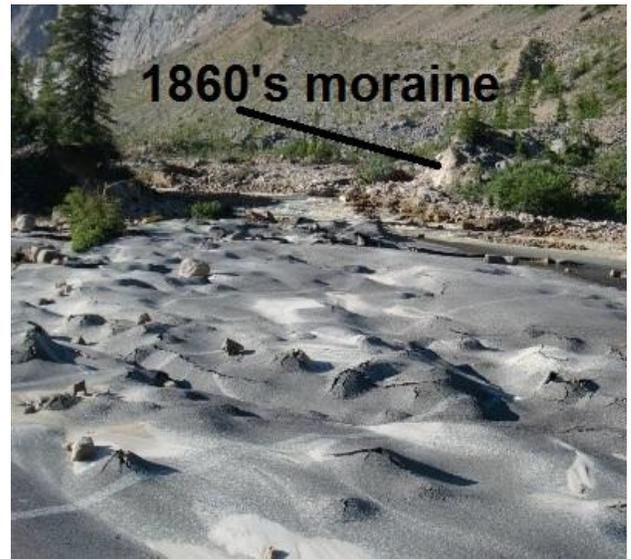
Figure 7 This August 11th image shows the collapsed pavement in the parking area, undermined by erosion of the underlying fine material, resulting in its curious deflated appearance. (Parks Canada R.Wedgwood)

Downvalley a terminal moraine, dating from the 1860s, constricted the flow of the water adjacent to the parking lot, 1,020 m from the tarn. Surge marks on nearby trees and rocks indicate the water was at least 1.6 m deep here. The relatively narrow creek channel through the 4 m high moraine wall was widened to 40 m by the surging water. Just below the moraine the floodwaters excavated the material from below the pavement in the parking area (1,170 m) causing the asphalt to fold and sag over the larger rocks below (Figure 7).

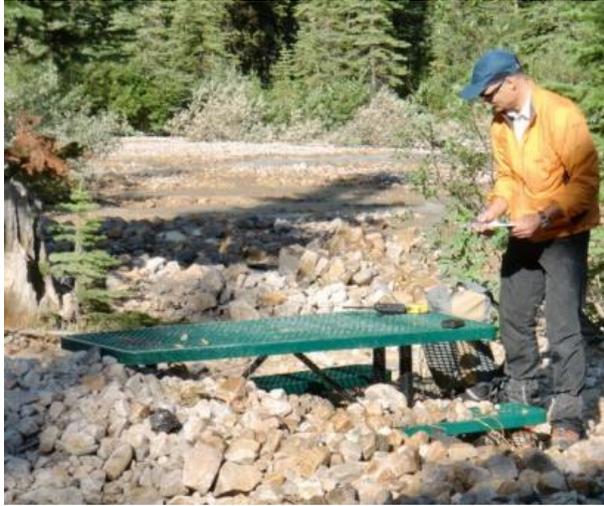
Figure 8 A picnic tables partially covered by rocks carried by the surging waters. (Parks Canada M.Eder)

One of the four outhouses was undermined and toppled over, while the nearby picnic area between the road and creek was buried by rocks and gravel (Figure 8). Part of the flow was diverted into the lower quarter of the parking area and down the area access road for approximately 100 m. Some of the quartzite boulders

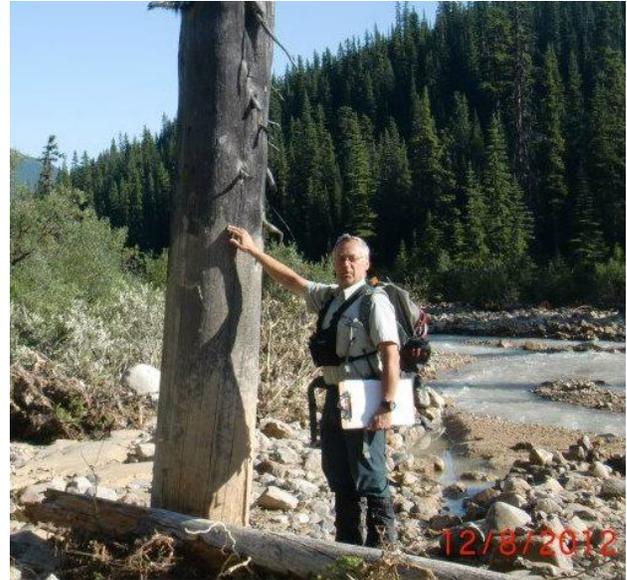
Figure 9 Water surge marks left on a snag indicate a depth of 1.6 m in this location 1 km downvalley from the tarn. (Parks Canada R.Wedgwood)

pushed onto the road measured 1 m x 0.75 m x 0.25 m. In the outwash downstream of the parking area a maximum estimated water depth of 1.6 m was estimated from the mud drape against a large standing snag (Figure 9).

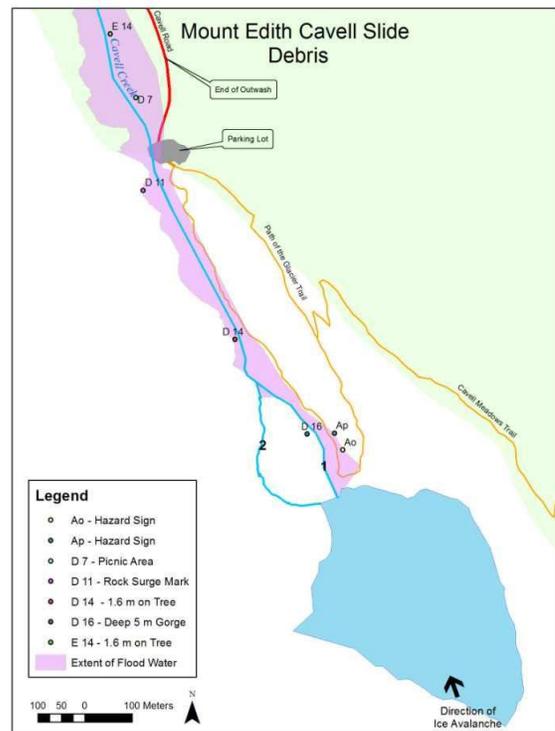
Figure 10 The site assessment focused on the terrain close to the tarn and drainage channels. Reference point D11 is located up valley of the 1860's terminal moraine.

With public safety concerns under control, and access to the area restricted, the site was visited on August 11th and 12th to measure and record the character and destructive nature of the event. The field work focused from the tarn and downvalley for 1.2 km (Figure 10).

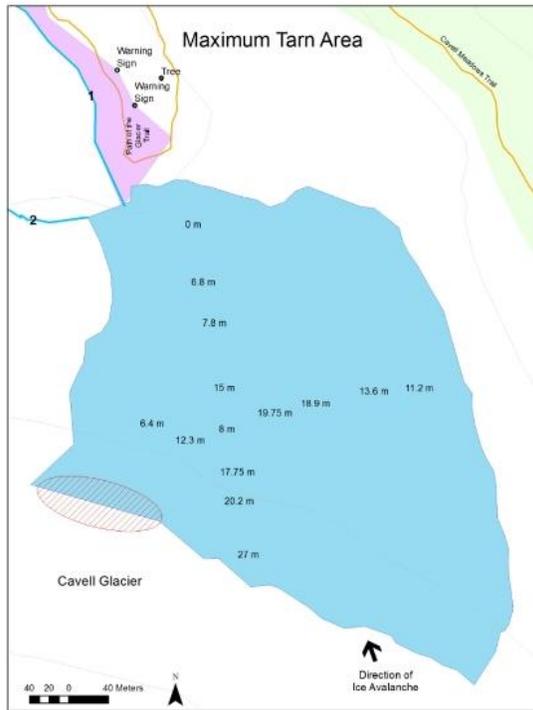
Figure 11 Cavell tarn showing the maximum tarn area and the depth measurements taken from the ice cover in October 2012. The primary (1) and secondary (2) drainage channels are shown in blue (top of map) and the pink polygon shows the area flooded by the overflow.

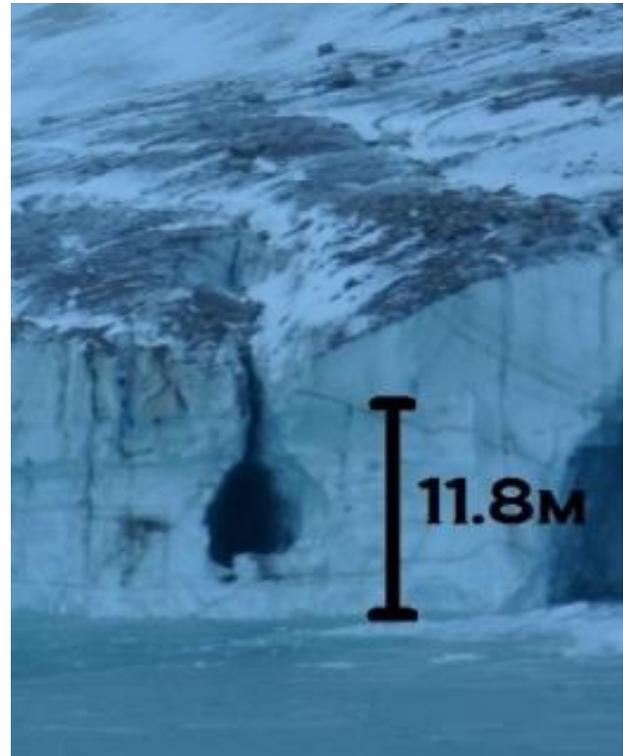
Figure 12 The drop in water level of Cavell tarn between August 10th and early October 2012. (Parks Canada R.Wedgwood)

Historical photographic images, dating from the early twentieth century, show the Cavell Glacier fully occupying the location of today's tarn. A pond at the snout of the Cavell Glacier started to become a regular seasonal occurrence in the 1960s. The tarn has developed and grown over the past fifty years as the glacier has receded. This process will likely continue. Several field trips were made to the tarn in October, 2012 to survey its depth, surface area and position. By this time the surface of the tarn was frozen 1-2 inches thick. Holes were chipped and depth measurement were taken with a weighted line at fifty meter intervals along two crossing transect (Figure 11). The periphery of the tarn was walked and crawled with a GPS in hand. The most westerly tarn-glacier interface was not walked due to icefall and avalanche danger. This location is shown in Figure 11 with red cross-hatching. The position of this interface was mapped using distance measurements, taken by range finder, from GPS locations. The high mountains surrounding the tarn often produced inaccurate GPS values. As several field trips were done these likely errors were replaced with those that were more representative of field observations. Over the course of the field trips the tarn drained noticeably. This could be inferred by the melt line on the ice cliffs of the Cavell glacier and the relative distance to the surface of the tarn (Figure 12), the high

water line on the shoreline and relative position of the tarn surface and the sagging surface ice of the tarn ice.

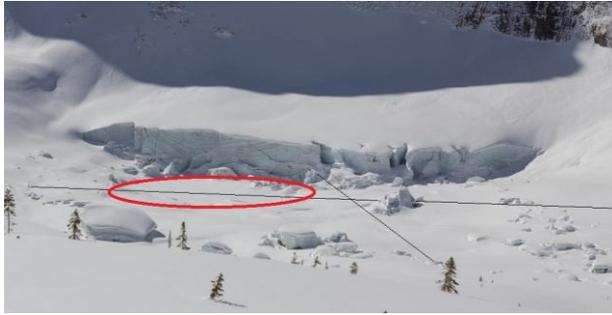
Figure 13 This image of Cavell Tarn shows the presumed deepest spot, marked by a red circle, as determined by the sagging ice in March 2013. The black lines show the two axes along which depths were measured in October 2012. (Parks Canada R.Wedgwood)

In the late winter, an avalanche forecasting field team, noted that the tarn appeared fully drained. The snow covered ice surface sagged noticeably (Figure 13). The lowest point (deep spot) lay close to where the bathymetric survey had placed the deepest part of the tarn three months earlier. The greatest recorded water depth was 27 m, measured 46 m from the ice cliff of the Cavell Glacier. During the time of the bathymetric survey it was calculated that the water levels had dropped between 5 m (minimum drop), and 11.8 m (maximum drop) since the GLOF. This variance is due to difficulties in interpreting where the high water mark was along different sections of the shoreline. The depth of the tarn at the time of the GLOF is estimate to be between 32 m – 38 m at the deepest location measured in October. With the winter melt and heavy rains in July and early August the tarn was filled to close to maximum capacity in August 2012. During this time the surface area of the tarn was calculated to be 15.6 hectares. Its north south dimension was close to 410 m and its east west dimension 408 m. The periphery of the tarn is calculated at 1,680 m. The data collected was used by BGC Engineering during their risk assessment.
