When Clay Attacks!

# When Clays Attack!

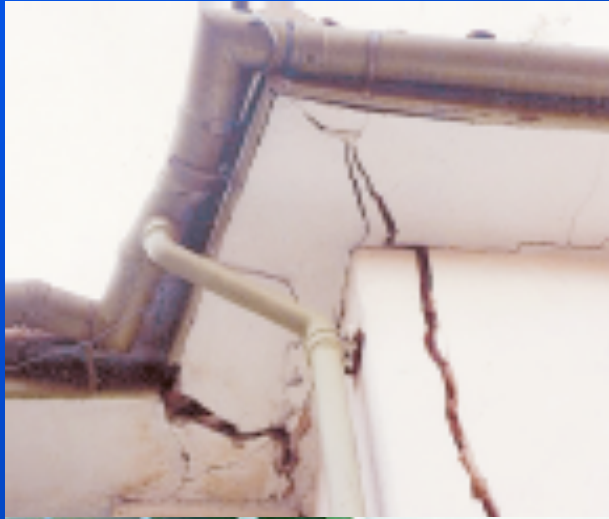
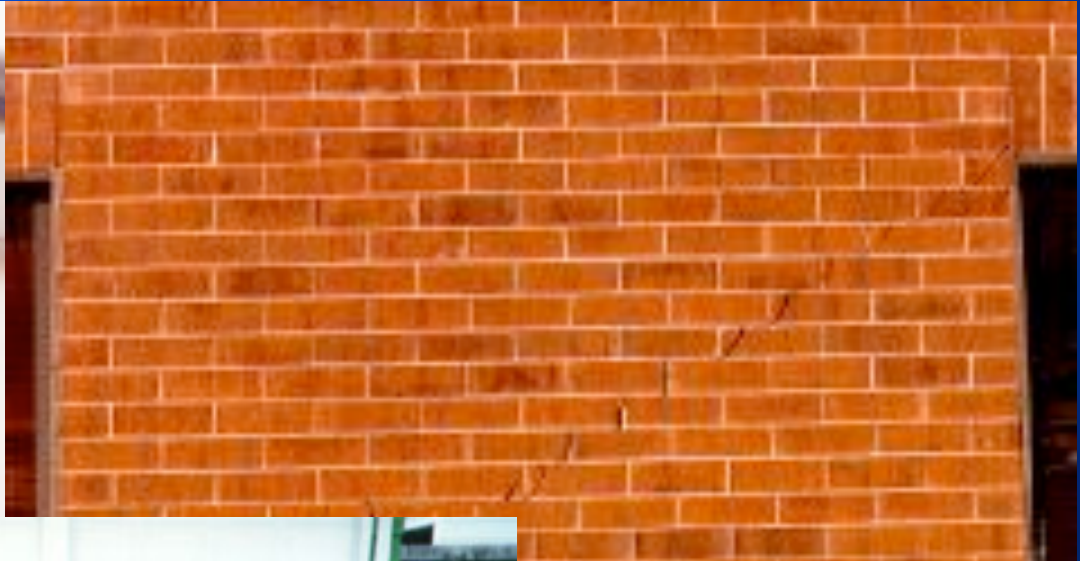
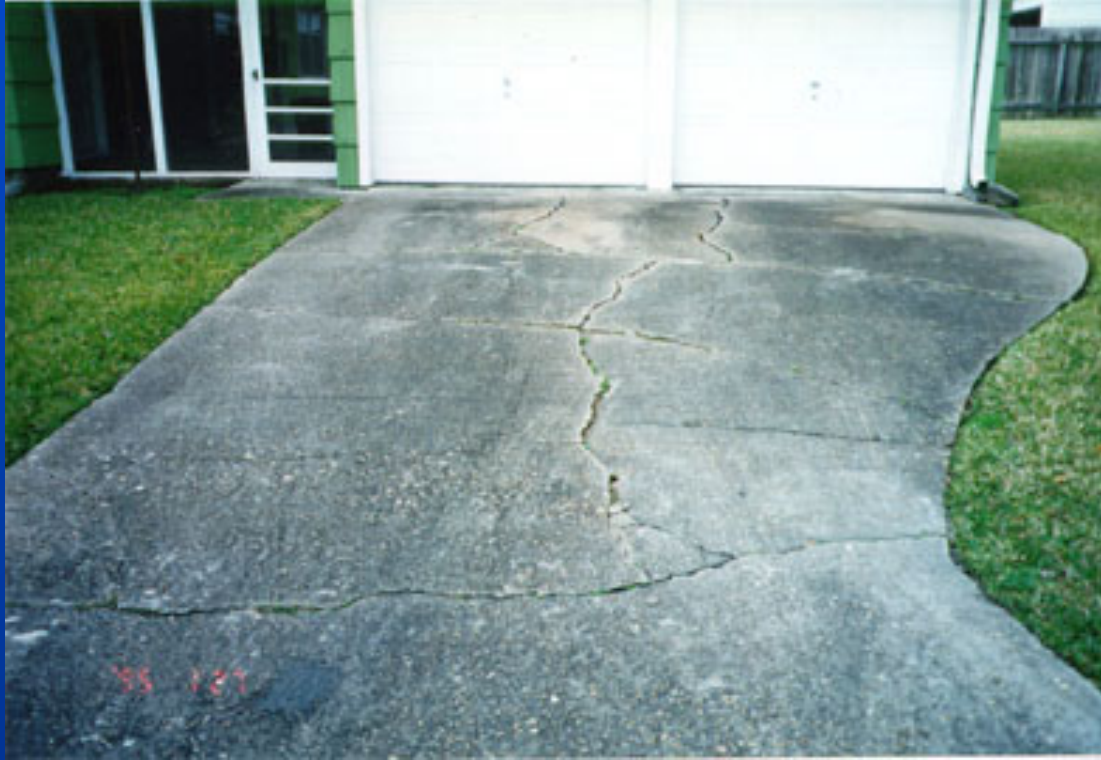
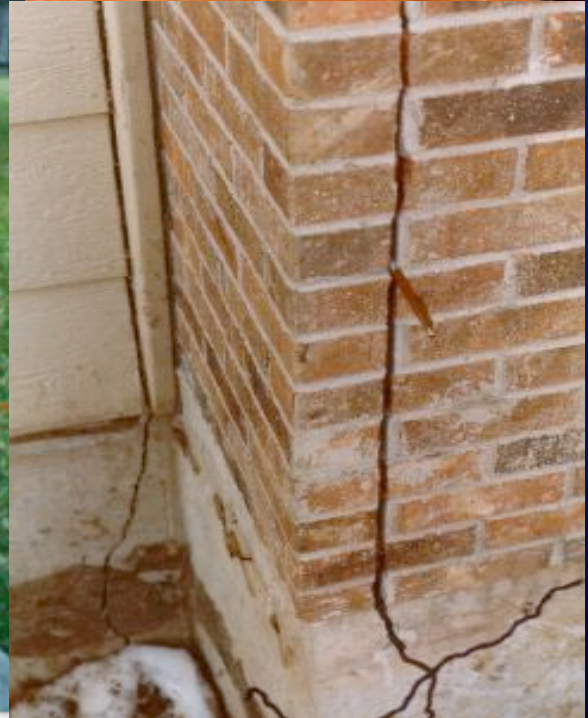
- Foundations in Winnipeg are notorious for movements associated with swelling of our high plastic clay.
- Houses often suffer from:
  - Uneven floors
  - Doors that won't close (or close on their own)
  - Unsightly cracks in walls / basement floor
  - Moisture that can lead to mold

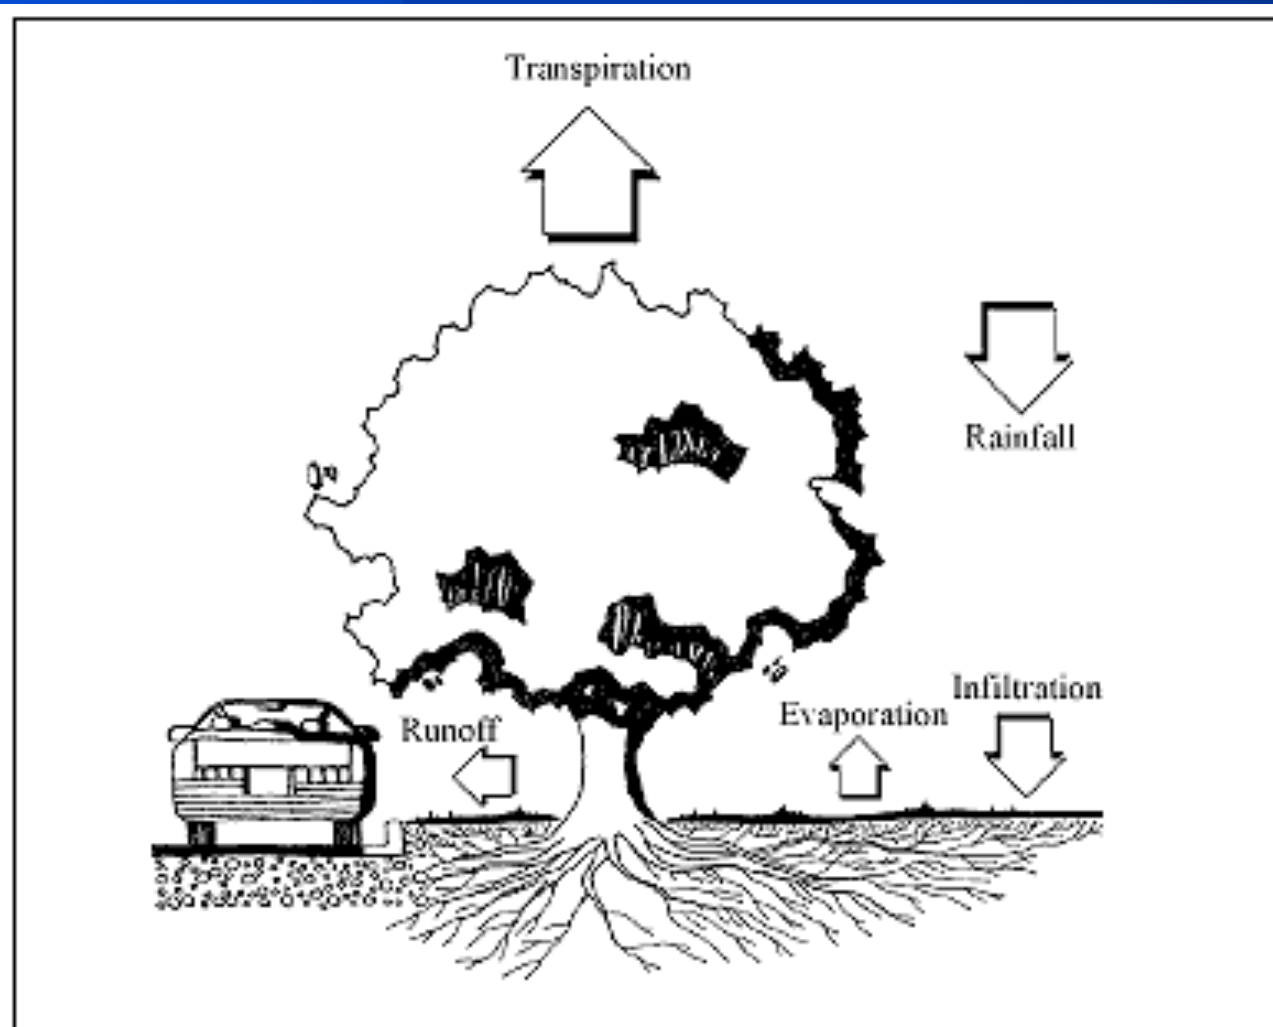
Figure 2: Main water movements in urban areas

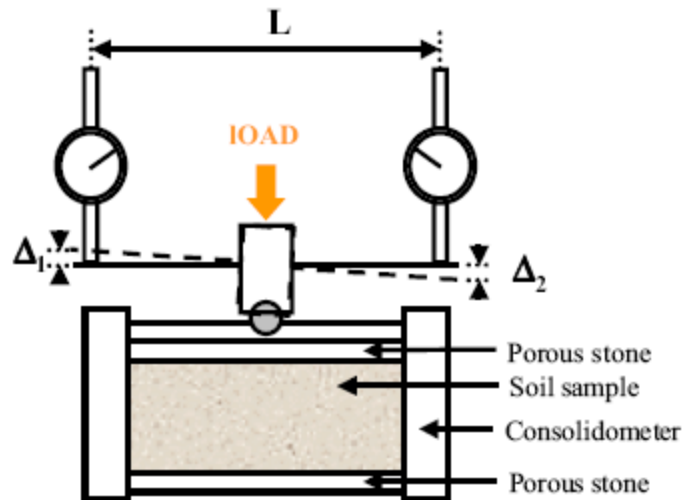
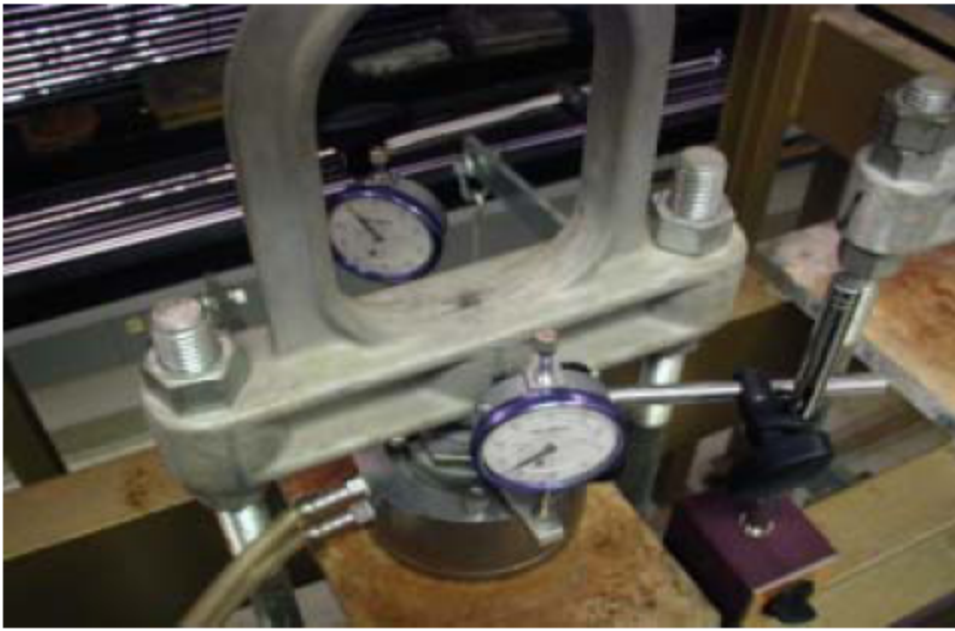
## Swell Test

# Oedometer Study

- Replicates swell conditions under confinement or constant pressure
- Allows examination of the influence of initial water contents.

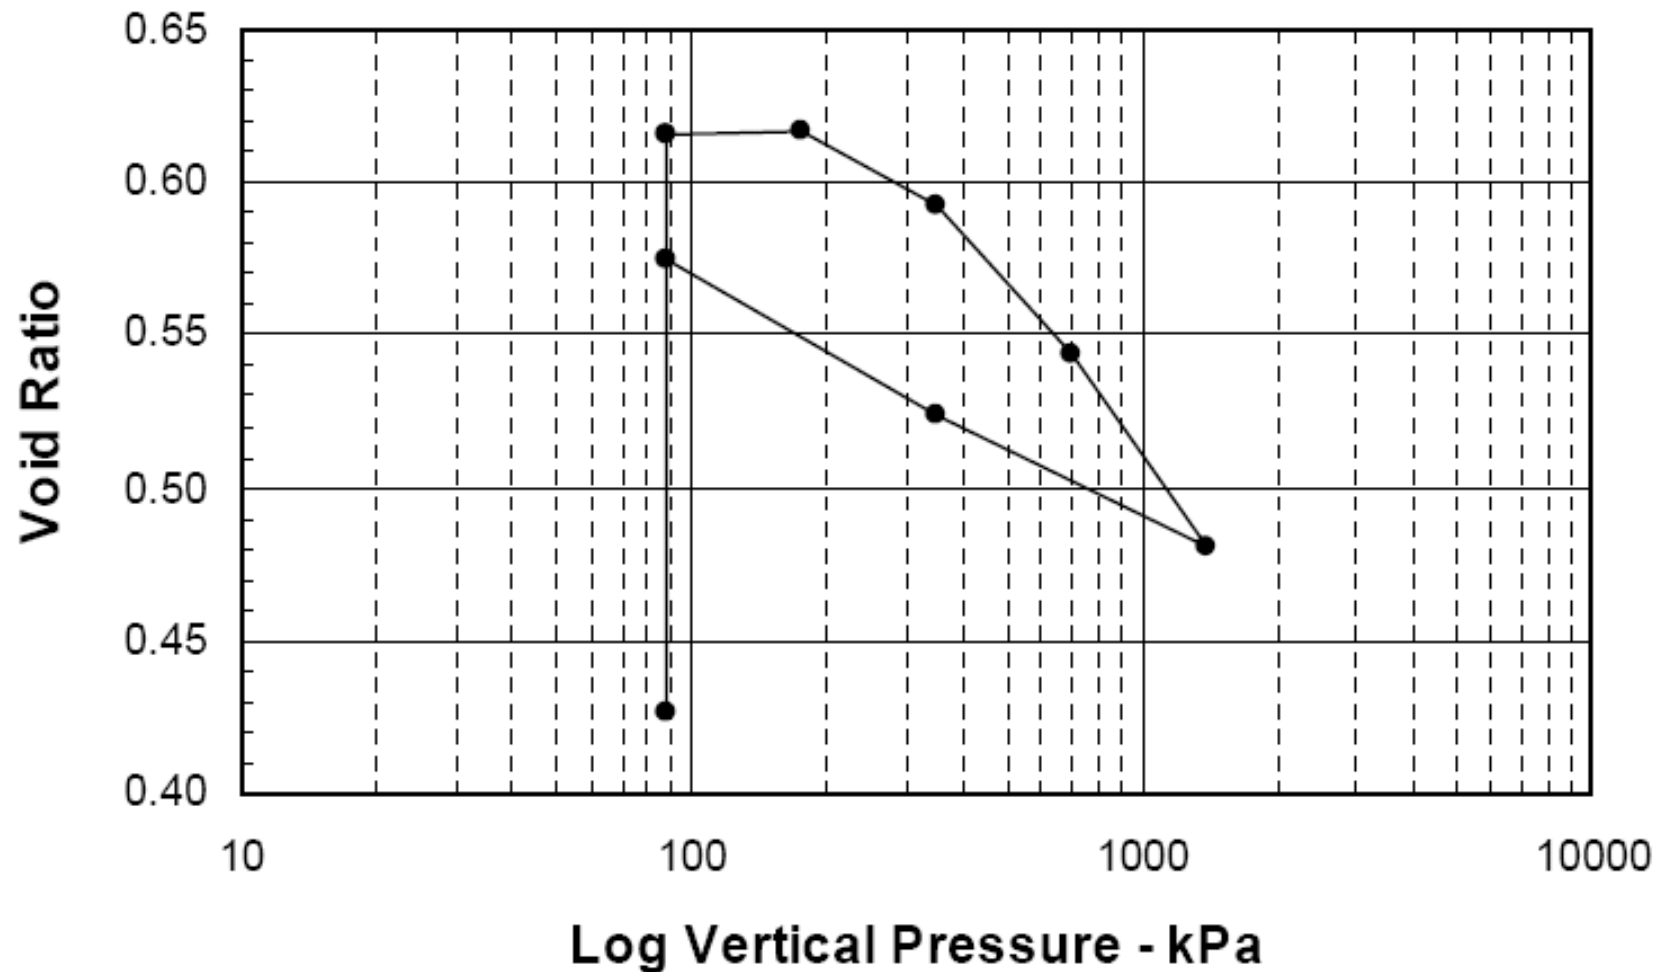
# Constant Stress – Basement Slab

Sample 46-3  
Void Ratio vs. Log Vertical Pressure

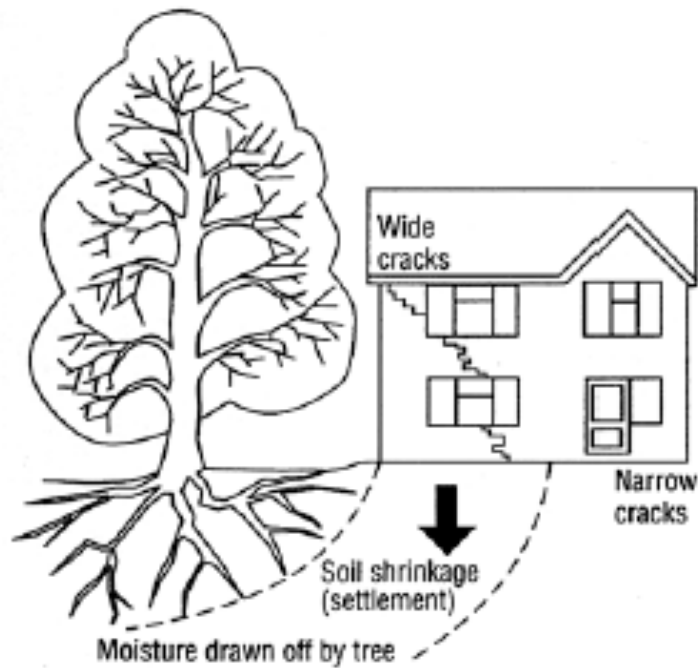
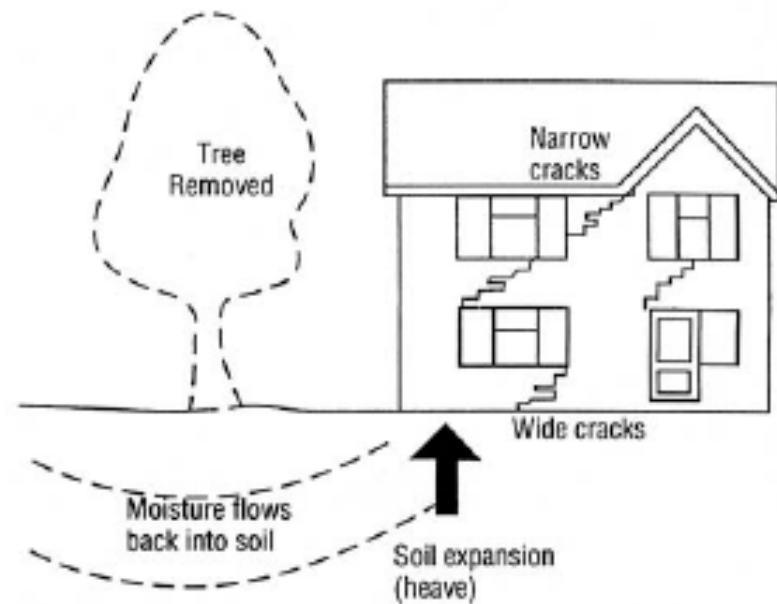
## Remove Vegetation Swelling

## Add Vegetation Shrinkage

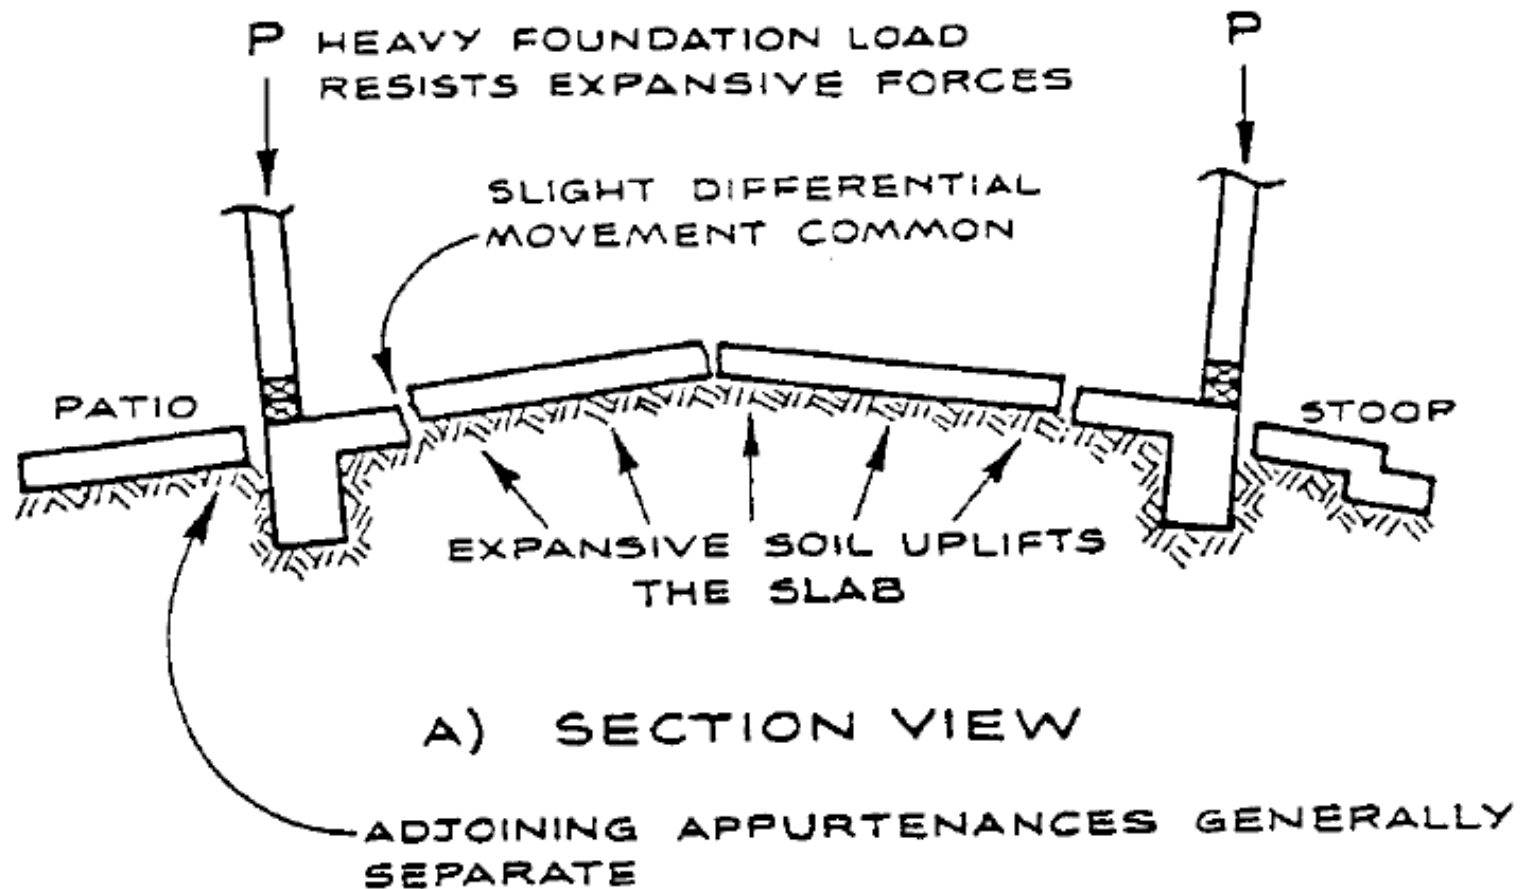
# Typical Swelling Scenario

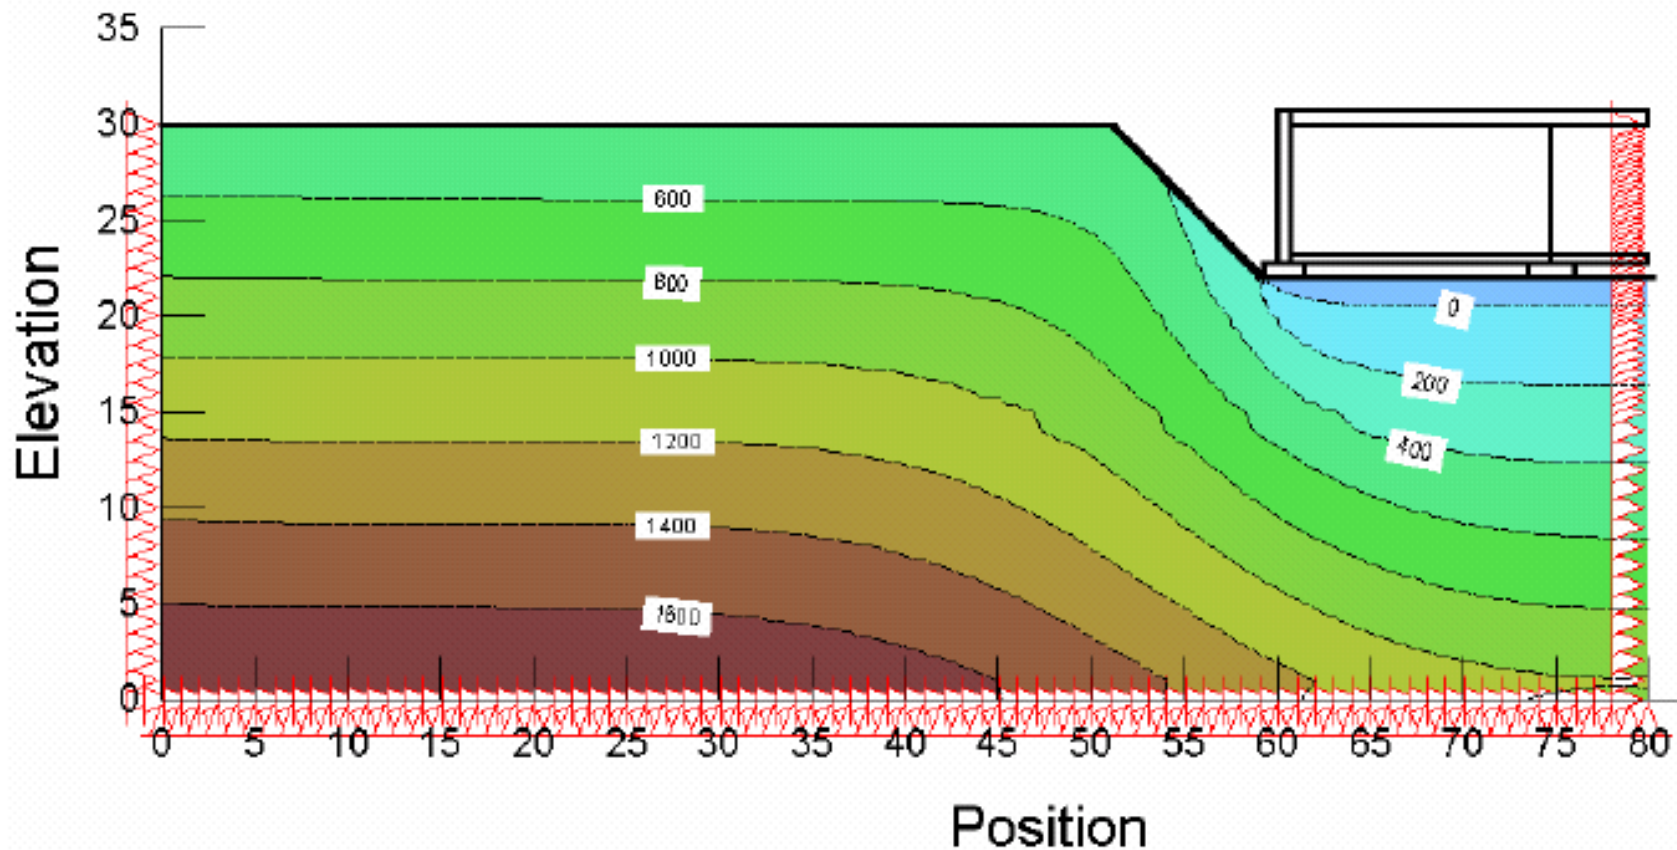
# Modeling Moisture Movements

Figure 13 - Post Excavation Vertical Effective Stress

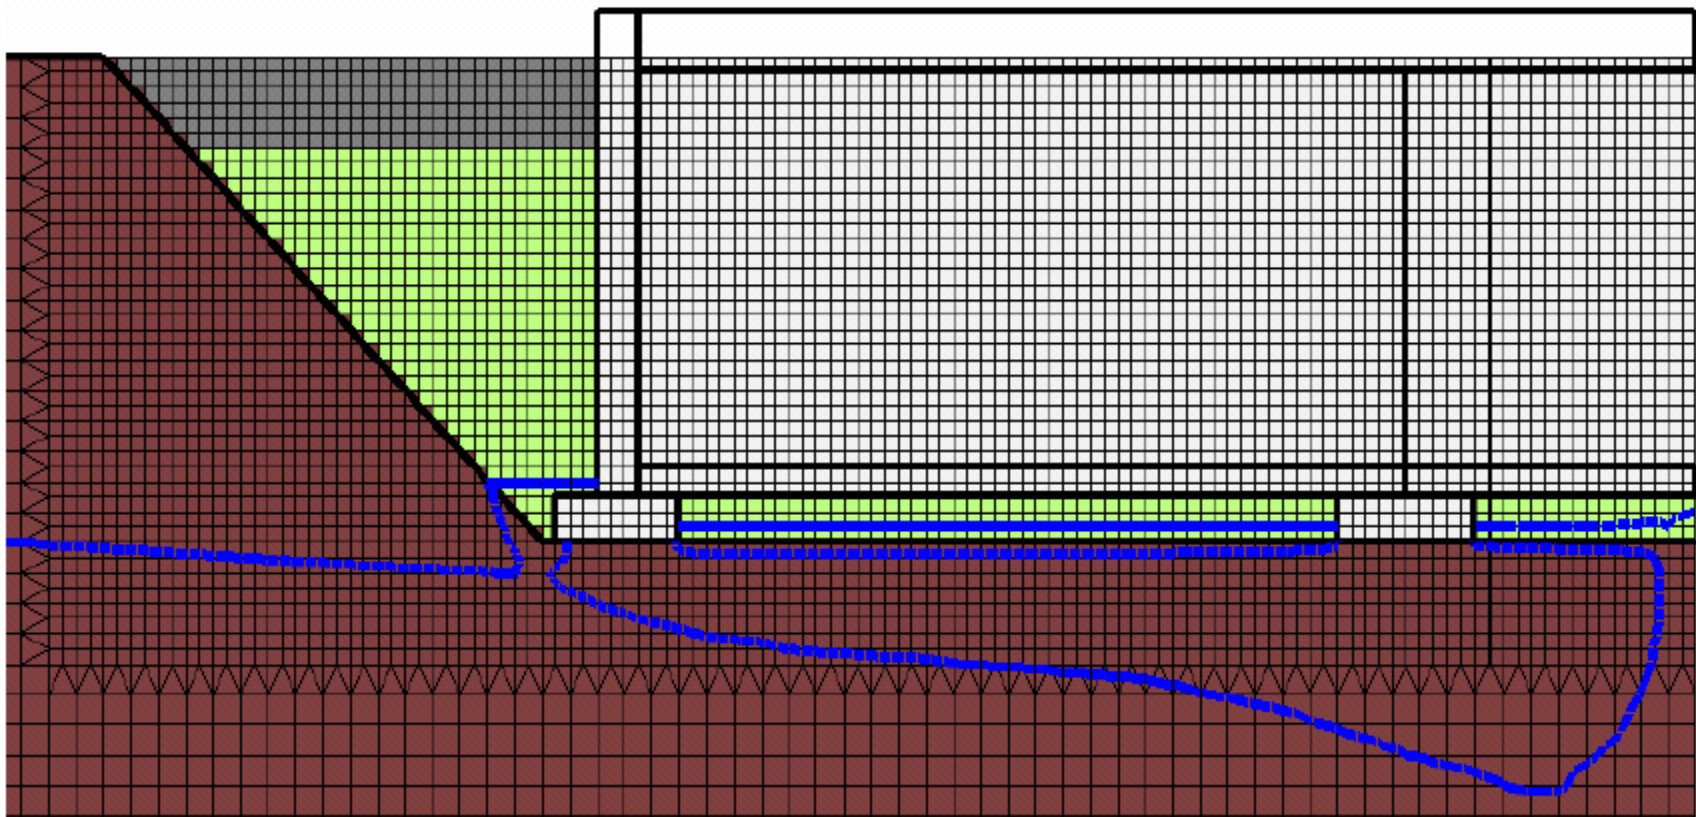
# Predicting Moisture Movements

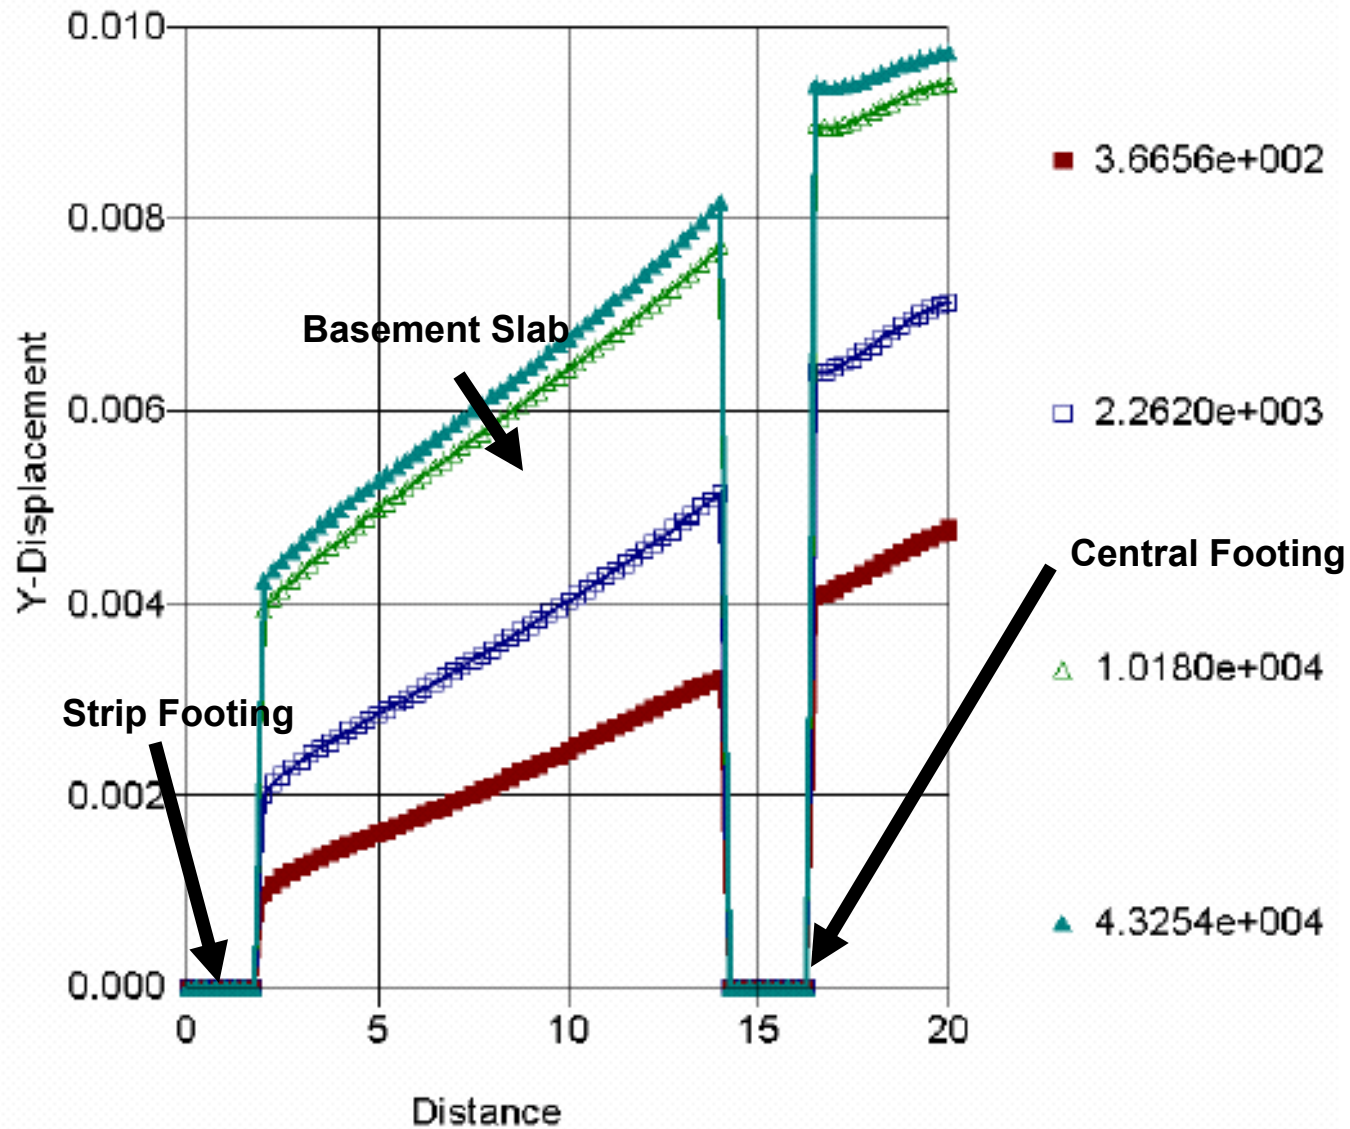
# Vertical Heave

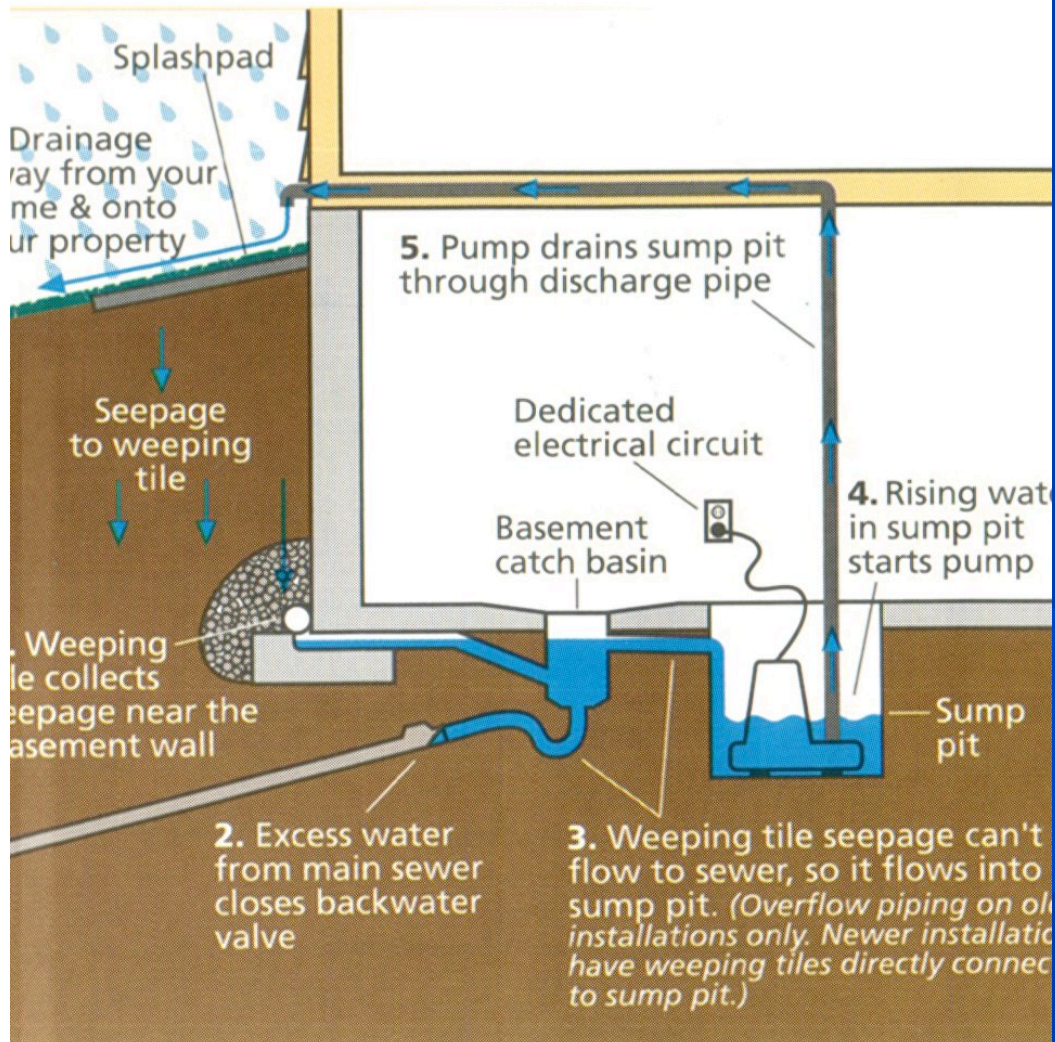
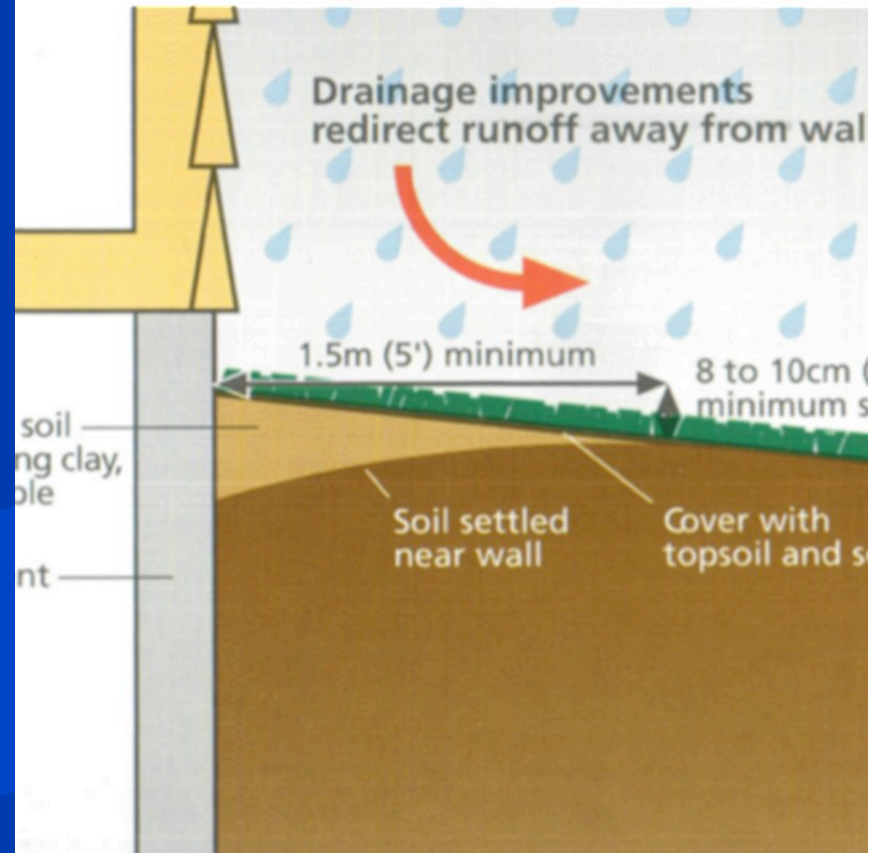
# Landscaping and Irrigation

- Any activities that change the ground cover or slope of the ground.
- Most common is depression of the soil around the walls of the house.
- ***Backyard sloped towards the house.***
- Result is increased soil moisture beside the house which goes to the foundation level.
