Geotechnical Instrumentation News

Using the Global Positioning System (GPS) to Monitor the Performance of Dams

Wireless Tiltmeters Monitor Stability during Trench Excavation for Reno Transportation Rail Access Corridor

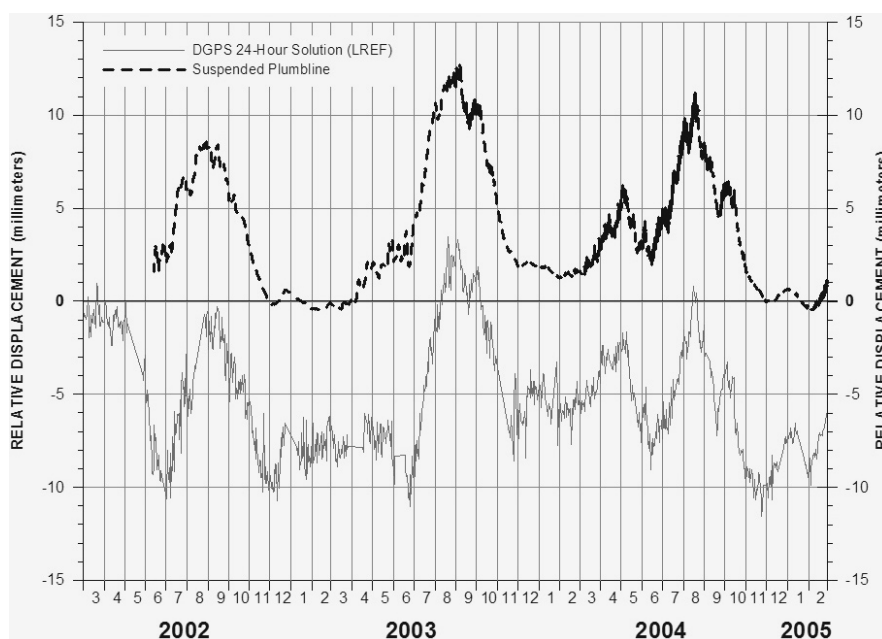
Figure 2. Upstream-Downstream Displacement at ML35 Plumb Line and DGPS (LREF)

Figure 2 shows the upstream-downstream displacement of Libby Dam at monolith 35 as measured by both the DGPS system and the plumb line system. The Corps of Engineers rotated the GPS frame such that the two horizontal axes were perpendicular and longitudinal to the axes of Libby Dam. This useful step allows us to track both upstream-downstream displacement and longitudinal displacement (the long axis of the dam). Plumb line data are displayed in black and DGPS data are displayed in gray. Plumb line 35 is read

automatically on a daily basis, whereas the DGPS station at monolith 35 computes a solution every 5 seconds. A daily average of the 5-second solutions is plotted in Figure 2 as a gray line. The time

All DGPS data shown in Figure 2 were computed by using the GPS reference station located near the left abutment of Libby Dam. We call this station

LREF for left abutment reference station. DGPS Measurements computed using LREF show a high level of correlation with the plumb line data, and both show the same pattern of normal elastic deformation.

DGPS measurements and plumb line measurements collected at monolith 35 are presented alongside one another in Figures 2 through 4. The positive region of the graph represents upstream displacement, while the negative region represents downstream displacement. Three years of data are displayed. These figures clearly show the strong correlation between the DGPS data and the plumb line data.

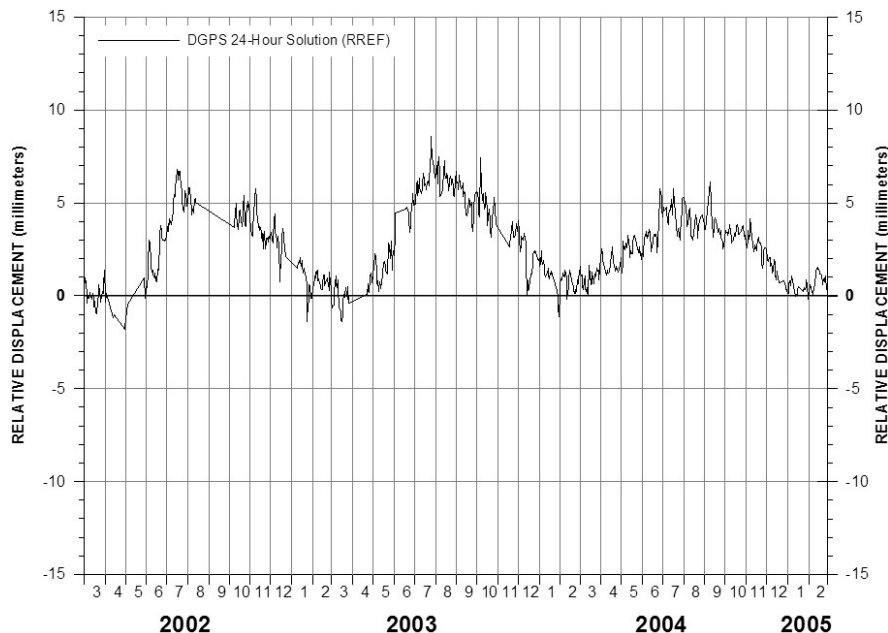
Figure 5. Vertical Displacement at ML35 (RREF)

The previous figures considered horizontal data only. Vertical data from monolith 35 is displayed in Figure 5. The installation of the DGPS network at Libby Dam marks the beginning of vertical displacement surveillance. This surveillance has revealed what appears to be a normal yearly displacement cycle of uplift and subsidence at the dam crest.

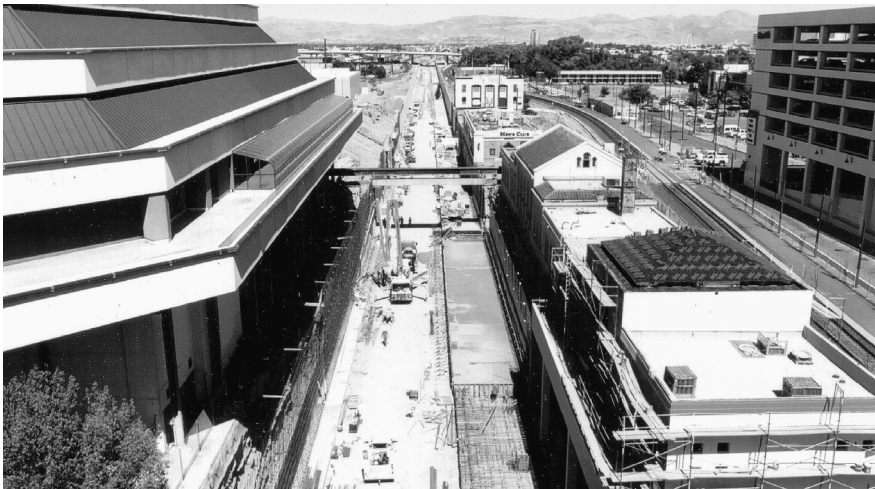
Figure 1. The ReTRAC rail trench is up to 33 feet deep, abutting sensitive buildings in downtown Reno, Nevada

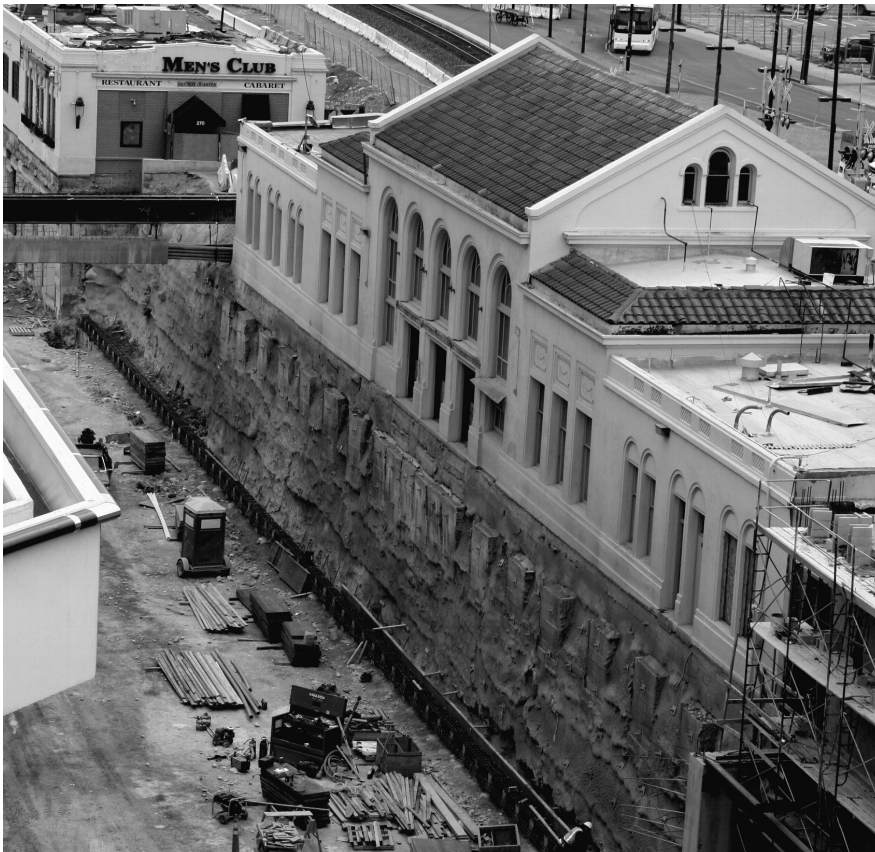
Figure 2. The historic Amtrak Station and Men's Club were two of the structures underpinned along the trench alignment

Geotechnical design for the support scheme envisioned several sections of continuous underpinning piers doing double service as the new trench walls (Figure 2), and this approach proved to be effective. The rail channel now is nearly complete.

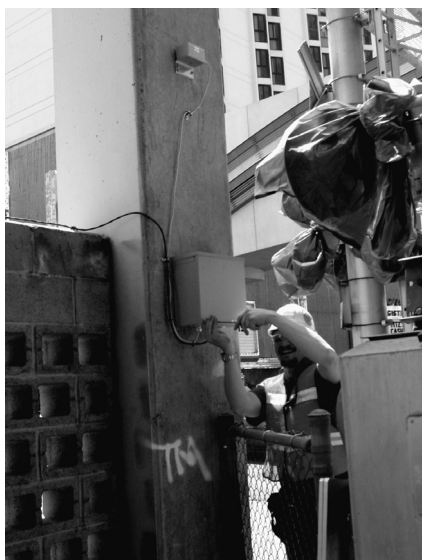
Figure 3. Typical ReTRAC instrument installation; tiltmeter is located on column above weatherproof enclosure containing step-down transformer and Wi-Fi transmitter.

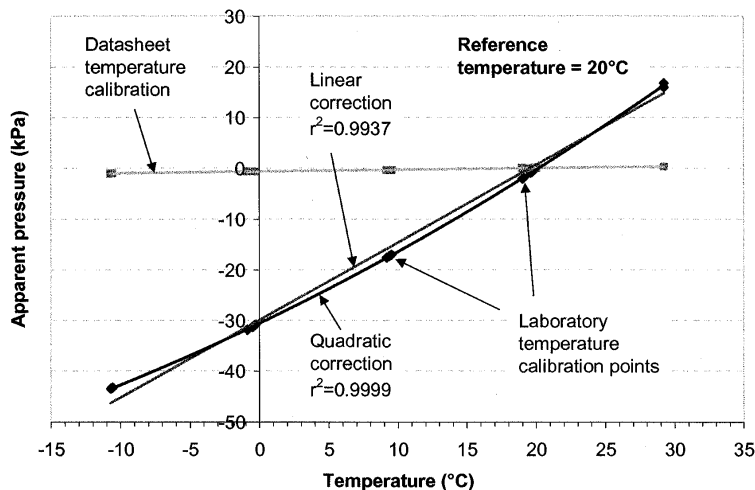
Figure 2 shows a typical curve obtained for the temperature calibration. A datasheet temperature correction factor of 0.0336 kPa/°C would cause an apparent pressure variation of 1.3 kPa (=0.0336 x 40°C) for the studied temperature range. An apparent pressure variation of 59.2 kPa was measured for the same temperature range. This variation represents 30.3% of the full-scale reading of the pressure cell. For the group of five cells, the ratio of the thermal factor (RCT) calculated from laboratory data to the one taken from the datasheet varies from 11 to 85. The percentage of the apparent pressure variation over the full-scale range due to a temperature difference of 40°C (PVFS₄₀) varies from 23.7% to 45.1%. In all cases, the degree of correlation between laboratory data and a second-degree polynomial was higher than with a linear model.

Figure 2. Typical temperature calibration curve of an unloaded 76-mm cell.

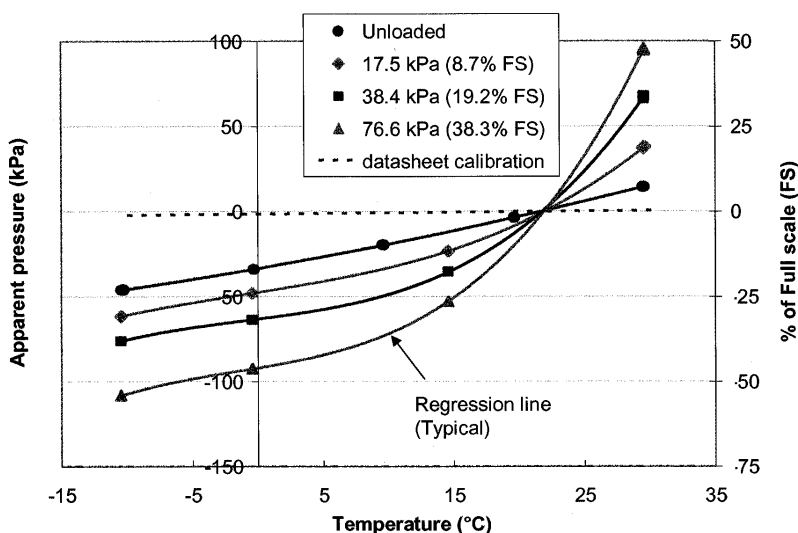
Figure 3. Loaded temperature calibration of a 76-mm cell.

The effects of the loads applied on the cells were subtracted from the pressure readings to obtain the apparent pressure variation and adjusted to zero at 22°C (the temperature of the datasheet calibration). Figure 3 shows the temperature calibration of one 76-mm cell. As the applied load increased, so did the absolute value of the apparent pressure due to temperature effect. For a 77 kPa pressure applied on the cell, an additional apparent pressure variation of more than 150 kPa was caused by a temperature variation of 40°C. This apparent pressure variation represented 75% of the full-scale reading and was larger than the applied pressure. The dashed line in Fig. 3 shows the thermal correction using the datasheet CT. In addition, the curvature of the correction equation for temperature effects increased with

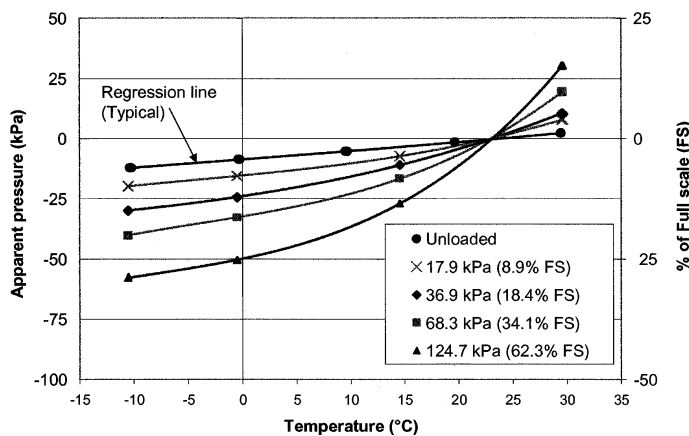
The temperature calibration was also carried out for four 228-mm loaded cells. Results are summarised in Table 2. Figure 4 shows the results of the four different pressures applied on cell # 3-A, the cell amongst the eleven tested that was the most sensitive to temperature variations in the unloaded condition.

Figure 4. Loaded temperature calibration of 228-mm cell 3-A.

The influence of temperature variation on loaded cells was larger on the 76-mm cells than on the low range 228-mm ones. For the 76-mm cells, the apparent pressure variation was at least twice the applied pressure in almost all cases. For the 228-mm cells, the apparent pressure variation ranged from 30% to 155% of the applied pressure, which was still not negligible. Although the pressure chamber dimensions were designed for the 76-mm cells, the results obtained for some 228-mm cells showed that the temperature effect was considerable when the load was increased.
