Decommissioning and removal of instrumentation

Lessons learned during removal of instrumentation after 13 years of monitoring at a large urban tunnelling project

David K Cook and Thijs Claus

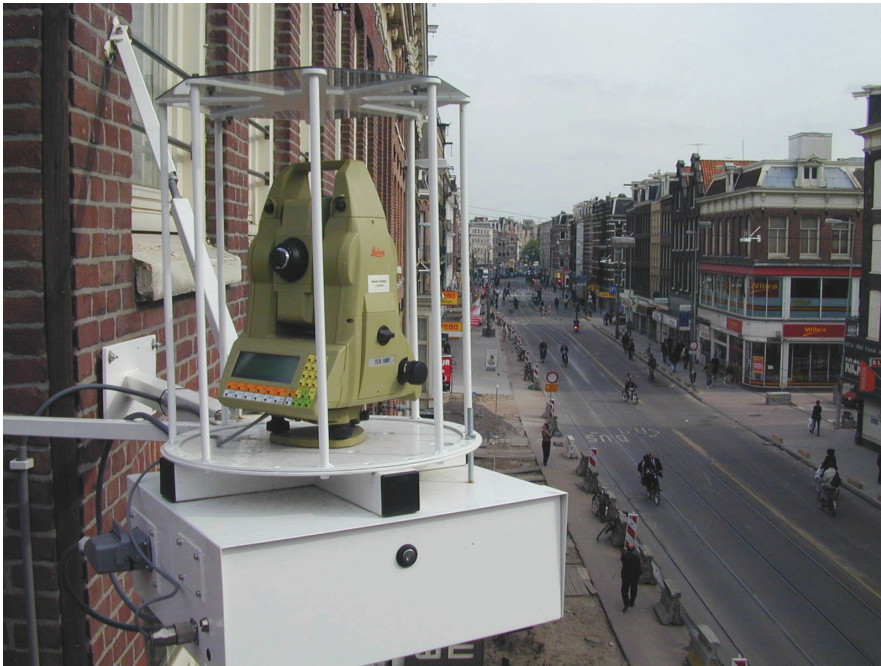
Figure 1. Typical RTS installation – (Photograph courtesy of SolData; all rights reserved).

cut and cover stations and construction under the historic Amsterdam Central Station, project-related settlement and consequent risks had passed. After a period of close-out monitoring, the instrumentation was decommissioned and removed. Figure 1 shows a typical robotic total station for monitoring any

deformation of buildings during tunnelling beneath the roadway.
