Failure 1913; righting was completed in October 1914

Why a Canadian geotechnical achievement?

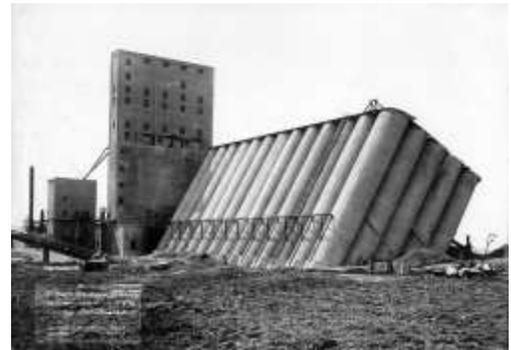
The foundation failure and righting of the Transcona Grain Elevator is a geotechnical achievement. The failure occurred during loading, after bearing pressures exceeded the limiting shear resistance of the underlying clay foundation soil. While the mat foundation for the elevator was likely designed to tolerate large settlements, its susceptibility to a deep-seated base shear failure was neither understood nor expected (Allaire, 1916). Early foundation engineers recognized this unique opportunity to compare the loading at failure with that predicted by classical bearing capacity formulae (Skempton, 1951). Subsequent studies demonstrated that the ultimate theoretical bearing capacity of 6,420 psf (307.4 kPa) was remarkably close to the actual observed bearing capacity at failure of 6,200 psf (296.9 kPa) (Blatz and Skaftfeld, 2003).

Elevator after failure.

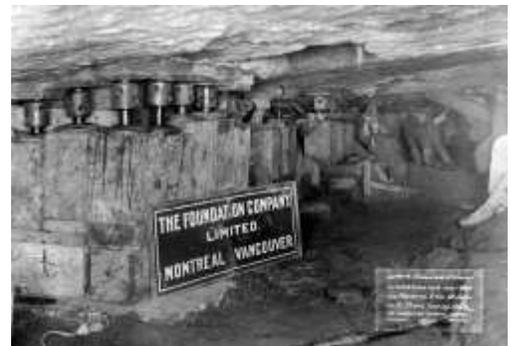
Shoring screws used to lift structure.

More remarkable was the effort to right the elevator by excavating under and lowering the high side and gradually raising the low side. Initially, a trench was excavated along the high side of the structure to the underside of the mat foundation. Drifts were then excavated beneath the mat foundation and a row of 14 piers was sunk to bedrock. The structure was raised using shoring screws and timber rockers installed on the tops of successive rows of piers. To assist, twelve timber pushers were placed against the side of the bins. On October 17, 1914, two days behind schedule, the elevator was back in its vertical position having been raised about 12 feet (3.7 m).
