### THE FAILURE AND RIGHTING OF THE TRANSCONA GRAIN ELEVATOR

The foundation failure and righting of the Transcona Grain Elevator in 1913 is a truly remarkable case history made famous by its collapse during filling after foundation pressures exceeded the bearing capacity of the underlying clay foundation soil. The following photographs and documentation provides a record of the bearing capacity failure, how the original designers struggled to understand the cause and most remarkably, how ingenuity and determination led to the successful righting of the 20,000 ton structure. It provides an account of the landmark work carried out in the 1950's ending with a modern perspective made possible by finite element modelling techniques.

### THE FAILURE AND RIGHTING OF A MILLION-BUSHEL GRAIN ELEVATOR\*

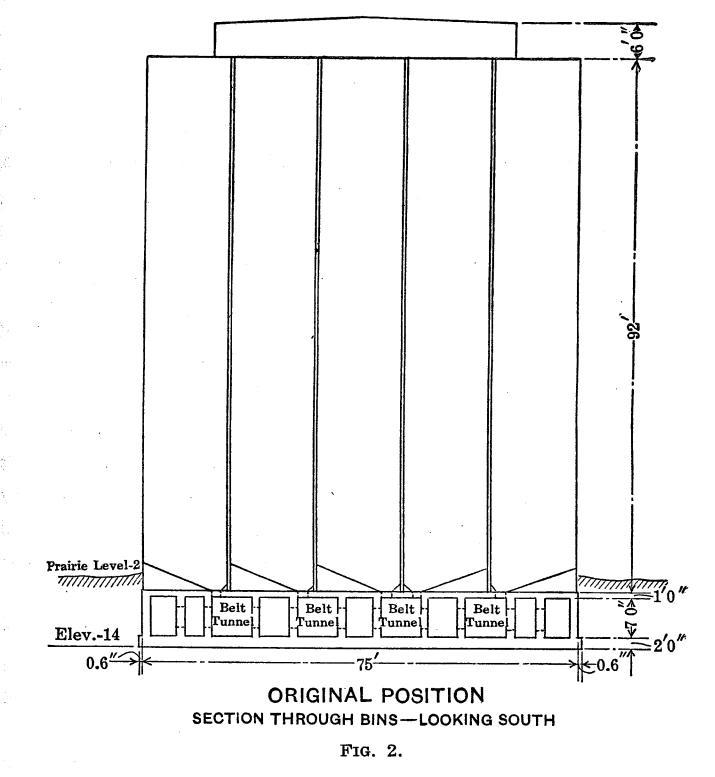
the filling of the different tanks so as to distribute the load uniformly. Settlement began on October 18th. The bins at this time contained about 875 000 bushels of wheat. A vertical sinking of 1 ft. occurred within an hour after the settlement was first noted. This was followed by an inclination toward the west, which increased until, at the end of 24 hours, the binhouse rested at an angle of  $26^{\circ}$  53' from the vertical.

An examination showed the east side to be 5 ft. above, and the west side 29 ft. below, the original position; the building was also approximately 4 ft. lower at the north than at the south end. An upheaval of 5 or 6 ft. of the ground surrounding the bins occurred during the settlement. At an angle of  $26^{\circ}$  53' the center of gravity of the loaded structure had moved over almost to the low edge. The upheaval and the compacting of the soil along the west side saved it from completely falling over. Above this, on the west side, 52 ft.

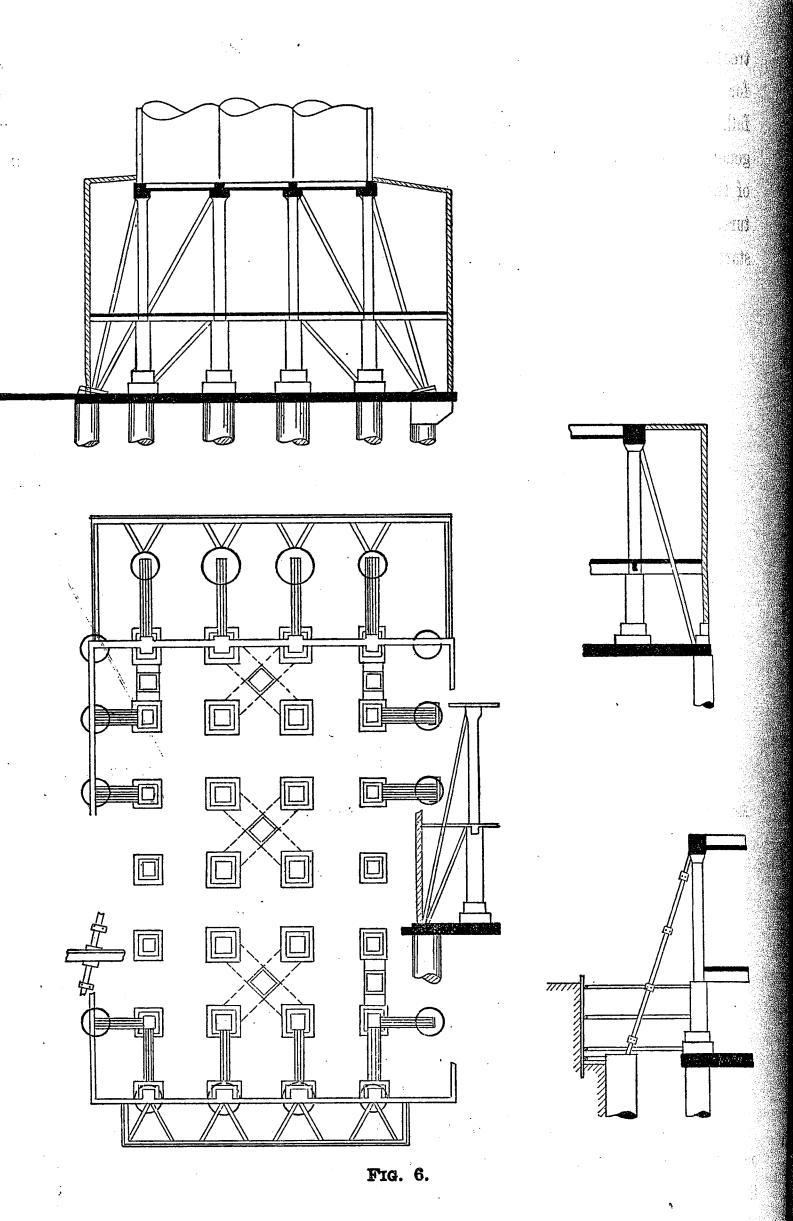
The shoring consisted of pushers from twenty small piers placed outside the building columns, as shown by Fig. 6. On account of the uncertainty of the condition of the material through which the piers would have to be carried, it was decided to eliminate any risk by sinking the first six with cast-iron shoring cylinders. The cylinders

were 4 ft. in diameter, and built up in 3-ft. sections. Flanges were cast at each end of the sections for making connections. The one exception to this was at the bottom section, on which one flange was omitted, the unflanged rim being used as a cutting edge.

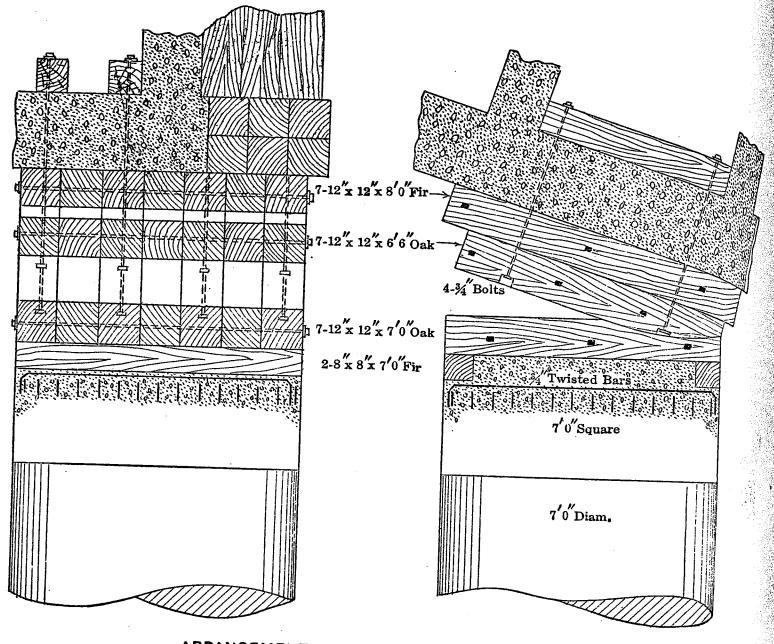
#### FIG. 15.

To form convenient working places, all the tops of the piers were made 7 ft. square. In preparing the piers for the rockers, as shown by Fig. 15, 8 by 8-in. timbers were embedded in the edges parallel to the longitudinal axis of the bins. The rockers consisted of two parts: the shoe and the rocker proper. The former was made by covering the top of each pier with 12 by 12-in. oak timbers, laid in

the direction of the movement and strongly bolted together. The upper surface of this shoe was concaved to a radius of 30 ft, and also in the direction of the rotation.

The rockers consisted of two courses of 12 by 12-in. oak timber, seven pieces in each course, directly above the timbers in the shee These two courses were strongly bolted together and also to the mat To make certain of an even bearing against the rough bottom of the mat, all uneven places were grouted. The lowest position, or hee of the rocker had previously been rounded to a radius of 15 ft. Thus the area of contact of the two surfaces was 2 ft. 6 in. by 7 ft. 0 in

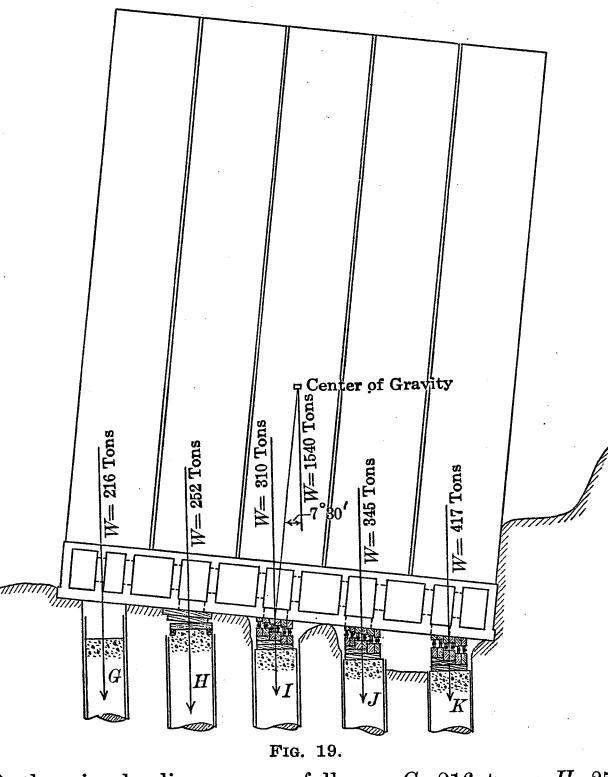
Fig. 19) the pier loading was as follows: G, 216 tons; H, 252 tons; I, 310 tons; J, 345 tons; and K, 417 tons. The center of gravity, in the meantime, had shifted until at this angle it was only 3 ft. 3 in west of the center line of the structure. During this last operation it was found advisable to assist the screws on the I piers by using oak wedges, 4 ft. long, 6 in. wide, and 3 in. thick at the butt end; these were driven between the shoe and the rocker on these piers. This was made necessary on account of the tendency of the mat to sage

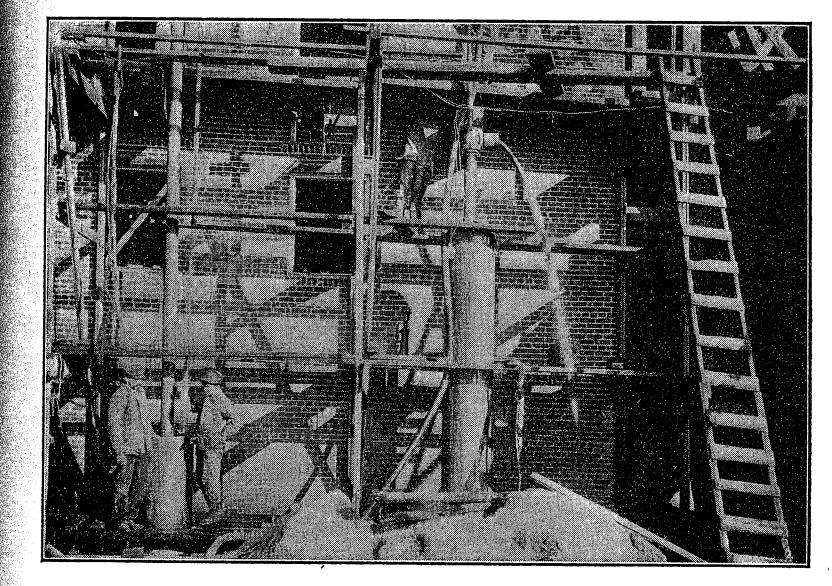
FIG. 22.—METHOD OF SINKING PILES, UNION MEAT COMPANY'S PLANT, NORTH PORTLAND, ORE.

Fig. 22 shows two piles being sunk. A man on the highest staging is manipulating the jet pipe with a wrench. The pile to the left has been sunk to a point where it requires to be extended. The inner tube has been lengthened, and courses are to be added to the outer shell. This will then be filled with concrete and the sinking will be resumed.

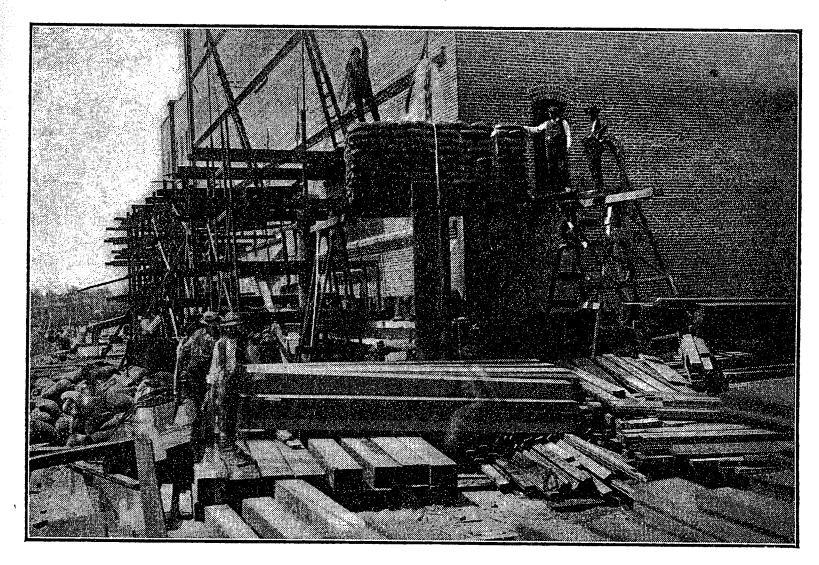
FIG. 23.-METHOD OF FORCING A PILE BY LOADING.

Fig. 23 shows a pile which has reached a depth where skin friction Mr. offers too much resistance to be overcome by the weight of the pile Phillip alone, or even by a process which was called the "blow." This consisted in shutting off the water where it is seen escaping above and thus forcing it to find an outlet around the outside of the pile, thereby lessening the skin friction. When the "blow" was not effective, the pile, if on the outside of the building, was loaded as shown, and, if inside, was forced down with jack-screws.

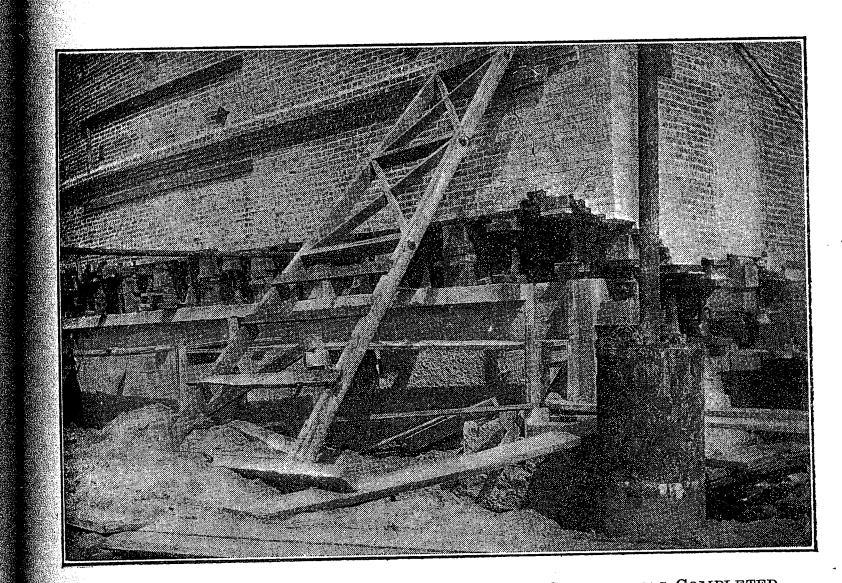
FIG. 24.—SAME PILE AS SHOWN IN FIG. 23, AFTER SINKING WAS COMPLETED.

Fig. 24 shows the same pile as Fig. 23, the sinking being completed. The lower end of this pile rests on cemented gravel, 116 ft. below the surface. The blocking and jack-screws show the method of holding up the brick walls while the foundation was sinking at the rate of 0.1 ft. per day. At the corner, inside the building, the mate of this pile has been sunk. A hole will be cut through the foundation, below the surface, and a reinforced concrete beam will be built on the two piles.

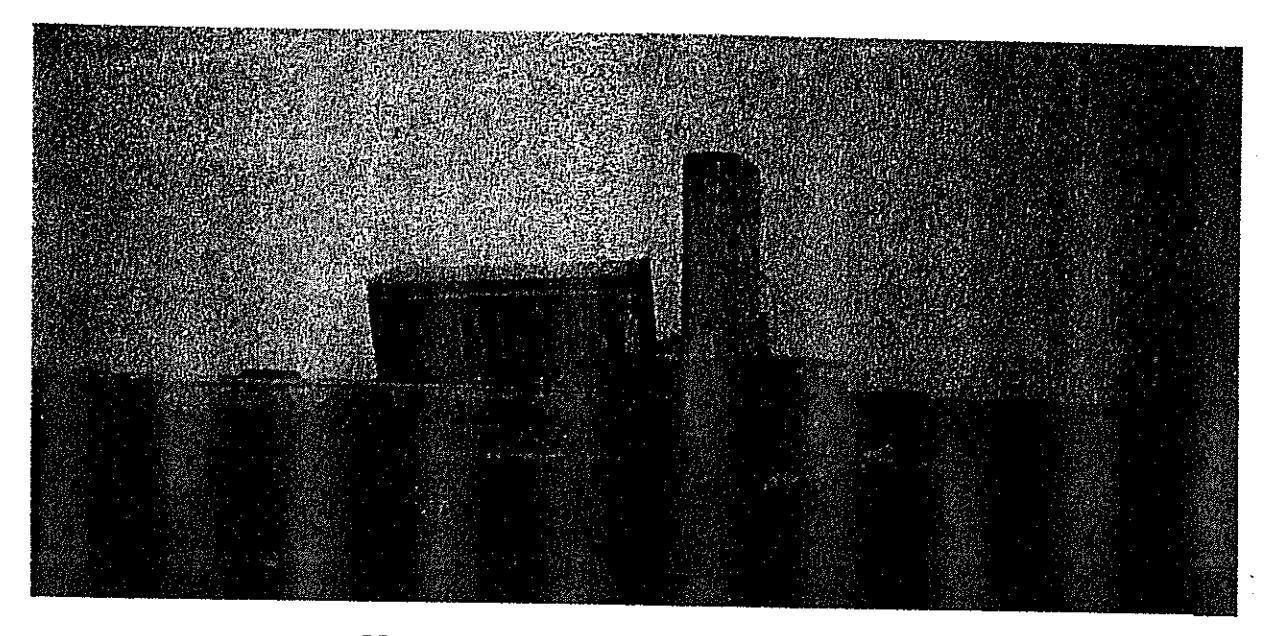
Fig. 5

Movement of elevator during first half-hour

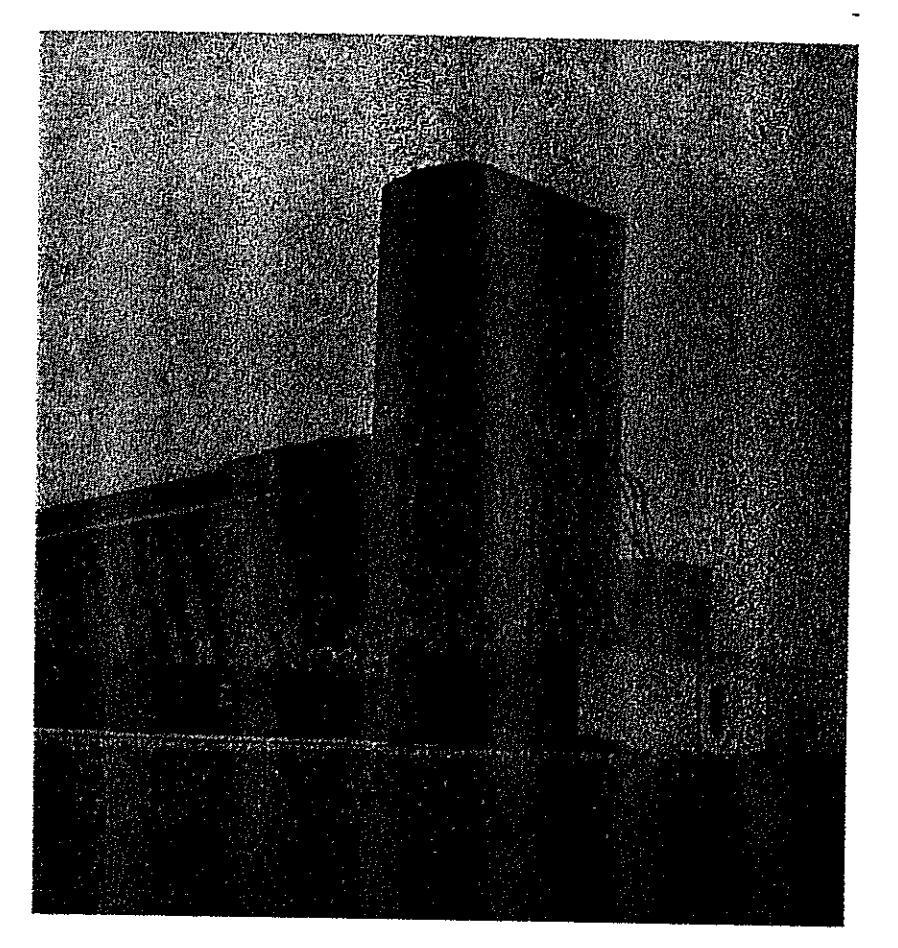
Close-up view showing extent of movement

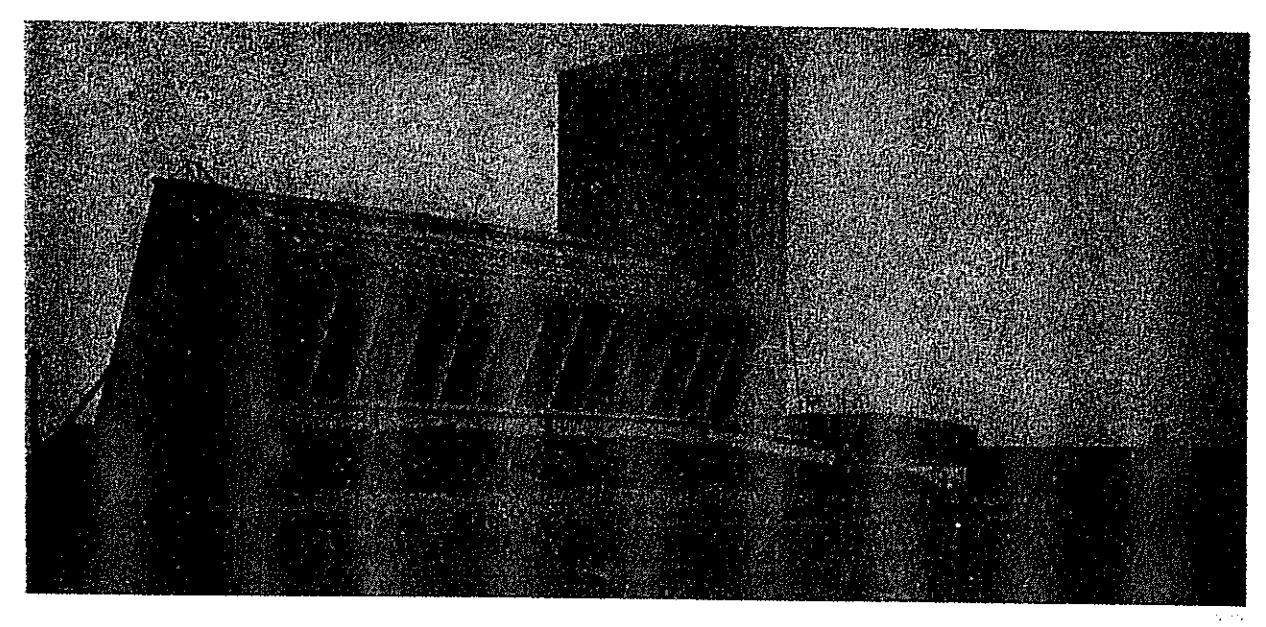
Fig. 9

An account of how the grain was discharged (Fig. 8) and how the bin structure was underpinned and jacked-up from new pier-foundations taken to solid rock is contained in Allaire's Paper "The Failure and Righting of a Million-Bushel Grain Elevator " reference to which is made in Professor Peck's article (see Figs 9 and 10).

Elevator being discharged and underpinned

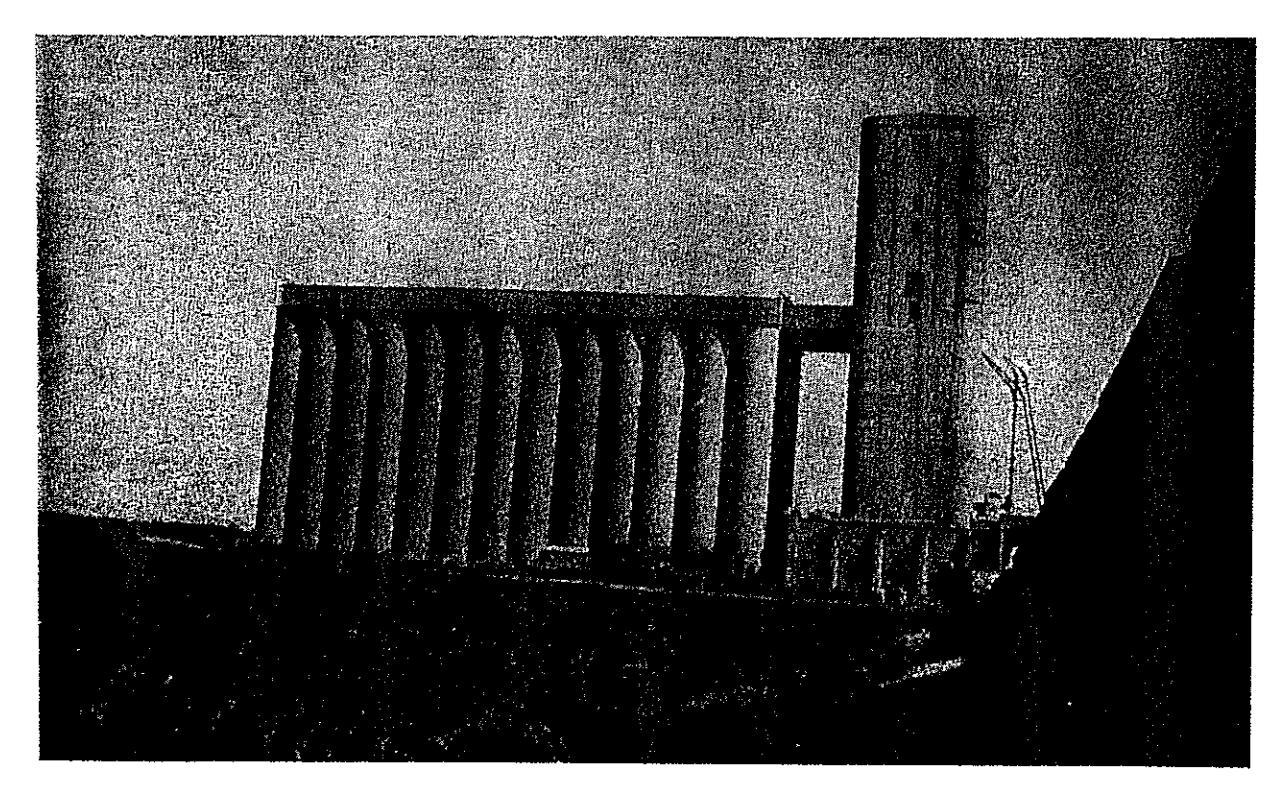
Elevator before subsidence

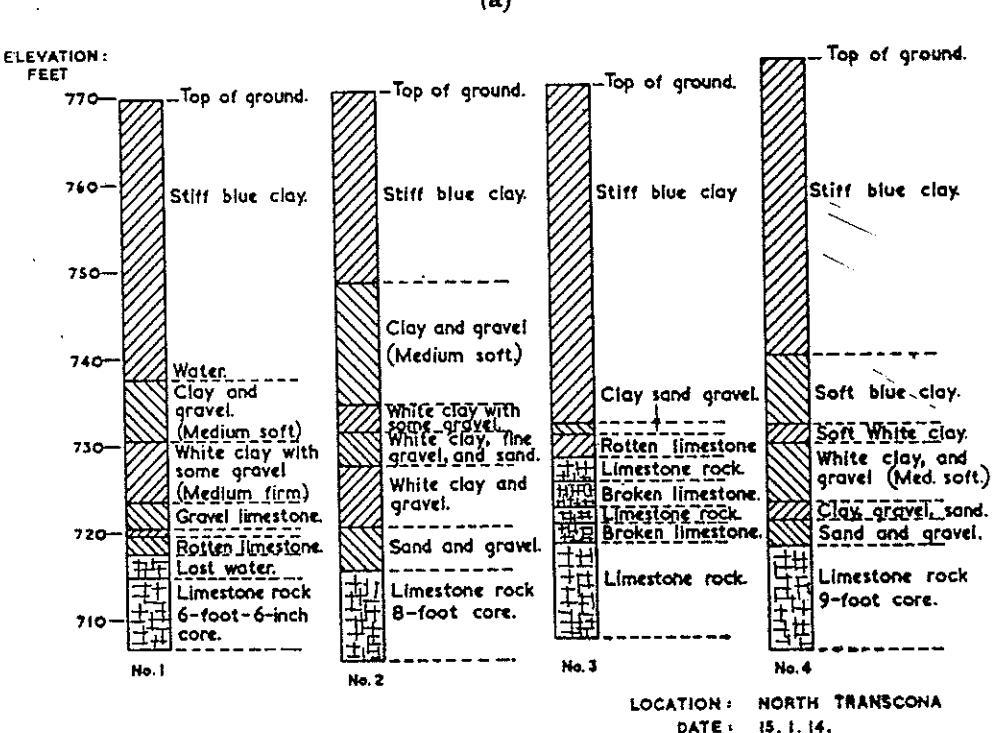
Figs 1 (a)

Several wash-borings were made immediately after the failure (Figs 1 (a), and 1 (b)). These indicated that the elevator was underlain by rather uniform deposits of clay. This finding was in agreement with the geological history of the area, according to which extensive fine-grained sediments were deposited in the waters of glacial Lake Agassiz which came into being when the Wisconsin ice-sheet blocked the region's northern outlet. Winnipeg lies above one of the deeper portions of the lake basin and, as a consequence, about 30 to 50 feet of laminated sediments are found overlying the Ordovician limestone bedrock.

Canadian Pacific Railway : Records of test holes

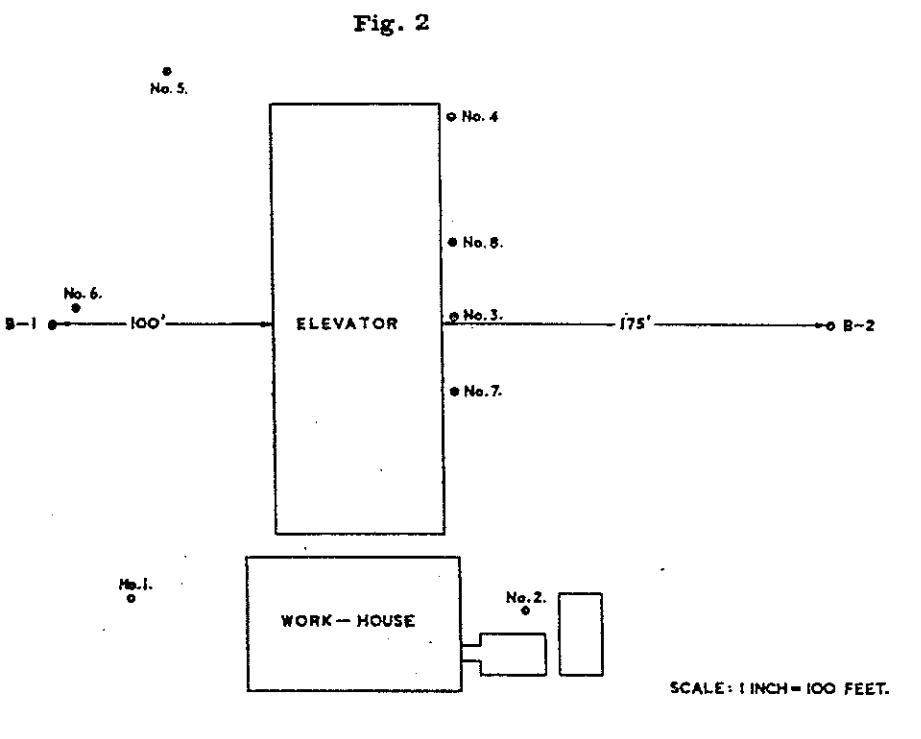
In 1951, the opportunity arose to obtain relatively undisturbed samples of the subsoil and to make the tests necessary for a theoretical computation of the bearing capacity. Two borings, B-1 and B-2, were made near to the site at the locations shown in Fig. 2, far enough from the zone of failure to be in material unaffected by the displacements. From each boring, samples in 2-inch thin-walled tubes were taken continuously through the clay strata. Laboratory tests were made to determine the index properties and the stress-strain relationships appropriate for the stability analysis.

Location of borings

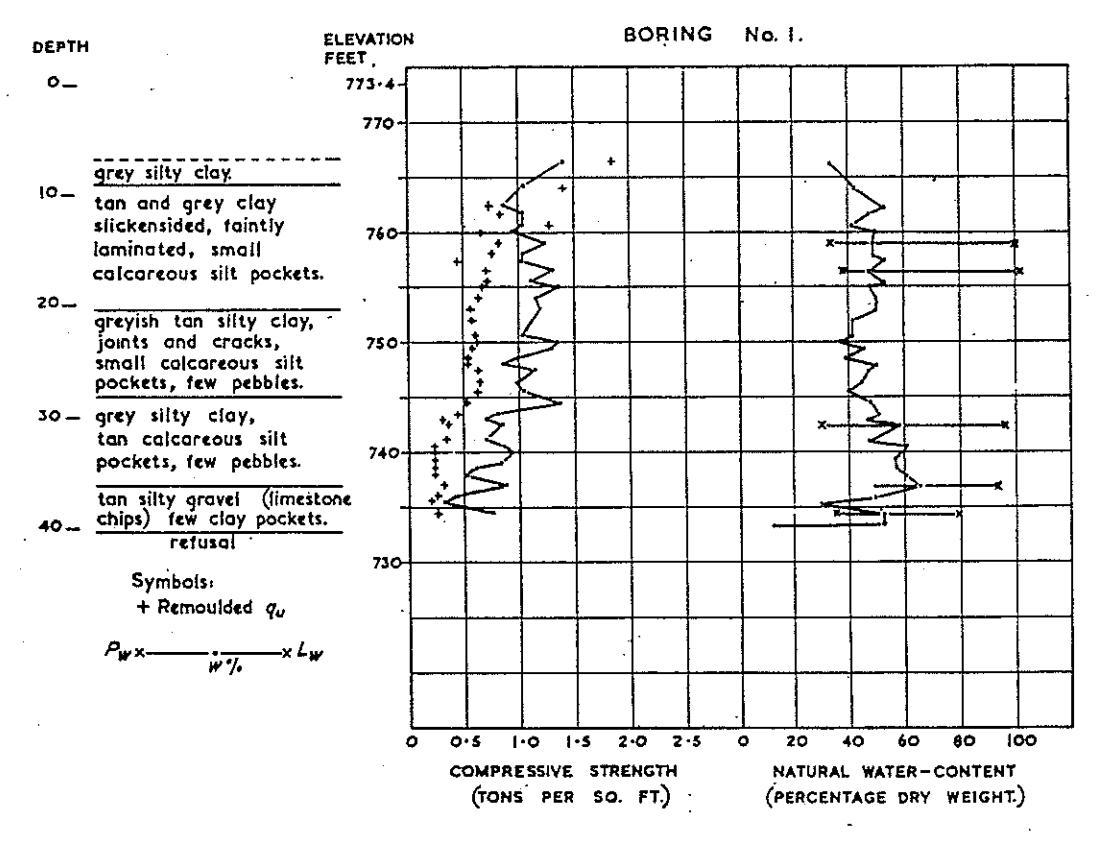
Fig. 3

Below the gray silty clay is a tan silty gravel containing limestone chips and pockets of clay. The bedrock is probably represented by refusal at El. 717 (B-2), whereas refusal in B-1 at El. 733 more likely represents a large fragment of limestone. The bedrock was not drilled.

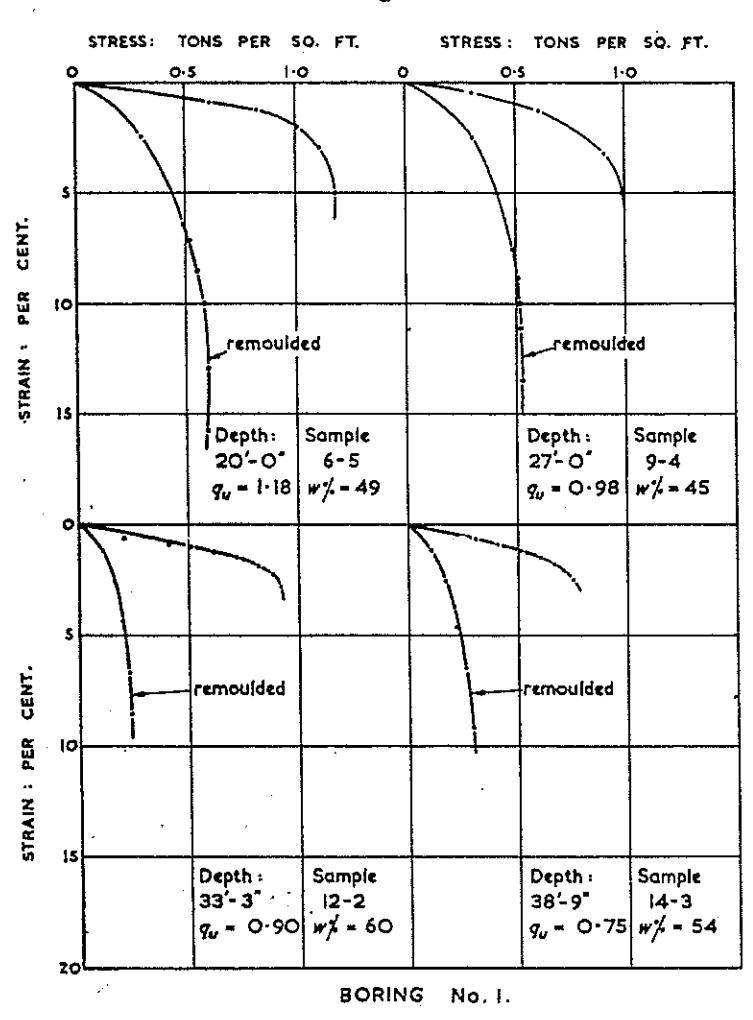
Fig. 5

The load on the base of the elevator at failure is known rather exactly. The elevator contained 875,000 bushels of wheat with a total weight of about 26,000 short tons. The dead load of the structure has been calculated \* to be 20,000 tons. The sum of these loads distributed uniformly over the mat (77 feet by 195 feet) represents a unit load of 3.06 tons per square foot. The bottom of the mat was originally established 12 feet below the ground surface. On the assumption that the unit weight of the upper 12 feet of soil was 120 pounds per cubic foot, the reduction in load owing to excavation was 0.72 ton per square foot. Therefore, the net unit-load applied 12 feet below the prairie level was 2.34 tons per square foot.

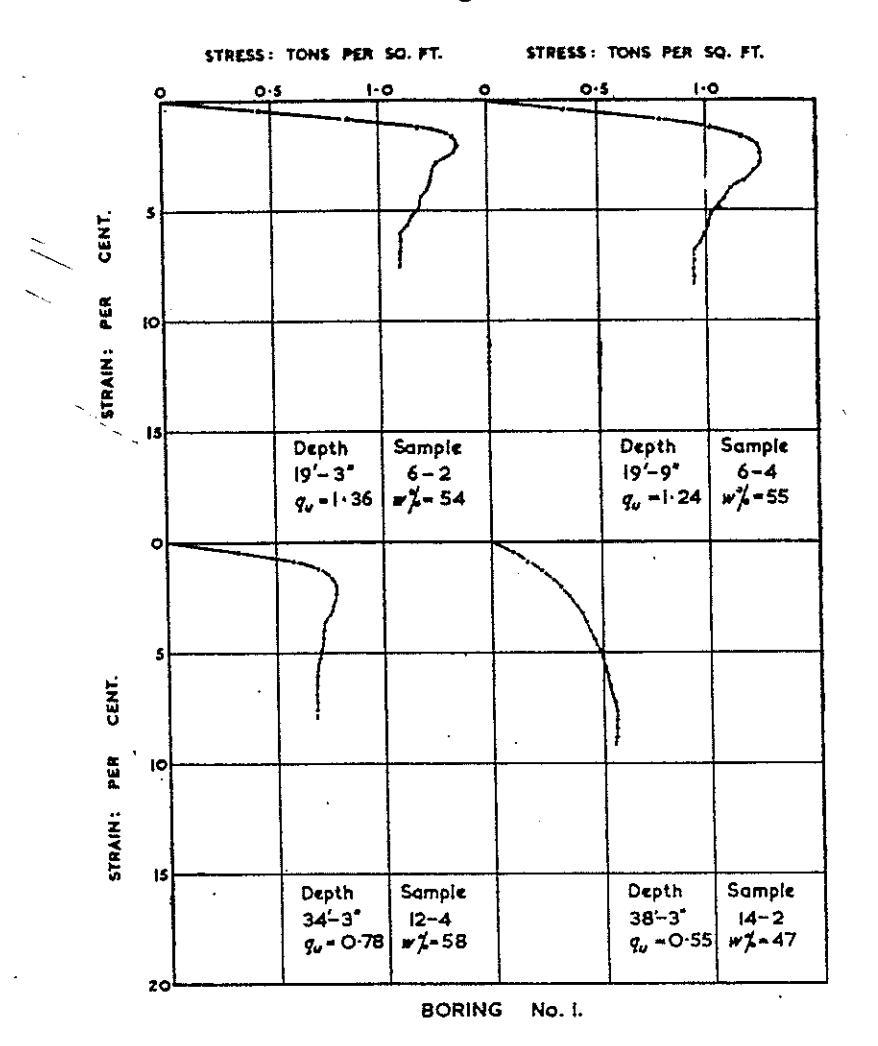
Fig. 6

A more precise investigation of the stress-strain characteristics in unconfined compression was made by performing tests on representative undisturbed 2-inch samples in constantstrain apparatus. The rate of strain was approximately 0.08 inch per minute. The corresponding stress-strain curves, shown in Fig. 6, indicate that the clays are all fairly elastic.

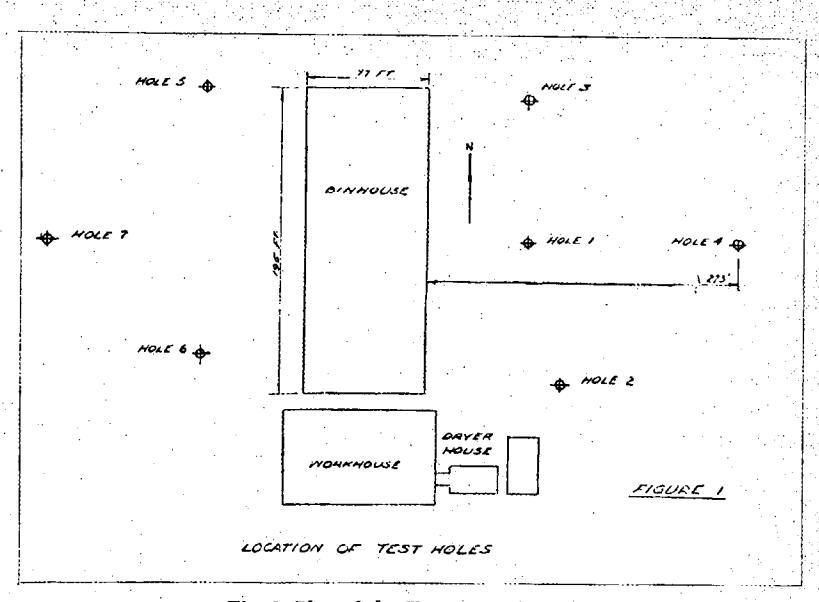
Fig. 1. Plan of the Transcona elevator.

The plan of the elevator is shown in Fig. 1. It consists of a dryer house 18 by 30 by 60 feet high, workhouse 70 by 96 by 180 feet high, and the bin house 77 by 195 by 102 feet high, all constructed mainly of reinforced concrete. The foundation failure occurred under the bin house which was designed for storing one million bushels of grain. It consists of 65 circular bins arranged 13 in each of 5 rows running north and south. The 48 interstices between bins are also used for storing grain. A raft foundation, of reinforced concrete 2 feet thick, supports the bins and the conveyor tunnels under the bins. The depth to the bottom of the footings was 12 feet below the ground surface. The design bearing pressure was 6,600 lb. per square foot based on load bearing tests for which the data are no longer available. Dead weight of the bin house was very nearly 20,000 tons.

Figure 1 shows the location of seven test holes used to obtain samples for the laboratory tests. Holes 4 and 7 were sufficiently removed from the structure to avoid disturbances caused by the failure and the righting operations.

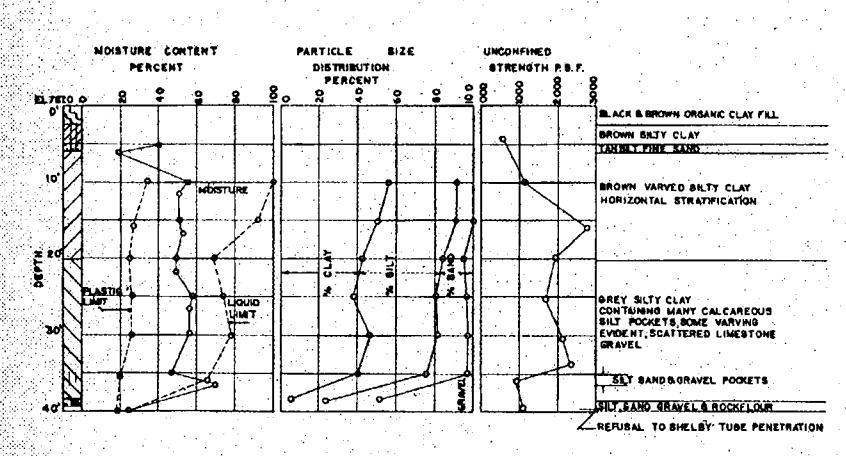
Fig. 3. Typical test hole log. (Test hole 4.)

Typical results of the tests are shown in the Log of test hole 4, Fig. 3. No tests were performed on the material above 10 feet in holes 1, 2, 3, 5, 6, and 7 where fill placed during the righting of the elevator was encountered. Hole 4 showed the silts and silty clays as they probably were over the entire area prior to the excavation for the foundations.

Below the 10-foot level to a depth of 20.5 feet in hole 4, and from 25 to 26 feet in the other holes, a brown highly stratified or varved silty clay was found. The stratification or varves were more or less horizontal and consisted of layers of silt of fractional inch in thickness between closely spaced layers of clay approximately ¼ inch thick. Average test results for this material were as follows: Unconfined compressive

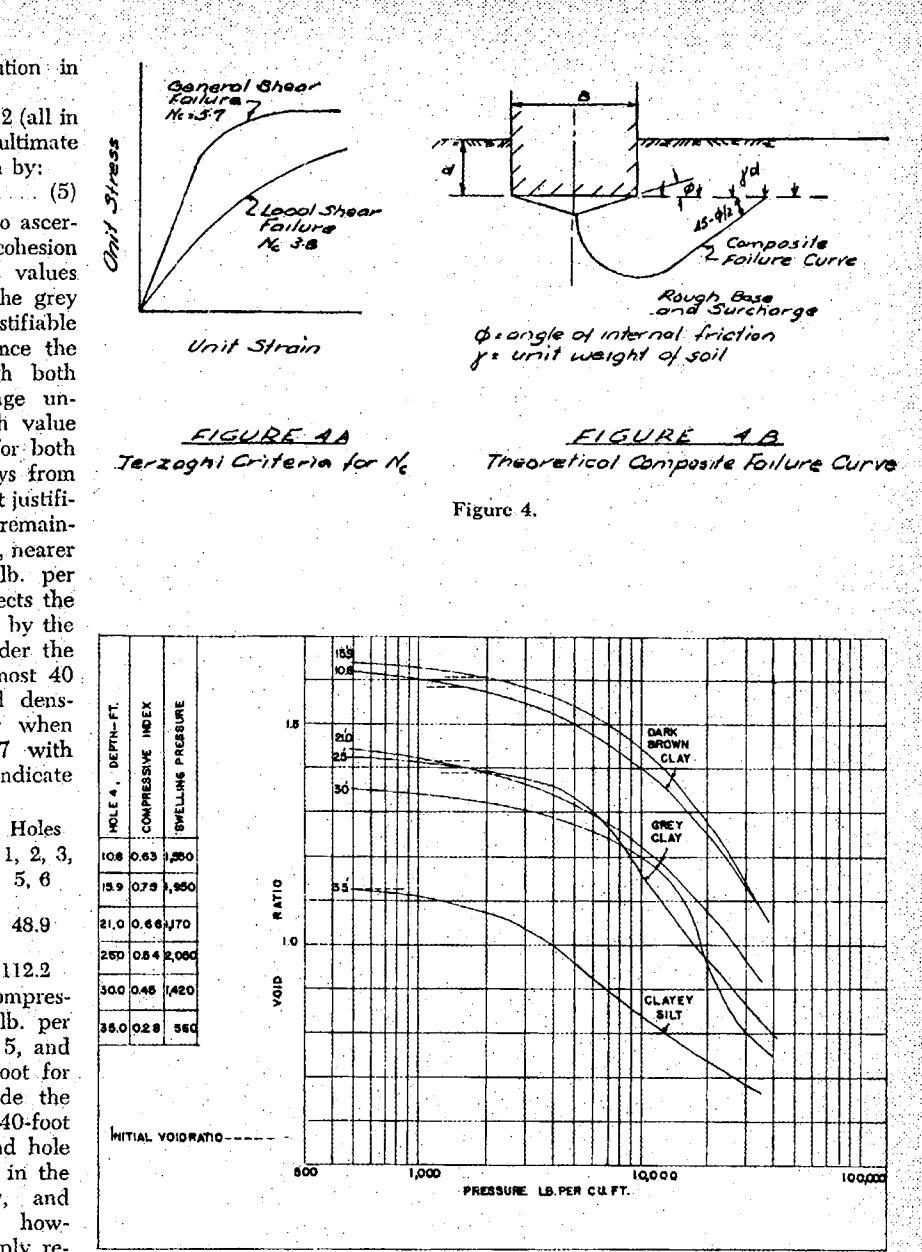
Fig. 5. Consolidation test results, hole 4.

All the samples below the 10-foot depth showed complete or near complete saturation. Twelve undrained triaxial tests on samples from hole 2 confirmed a negligible angle of internal friction for this type of loading. The consolidation test results (for samples from hole 4) indicate a decrease in compressibility with increased depth. Swelling pressures determined by permitting undis-turbed samples to swell under a small load and determining the pressure required to return the sample to its original volume, range from 560 to 2050 lb. per square foot and are typical of the Greater Winnipeg clays which contain about 30 percent of the more active clay minerals (montinorillonite). Preconsolidation pressures are not accurately determined on these clays but indicate that they are somewhat in excess of overburden pressures probably due to desiccation. The void ratio pressure curves are shown in Fig. 5.

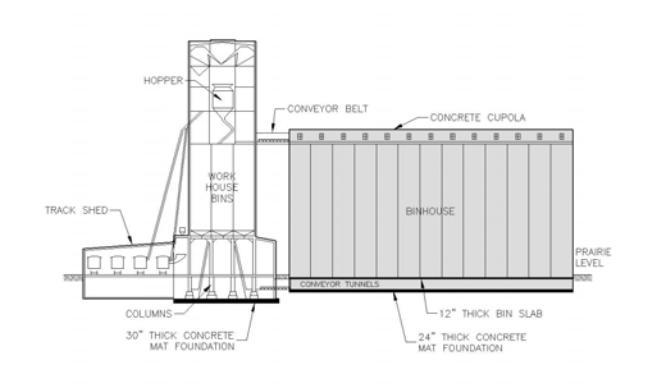
Figure 1. Profile of the workhouse and binhouse.

The Transcona Grain Elevator consists of a sixteen story workhouse and a ten story binhouse connected by two conveyer tunnels as illustrated in Figure 1. On October 18 1913, grain transfer into the newly constructed 1,000,000 bushel Transcona Grain Elevator was well underway when the binhouse began to settle and tilt to the west.

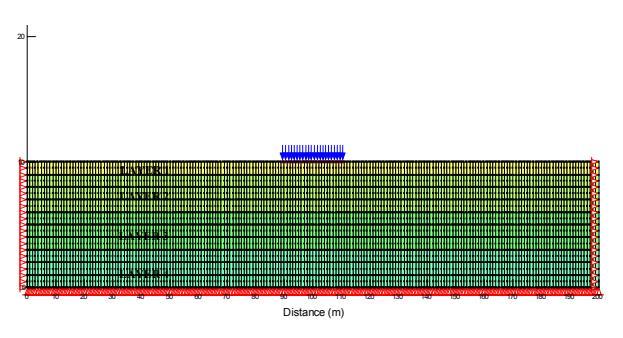
Figure 8. Finite element model domain.

For the stress deformation component of the model, stress-strain properties were taken from laboratory measurements provided by Allaire (1916) and Baracos (1955) in addition to local experience. The east and west boundaries were set far enough from the edge of the footing to ensure that they would not influence the stress or strain fields resulting from the applied loading. Figure 8 shows the Sigma/W domain with the four soil units, applied vertical stress loading and the structural elements used to define the properties of the rigid concrete mat. The east and west boundaries were set as zero displacement in the horizontal direction and the base horizontal boundary was specified as zero vertical displacement. Unit weights were applied to establish the in-situ stresses and a surcharge load was applied to represent the overburden soil above the foundation level that was excluded from the finite element mesh. This simplificaton ignores the shear strength of the soil above the foundation elevation. Although the strength of the brown clay within this upper horizon is significantly greater than the soil underlying the foundation, it can be argued that because of desiccation, only very small shear resistance could have been developed in this layer and therefore, its omission would have little affect on the results.

As expected, the veritical and horizontal stress distirbutions are hydrostatic as a function of the unit weight of the soil materials. For the transient model, the boundary conditions remained the same and the load was applied as a constant increase from day zero to time 30 days at the maximum load of 300 kPa. The footing was represented using structural elements with very high values of moment of inertia and stiffness to ensure rigid response under applied loading. The upper 1.8 m was defined as a linear elastic material to avoid numerical instability at the corners of the rigid footing (excessive shear and tension stresses) followed by three layers of modified Cam-clay material. Table 2 outlines the model stratigraphy including the final soil properties used in the model. Once the time dependent consolidation model had been run, the stress and porewater pressure distribution was imported into Slope/W to examine the factor of safety against bearing capacity at a specific time. The strength parameters were the same as those used in the modified Cam-clay model and the minimum failure surface was searched for using a grid of radius points.

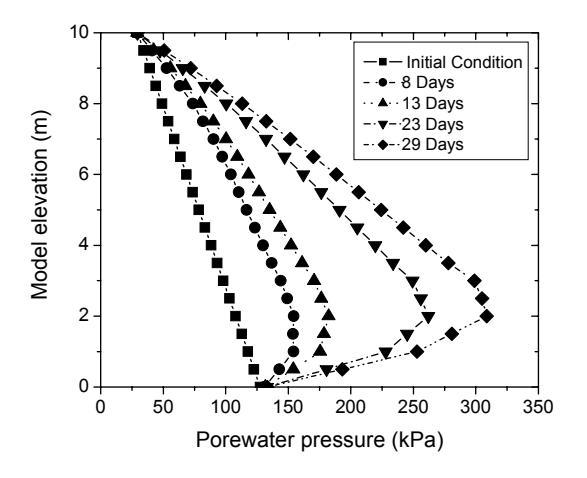
Figure 9. Porewater pressure distribution below mat.

The model was first calibrated using the behaviour of the failed structure. Soil properties were modified during the initial runs to calibrate both the factor of safety at the failure load (300 kPa) and the vertical displacements at the point of incipient collapse. Figure 9 shows the porewater pressure profile versus depth under the center of the mat at increasing time intervals. Constant values of porewater pressure at the surface and underlying till are representative of the boundary conditions applied in the Seep/W model. As the total stress increases with time, so does the porewater pressures under the mat, reaching a maximum value at approximately 8 m corresponding to

the softest clay unit (OCR of 1.1) just above the clay till interface. Figure 10 shows the porewater pressure distribution below the mat at failure corresponding to a surface load of 300 kPa. The 300 kPa contour represents the zone of maximum porewater pressure (308 kPa) with values decreasing to approximately hydrostatic at the edge of the zone of influence from the loading.

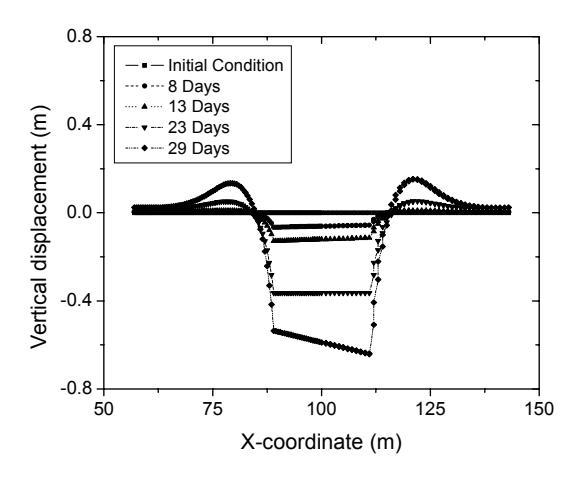
Figure 11. Surface profile of mat during loading and at incipient failure.

Figure 11 shows the vertical surface settlement profile for different time steps. It is interesting to note that the vertical settlements are relatively uniform until approximately 18 days after the initiation of loading at which time rotation of the footing initiates. The maximum unform settlements in the model match well with the 0.3 m observed settlements (White 1953) providing confidence that the model is representing the observed behaviour. The transition from uniform vertical displacements to a rotational displacement pattern suggests a progression from consolidation settlements to a bearing capacity failure. The model became unstable after the 29th day time step. Although this is not a clear indicator of instability (due to catastrophic shear failure) it can be interpreted as the development of an unstable loading condition.

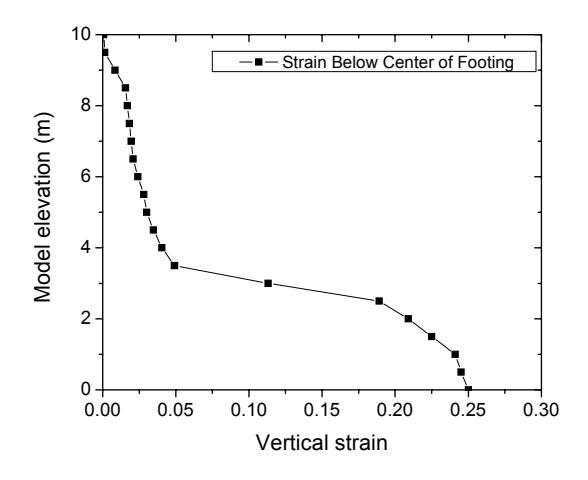
Figure 13. Strain profile below center of mat at maximum pressure.

The major difference between the Transcona Grain Elevator and many other shallow foundations is the foundation breadth. Since the breadth of the Transcona Grain Elevator mat is very large in comparison to conventional spread footings (and the plate loading tests), the depth of influence for the Transcona Grain Elevator was much larger. Penetration of the zone of influence to the softer clay above the glacial till interface provided a preferential zone of weakness for shear failure and also a more compressible zone for vertical settlements. Conceptually, this observation might support the development of progressive failure in which the maximum shear stresses are not mobilized simultaneously. Figure 13 shows the vertical strain distribution below the foundation at the failure load. The maximum strains (and therefore compression) occur in the soft clay directly above the till interface. This is also the zone where the maximum porewater pressure increase occurred due to the compressibility of the soil.

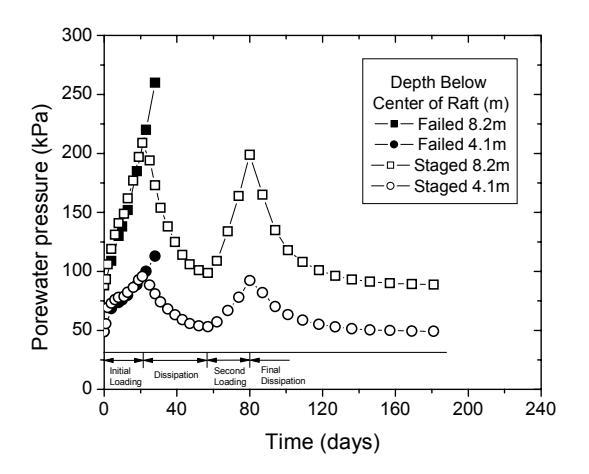
Figure 14. Porewater pressure at two points under the center of the mat.

Beyond simply understanding why the failure occurred, the fully coupled consolidation model provides the opportunity to ask the question, 'could the elevator have been filled successfully by staging the loading to ensure that the stress paths below the foundation did not reach the shear failure condition?'. To answer this question, staged loading was modeled by determining the time of loading where the stress and porewater pressure conditions corresponded to a factor of safety of 1.2 in the limit equilibrium model. The loading at that point was then held constant for a period of one month to allow for porewater pressure dissipation (and corresponding consolidation) and then loading was recommenced to the final design value (380 kPa). Figure 14 shows the porewater pressure at depths of 4.1 m and 8.2 m below the center of the mat for the original calibration model (to failure) and the staged model designed to examine an alternative loading function. As shown in the figure, porewater pressures in the original model (solid symbols) increase at both depths with increasing load up to a time of 28 days when failure occurred.

The initial porewater pressure response matches the staged model up until approximately 20 days when the loading was stopped to allow for porewater pressure dissipation. Following the end of loading, the staged model shows decreasing porewater pressure due to dissipation until approximately three months when the loading is again initiated. The porewater pressures then increase until the maximum stress is reached (380 kPa) however, the porewater pressures never exceed those reached in the first stage of loading indicating the factor of safety was greater than 1.2 for all time steps in the second loading stage. The final time of six months shows nearly complete dissipation of excess porewater pressures corresponding to a stable condition.

If one assumes that serviceability of the elevator could have been maintained even with unavoidable vertical settlements from the loading, the model demonstrates that staged loading could have been employed to reduce the likelihood of catastrophic bearing capacity failure which occurred. Using a design factor of safety of 1.2, the bins could have been safely loaded to about 60 percent of their capacity over a one month period before allowing approximately one month for dissipation of excess pore water pressures. The bins could then have been loaded to their maximum capacity over the third month and if left loaded, excess pore water pressures would have been completely dissipated three months hence. Given the rigidity of the foundation, this postulation relies on perfectly concentric loading and uniform soil conditions, conditions which arguably may not have been possible or may not exist. It does however suggest that it may have been possible to avoid what at the time was explained as an act of God. Although more than a foot of settlement may have occurred at that point, the ingenuity displayed in righting the structure leaves no doubt CP Rail would have modified the operation of the elevator accordingly.
