The Peace River Bridge Collapse:

***Fourteen Illustrations of the Collapse of the Bridge over
the Peace River at Taylor, British Columbia in October,
1957 with some personal recollections***

S. Thomson

Canadian Geotechnical Society, 2010

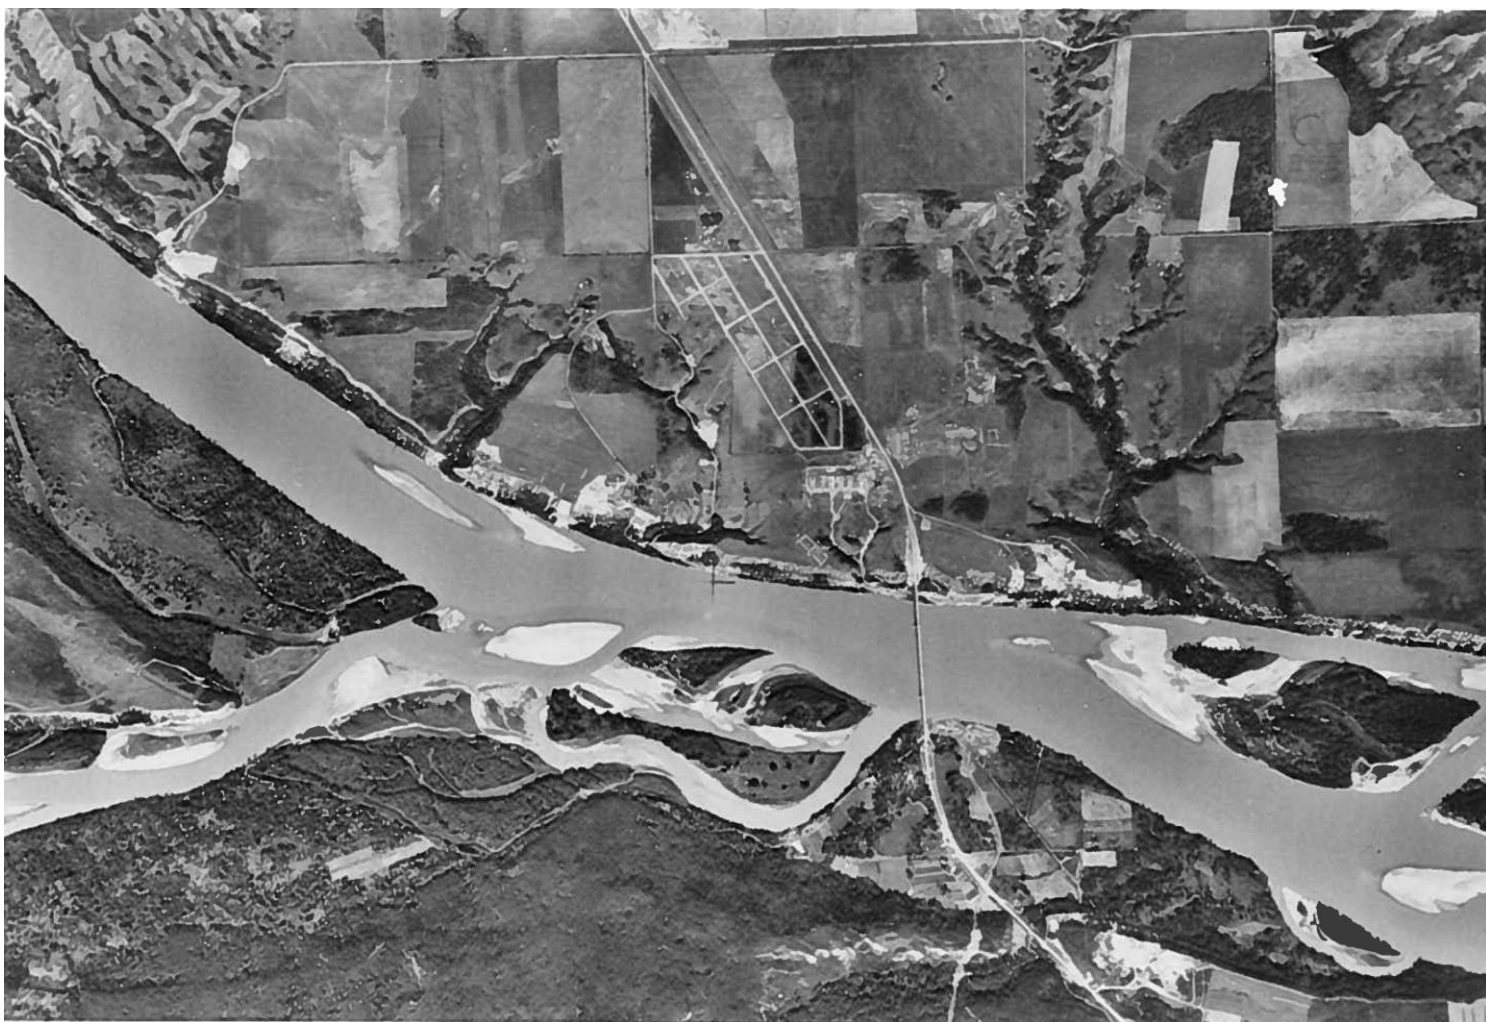
Figure 2. Peace River Bridge, 1956. The Peace River flows from left (west) to right.
The Pine River enters the Peace River in the lower left of the photo.
